STABILITY INVESTIGATIONS OF THE WHAMPOE SLIP

S. B. TAN*

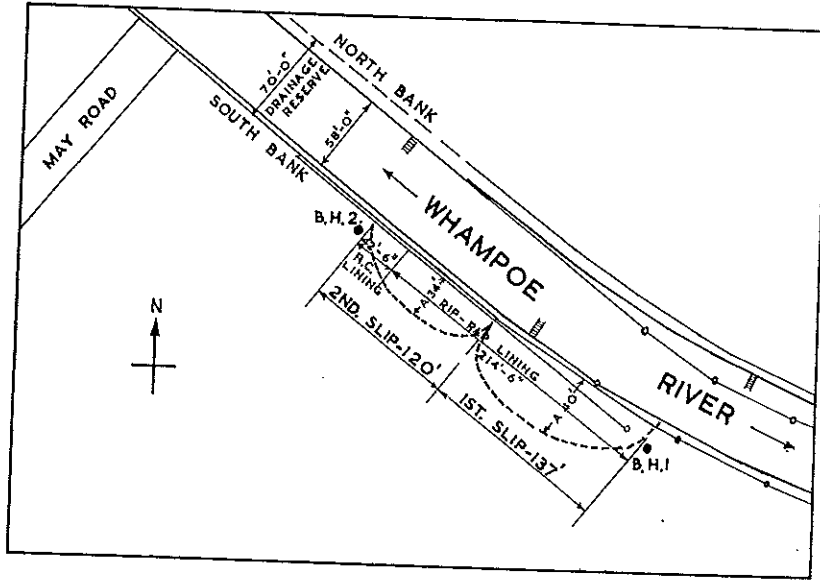
The slide occurred on 24th September 1967. It was a deep-seated one which stretched for a length of approximately 137 ft with a maximum width, measured from the edge of the bank, of about 40 ft (see Fig. 1). The slide destroyed the riprap lining completely and chunks of soil appeared to have been pushed up from the river bed to the opposite bank. The extreme landward end of the slide surface sank about 3 ft. The slip seemed to be very sudden. At the time of the slide stacks of granite stones about 7 ft high, which had been placed there sometime in June or July, were seen on the bank;

the water in the river was then only about 6 in. deep. The external loading, coupled with the low water level, was probably the main cause of the slip.

Fig. 1. Site plan of slip area showing positions of borings.

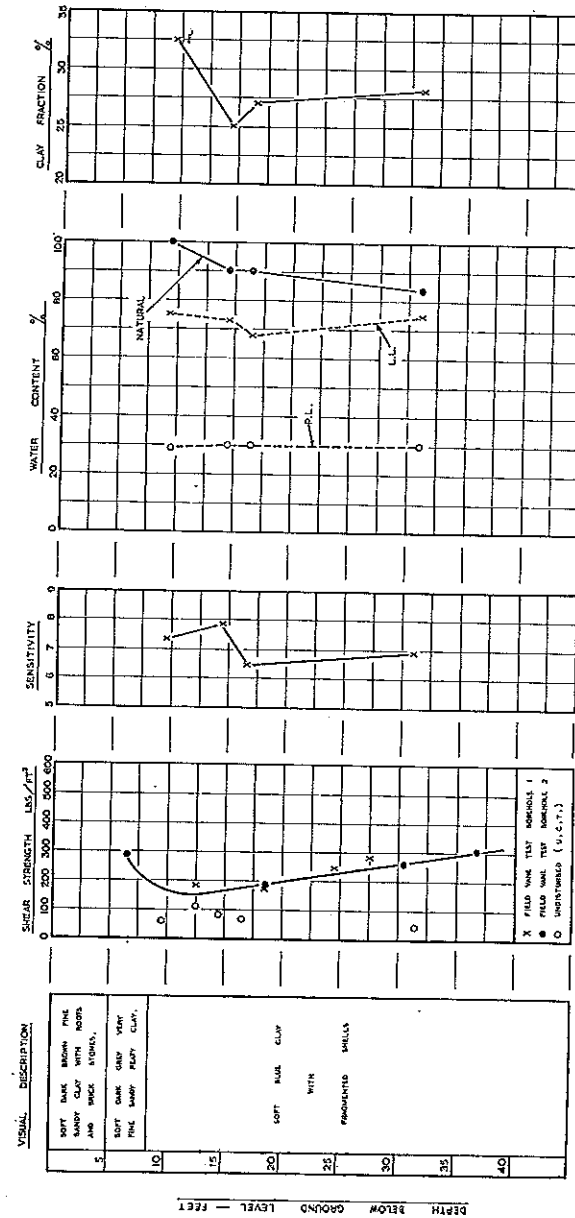
Fig. 2. Borehole log and test results for Borehole 1.

The results of boring and laboratory tests for Borehole 1 are shown in Fig. 2. Except for the first few feet of surface soil, soft, blue clay with fragmented shells predominates up to the end of the boring. The moisture content is high (about 100%) and decreases slightly with depth. The liquid limit drops slightly with increase in depth but the plastic limit remains almost constant; it should be noted that the Atterberg limits were determined on oven-dried samples. This gives a decrease in plasticity index with depth which is reflected in the observed decrease with depth of the clay fraction. Vane test results show an approximate linear increase in undrained shear strength with depth, the higher values for the top few feet presumably being due to desiccation. The results for Borehole 1 agree well with those for Borehole 2, suggesting consistency and uniformity. The value of c_u/p' is 0.27. For the plasticity index shown this value conforms with the well-known relationship between c_u/p' and plasticity index given by SKEMPTON (1957). This observation suggests that the clay is normally-consolidated, which is confirmed by the results of consolidation tests, although the preconsolidation pressures for these tests are poorly defined.

The sensitivity, which is defined as the ratio of field vane strength to remoulded vane strength, shows a slight decrease with depth and ranges from 6 to 8, indicating that the material is very sensitive. The bulk density, in general, is fairly constant with depth at a value of 93.8 lb/ft.³

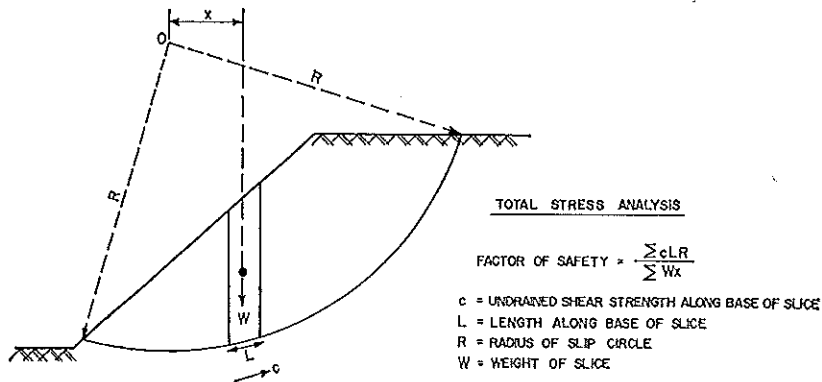
Fig. 3. Outline of the ' $\phi = 0$ ' analysis.

The outline of the ' $\phi = 0$ ' analysis for the slide is shown in Fig. 3. This method is based on the assumption that there is no change in soil water content on loading (i.e. failure takes place under undrained conditions). When a fully saturated clay is sheared under such conditions, it will behave as if it were a purely cohesive material with $\phi = 0^\circ$. The undrained shear strength is, hence, appropriate for use in the stability analysis. In the stability calculations for the Whampoe slip the undrained shear strengths determined by the field vane test were used, since it was felt that these results were the most reliable and representative.

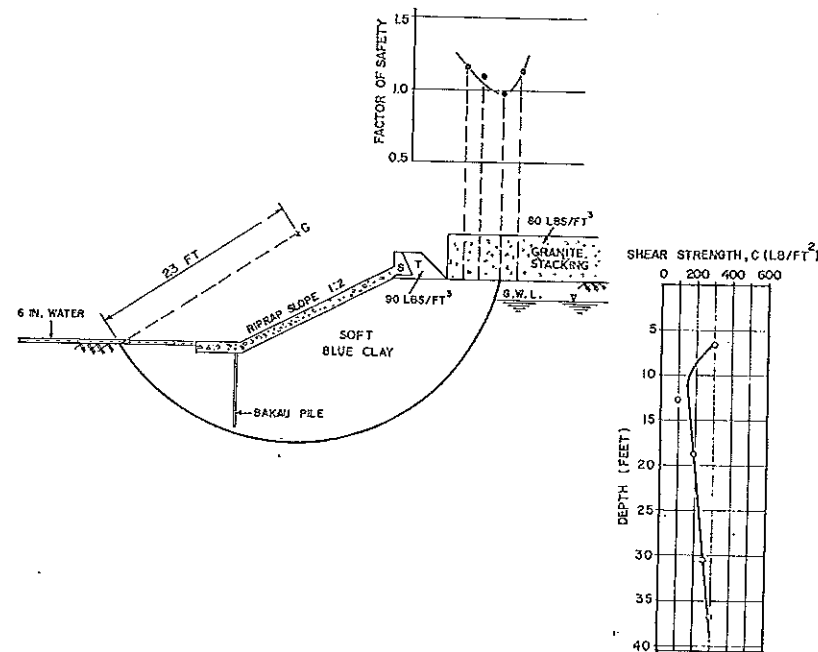
In Fig. 4 the results of the stability analysis for the slip are presented. The minimum factor of safety obtained is 0.97. This is less than the value

Fig. 4. Stability analysis of slip ($\phi = 0$).

of 1.0 at which failure should occur, and the difference is probably due to the fact that the effects of the forces on the ends of the cylindrical soil body under consideration were ignored in the calculations. Nevertheless, the critical factor of safety of 0.97 is very close to unity, from which it is evident that the total stress analysis gives a good estimate of the stability of the Whampoe River bank.

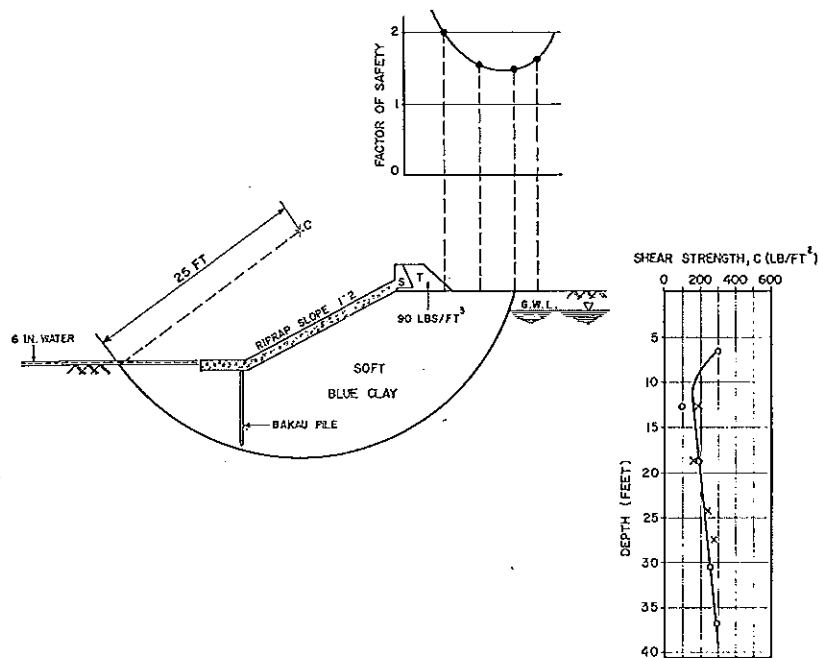
The stability analysis for the unloaded slope is shown in Fig. 5. The minimum factor of safety is 1.45. Therefore, the slope is stable so long as there is no excessive surcharge loading on its bank, which accounts for why no failure of this slope has occurred.

Fig. 5. Stability analysis of stable slope ($\phi = 0$).
