REACTIVATED SETTLEMENT OF AN OLD MONUMENT FOUNDED ON BANGKOK CLAY

N. Phienwej¹, and D. K. T. Loan²

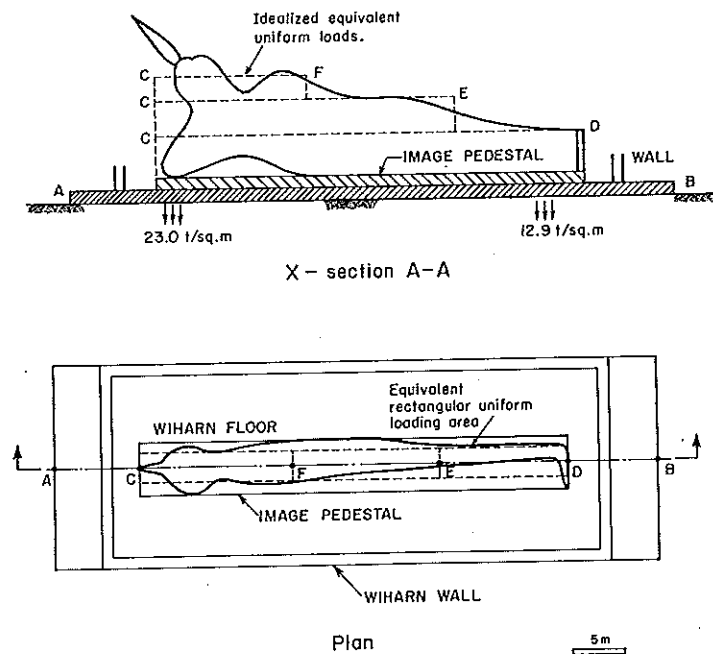
Fig. 1 Profile and Plan Layout of the Buddha Image.

The image of the Reclining Buddha of Po Temple in Bangkok is one of the most prestigious and sacred national monuments of Thailand. This huge, gold-plated masonry structure, 46 m long and 5 m wide, was constructed more than 160 years ago in a swampy land, 150 m from the bank of the Chao Phraya river next to the world famous Grand Palace. The image is placed on a 1.3 m high pedestal in the central part of a brick building (wiharn). The wiharn's floor is in turn elevated 1.3 m above the present ground surface. Both structures are founded on a mat foundation made of brick and timber log grillage. Below the pedestal the foundation extends about 3 m below the ground surface in the soft Bangkok clay. According to the record the land was backfilled about 40 years prior to the construction of the image. The layout and profile of the image are shown in Fig. 1. The image is 5 m high in the foot side but 15 m high with a wider base in the head side resulting in a big difference in dead load intensity along its length. Presently, a large differential settlement exists along the pedestal and wiharn floor which is undoubtedly attributed partly to this non-uniform load intensity imposed on the underlying soft clay.

The ranges of the state of stresses that presently exist at various depths in the soft clay layer below the head and foot side of the image are outlined in Fig. 5. These stresses are calculated from the weight of the structure using an elastic solution assuming an equivalent stack of uniform loads (Fig. 1) on a flexible foundation. It can be seen that in the head side area the soft to medium clay layer is presently subjected to vary high stress levels as compared to its strength. On the contrary, the stress levels are not so high in the foot side area.

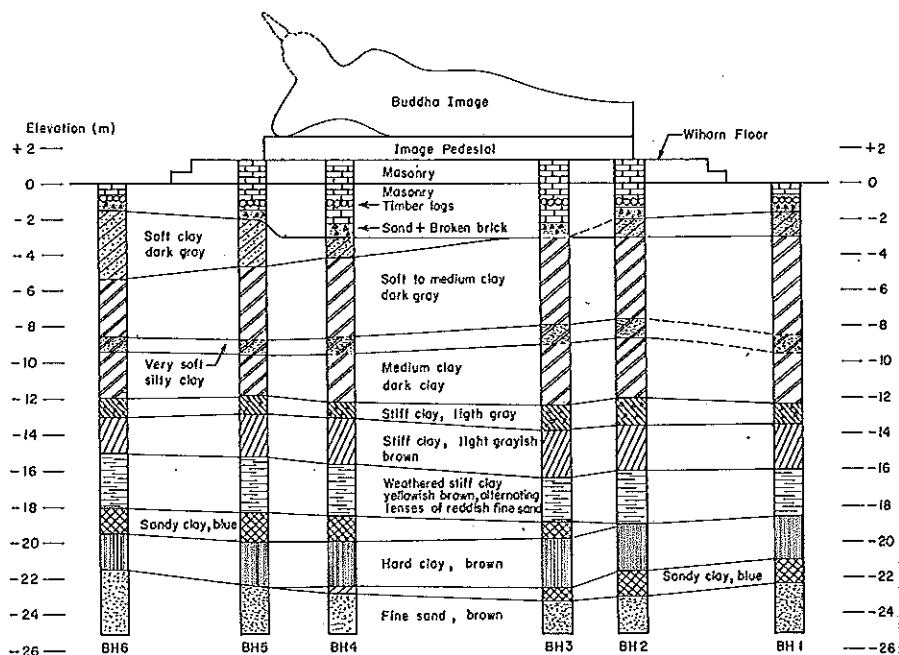
Fig. 3 Subsoil Profile underneath the Buddha Image.

The subsoil stratigraphy (Fig. 3) is relatively uniform throughout the area except for the thickness of the very soft clay layer below the surface which is about 2 m thicker in the head side area. This layer is suspected to be an old landfill. Three distinct features are present in the subsoils as described below.

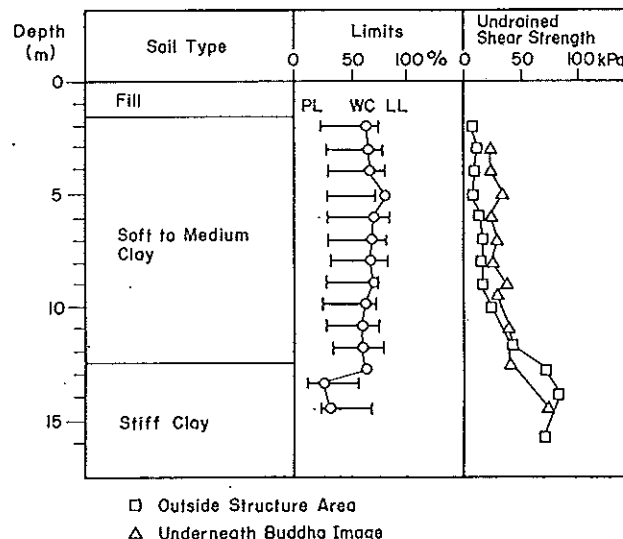
Fig. 4 Index Properties and Undrained Shear Strength of Subsoils.

Unconsolidated undrained triaxial test results (Fig. 4) clearly showed that the undrained shear strength of the clay was higher in the area underneath the image than that in the outside area. This was thought to be the result of the post construction consolidation of the clay from stress increases by structural loading.

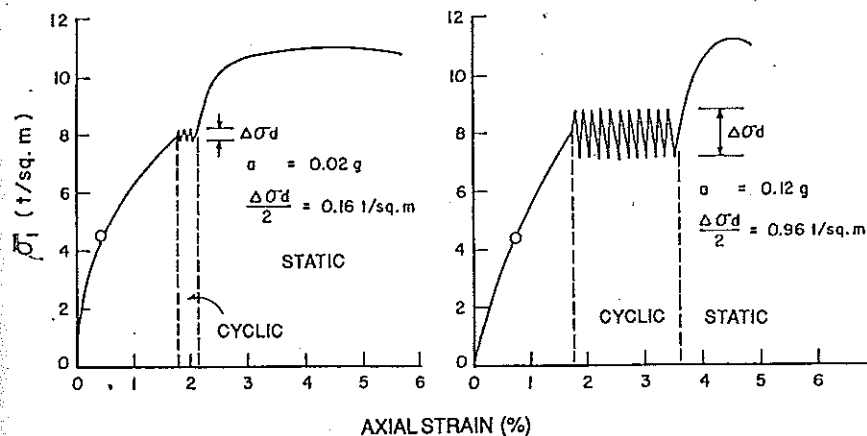
Fig. 6 Stress-Strain Relation of Soft Clay from Cyclic Triaxial Tests, $\bar{\sigma}_3 = 4.5$ t/sq.m.

The test results indicated that even for the worst cyclic stresses adopted in this test series (i.e. particle acceleration of 0.12 g on a specimen consolidated at the largest anisotropic stress: $\bar{\sigma}_1 = 80$ kPa and $\bar{\sigma}_3 = 45$ kPa, shown in Fig. 5) the application of cyclic stresses up to 10000 cycles did not weaken the subsequent static undrained strength (Fig 6). Therefore, traffic induced vibration was excluded as a cause of the settlement.

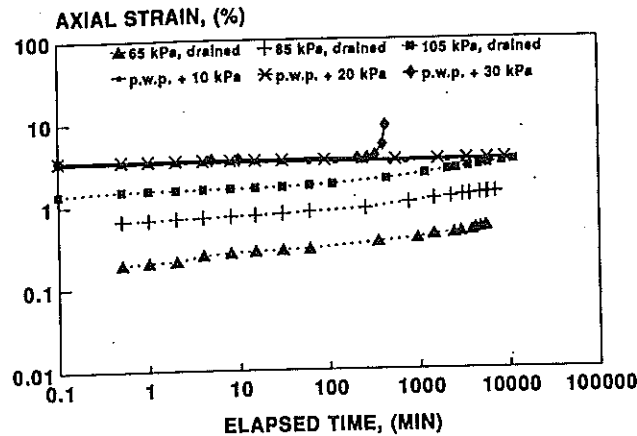
Fig. 7 Axial Strain-Elapsed Time Relationship from Anisotropically Consolidated, Drained Creep Test of Soft Clay, Test CAH 1.

and foot side areas. The combined effect of swelling and drained creep response to an increase in porewater pressure by 10 kPa resulted in a very minor increase in axial strain with time for both initial stress conditions. The creep parameter was smaller than 0.004. For test CAH1 (the state of stress corresponded to that existing below the head side) the specimen did not start to show significant creep response until a 30 kPa of porewater pressure increase was applied (Fig. 7). Therefore, it was concluded that creep of the soft clay was not a significant factor contributing to the continuing differential settlement of the image.

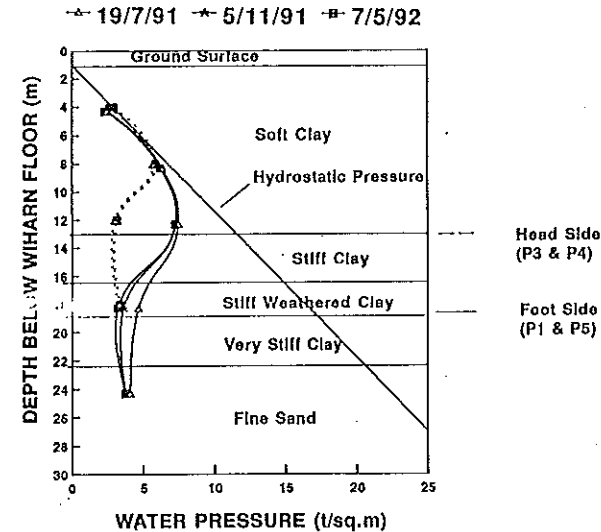
Fig. 8 Difference in Groundwater Conditions between the Head and Foot Sides of the Buddha Image.

Piezometric pressure distribution with depth in the subsoils underneath the Buddha image observed from a network of open-stand pipes with AIT type piezometer heads installed in the latest investigation is summarized in Fig. 8. There is a marked difference in the magnitude of piezometric pressures at depths deeper than about 8 m between the head side and foot side areas. The drawdown in the head side area was similar to those typically observed throughout Bangkok area due to deep pumping

(AIT, 1981 and Ng, 1983). However, it was much smaller in the foot side area. The reason for this big difference in the drawdown within a short distance of 46 m along the length of the image is not yet clear. However, it is considered that the groundwater levels may be influenced by recharge from the Chao Phraya river located just 150 m away from the foot side (Fig. 9).

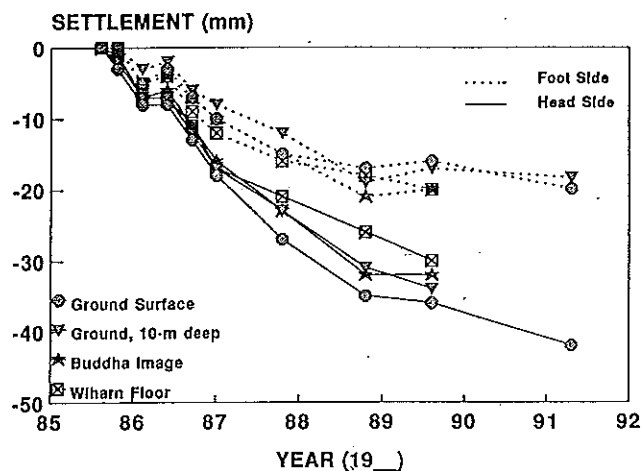
Fig. 10 Increases in Settlement of Various Parts of Structure and Ground.

Settlement monitoring of the Buddha image began in 1985 and revealed a continuing increase in settlement but at a decreasing rate beneath all parts of the structure and outside ground surface as summarized in Fig. 10. The magnitudes of the settlement shown in the figure were in reference to a 20-m deep benchmark located 400 m away. The benchmark must have also undergone some deep settlement itself. However, subsidence of the benchmark during the monitoring period was not recorded.

The data revealed that the ground surface outside the loading area from the weight of the structure continued to settle at a similar rate to those of the structures in both the head side and the foot side (Fig. 10).

Deep ground settlement points installed in the head side area of the image (EGAT, 1987) showed only a slightly smaller settlement than those recorded by the corresponding surface settlement points (Fig. 10). This indicated that most of the recorded surface settlement was from consolidation of soil layers deeper than 10 m, not the shallow soft clay layer. Multiposition borehole extensometers were just installed a year ago to verify this but the data recorded is still too small.

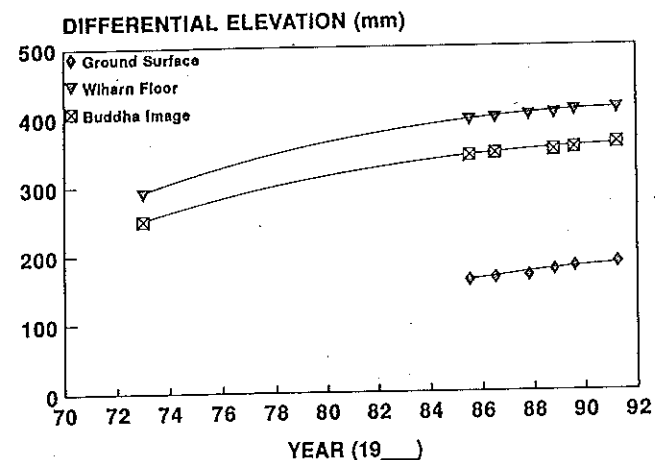
Fig. 11 Increases in Differential Settlement of Various Parts of Structure and Ground.

All settlement points showed greater rates of settlement in the head side area than in the foot side area resulting in the continuing increase in the differential settlement as shown in Fig. 11. The differential settlements of the structures and outside ground surface showed a similar trend of a decreasing rate with time that almost leveled off at present.

At present, no remedial measures have been undertaken due to two reasons. Firstly, the current rate of settlement is very small and has shown a levelling off trend. Secondly, the integrity of the foundation of the structures is not known yet. Thus, an attempt to stabilize the ground might damage the structures.
