LESSONS LEARNED FROM RECENT MRT CONSTRUCTION FAILURES IN ASIA PACIFIC

Z.C. Moh¹ and R.N. Hwang¹

Keywords: MRT construction failures, Tunneling

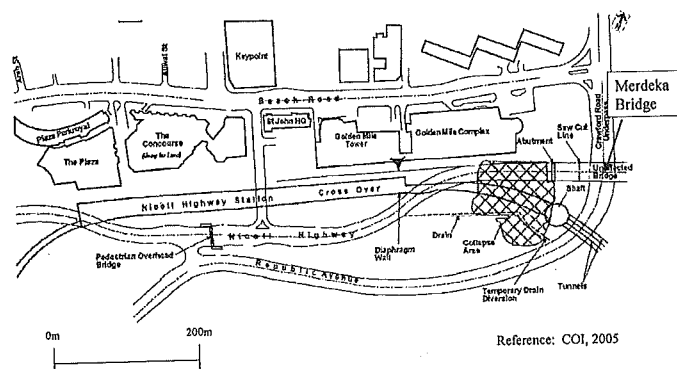
Failure started as the waling on the northern wall buckled at 9am on 20 April and by 3pm all the struts for a 100m section totally failed. As Nicoll Highway sank, gas, water and electricity cables ruptured, causing power to go out for about 15,000 people and 700 businesses in the Marina and Suntec City area. Tremors were felt at Golden Mile Complex. Tenants and residents in the building were also evacuated. One of the spans of Merdeka Bridge was demolished as a precaution and was rebuilt shortly afterward.

The Committee identified critical design and construction errors, particularly the design of stiffeners on the walings at the connections between the diaphragm walls and the struts, that led to the failure of the earth retaining system. The Committee also found deficiencies in the project management that perpetuated and aggravated the design errors, including inadequate instrumentation and monitoring of works, improper management of instrumentation data, and lack of competency of persons carrying out specialized work.

Fig. 1 Collapse of Nicoll Highway due to construction of the Circle Line, Singapore MRT

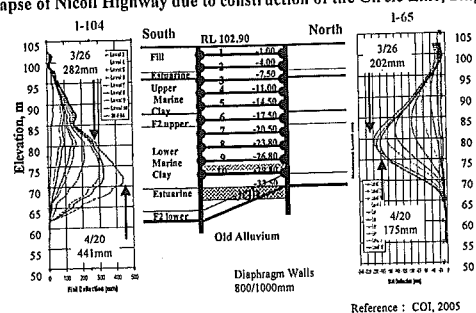
Fig. 2 Ground conditions and retaining system at the MRT site next to Nicoll Highway, Singapore

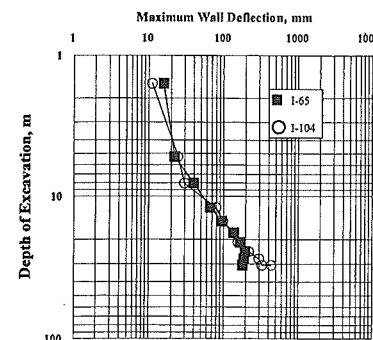
Figure 4 shows the wall deflection paths, which are the plots of maximum wall deflections versus depth of excavation in a log-log scale, for the two inclinometers installed on the two sides of the excavation (Hwang et al., 2007). Wall deflections on the two sides were about the same till 9 March, 2004, when excavation reached a depth of 25m, and deflections of 198mm and 215mm were recorded by Inclinometers I65 and I104, respectively. Subsequently, there was a period in which I104 was not read because it was damaged. When monitoring resumed on 26 March, the deflection of the southern wall was found to have increased by 67mm to 282mm while the readings for Inclinometer I65 on

the north were fairly steady in this period. The readings for Inclinator 1104 kept on increasing while those for I65 remained to be steady subsequently, presumably, because of the asymmetry of ground conditions. In fact, I65 appeared to move outward by 27mm, from 202mm on 26 March to 175mm on 20 April, as depicted in Figs. 2 and 4. On the other hand, Inclinator 1104 moved inward by 90mm to 441mm in the 3-day period from 17 April to 20 April.

Fig. 4 Deflection paths for diaphragm walls at MRT site next to Nicoll Highway, Singapore

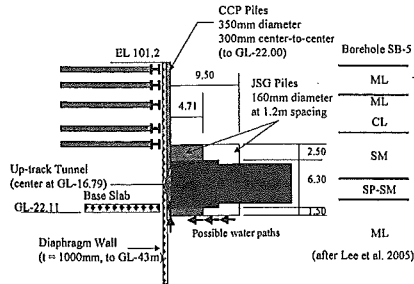
As the shield machine in the Up-track tunnel arrived at O2 Station and a portion of diaphragm wall was knocked out to make a portal at the tunnel eye, groundwater spurting into the pit (Lee et al., 2005). The site is very close to the seashore as shown in Fig. 5 and was a salt pan decades ago. It is located in a delta formed by the estuary of the Ai River. Groundwater table is very close to the surface and is influenced by the fluctuations of tides. The ground conditions at the site are shown in Fig. 6 and the N-values obtained in SPT tests at a nearby borehole are shown in Fig. 7. The properties of subsoils below the invert of the tunnel are given in Table 11. Although the SPT blow counts are in general greater than 15, subsoils consist predominantly of silts with natural water contents very close to their liquid limits. Such soils may easily be softened once disturbed or even liquefied when subjected to large hydraulic gradients.

Leakage started at the invert of the tunnel eye at 20:30 on 29 May 2004 and ground started to settle at 22:30 as the flow increased and sands were washed out. A sinkhole was finally formed and measurable ground settlements reached a distance of 50m. Seven 3-storey buildings in the vicinity were seriously damaged as the foundations settled by more than a meter and about 40 families were evacuated. The buildings were demolished shortly afterward and had already been rebuilt by the time this paper was prepared.

Fig. 6 Collapse of tunnel portal, O2 Station, Kaohsiung MRT

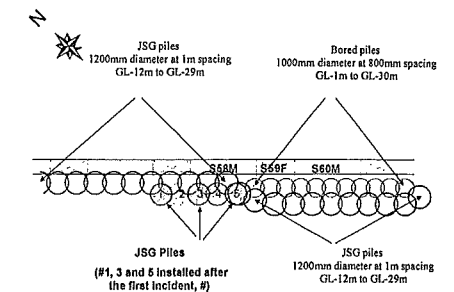
Water spurted from the bottom of the excavation in front of Panel S60M, refer to Fig. 9, on the southern wall at 13:20 on 9 August 2004 as excavation reached a depth of 15m at O1 Station which is located near the seashore as shown in Fig. 5. A sinkhole of 3m maximum depth was formed behind the diaphragm wall and the area affected was around 500m². Four 3-story buildings collapsed in less than an hour and were demolished overnight. Several low-rise shops were severely damaged and were demolished sometime later.

Fig. 9 Ground treatment prior to July 7, 2005, O1 Station, Kaohsiung MRT

To be on the safe side, one row of JSG piles was added along the entire perimeter of the station. Furthermore, the joints between JSG piles were treated by using CCP piles. Pumping tests were again performed subsequently to confirm the effectiveness of these measures. The results were not satisfactory as the rate of recovery of groundwater inside the excavation was only slightly smaller than that obtained previously (Ho et al., 2007). It was decided to add more JSG piles at the back of Panel S58M. Three new piles were installed without problem. As No. 4 pile, refer to Fig. 9, was installed on 7 July 2005, groundwater brought a large quantity of soil into the pit. A nearby hospital was endangered and the patients in the hospital

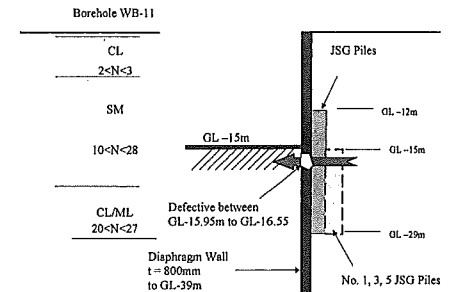
The site is located right at the mouth of the Ai River and the ground conditions are extremely poor. Figure 10 shows the soil profile obtained at Borehole WB-11. The pit was retained by diaphragm walls, 800mm in thickness and 39m in length. As mentioned in Section 3.3, subsoils on the west coast of Kaohsiung City can easily be softened once disturbed, or liquefied when subjected to large hydraulic gradients and, therefore, failures of trenches during installation of diaphragm walls were quite common. In many cases, mini-piles and/or micro-piles were installed to prevent trench collapse. Even so, necking frequently occurred and reduced the sectional areas of diaphragm walls. Furthermore, groundwater has extremely high chloride contents and the quality of diaphragm walls deteriorates quickly as a result of chloride attack. Ground treatment frequently had to be applied behind defective diaphragm walls to stop ingress of groundwater into pits.

Fig. 10 Soil profile and ground treatment behind Panel S58M prior to July 7, 2005, O1 Station, Kaohsiung MRT

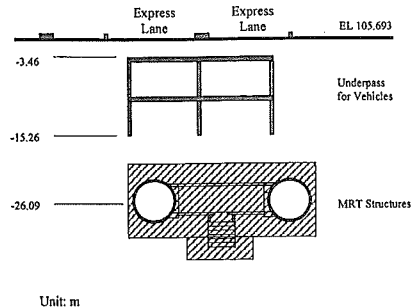
As excavation was carried out at the bottom of a crosspassage, refer to Fig. 5 for the location of the site, for constructing a sump, water started to spurt out at 5pm on 4 December 2005 and the flow soon became uncontrollable because of the huge water pressure. The center of the crosspassage is located at a depth of about 26m below the

surface and excavation was supposed to go down to a depth of, roughly, 33m for constructing the sump as depicted in Fig. 11. Excavation for the sump, with an outer diameter of 3.9m, was carried out in 7 stages, each 0.5m in thickness, as shown in Fig. 12. The sidewall of the excavation was protected by shotcrete as temporary lining. At the time the incident occurred, excavation had reached the last stage and half of the area had already been completed.

Fig. 11 Section at the location of the crosspassage and the sump

The situation was aggravated by the rupture of 300mm and 600mm water pipes. The tunnels, together with the underpass above the tunnels, about 100m in length were totally damaged as a result. The tunnels and the underpass

will be rebuilt by using the cut-and-cover method of construction with diaphragm walls to depths exceeding 60m. Ground freezing technique will be applied at the two ends of the damaged section to seal off the gaps between the diaphragm walls and the tunnels and to solidify the sludge in the tunnels to become plugs to enable excavation to be carried out. Finally, these plugs will be removed and damaged segments replaced.

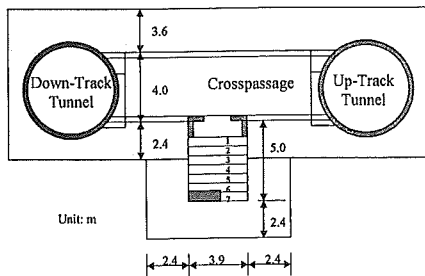
Fig. 12 SJM treatment for excavation for the crosspassage and the sump

The soils surrounding the crosspassage and the sump had been treated by using the JSM (Superjet Midi) grouting method prior to the commencement of excavation as depicted in Fig. 12. The quality of ground treatment might have been affected by the fact that grouting had to be carried out mostly in inclined holes because of the presence of an underpass running in parallel with the tunnels. Water tests were carried out to confirm the effectiveness of the treatment. Additional grouting was carried out to seal off water paths when seepage was noticed. This however did not prevent the failure from happening.
