# **Case Histories of Failures in Geotechnical Engineering Practice**

**Richard Hwang**

# Case 1 – Human Error (Negligence)

# Case 3 - Unforeseen Condition

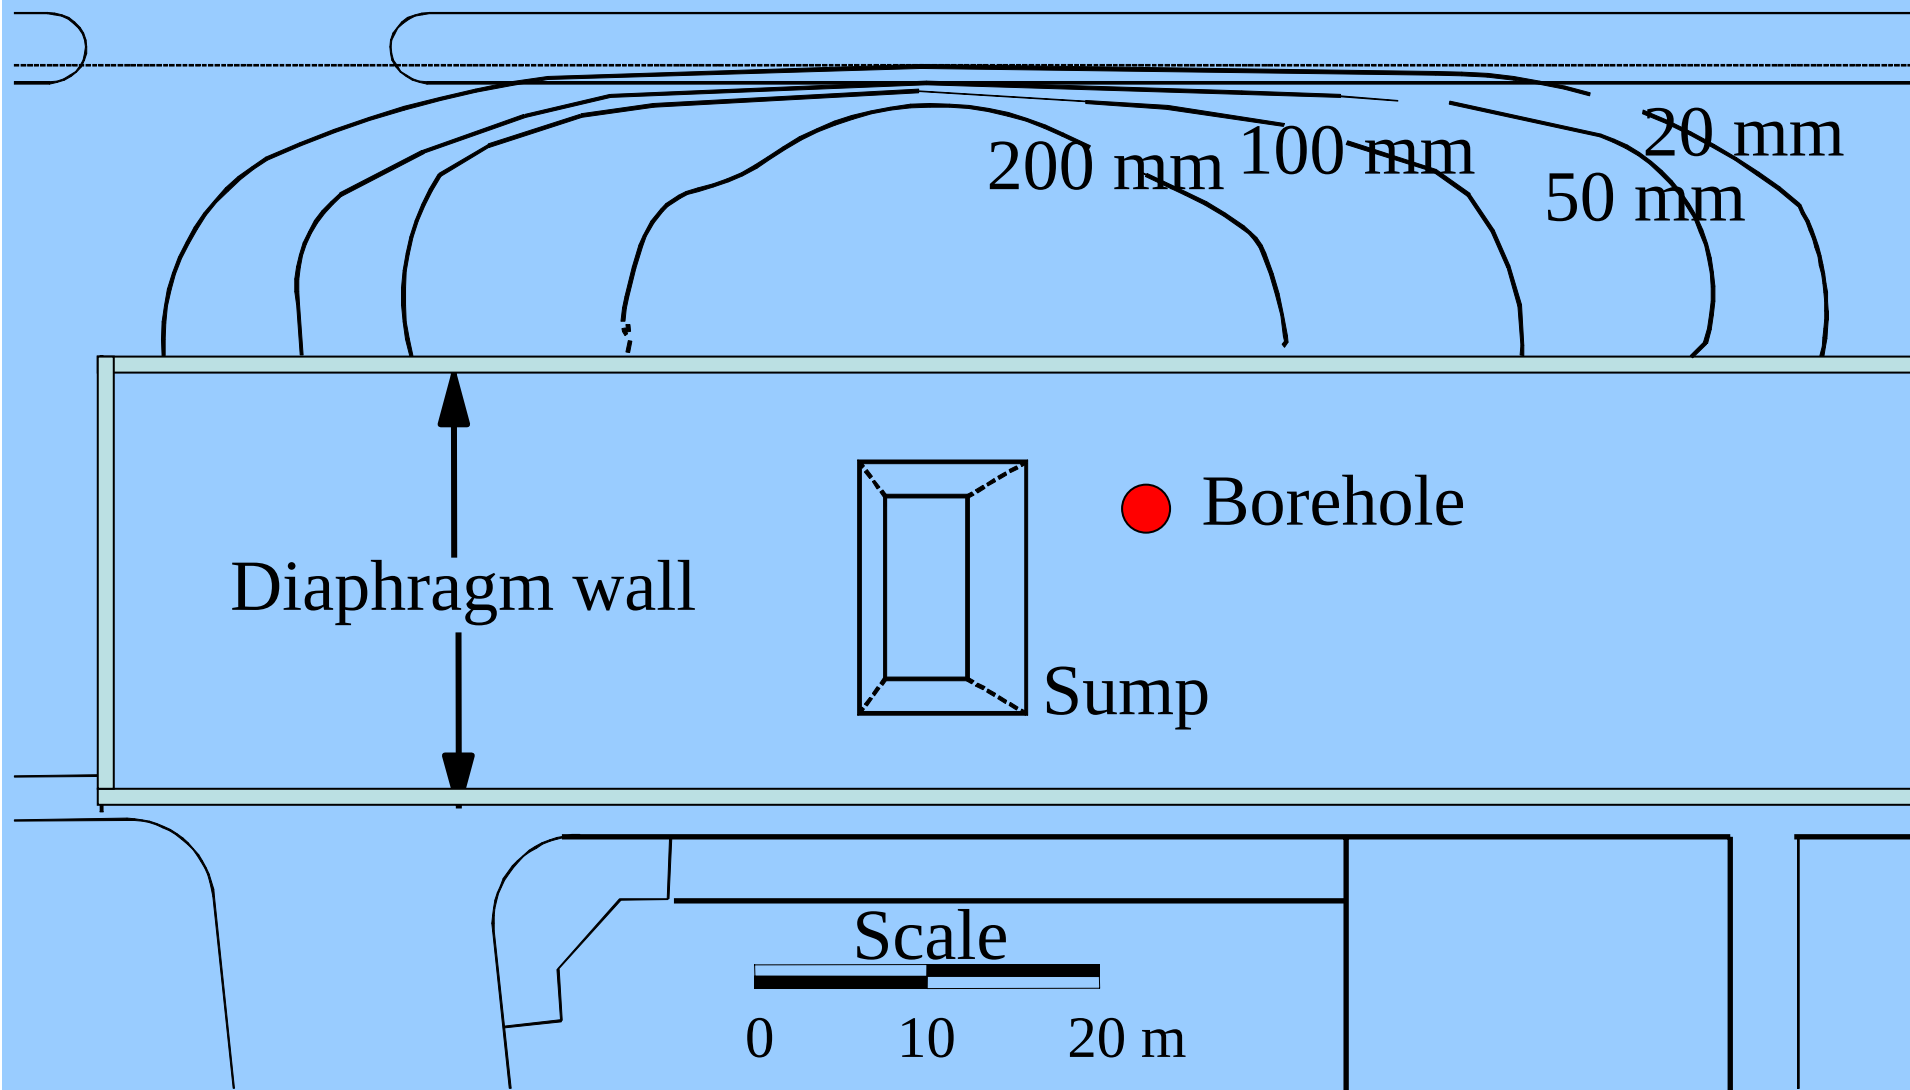
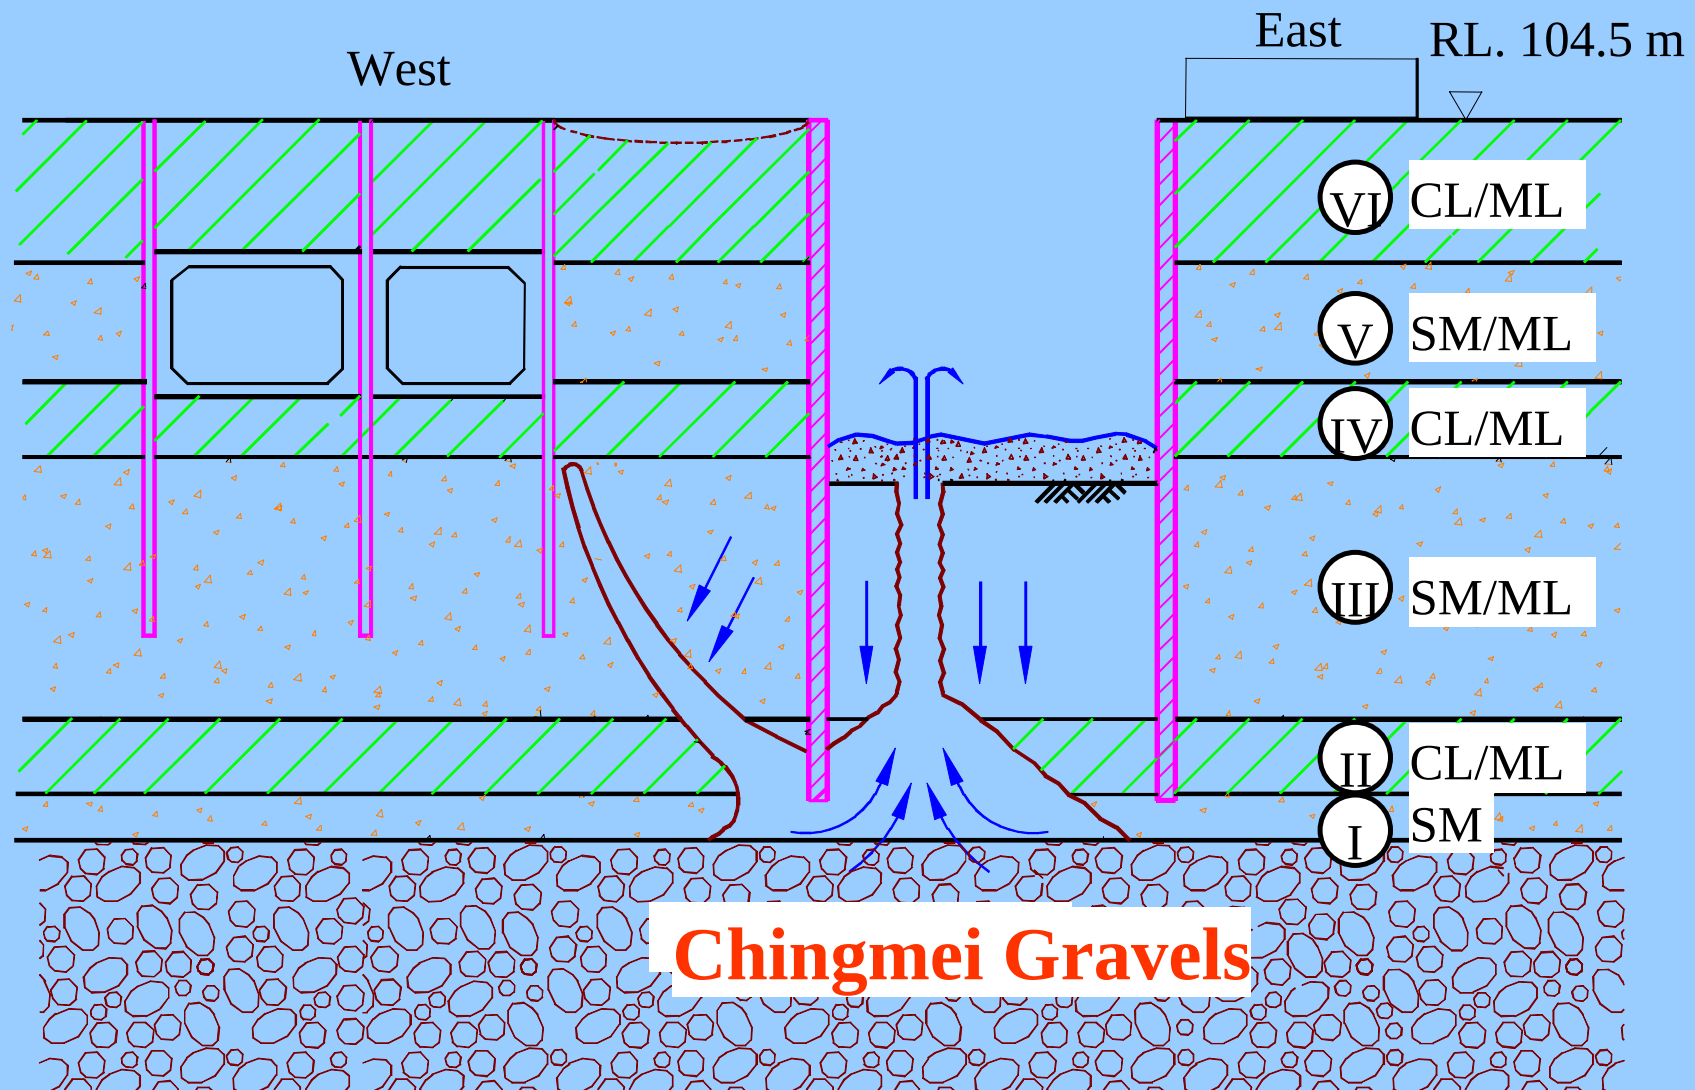
**Scenario of the Incident**

700m to diaphragm Wall (500m excavated)

70,000 tons/13 hours

9,000 m<sup>3</sup> sand & gravels
