Long-term Deformations of a Historical Church on the Anzer Island, White Sea

Chernyshev Sergei N.

Doctor of Geology and Mineralogy, Full Professor, Moscow State University of Civil Engineering, Moscow, Russia

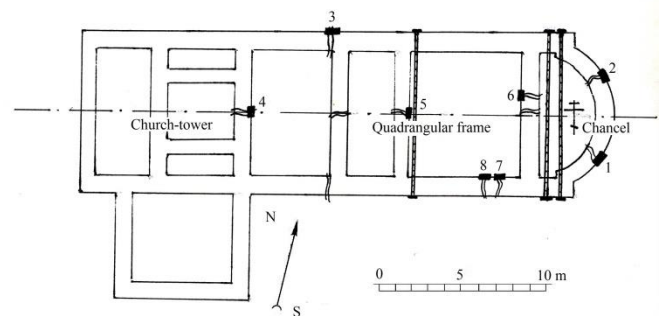
Figure 2 Structure plan specifying the location of the telltales on the fractures 2000

Through cracks emerged in these structures. Prior to restoration, the bearing walls of the eastern part of the church had major fractures (Figure 2). The largest fracture went along the church axis from the chancel apse through the eastern and the western walls of the quadrangular frame (Figure 4).

opening of the fractures, shown in Figure 2 and Figure 4. The values of the velocity are of the same magnitude, but three-fold different. The direction of the velocity vector, according to the pattern of the tensile fractures, has not been changed over the whole history of the church since 1830. It is possible that the differences in the values were caused by temporal inconsistency of the fracture expansion. Nonuniform rates of the fracture expansion are confirmed by the fact that the telltales on the fractures were not broken over two years, from 2000 to 2002, but the expansion resumed in less than a year after the end of restoration in 2007, by the beginning of the summer 2008. Probably, the rapid escalation of the fracture expansion coincides with the coldest years, when the tensile stress, caused by thrust and separation of the hill, is accompanied with major temperature stress. It is possible that significant expansion of fractions occurred during the period from 1940 to 2000, when the church was not heated, and the temperature stress in the brickwork reached maximal values during the extremely cold winters in the early 1940s. It would lead to higher values of the average secular velocity over the period before 2000. At the same time, suffusion in the outer surface of the footing promoted separation of the church walls. This is when the footing was torn from the wall at the site of decompaction of the foundation, caused by suffusion and marked by the suffusion sinkhole observed in 2000 near the church wall.

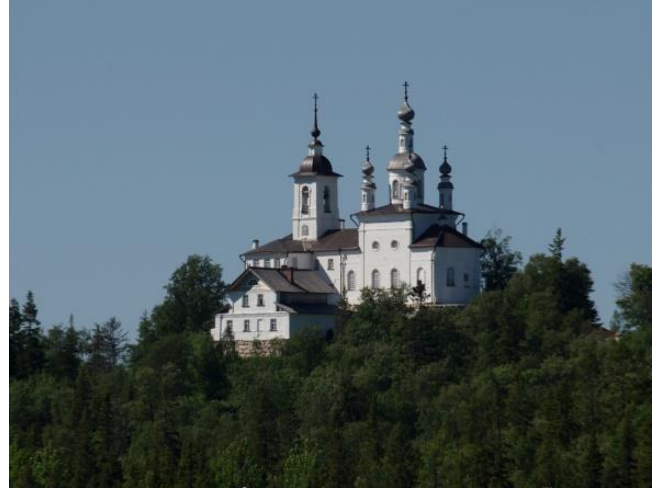
Figure 3 The church on Golgotha Mount after the restoration, 2008

The church building was architecturally restored in July to August 2007, when the faces and the interior were plastered (Figure 3).

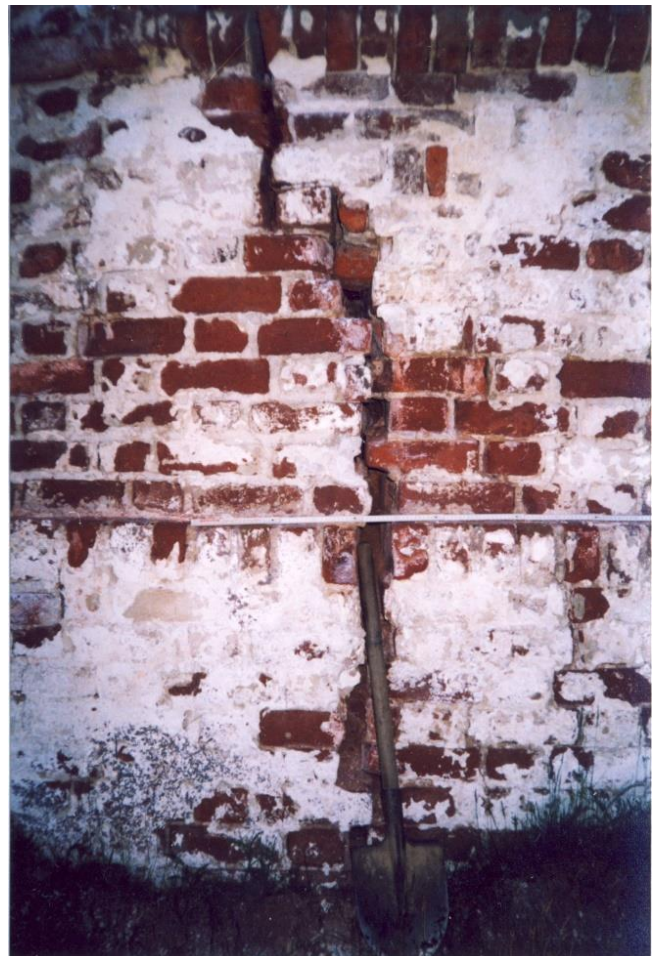
Figure 4 Vertical fracture in the chancel wall, 2000

The fracture along the church axis in its eastern, structurally weaker part, indicates both thrust and dislocation of the walls. These factors are superimposed. However, the maximal opening of the fractures is observed at the eastern wall, predominantly at the wall base. Low apses cannot cause the maximal thrust stress here. Therefore, the apse is tensioned in the northern and the southern directions due to the stress originating in the footing, as the fractures are wider at the base of the wall. Thrust fractures would have a different pattern, on the contrary, opening from the top and narrowing to the bottom.

In June 2000, the fractures on the external side of the apse, in the window openings, were up to 50 mm wide (Figure 4). Total width of the fractures in the eastern wall of the church was 90 mm. The plaster telltales, installed in 2000, had not been broken by June 2002. The

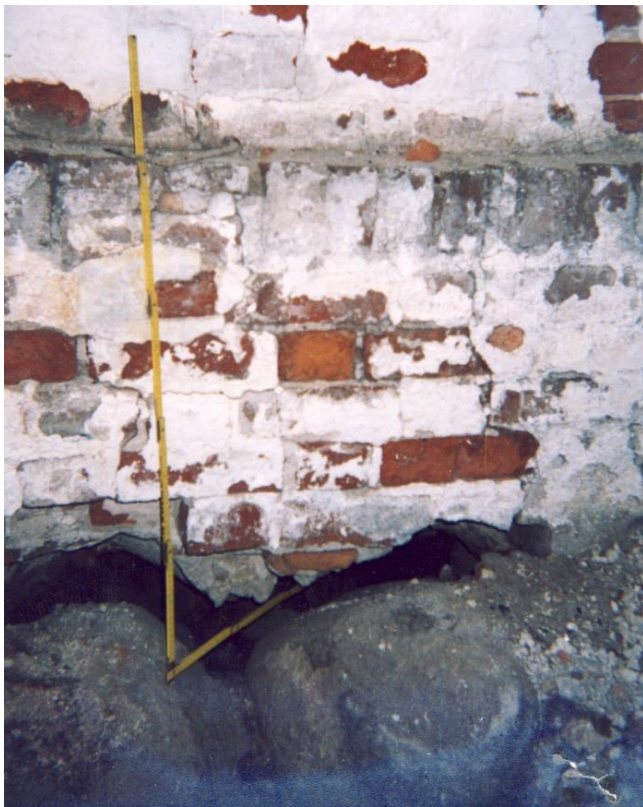
Figure 5 Horizontal fracture of the wall brickwork uplifting from the rubble boulder foundation, 2002

listed factors and some other ones. The short horizontal fracture of the wall brickwork uplifting from the boulder foundation with an opening of approximately 10 cm (Figure 5) was, undoubtedly, caused by suffusion due to runoff water, flowing from the roof during the period of abandonment, lasting from 1940 (liquidation of the Solovki prison camp) to 2000 (arrival of the monks to the island, reestablishment of the monastery).

It did not cause the destruction of the brickwork above the cavity (Figure 5). Length of horizontal crack is about 2 m and above it here

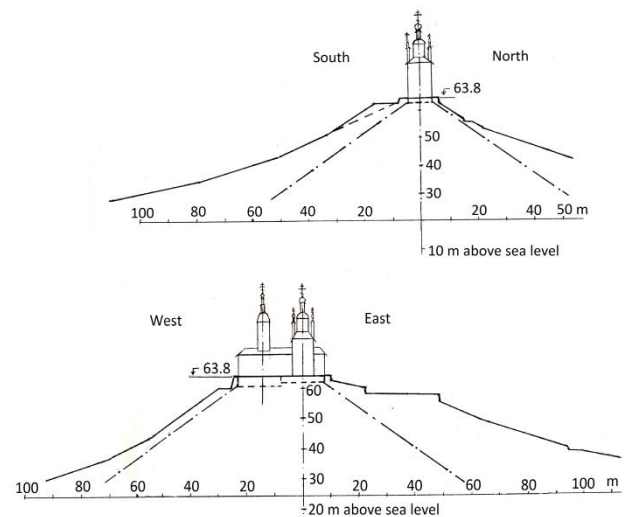
Figure 6 Profiles of Golgotha Mount: top – along the south-to-north direction, bottom – along the west-to-east direction. Dotted line indicates the natural slope angle

In 2000 and 2002, the northern and the southern bearing walls, precisely in the middle part of the building, had fractures, caused by the movement of the western solid and heavy part of the church in the western direction, toward the steepest slope of Golgotha Mount. One could assume similar movement of the eastern part to the east, but this slope is gradual, approximately 15°, whereas the upper part of the western slope has an angle of 35°, the middle part is more gradual, with an angle of 25°, reaching 20° in the lower part (Figure 6).
