## Evaluation of Remedial Works for a Spillway on Landslide-dammed Lakes by an Earthquake, a Case Study in the Jiufengershan Landslide

<sup>1</sup> Department of Civil Engineering, National Chung Hsing University, Taichung City 402, Taiwan

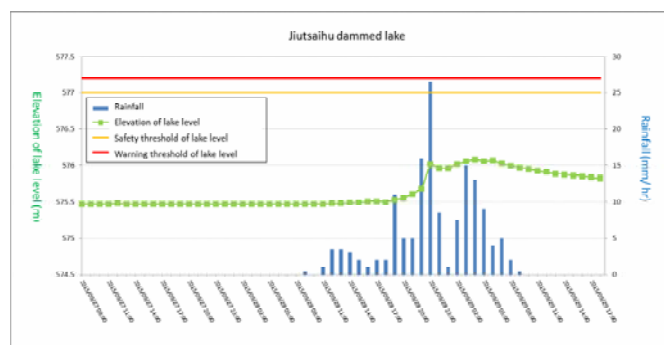
Figure 3 Relationship between rainfall and elevation of lake level in the Jiutsaihu dammed lake

For long-time monitoring the lake surfaces of the Jiutsaihu and Sezaikeng lakes in Figure 3 and Figure 4, the elevations of lake surfaces dropped to 575.89 m and 570.05 m, respectively, after completed spillway. From rainfall and lake-surface monitoring data of typhoon events in September 2015, the highest water levels of the Jiutsaihu and Sezaikeng lakes was 577.1 m and 574 m which went up approximately 1.2 m and 4 m, respectively. As a result, it is successful to control the water surfaces of two dammed lakes while the spillway completed.

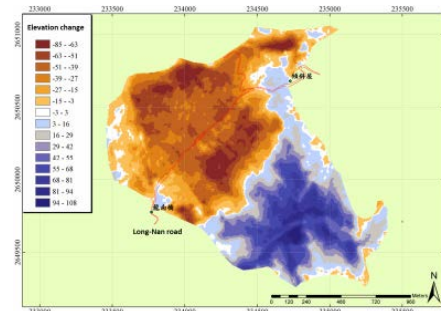
Figure 7 Landform change between 1998 and 2002 (collapse is in brown color; deposit is in blue color)

Digital aerial photogrammetry and analysis tools of ERDAS IMAGINE were used to rebuild orthophotos and DEMs for different periods before and after the 1999 Chichi earthquake. The result is shown in Figure 7. According to the topographic analysis (see Table 2), the average depth of the landslide is 34 m with a collapse volume of 34.92 million cubic meters and a deposit volume of 36.58 million cubic meters.

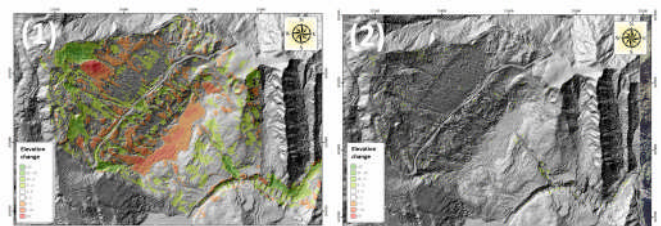
Figure 8 (1) Landslide change between 2004 and 2015; (2) Landslide change between 2011 and 2015. (Erosion area is in green color and deposit area is in orange color.)

The data of DEMs was built in 2004, 2011 and 2015. The results of elevation changes illustrate the differences in elevations from 2004 to 2015 in the landslide, as shown in Figure 8(1). The figure shows that erosion area is in blue color and deposit area is in red color between 2004 and 2015 in which the landslide volume is estimated about 267,000m3 with a maximum erosion depth of 27 m and maximum deposit depth of 24 m. However, the elevation variation was smaller from 2011 to 2015 in Figure 8(2).

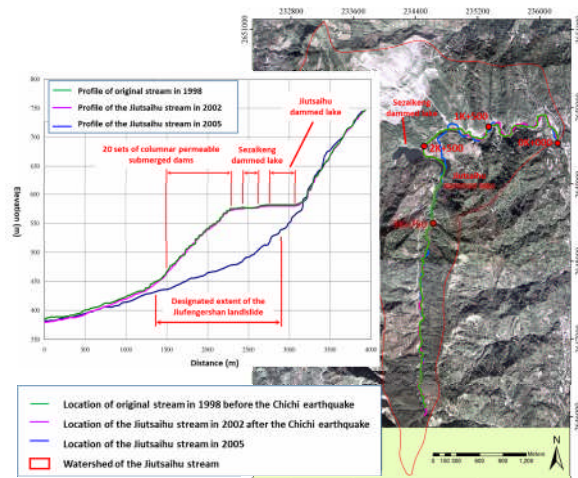
Figure 9 Location and profile of the Jiutsaihu stream before and after the Chichi earthquake

DEMs of the area were built by the data of photogrammetry in 1998, 2002 and 2005. Then, profiles of the Jiutsaihu stream before and after the 1999 Chichi earthquake were drawn in Figure 9 by using the data of DEMs. The graph of profiles in the figure shows elevation changes of the stream bed before and after the earthquake in which the maximum landslide depth is 87 m at 2K+250 of the profile line. It is clear for the profiles that there was an erosion

phenomenon at 3K+500 of the upstream and a deposit area occurred from 0K+775 to 1K+365 at the downstream that was possibly caused by excavated spillway or collapsed debris of the upstream.

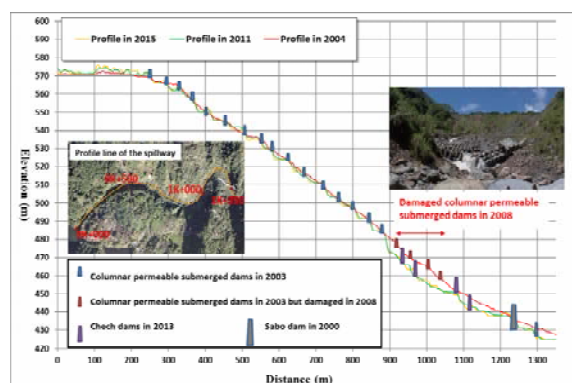
Figure 10 Elevation changes of the spillway for different periods

Other DEMs of the area were built by the data of LiDAR in 2004, 2011 and 2015 with the grid precise of 5 m. Then, profiles of the spillway were drawn by using the data of DEMs in the three periods, as shown in Figure 10. Meanwhile, the locations of remedial works, including a sabo dam, 20 columnar-type submerged dams and check dams, are plotted in the figure.

Figure 10 illustrates that there was a significant downcutting in the elevation change by 20 meters between 0K+870 m and 1K+80 m in the spillway from 2004 to 2011, which caused falling and damage of some columnar-type submerged dams. Nevertheless, the elevation changes gradually remained stable from 2011 to 2015 after remedial check dams and groundfills from 2008. The other point is that the sabo dam effectively blocked the massive debris against its flowing to downstream. All spillway works could have a capacity of debris pool by 6 million cubic meters. Dammed-lake failure and debris flow did not occur in the landslide area while all spillway works completed.
