Case Study of a Partially Collapsed RS Wall at a Building Site

EG Balakrishnan¹, Allan Y. L. Chwee² and A. Mohd Redzuan³

¹ Managing Director, GCU Consultants Sdn Bhd, Malaysia

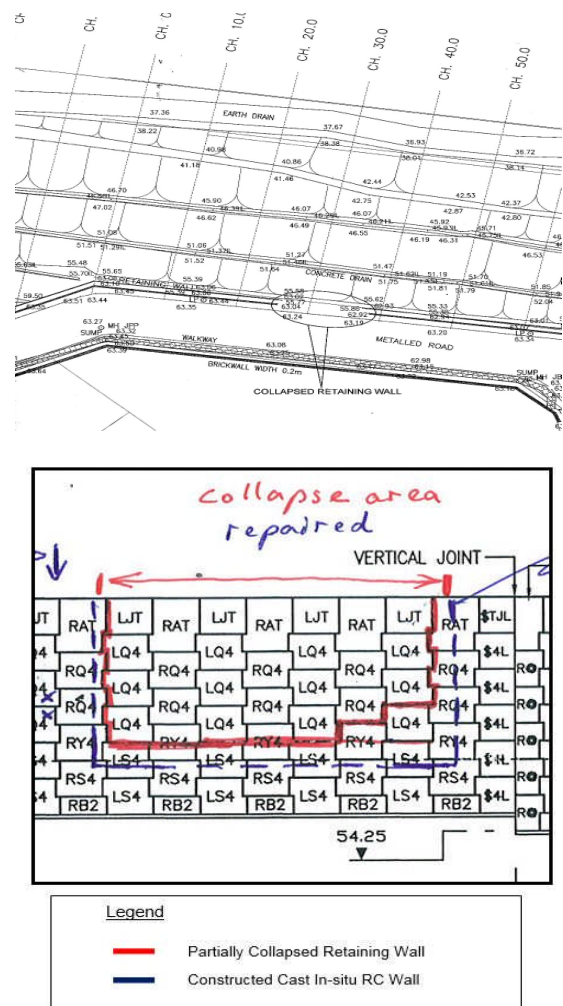
Figure 1 Location of collapse wall

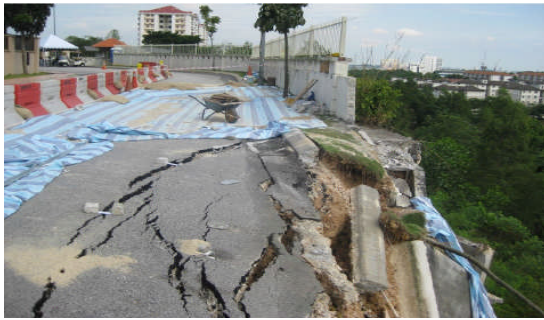
Part of the wall about 11m stretch collapsed on 20 May 2011. The collapsed wall is 9m high with exposed wall height of 25 m. The top 6 m of the RS wall with 4 panels vertical and 7 panels horizontal collapsed. The location and photograph of the collapsed wall is shown in Figure 1 and Figure 2.

Figure 2 Partial collapsed of reinforced soil wall on 20th May 2011

Immediately after the wall failure, a short term remedial of reconstructing the wall using cast insitu RC wall was carried out. After removal of the collapsed RS panels, an RS wall was built with the existing tendons were extended into the RC wall. Damaged or bend tendons were replaced with new tendons. This allows the road to be constructed immediately for the residents to use. This is the only road for the residents to access their homes. One (1) row of horizontal drains of 12m length were also installed at about 4m from the top of wall to mitigate any buildup of water and allow flow of any trapped water behind the wall. Figure 12 illustrated the short term remedial works using RC wall.

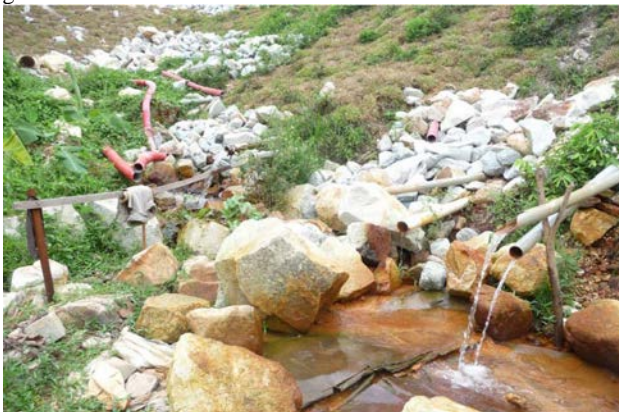
The collapsed wall is founded on a fill ground of maximum 19 m high with 4 fill slopes below the wall. Based on the survey drawings and detail site inspection, variations in the slope height and gradients were observed. The slope height was not consistent with heights varying from 3.5 m to 7 m. The slope gradient also was inconsistent with varying values of 1(V):1.2(H) to 1(V): 2(H). The slope berms also vary from 1 m to 2 m. The slopes were generally covered with vegetation with shrubs and small trees have grown on the slopes. The fill slopes have shown signs of erosion over the years with some locations only resulting in three (3) slopes with the bottom slope has been eroded badly. Water seepage was observed coming out from behind the wall after collapse and continuous flow at the toe of the thick embankment fill as shown in Figure 3. The topography and drainage pattern of the study area are shown in Figure 4.

Figure 3 Copious flow of water seeping out from the toe of embankment

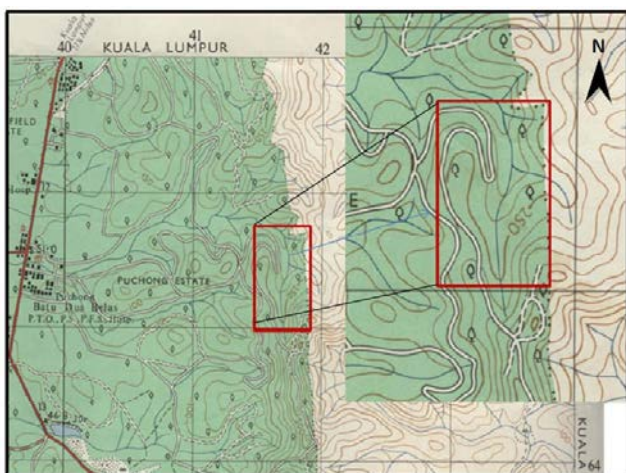
Based on the topographic map obtained from the relevant authority of Malaysia, the site was located at the eastern boundary of an estate on a north trending valley along the eastern slope of a ridge. The map also indicates a stream together several ephemeral streams originally passed through the site. Three streams or rivulets coming from the north and east directions converged into a bigger stream north of the site. As the three streams shown in the map initiated just outside or within the development site, this may not contribute to any underground seepage. The stream from the north side originating within forest serve may contribute to the underground seepage as this stream was not diverted during the site development stage in year 2000 to 2001.

Figure 4 Original topography and drainage pattern of the site

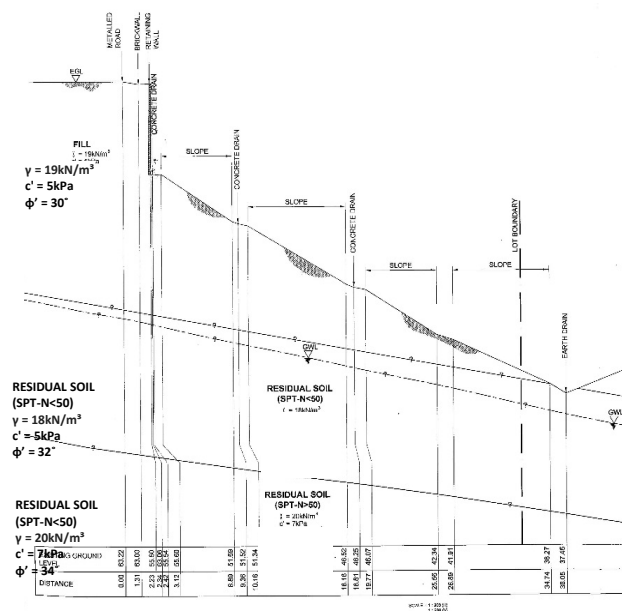
The groundwater levels vary from 3 m to 21 m below existing ground level with closer to the surface at the toe of the slopes. The typical subsoil profile at the distress area is shown in Figure 7.

Figure 7 Typical subsoil profile at distress area

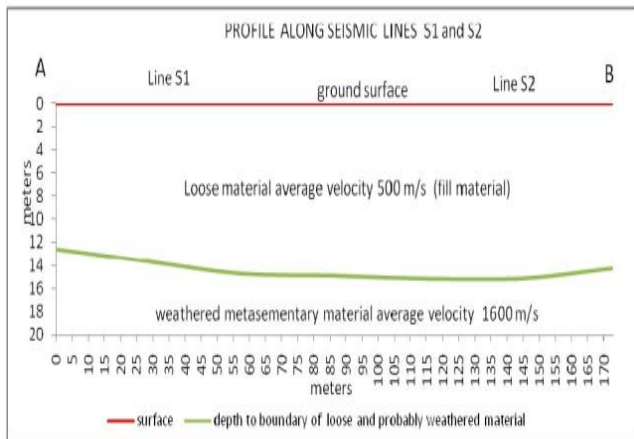
Seismic refraction survey was carried out along the wall line as shown in Figure 8 and the results in shown in Figure 9. The seismic refraction survey indicates two distinct layers based on the contrast of the velocities. The upper layer is characterized by low p-wave velocity representing the fill materials of sandy SILT or silty SAND. Underlying this fill layer is the highly weathered meta-sedimentary profile with higher p-wave velocity. These results conform closely to the findings of the boreholes.

Figure 9 Seismic profile along seismic lines S1 and S2

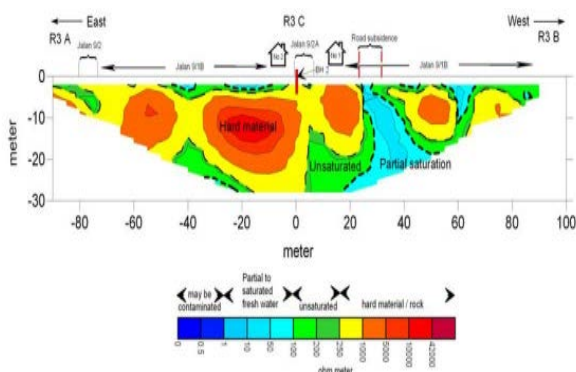
Three lines of resistivity survey were carried out at the first berm from the base of slope, base of the RS wall and at the roadside near to the houses. Typical resistivity profile is shown in Figure 10. These profiles show the presence of partial saturated soil layers indicating presence of groundwater seepage.

Figure 10 Typical resistivity profile along the affected area

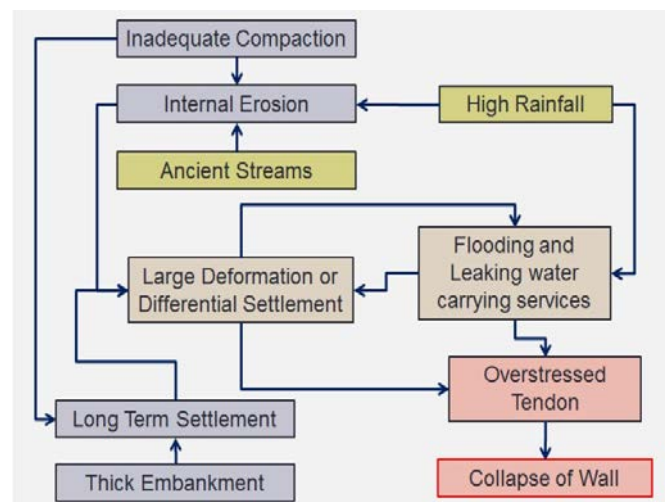
- Leakages of fluids from certain sources which could indirectly increase the hydrostatic pressure behind the RS Wall. These leakages may not be from recent incidents and may have been occurring over a long period. The potential sources would be from concealed drains, water supply pipes and sewerage pipes. 2 out of 3 sources have been confirmed by the respective owners that leakages have been detected in the nearby pipes. These pipes could have been damaged over the time due to the post construction settlement of the fill materials not properly placed and compacted.

- Regular water ponding after each heavy downpour on the road next to the collapsed wall area. Due to the water ponding and delayed dissipation of surface runoff, water could have infiltrate into the ground and cause an increase in hydrostatic pressure behind the wall especially over a prolonged period of time.
- From the site visit, it is observed that a lot of shrubs and some trees growing between the RS Wall panels. This could be another contribution factor to the failure as the roots growing from the shrubs and trees may cause the wall panel to be displaced and instill additional stresses in the reinforcing tendons.

The RS wall has been designed in accordance to the code of practice BS 8006 (1995). Flooding and leakages of the water carrying services near to the wall has caused an increase of pore water pressure. This has caused the overstressing of the tendons. A detail analysis simulating the buildup water pressure show that reinforced wall tendons in layers 5 to 8 were overstressed and the final collapse took place due to the failure of the tendon T12 at layer 8 which has the highest stress. The settlement of the fill under the wall could have further aggravated the situation. The likely postulation of the failure is shown in Figure 11.

Figure 11 Flow Chart of possible factors for the wall collapse

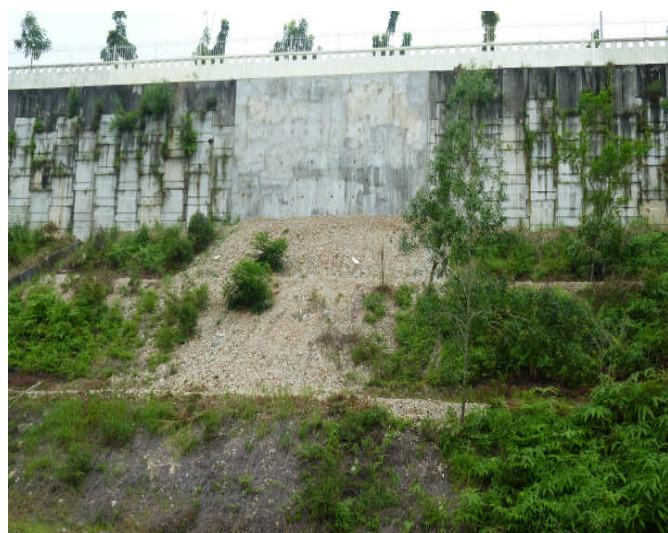
Figure 12 Short term remedial work using RC wall

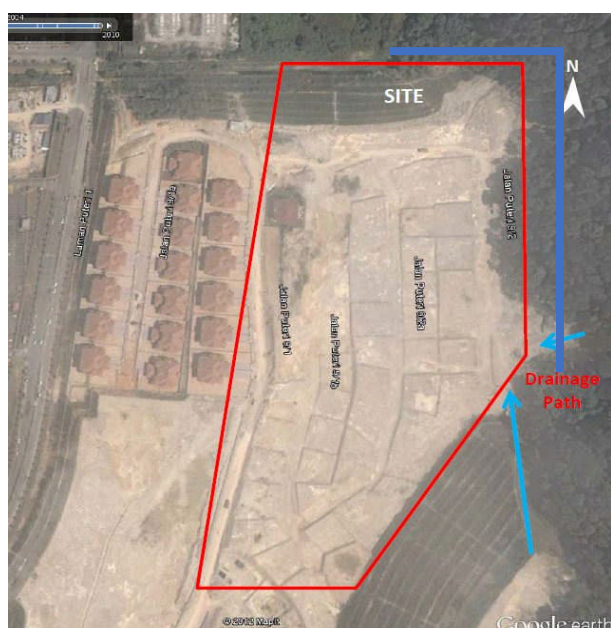
Figure 13 Drainage path for short term measure

Another short-term measure proposed and constructed at the site is the permanent drain channel along the forest reserve to allow water from the forest reserve to flow to the toe drain. This will reduce the ground water seepage due to surface runoff from the Forest Reserve. Figure 13 indicated the drainage path.

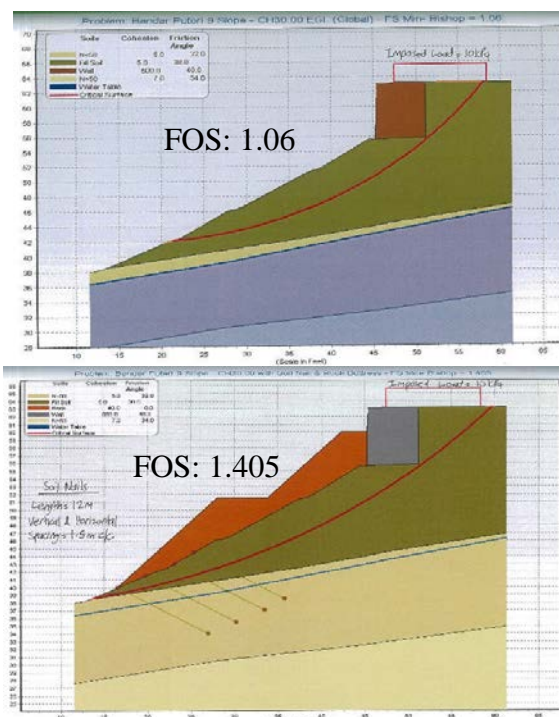
Without strengthening works, the current embankment slope shows FOS of about 1.06 to 1.14. The embankment slope has been strengthened using soil nails, horizontal drains and rock fill buttress to enhance the FOS to the required levels. The analysis output for slope without and with strengthening are shown in Figure 14a and 14b.

Figure 14 Typical slope analysis output (a) without strengthening (b) with strengthening

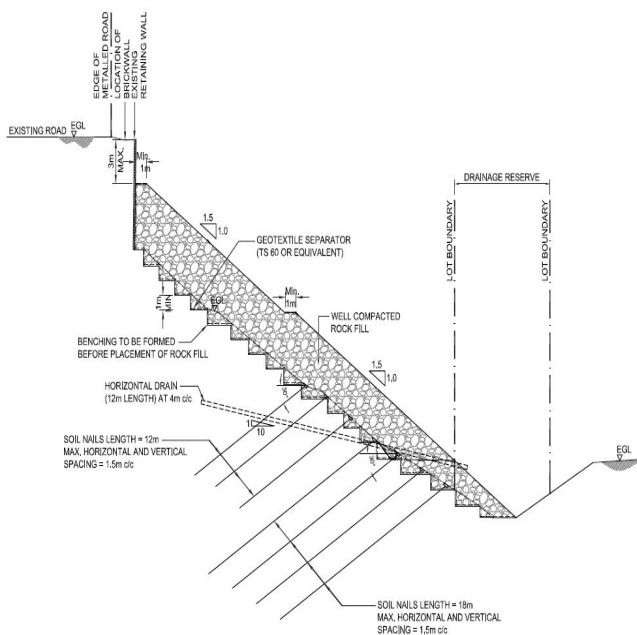
Figure 15 Typical strengthening details

- Significant rise in the ground water table may adversely affect the stability of the slopes and the wall and cause potential failures. In order to mitigate the ground water fluctuations, horizontal drains have been installed. One row of drains at a spacing of 4 m centers and 12 m length installed along the bottom berm. A total of forty horizontal drains of 12 m length and four (4) no's of 7 m to 8 m length due to rock were installed.

- Additional soil nails of 100 mm diameter and 12 m length at horizontal and vertical spacing of 1.5 m centres at the bottom slope to enhance the FOS of deep seated failure. Galvanized T25 reinforcement bar with working load of 100kN and cement grout of minimum compressive strength of 30 N/mm² was used. The nails were inclined at 30 degree from horizontal. A total of 249 no's of soil nails were installed with some socketed into rock. Pull out tests were performed on 4 soil nails up to 150 kN, i.e. 1.5 times the working load. The values are within the acceptable limits of 12.5 mm.

- A rock fill buttress of compacted stones were placed on the existing slopes after the soil nails and horizontal drain works. The stone used consist of hard durable inert rocks of granite origin. The rock fill was well graded from 150 mm to 400 mm. The rock fill was placed in layers of 500 mm and compacted by at least 12 passes of vibrating roller. The gradient of the rock slopes was initially fixed at 1; (V): 1(H) but later amended to 1(V): 1.5 (H) upon review of the independent consultant to avoid any localized failure of the rock fill.

- To mitigate erosion problems on slopes, close turfing and mortared stone pitching were used on slopes not covered by the rockfill.
- As failure of the reinforced soil wall involved leakages of the water carrying services and soaking of the cohesive soil behind the wall, free draining material was used to backfill behind the wall. By doing so, water will be easily drained out from behind the wall and the probability of another failure would be much reduced. The existing precast drainage system along the wall and part of the site road, which is currently leaking was replaced with cast in situ drains to reduce or avoid leakages. The water supply pipes along the wall was totally exposed and installed inside a RC channel with measure to drain the water from the pipe if any leakage. Sewage pipes along the wall was also redesigned and replaced with a more robust system that could withstand large differential settlement.

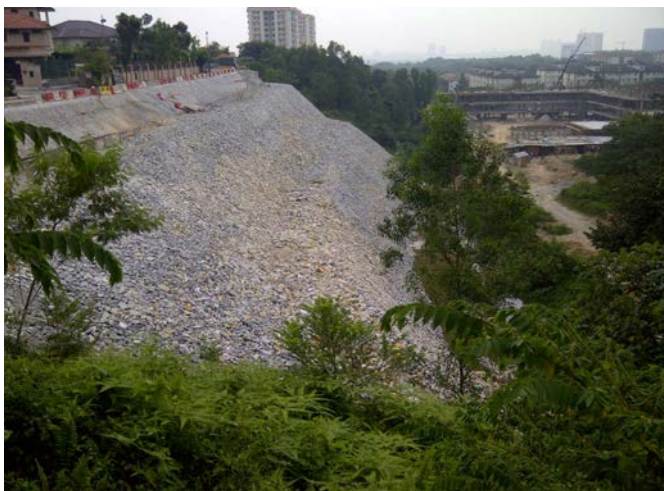
Figure 16 Final view of completed rectification work
Geotechnical Instrumentation

The damaged water and sewer pipes were repaired with special allowance for damage. The final completed remedial work is shown in Figure 16.

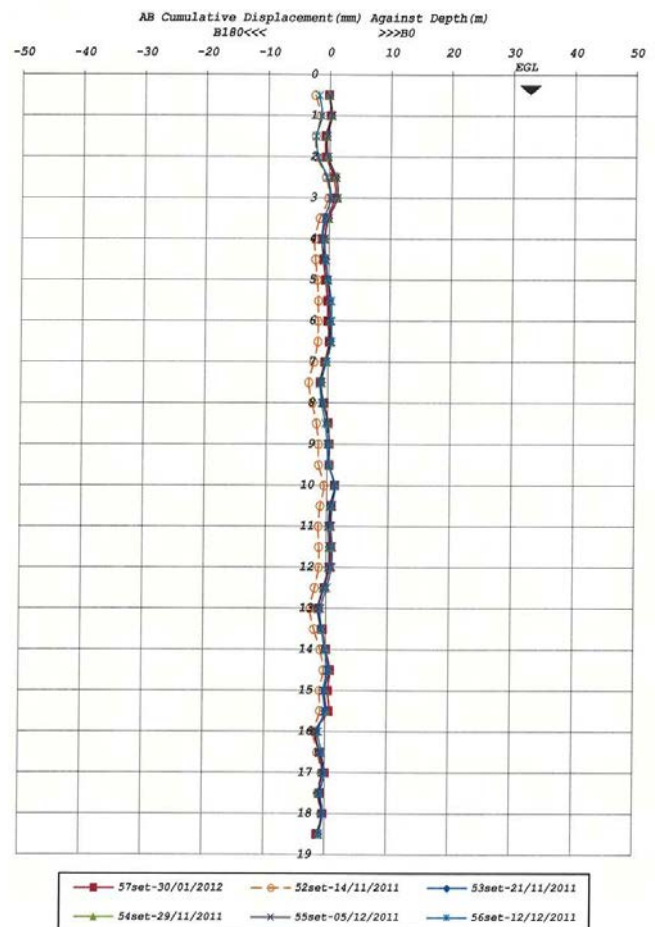
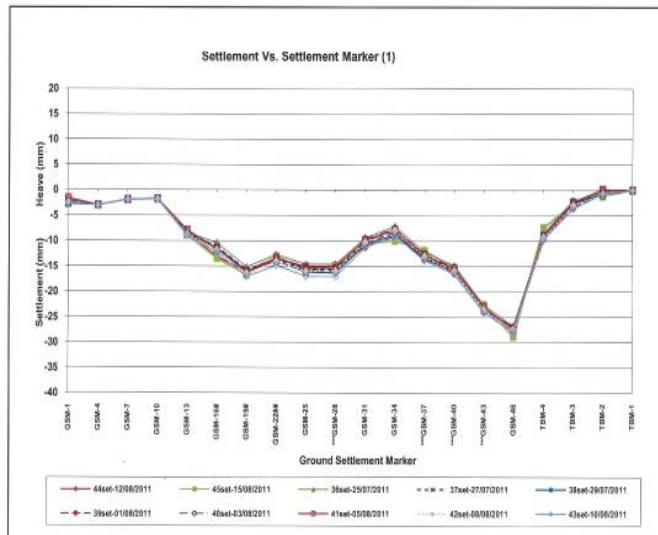
The instrumentation readings showed that the constructed remedial works have performed as expected and all the readings are well within the acceptable limits. Typical results of the instrumentation readings are shown in Figure 18a and 18b.

Figure 18 Typical instrumentation results (a) Inclinomometer reading (b) Ground Settlement Marker reading
