Damages Associated with Geotechnical Problems in 2018 Palu Earthquake, Indonesia

The National Center for Earthquake Studies (PuSGeN) and the Indonesia Association of Geotechnical Engineering (HATTI) deployed a team to conduct field survey assessing impact of Palu Earthquake, from 8 to 15 October 2018. This paper presents findings of field surveys with emphasis on geotechnical impact and fault rupture offset observed in the field.

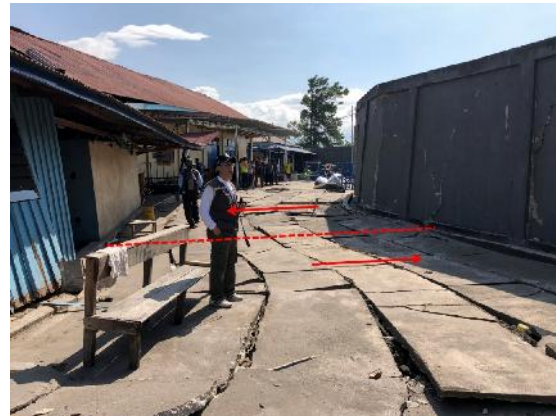
The field survey conducted on 8 to 15 Octobers 2018 by Natawidjaja, Daryono, Gunawan, Meilano, and Pamumpuni observed rupture horizontal offset as large as 4-6 meters and vertical offset up to 30-50 cm running through Palu city from south to north (Figure 7-8). The rupture went into the sea in the Palu bay, and is observed again on the ground in Labuan Salumbone, Tawaeli, Donggala, Central Sulawesi, with a much smaller offset of less than 1 meter. The offset of the rupture of Palu Earthquake was then mapped according to field observation as shown in Figure 7.

Figure 7 Offset Rupture 4,8 m at desa Donggala Kodi, Ulujadi, Palu city, Central Sulawesi

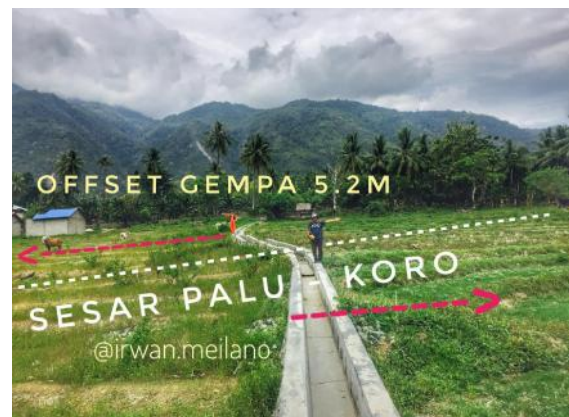
Figure 8 Offset Rupture desa Bomba, Marawola, Sigi regency, Central Sulawesi

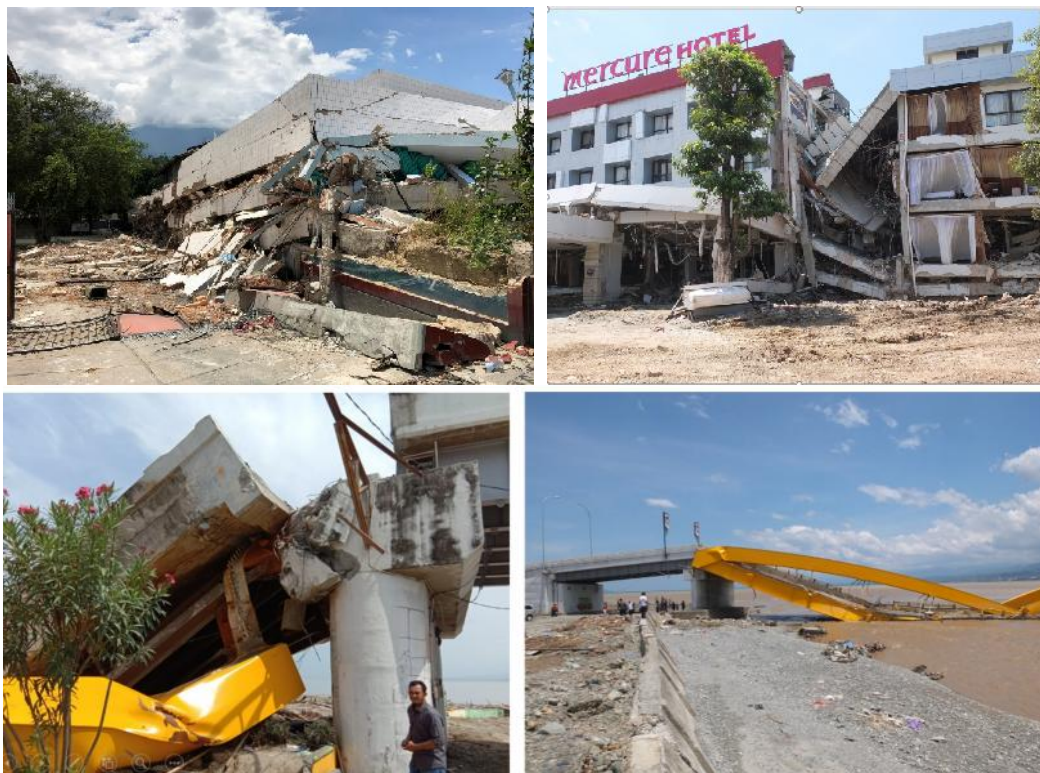
Building and infrastructure damages were reported just after the 7.4 earthquake. Examples of building and infrastructure damages are shown in Figure 10.

Figure 10 Building and bridge damages induced by earthquake in Palu

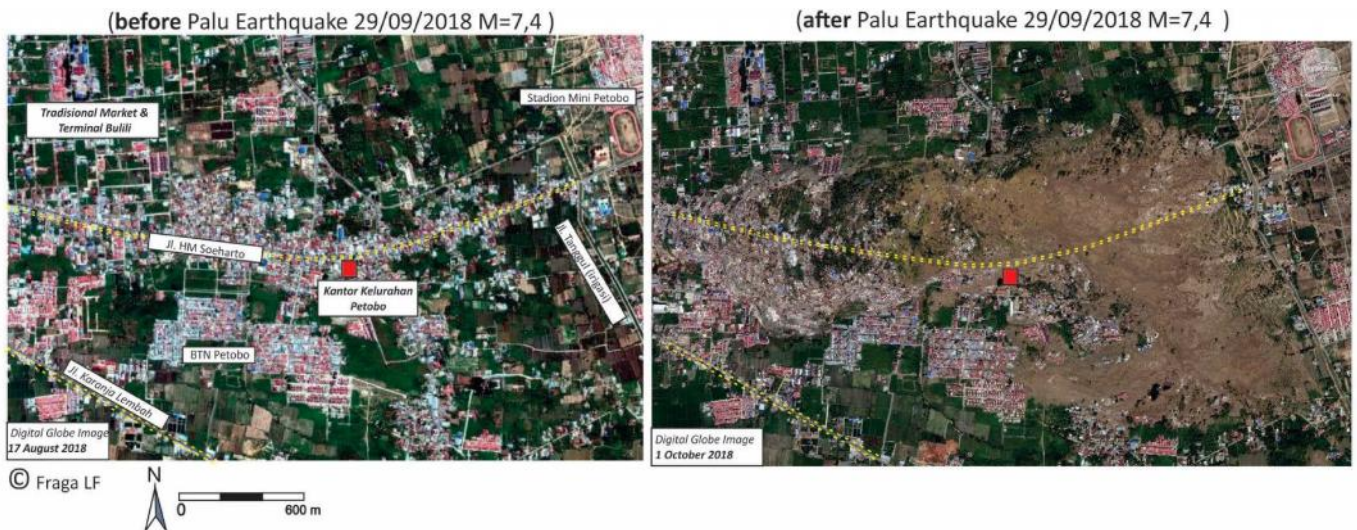
During Palu earthquake 2018, two major interesting phenomena occurrences were observed, namely liquefaction induced ground failure and massive lateral spreading. These incidents resulted in the affected villages to be buried as well as shifted (Figure 11). The following sections describe liquefaction and lateral spreading in the affected area in more detail.

Figure 11 Liquefaction induced lateral spreading in Petobo village (Digital Globe)

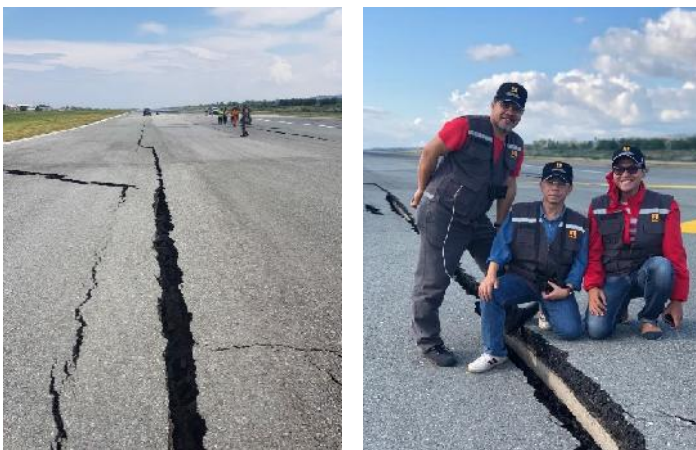
Ground cracking was also observed at runway in Palu main airport, which is located nearby Petobo area (Figure 12). It was informed that the typical top soil layer is clayey and silty soils. The ground water table is relatively deep. Thus far, this situation only generated a minor damage in the air strip, while in the other areas, more severe damages were observed.

Figure 12 Longitudinal Cracks on the Palu airstrip

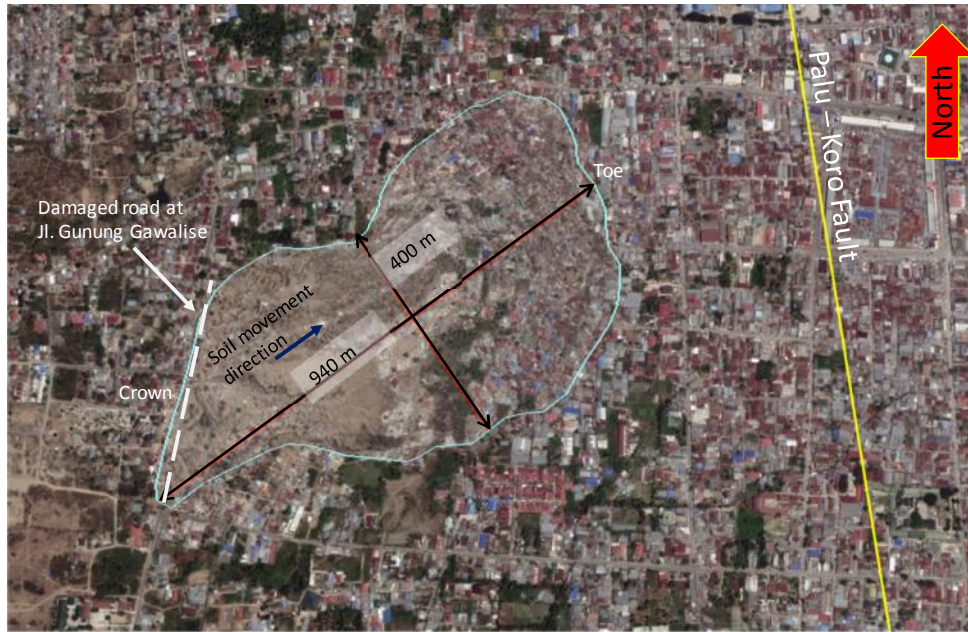
Soil failure in Balaroa area is located about 1 km to the west of Palu – Koro fault. The crown of soil movement is located in Jalan Gunung Gwalise, whereas the toe is located in Balaroa village. The affected area is mainly residential housing comprising of 34.5 Ha with perimeter of 2.5 km. Aerial view of damages in Balaroa is presented in Figure 13. Field observation at Jalan Gunung Gwalise where the crown is located showed that slope failure may also be attributed to rotational land slide.

Figure 13 Estimated soil failure affected area in Balaroa

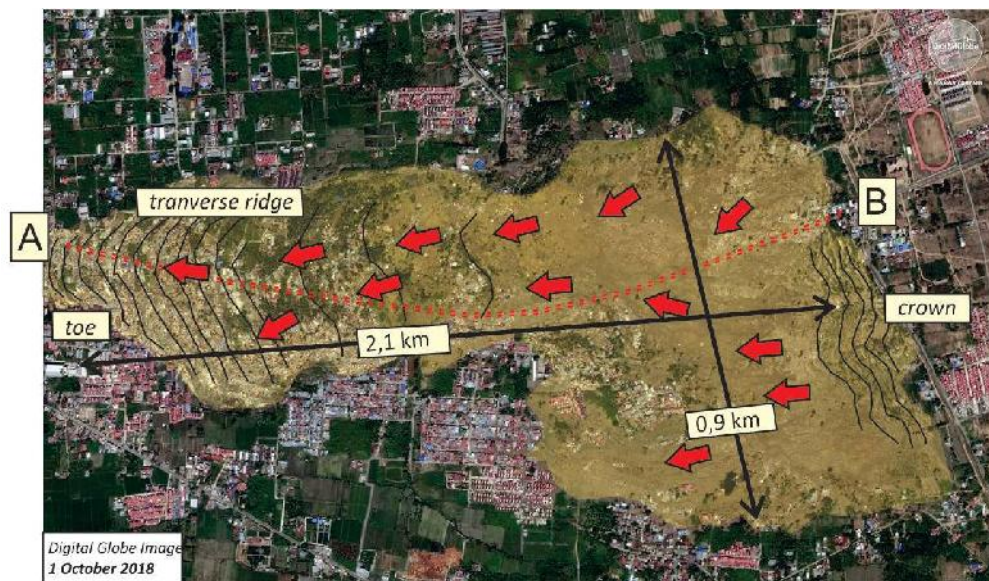
Petobo, a populated residential area was severely damaged due to liquefaction. This area is about 7.2 km to the east of Palu - Koro

fault. Although this area has slight inclined ground surface, the occurrence of mass movement to downslope was triggered by liquefaction (Figure 14).

Figure 14 Liquefaction on the residential at Petobo (Digital Globe)

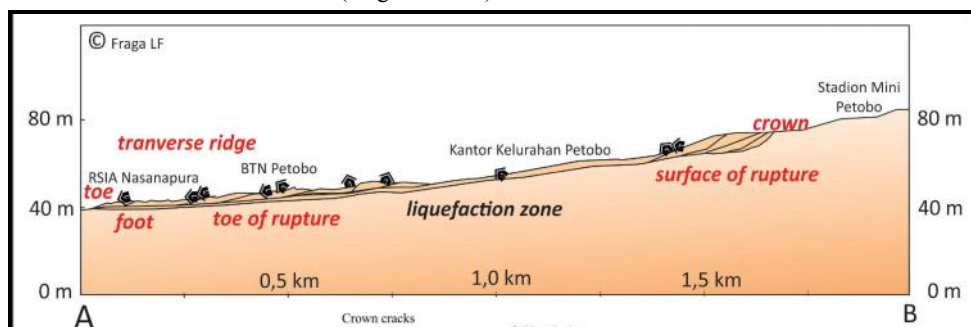
Figure 15 The illustration of mass movement due to liquefaction in Petobo village (Fraga LF)

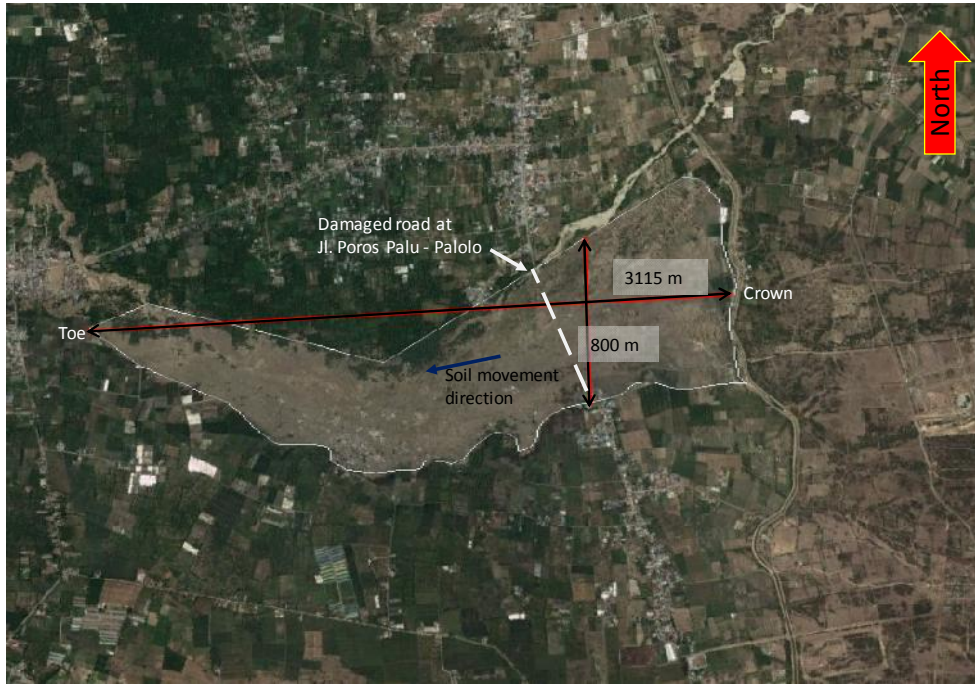
Massive soil failure in Jono Oge village is located about 6.7 km to the east of Palu – Koro fault. The crown of soil movement is located in the east nearby a water channel, whereas the toe is located in the west (Figure 16). In general, north boundary of the affected area is bounded by a river. The affected area is estimated about 185 Ha with a perimeter of 8 km and is mainly comprised of corn farm,

Figure 16 Estimated soil failure affected area in Jono Oge

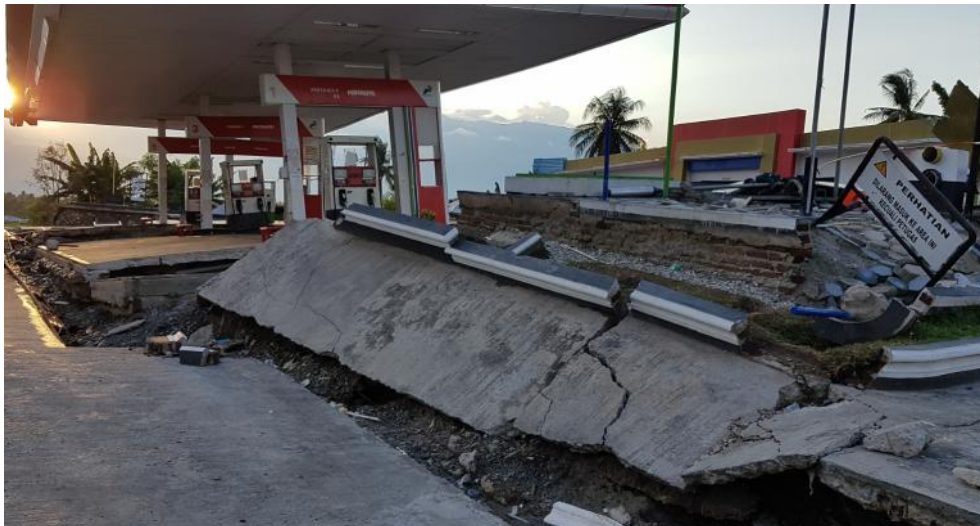
residential housing, and roadway. Practically, damaged roadway area turned into a large corn farm which initially is located nearby the crown. It should be noted that the roadway leading to this damaged roadway section and the surrounding area are also heavily affected by the earthquake. Damages in a gas station located about 1 km north to the damaged roadway section is shown in Figure 17.

Figure 17 A damaged gas station in Jono Oge

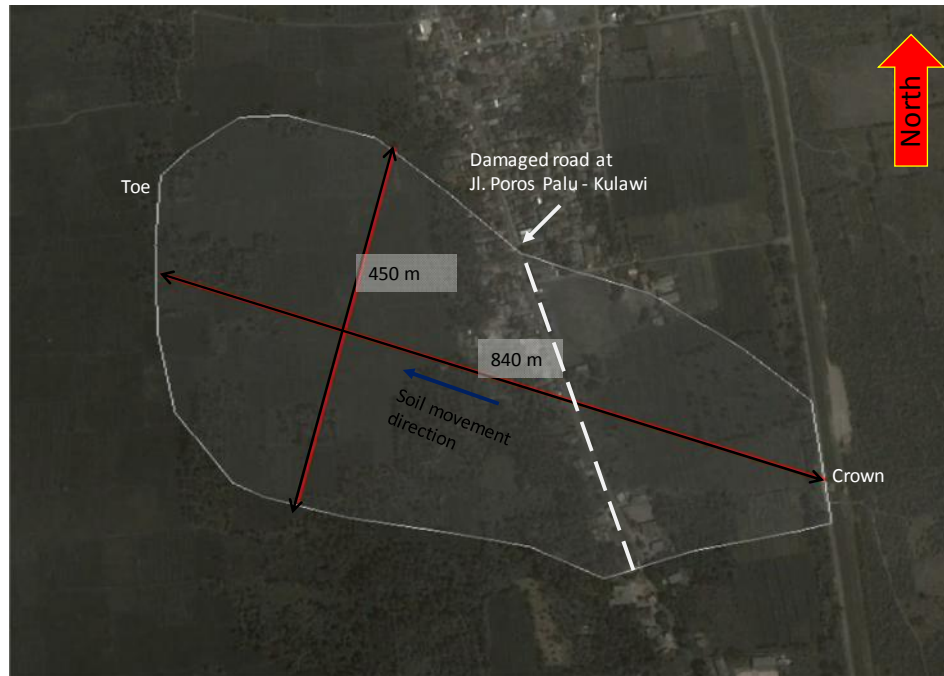
Soil failure in Sibalaya Selatan village is located about 3.6 km to the east of Palu – Koro fault. The crown of soil movement in this location is located in the east nearby a sluice gate, whereas the toe is

located in the west (Figure 18). The affected area is estimated about 29 Ha with a perimeter of 2.2 km and is mainly comprised of paddy farm, residential housing, and roadway. Figure 19 shows the impact of Palu Earthquake 2018 of translated housing and football field in Sibalaya Selatan village.

Figure 18 Estimated soil failure affected area in Sibalaya Selatan

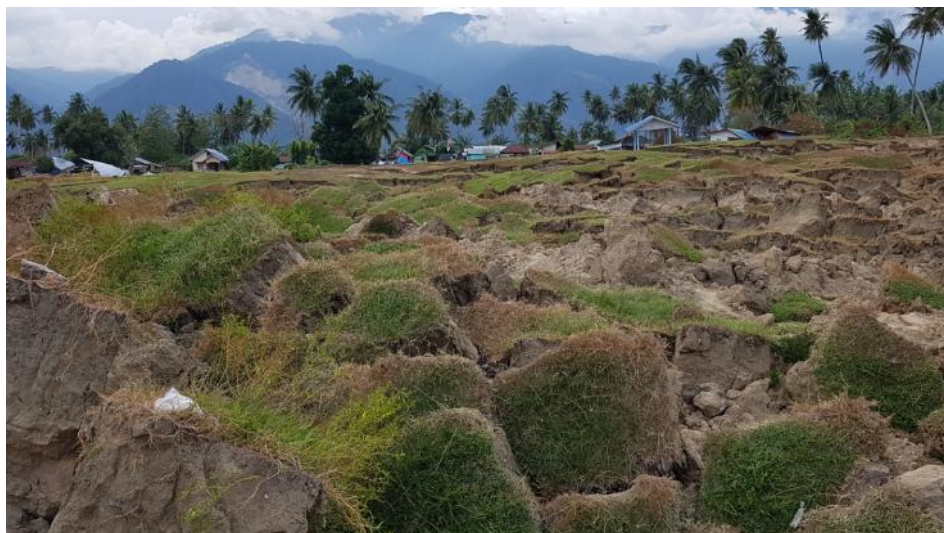
Figure 19 Translated housing and football field in Sibalaya Selatan after Palu Earthquake 2018
