# Forensic Investigation of A Subway Tunnel Construction Failure

**ABSTRACT:** In this paper, the forensic evidences and investigation of a subway tunnel construction failure occurred in Kaohsiung, Taiwan are presented. The studied construction failure occurred during a cross passage excavation of a shield tunnel construction work of the Kaohsiung Mass Rapid Transit System, and resulted in severe tunnel collapse and extensive ground failure that even reached to ground surface 30m above the tunnel depth. Valuable photo images obtained during and post event, as well as results of special geophysical testing methods were presented and compared to verify proposed failure scenario. Information presented in this paper is hoped to be helpful to improve engineers' knowledge for preventing similar construction risks.

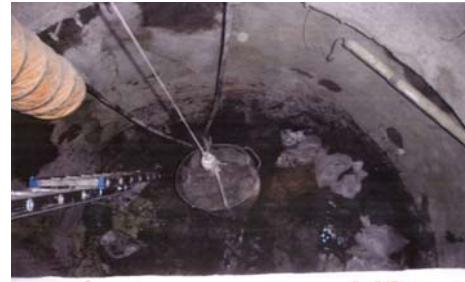
In the afternoon of December 4th 2005, when the sump excavation reached a level 4.95m from the floor of the crosspassage, a chunk of wet soil tumbled out from the southern wall of the sump at the bottom around 3:30pm. The small collapse was followed by steadily increased outflow of mud water as shown in Figure 6. At the beginning of the seepage, sand bags and shotcrete were adopted in an effort to stop the flow. However, the amount of water increased with time despite more dry cement and coagulating agents were dumped into the sump. At 4:50pm, water inside the sump started to whirl turbulently showing the signs of collapse of the side wall of the sump. The top cap of the sump was then sealed with anchor bolts, more sand bags, and vertical posts as shown in Figure 7. At 6:00pm, collapse of the sump led to the undermining of the already completed shield tunnels. Water started to spit out between ring lining segments, and chunks of concrete were found to be detached from the edge of ring segments of the shield tunnels (Figure 8). At 6:30pm dislocation of the ring lining segments was clearly identified (Figure 9) and all engineers and workers were forced to evacuate. At 9:30pm nearly 6 hours after the occurrence of the incident, ground above the up-track (south side) tunnel started to settle by 200mm to 250mm. The settlement area soon developed into a big sinkhole within a very short time as depicted in Figure 10, and ruptured several lifeline pipes including two tap water mains of 300mm and 600mm in diameters (Figure 11). By the morning of December 5th, the sinkhole developed to a size of 80m in length and 20m in width (Figure 12). In the meantime, another ground collapse in a size of 20m long and 10m wide was quickly developed on the north side where the down-track tunnel sit below (Figure 13). These two huge cave-ins on the ground surface led to the threat of large scale collapses of the shield tunnels and the crosspassage. These ground cave-ins were finally backfilled and stabilized near the midnight on December 5th, over 30 hours efforts. In addition to the ground failures, the existing vehicle underpass above the failed tunnels was also found to have been seriously damaged by the accident (Figure 14).

Figure 6 Muddy water started to flow into the bottom of the sump (4:15pm, December 4th, 2005)

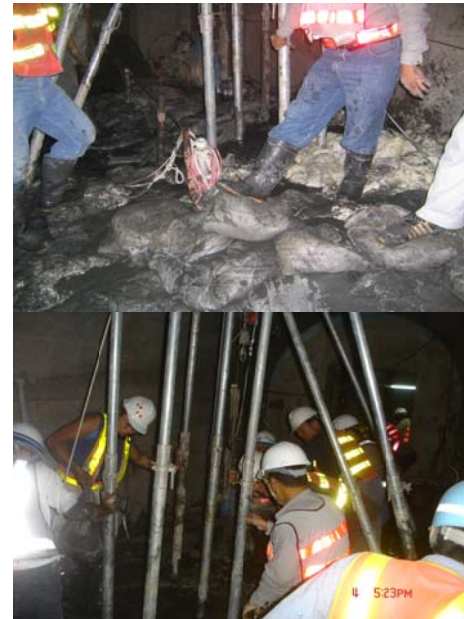
Figure 7 Effort made to seal the top of the sump (5:23pm, December 4th, 2005)

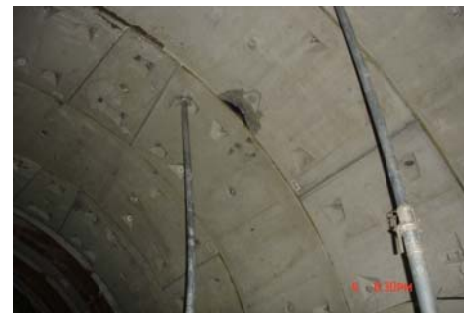
Figure 8 Concrete chunks detached from the ring segments of the up-track tunnel (6:30pm, December 4th, 2005)

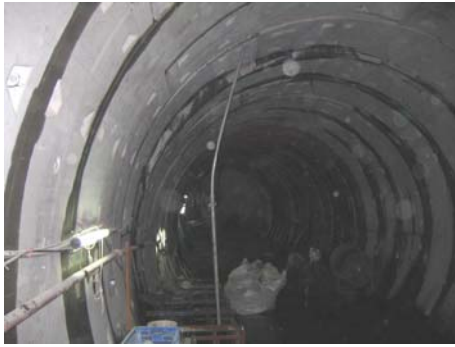
Figure 9 Serious water inflow and dislocation of lining segments inside the up-track tunnel (6:50pm, December 4th, 2005)

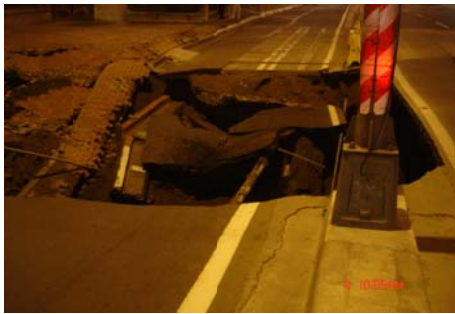
Figure 10 Sinkhole appeared on the ground above the up-track tunnel (10:05pm, December 4th, 2005)

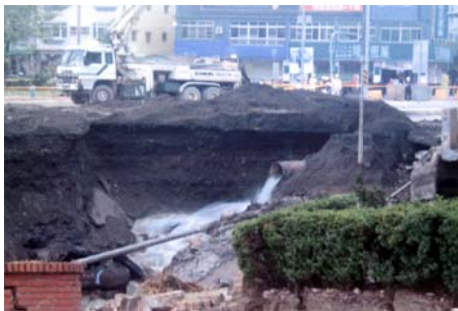
Figure 11 Rupture of the water main (morning of December 5th, 2005)

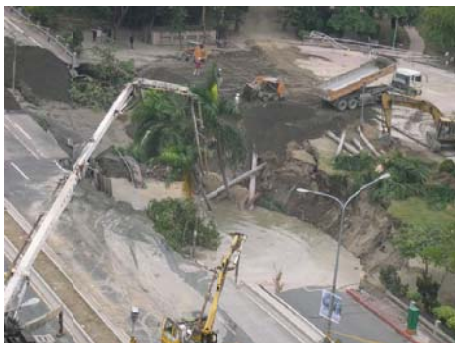
Figure 12 The large sinkhole on the south side and emergency backfill works in progress (daytime of December 5th, 2005)

The first stage of immediate retrofit work mainly focused on backfilling the sinkholes. A total volume of  $12,000\text{m}^3$  sand and aggregates,  $2,326\text{m}^3$  concrete, as well as 1,150 bags of dry cement,

were dumped from ground surface to fill the sinkholes developed from the deep seated tunnel failures within two days. In addition to backfilling works, remediation grouting and curtain grouting were also applied from both the north and the south boundaries of the vehicle underpass trying to stabilize the existing underground structures and to further confine damaged ground. Figure 15 shows the layout and the total injection volume of grout in cubic meters for the immediate work. In the meantime, four concrete walls sandwiched with sand bags were also constructed at tunnel portals (both up-track and down-track) of O7 and O8 Stations in an effort to retain debris from flowing into the adjacent station areas, as shown in Figure 16. Moreover, in order to stabilize the seriously disturbed ground, water were injected into the tunnels after completion of these retaining walls. This measure was in an attempt to maintain hydrostatic condition of ground, especially at the depth of damaged tunnels. The wall construction and water injecting process was in operation for about seven days before the targeted stable ground water table was reached and maintained (TCRI, 2006). While the retrofit work was in process, ground water table was closely monitored by automatic piezometers installed at different depths at different locations. In addition, settlement survey was conducted on a hourly basis to monitor ground surface settlement closely. Both the settlement and the ground water table measurements were adopted as vital information for safety monitoring and effectiveness of the retrofit works.

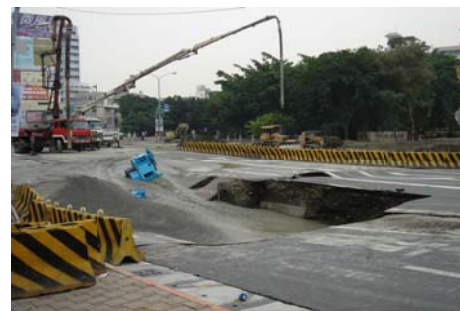
Figure 13 the sinkhole development on the north side above the down track tunnel (4:30pm, December 5th, 2005)

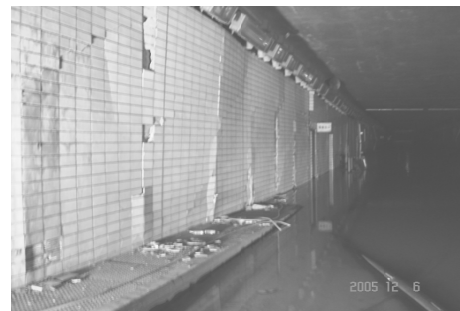
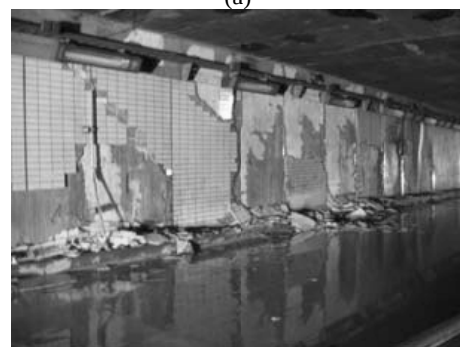
Figure 14 Damaged vehicle underpass

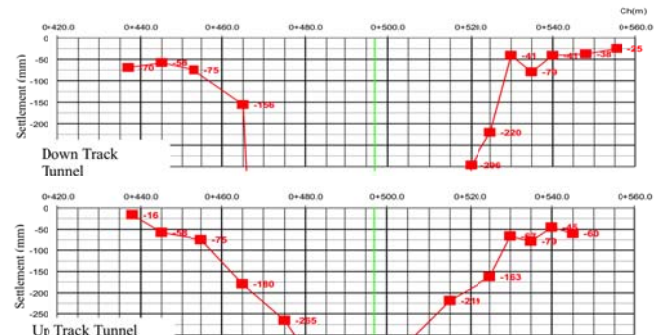
Failure investigation was first conducted by drilling boreholes along the original tunnel alignments. The drilling rod was lowered down to the failed ground in an attempt to reach the pre-casted ring segments of the shield tunnel lining. This borehole probing method was used as a direct inspection measure to assess the damaged condition of the shield tunnels and to estimate the length of collapsed and distorted tunnel portions. Borehole probing results of both the up-track and the down-track tunnels are shown in Figure 17 (Lee and Ishihara, 2008b). The cross passage where the incident occurred was located between mileages of 0+495m to 0+500m. As shown in the figure, the section between mileages 0+465m to 0+520m of the up-track tunnel had collapsed due to the failure and could not be located by the probing rod. Near 120 meters of the up-track tunnel was seriously dislocated. For the down-track tunnel at

the south of the failed cross passage, the section between mileages 0+475m to 0+515m had collapsed and was out of reach by the probing rod. Similar to the up-track tunnel, near 100 meters of down-track tunnel was seriously disrupted. The result of this borehole probing revealed that ground failure might have destroyed the crosspassage and have destructed nearly 120 meters long up-track and down-track shield tunnels.

Figure 17 Borehole probing results of the up-track and down-track tunnels

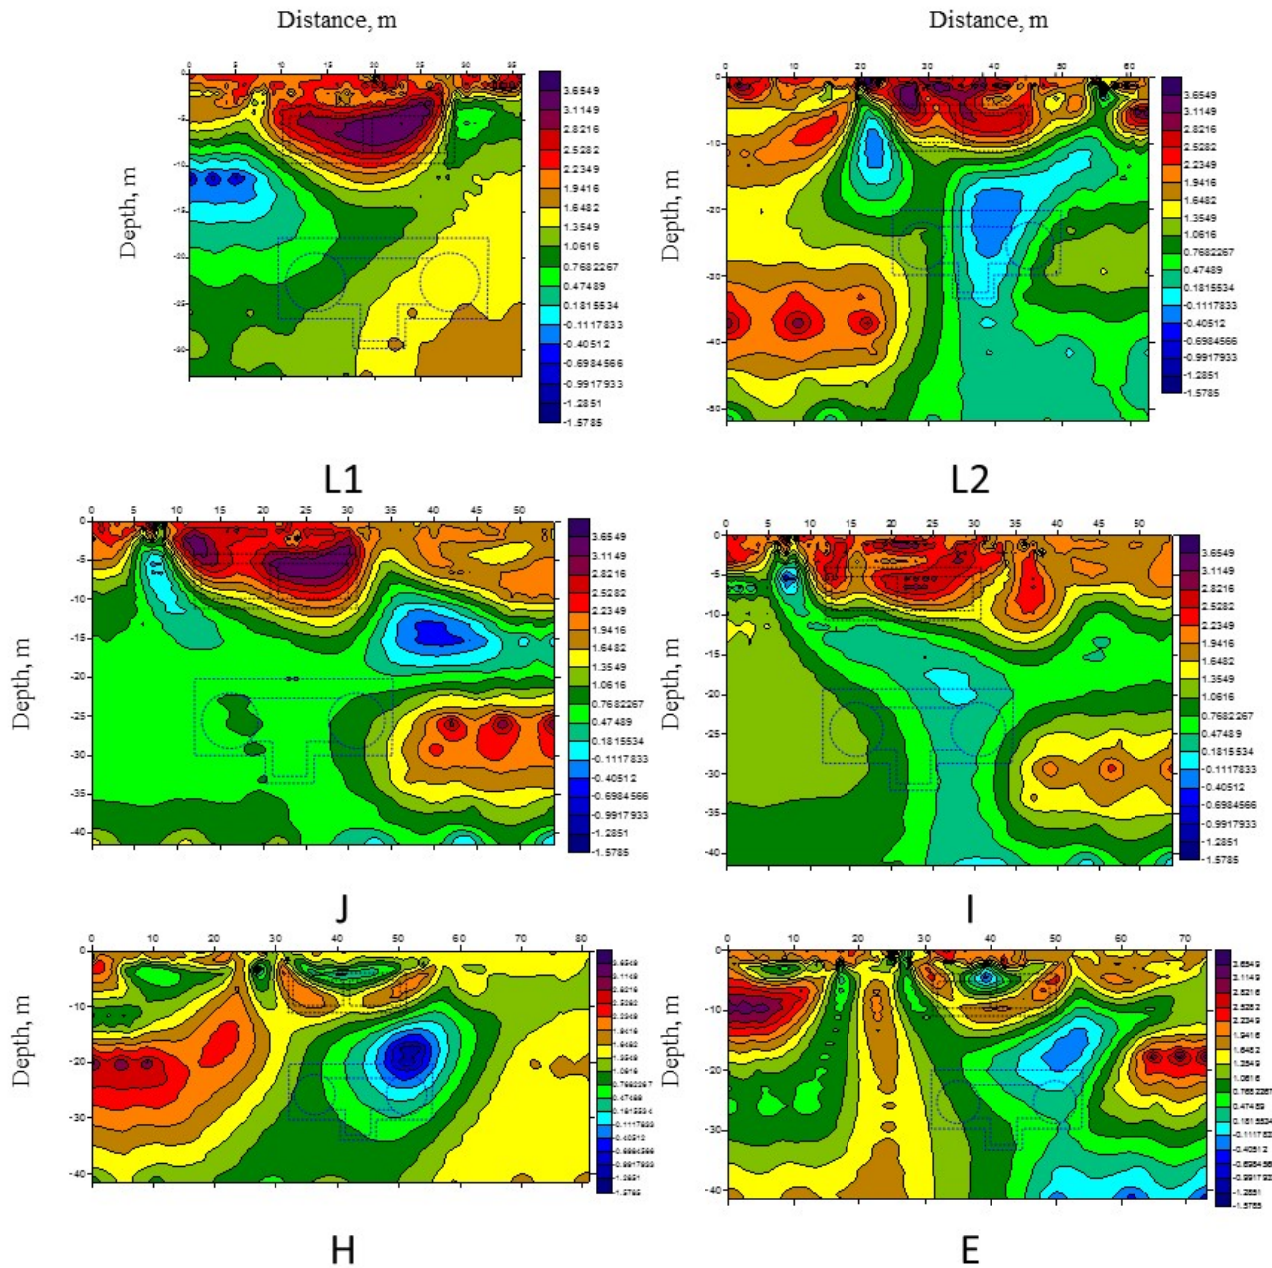
Figure 23 shows the results of 2D RIP test along the selected survey lines marked in Figure 21(b). In these figures, Calibrated values of resistivity are scaled on the right to each profile. As shown in the image profiles, cold colours, from green to deep blue, represent material with relative low resistivity such as disturbed ground with high ground water content or voids. On the contrary, warm colours, from yellow, orange, to red and brown, represent material with relative high resistivity such as dense soil, injected grouts or concrete. In this case, images obtained by the 2D RIP test tend to be slightly distorted upward because only ground surface probing posts were installed to record response resistivity (Lee and Ishihara, 2008a). However, resistivity profiles shown in Figure 23 still clearly indicate that the area in between the vehicle underpass and the cross passage were in serious distressed condition. Profiles L2, H, and E, identify that ground in between the vehicle underpass and the cross passage in south contained high water content and in a loose state at the time of testing. Similar ground condition was also observed in the ground under the sinkhole on the north as shown in Profiles L1, L2, I, and J. In addition, ground failure area on the south where the up-track tunnel was located was found to be more serious than that on the north where the down-track tunnel is.

Figure 23 Results of 2D RIP tests

The 2D RIP results also indicated that damaged areas were larger than two sinkholes appearing at ground surface, and further verified the results of borehole probing that near 120m long tunnels in both directions were destroyed by the piping ground. At the locations of profiles L2, H, and E, which were the east and the west boundaries of the soil improvement work for the damaged cross passage, soil beneath the subway tunnels was also found to be severely agitated by possible soil piping or boiling failures. As shown in these image profiles, the shapes of the agitated soil layers are in funnel shapes. This observation indicates that ground failure was initiated at bottom of water sump and then spread upward through the up-track tunnel first to cause large sinkhole on ground surface. Ground failure then migrated to the soil surrounding the down-track tunnel to cause another sinkhole on December 5<sup>th</sup>, the second day of the accident. Moreover, no clear image of the cross passage or soil improvement block installed before tunnel construction was found in 2D RIP results; this indicates that the cross passage and the shield tunnels attached to it should have been all broken by the huge soil piping pressure. The 2D RIP results also show that immediate remediation and grout treatments had effectively reached the perimeter of the ground failure to possibly stabilize the ground, as the warm colour areas shown in profiles L2, J, I, H, and E.

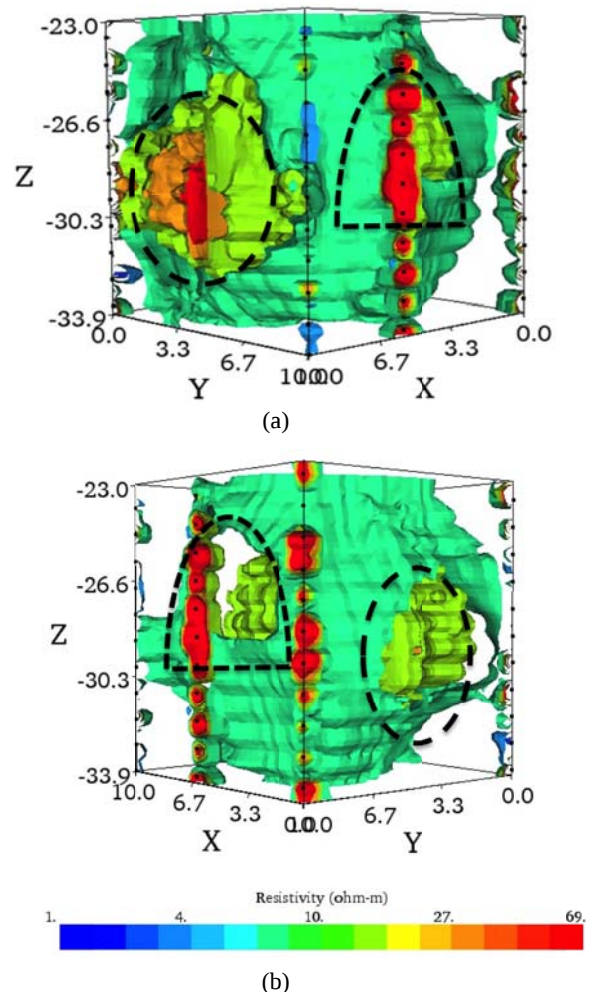
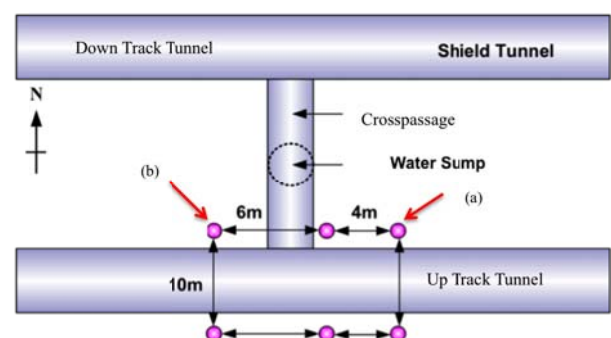
Figure 24 shows the results of the 3D RIP test. As the results of 3D investigation contained fairly complicated stereo information, images shown in the figure have been processed by carefully differentiating assorted materials underground. The light green or blue portion shown in the figure indicates the most of jet grout material applied prior to the construction of the cross passage and the shield tunnels. Reinforced concrete portions of shield tunnels and the cross passage are probably in bright green to yellowish colour. The exposed steel truss and rebar of the cross passage are in orange to red colours with least electrical resistivity. As shown in Figure 24, the integrity of the shield tunnel and the crosspassage was barely observed. The east portion of the shield tunnel was found to have an offset of at least 1m from the cross passage, and the west portion of the shield tunnel was found to be out of shape with an offset over 2m. There was very low resistivity response in both images indicating that the cross passage might have been seriously damaged to expose steel truss components. The results of 3D RIP test denote that piping failure induced from the water sump had probably destroyed the connections of the shield tunnel to the cross passage. The results of both 2D and 3D RIP tests have further verified the results of borehole probing shown in Figure 17. Moreover, it has provided visualization images describing the failure extent and the actual ground condition. This information is valuable for both forensic investigation as well as retrofit design.

Figure 24 Results of 3D RIP tests

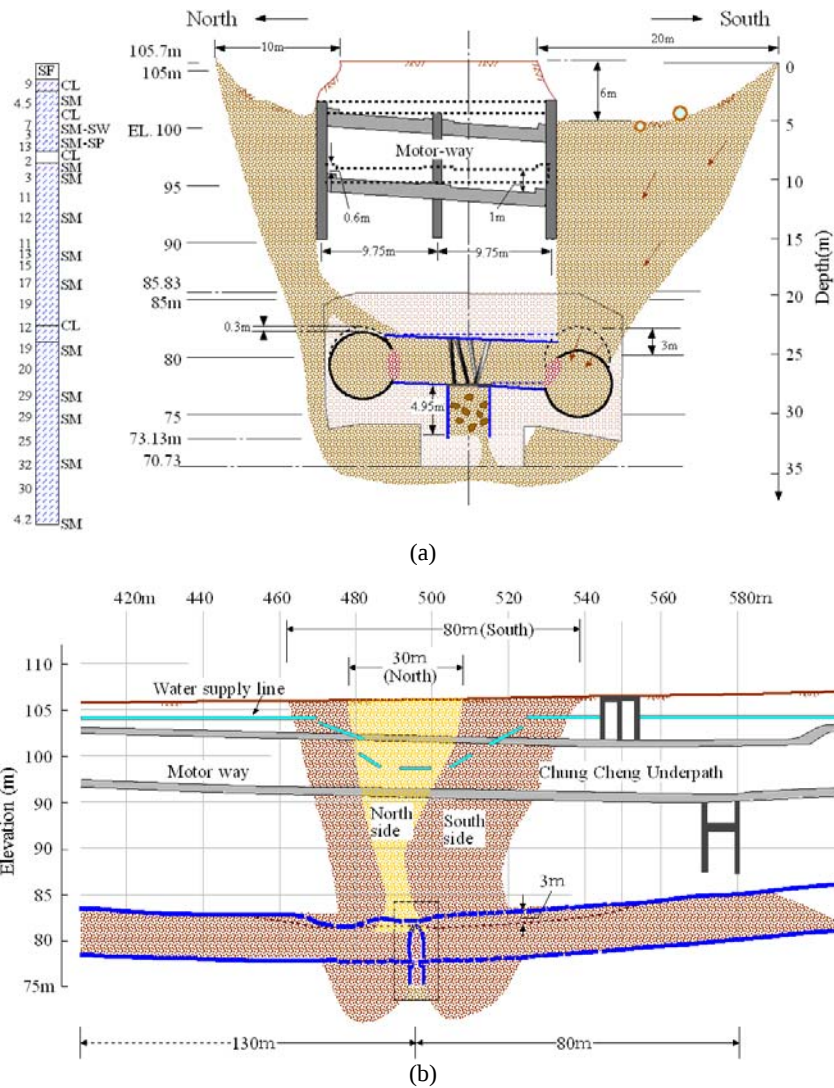
Ishihara and Lee (2008b) first proposed the failure hypothesis of the studied incident (Figure 25) based on the investigation data including workmen testimonies, emergency retrofit work records, as well as the forensic testing results presented in this paper. They described that the failure started from the bottom of the water sump highly likely via a vertical piping crack (Ishihara and Lee, 2008). The invasive hydraulic pressure near 300kPa caused by such a piping failure forced debris to flow into the crosspassage from the collapsed water sump. In the early stage of failure, the jet-grouting block installed for crosspassage construction was fairly strong; it was not broken until the hydraulic pressure caused by piping and flown-in debris had ripped off the ring lining segments of the shield tunnels outside such a jet-grouting block. Ground failure was enlarged when the debris flowed into the tunnels and created large voids underground. The failed ground was in a state near liquefaction due to the high hydraulic pressure and strong downward seepage. The shattered ground soon expanded upward to ground surface forming a huge sinkhole above the up-track tunnel on the south and widely spread to the down-track tunnel on the north

Figure 25 Failure scenario proposed, (a) cross sectional view, (b) longitudinal view (after Ishihara and Lee, 2008)

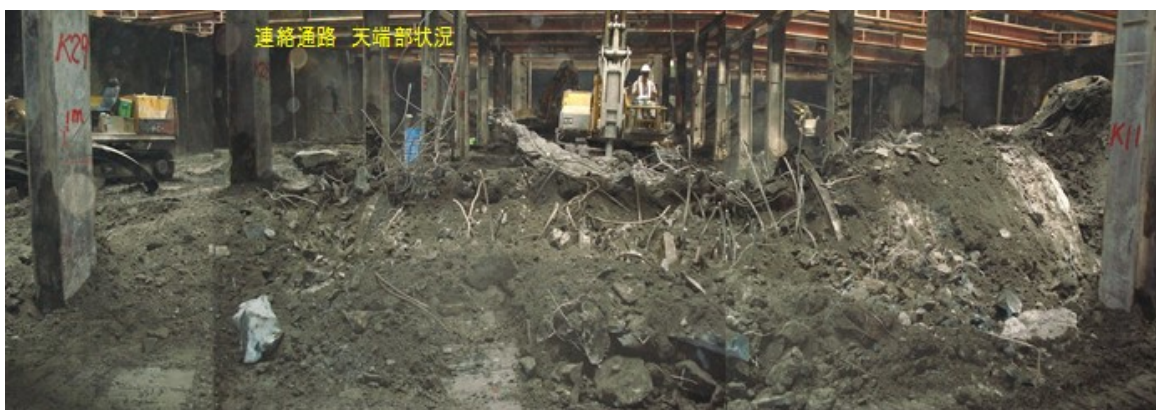
creating similar failure. The vehicle underpass sitting above was thus damaged by distressed ground underneath and all ground as depicted in Figure 25 (Ishihara and Lee, 2008). Moreover, Figures 26 and 27 show the wreckages of the cross passage and the shield tunnel excavated during the retrofit works. As shown in Figure 26, the cross passage inclined to the south and sunk over 2m at the edge connecting to the shield tunnels. The shotcrete lining and the inner truss of the cross passage was found to have been severely broken by the debris flown in. Figure 27 shows clearly that the ring lining segments of the shield tunnel had been ripped off and sunk as revealed in the investigation using borehole drilling and RIP tests. Where the cross passage connecting to the two shield tunnels had the most serious settlement and thus damages included dislocation and collapse to lining segments of the shield tunnel as shown in Figure 27. The proposed failure scenario was further verified by such forensic recovery work.

Figure 26 Wreckages of the crosspassage.

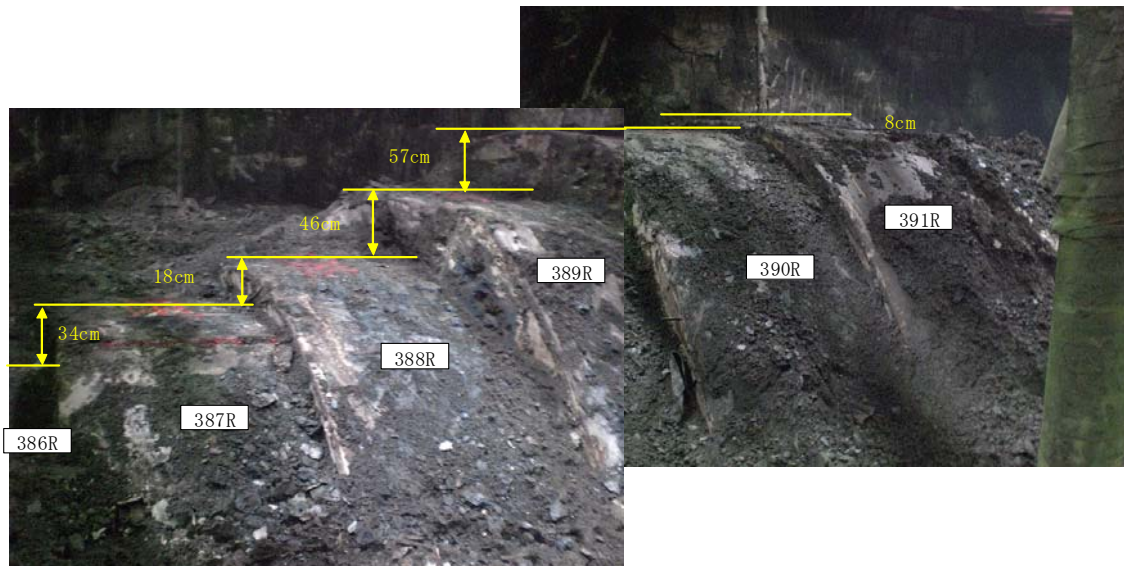
Figure 27 Damaged shield tunnel excavated during the retrofit works
