# Study of Slope Failure and Reinforcement Analysis to Restore and Increase the Slope Stability in Flores, East Nusa Tenggara Using Plaxis 2D and 3D

Rendra Priatno<sup>1</sup>, Ali Iskandar<sup>2</sup>, and Jo Lian Huat<sup>3</sup>.

<sup>1</sup>Geotechnic Engineer, PT. Tarumanegara Bumiayasa, Jakarta, Indonesia.

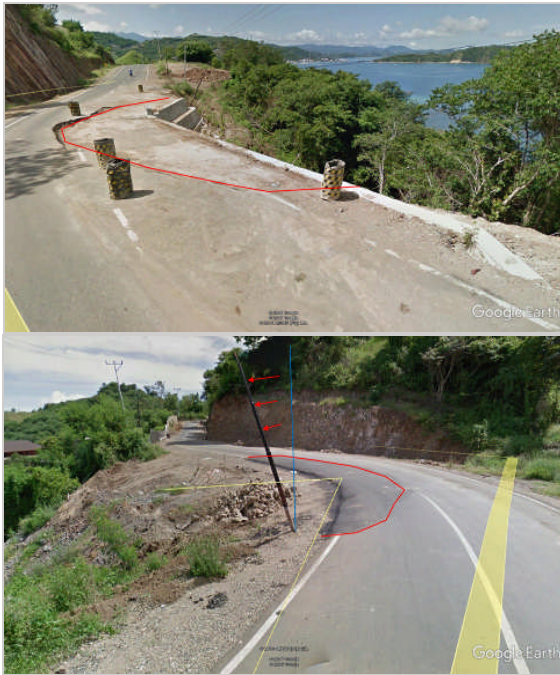
Based on field observations before constructions phase started, the slope conditions are unstable. This is shown by several signs of slope deformation, including initial crack above the site, repaired road and tilted electric pole due to sliding, and road rectified due to slope deformation. So that in the stage of stripping construction need slope reinforcement such as crib wall, soil nailing, and drainage on the edge of the highway to stabilize the slope and reduce erosion on the slope.

Figure 1: Site condition from Google Earth observation (Source: Street View of Google Earth)

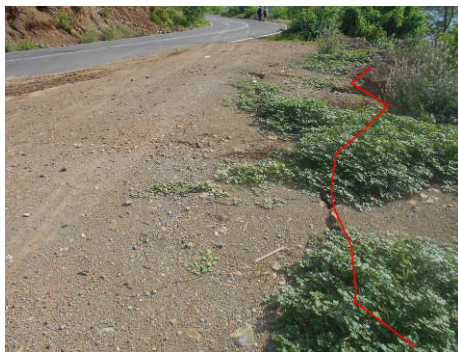
Figure 2: Initial crack above the site project

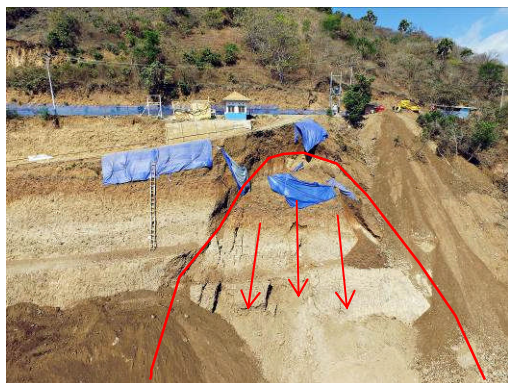
From the slope failure pattern it can be classified into Multiple Rotational Debris Slides. This is because the slope failure geometry consists of one crown and scrap but there is also a fracture that forms a crown behind the avalanche. Therefore, the situation is very dangerous around the location if the construction activity is continued without any mitigation to the collapsing area. Response to the slope failure slope should be done by restore the slope before the construction continued. During the process of restoring the slope, it is necessary to observe periodically on the fractures formed by slope failures. The Slope reinforcement that can be done, such as backfilling and gabion installation at the bottom of the slope to the collapsing area serving as counterweight, installing an anchor at the top of slope, and installing soil nailing on the slope to the elevation of the plan.

After the excavated slope collapsed, there are appear cracks in some location around the crown. This is an indication that the slope is still in unstable condition and there is a possibility of further slope failure potential. So that it is necessary to conduct intensive observation of slope deformation during the process of slope reinforcement until the construction phase is complete.

Figure 3: Post-Slope failure Condition.

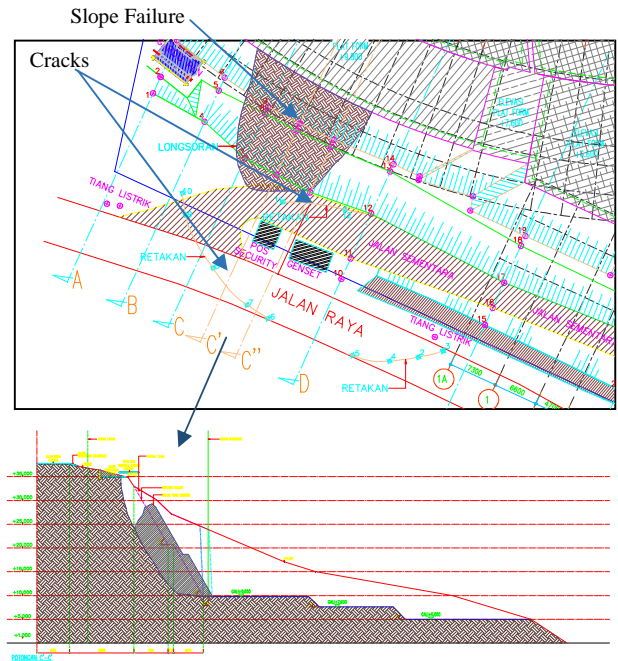
Figure 4: Land Situation and vertical cross section.

Based on the result of monitoring the slope deformation carried out at 6 monitoring point, it can be seen that the slope deformation in the cracks has decreased. The slope deformation observation for 9 days after the slope failure shows a downward trend until it stops. From the result of slope deformation, it can be concluded to be classified as Extremely Slow, with an average deformation speed of  $9.65 \times 10^{-9}$  mm/sec  $\approx 0.3$  mm/year.

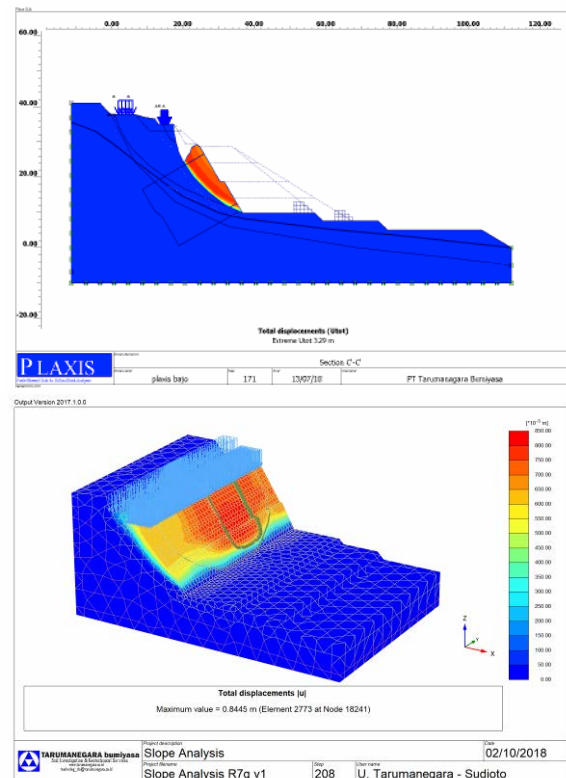
1. In the early phase is the initial load or gravity load stage in the post-slope failure condition. This stage still includes the traffic load of main road and the temporary road to the location.

Figure 7: Back analysis of post-slope failure phase, Top: Plaxis 2D, Bottom: 3D

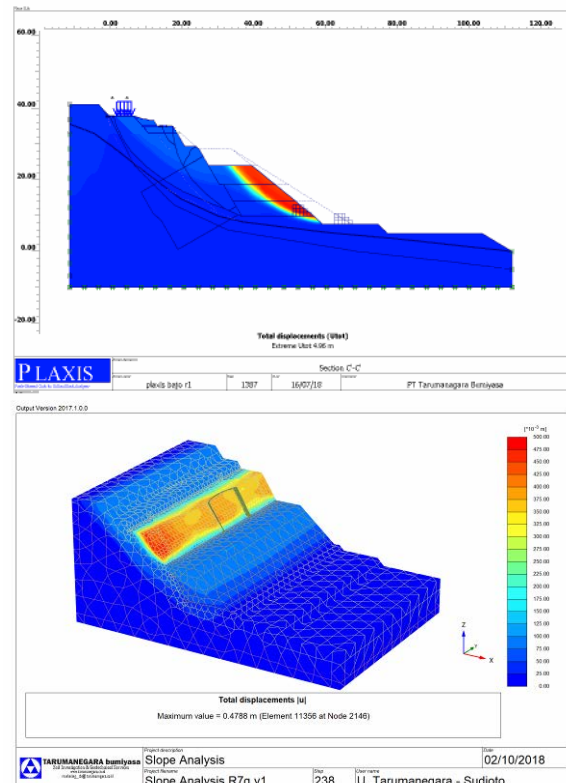
Figure 8: Early treatment phase, add fill material for counterweight and gabion, Top: Plaxis 2D, Bottom: 3D

2. The second phase is the early treatment phase where to backfill the fill material that serves as counterweight up to +28.7m and installation of gabion on the toe of counterweight. At this stage the main road is shifted and the road temporarily stopped.

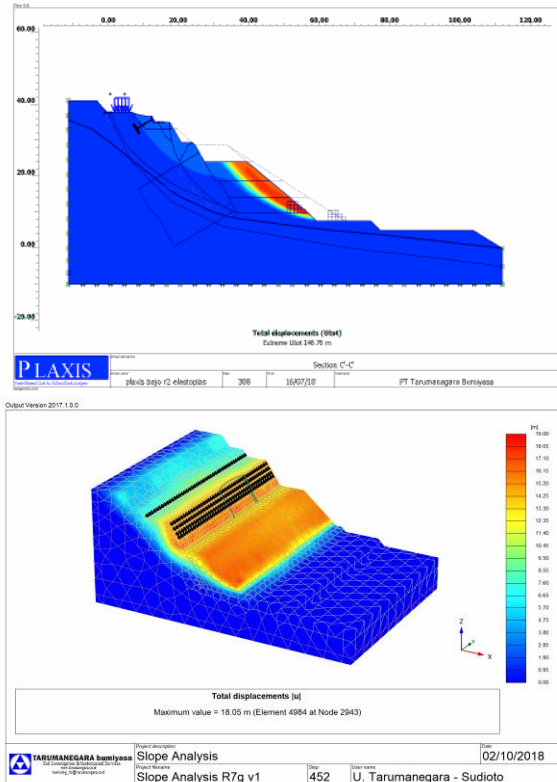
Figure 9: Slope Reinforcement Phase 1, Top: Plaxis 2D, Bottom: 3D.

3. The Slope reinforcement phase 1. The installation of ground anchor and crib wall for slopes close to the main road.

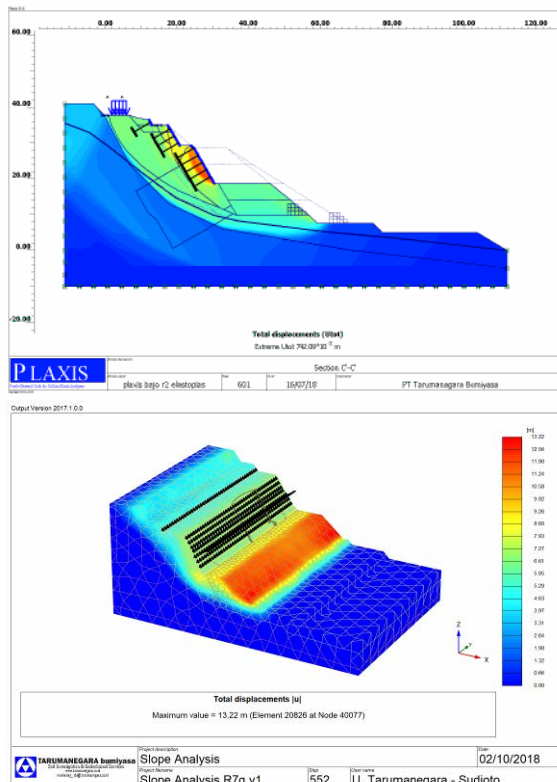
Figure 10: Slope Reinforcement Phase 2, Top: Plaxis 2D, Bottom: 3D.

4. Slope reinforcement phase 2, the installation of soil nailing and crib wall down to +18.5m elevation. In the installation of soil nailing and crib wall, counterweight excavated gradually then follow by installing the soil nailing and crib wall.

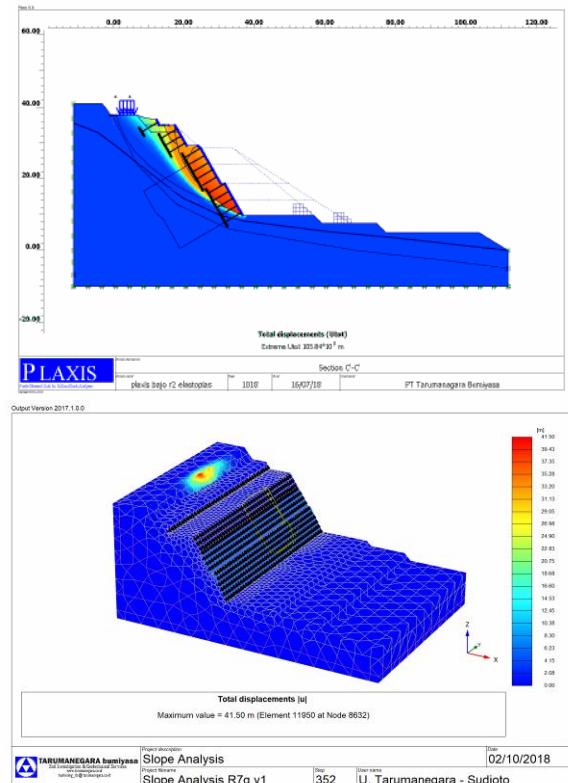
Figure 11: Slope Reinforcement Phase 3, Top: Plaxis 2D, Bottom: 3D.

5. Slope reinforcement phase 3, the installation of soil nailing and crib wall down to +9.8m elevation and external load (traffic on the main road has been running normally).

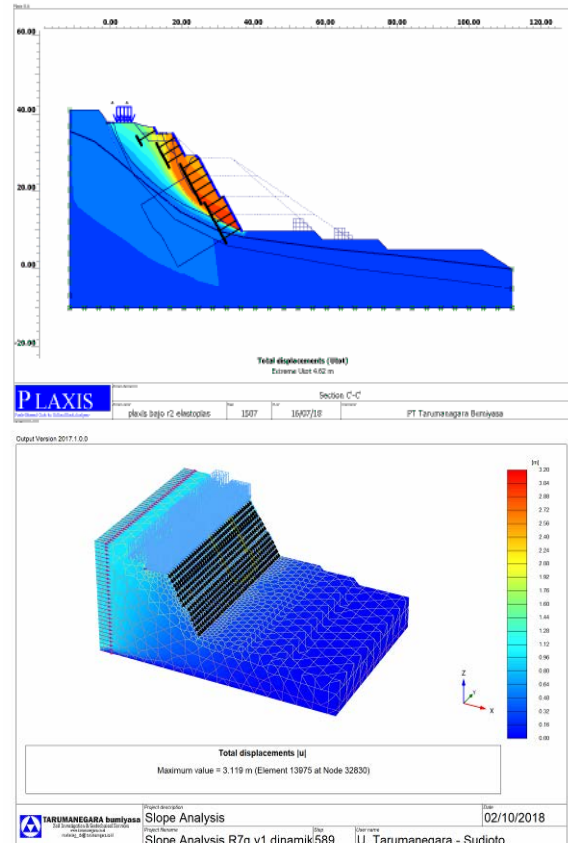
6. The final phase is applying earthquake load  $a_h = 0.288g$ .

Figure 12: Earthquake load phase, Top: Plaxis 2D, Bottom: 3D.
