Case Study of Renovation on Alishan Route 18 after Typhoon Morakot

Kung-Tai Chou¹, Wen-Long Wu², Chiao-An Hsiao³, Kun-Hsien Chou⁴
CECI Engineering Consultants, Inc., Taiwan

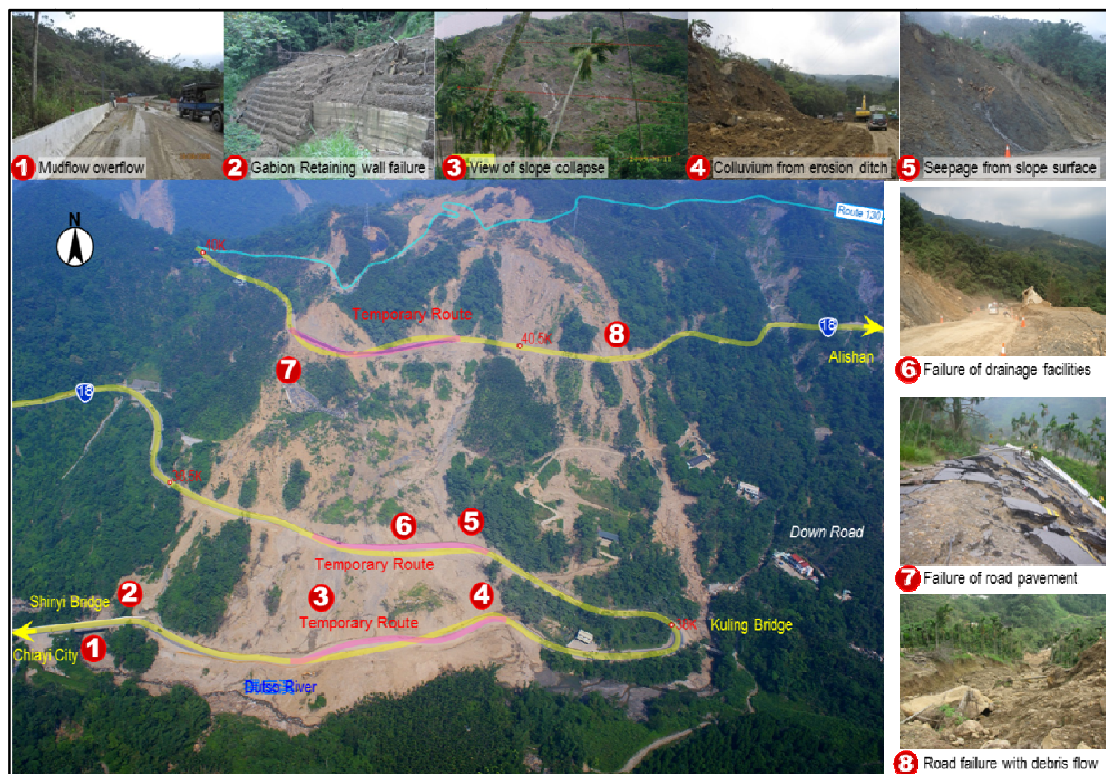
Typhoon Morakot had damaged more than 40 locations along Alishan route 18, including slope slides and road erosions. Mileages 37.5k~40.1k, 59.1k, and 71.1k are the three most disastrous sites. The main disaster types are upper and lower slope slides, and deep seated landslides. Figure 3~5 show aerial and site figures after Typhoon Morakot. After disaster, temporary road was constructed at the above road sections to maintain accessing. However, due to the unstable roadbed, the temporary road may be unable to withstand the erosion of heavy rainfall in the typhoon seasons.

Figure 3 Slope slide disaster photos at mileage 37.5k
