Figure 9 Type of slope failures on Alishan Route 18

3. REMEDIATION METHOD AND REHABILITATION STATUS

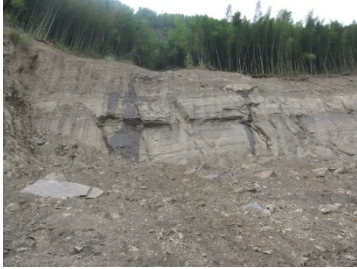
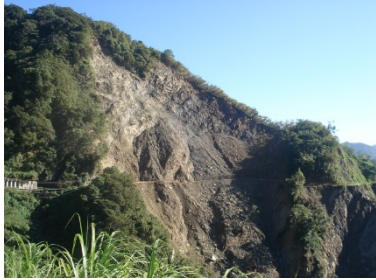
Dip slope landslide at upper slope and circular landslide at 37.5k.	circular landslide at lower slope and mixed type landslide at 37.5k.

upper slope toppling failure at 59.1k	upper slope circular landslide, Dip slope landslide at lower slope at 71.1k

location	Cause analysis of disasters	Failure types
37.5k ~ 40.1k	<ul style="list-style-type: none"> Runoff erosion due to heavy rain Shallow-rooted plant, poor soil and water conservation No vertical and horizontal cut-off drainage facilities in slopes Road drainage not properly segmented and discharged into stream, causing water overflow The exposed toe of dip slope in the east side lead to landslide Rainwater infiltration in west side colluvium deposits soften soil strength and reduce slide resistance of soil that lead to circular landslide of slopes 	<ul style="list-style-type: none"> The upper slopes are classified as dip slope landslide; the lower slopes belong to circular landslide and a large number of earth and rock piled on the roadbed 37.5k ~ 38k

59.1k	<ul style="list-style-type: none"> Runoff erosion due to heavy rain No vertical and horizontal cut-off drainage facilities in slopes Formation steep, more broken joints in the upper shale slope, lots of rain infiltration in joints increase tension cracks. Rainwater infiltration in colluvium deposits at lower slopes soften soil strength and lead to slope failure 	<ul style="list-style-type: none"> Topping failure due to the crest rock with high angle joints, the slopes in vicinity of tunnel belong to dip slope plane slide. Other sections are classified as circular landslide

71.1k	<ul style="list-style-type: none"> Runoff erosion due to heavy rain After rock crushing and highly weathered, the rain infiltration in rock cracks increase water pressure and soften soil strength. This road section includes streams through, runoff flow wash out slope and rock rushed shift which results in steep terrain in some sections. In the upper slope of road, the heavy rainfalls leads to the broken rocks fall and accumulate on the roadbed. In the lower slope of road, the exposed toe of dip slope leads to landslide and the loss of roadbed. 	<ul style="list-style-type: none"> The upper slopes are classified as circular failure, the upper broken rocks fall and accumulate on the roadbed. The lower slope valleys are wash out by rains, the exposed toe of dip slope lead to landslide in the lower slope.

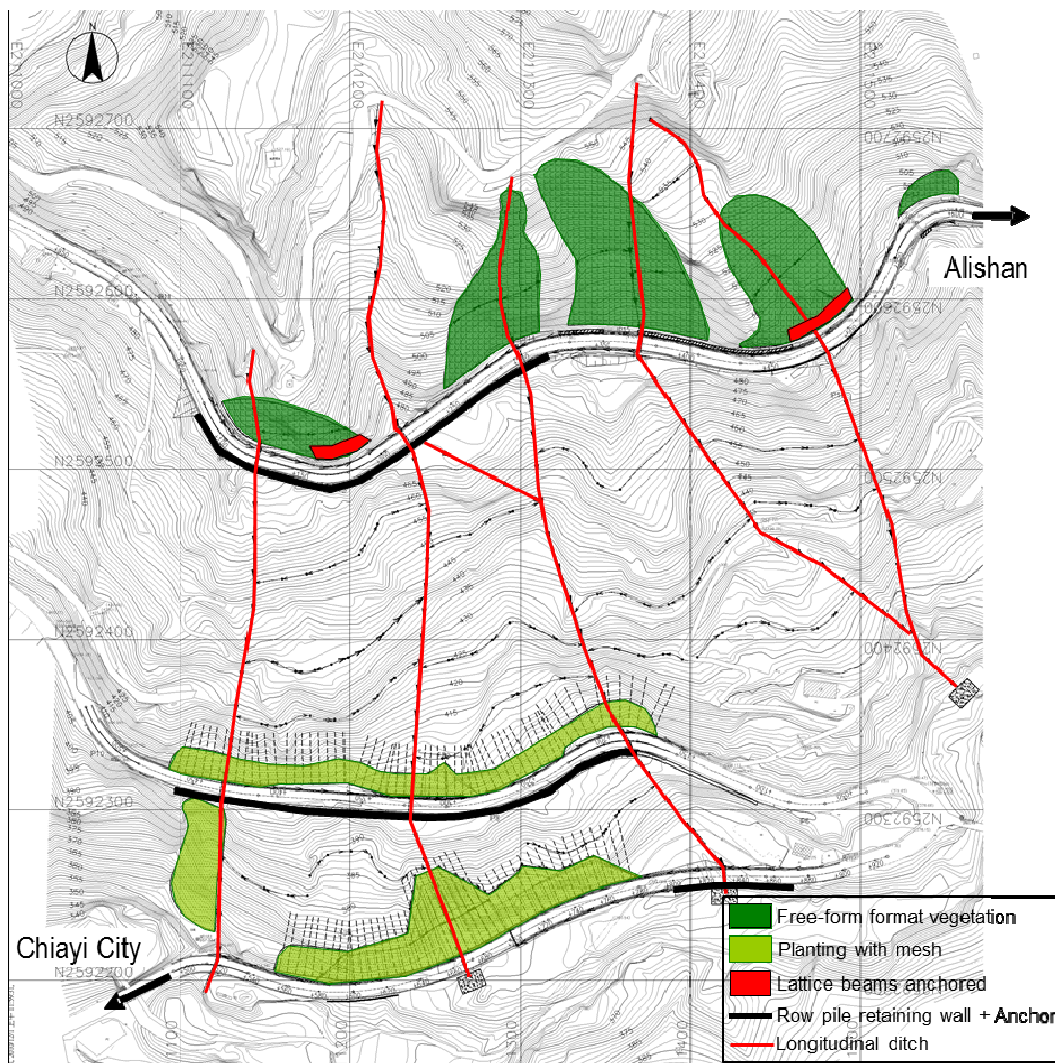
Figure 10 Layout of repair works at Mileage 37.5k ~40.1k of Alishan Route 18

This section close to the collapse sources at County Road 130. The rock collapse leads to large area exposed in the slope and some plane slides occur in the dip slope. The circular landslide induced around 200 meters subsidence in the lower slope of the road. Lattice beams anchored near slope toe are used in the dip slope for the slope protection. Grouting anchorage of free-form format is adopted for the slope protection in the exposed area. A single row pile of ϕ 1.2m retaining wall with rock anchors are carried out in the lower slope due to the circular slide. In addition, vertical and horizontal drainage ditches and crossing culvert are installed so that the runoff in the upper slope can be smoothly guided to the existing ditches in downstream for emissions.

More buffer space is reserved for slope repair use in this and previous section. The vegetation way for slope protection are used in this section and Mileage 38.1k~38.5k. Moreover, the necessary vertical and horizontal drainage ditches, chute and crossing culvert

are installed so that the runoff in the upper slope can be smoothly guided to the existing ditches in downstream for emissions.

This section is located at the area of colluvium circular landslide. A single row of ϕ 1.2m piled retaining wall with rock anchors is implemented in this section. In addition, the necessary vertical and horizontal drainage ditches and crossing culvert are installed so that the nearby runoff can be smoothly guided to the adjacent drainage system of Mileage 38k.

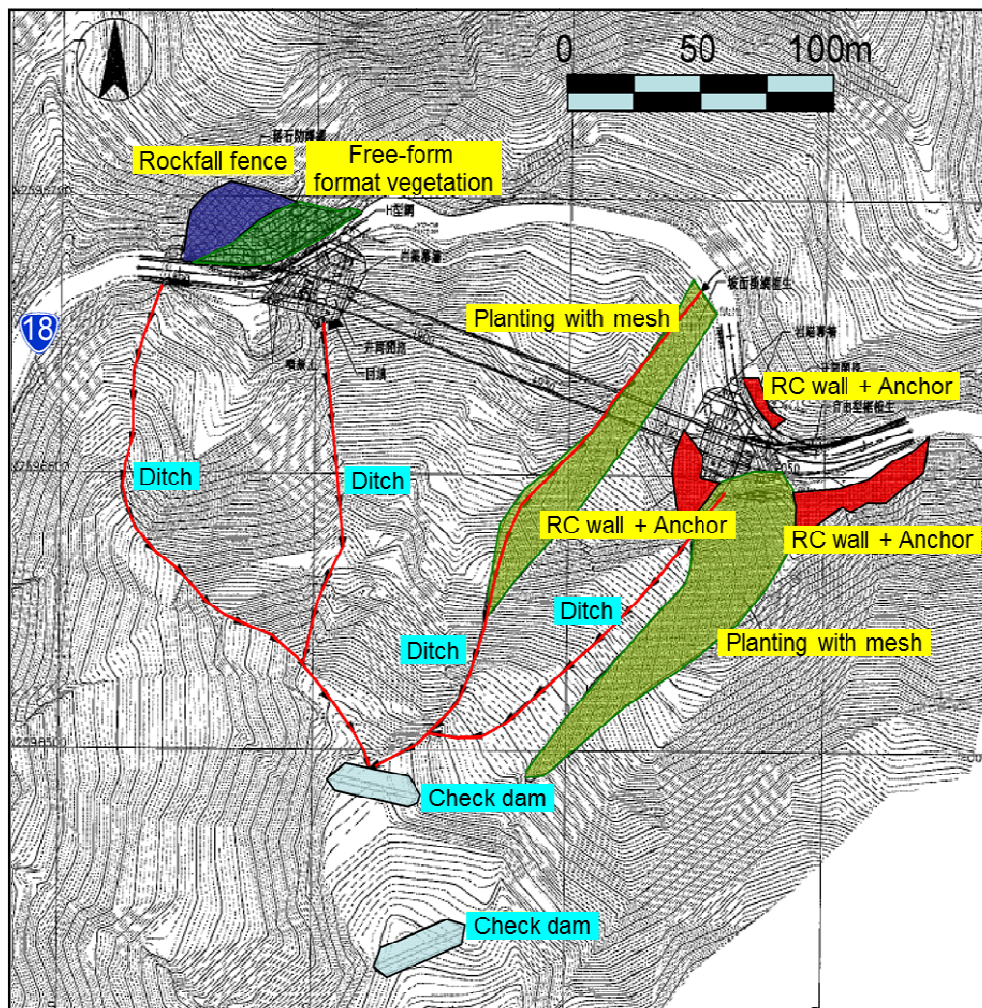
Figure 14 Layout of repair works at Mileage 71.1k of Alishan Route 18

The upper slopes are classified as circular slide failure. The downslopes belong to dip slope plane failure. It is difficult to use road rehabilitation plan when the road slope is steep and the hinterland is not adequate in this road section. The rehabilitation adopts a new bridge to avoid the landslides area. The main slope stability treatments consist of lawn nursery, rock fall fence and rock anchor curtain wall. The upper slope of bridge abutment (A1) in the east side implements free-form vegetation for slope protection and rock fall fence protection; The upper slope of east bridge abutment (A2) carry out rock anchor curtain wall (dip slope stratum). The

vegetation for slope protection is installed in the lower slope. Layout of remediation work is shown in Figure 14.

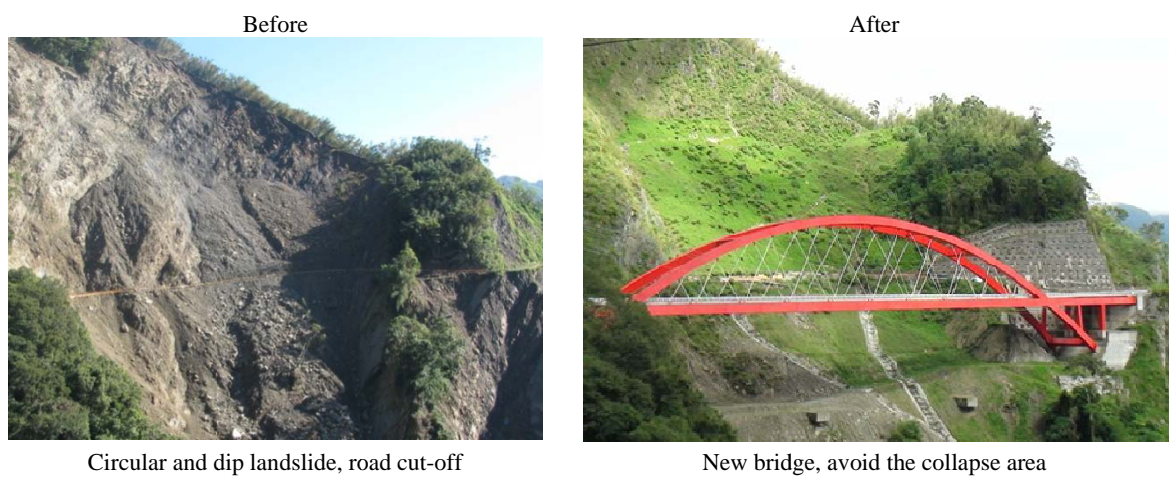
Figure 15 Before and after Photos at Mileage 71.1k of Alishan Route 18

Circular and dip landslide, road cut-off

In consideration of the site characteristics of collapse and the geological conditions, a bridge with steel structure is used in this project. The steel structure bridge can not only reduce the weight of the structure and also plan steel block size in accordance with the needs of transport and construction conditions. The steel structure is produced in the factory and its quality can be assured and have a rapid construction. The project employs a half-through steel arch bridge and gives a Tsou aboriginal name in accordance with the aboriginal culture and totem. Photos are shown in Figure 15.

New bridge, avoid the collapse area
