FIELD MONITORING OF SUBSIDENCE EFFECTS IN AIT CAMPUS, BANGKOK, THAILAND
D.T. Bergado, A.S. Balasubramaniam and W. Apaipong
Asian Institute of Technology,
Bangkok, Thailand.

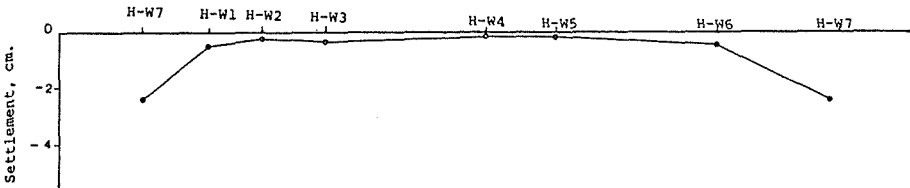
The other damages can be seen in the Academic Buildings, namely: SEC and GTE Building and HSD and ENV Building. Both buildings show cracks in the first floor walls (Fig. 10a, b) due to differential settlements with a maximum of 2.40 cm in 3 months as plotted in Fig. 6 and Fig. 7 on observed points indicated in Fig. 1. The horizontal and vertical cracks are evident in the weakest portion of the walls such as lines of mortar joints. Measured settlements of the columns on piles were negligible.

Fig. 7 Settlement of The First Floor Walls, HSD & ENV Building (See Fig. 1)

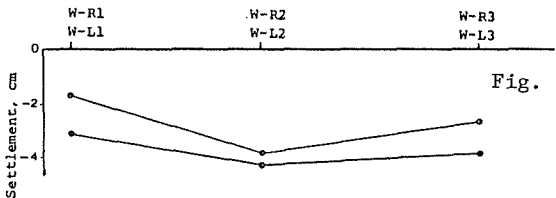
The walkway between the Hockey and Football Fields (see Fig. 1) registered differential settlements as plotted in Fig. 8. A maximum settlement of 4.30 cm was measured in 3 months period. The larger settlement registered in this area may also be caused by erosion of the sand subgrade below the walkway due to rain water run-off.

Fig. 8 Settlement of the Walkway Between Hockey and Football Fields

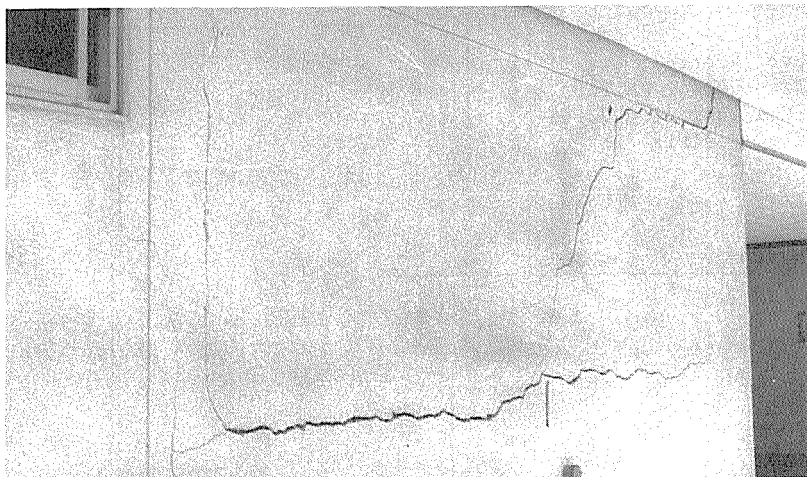
Fig. 10a Cracks in the First Floor Walls in ENV and HSD Building

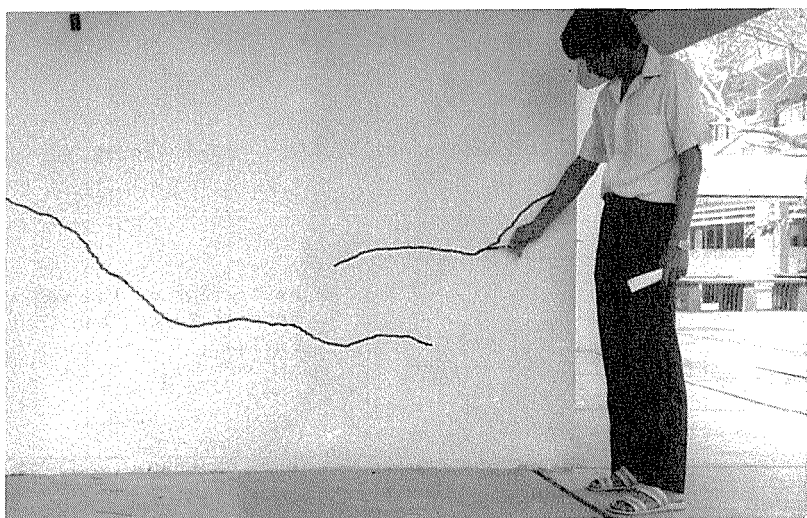
Fig. 10b Cracks in the First Floor Walls in SEC and GTE Building

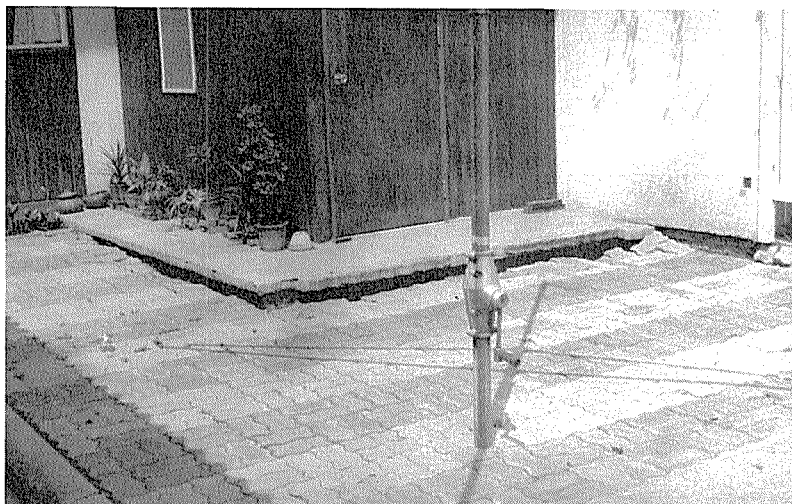
The NZ Faculty Housing Area also suffers structural damages due to subsidence of the surrounding ground relative to the houses which are supported by piles. The sidewalks are cracked forming scarps around the houses (Fig. 11a, b) and the servant's quarters which directly rest on the ground are sinking with a maximum measured settlement of 3.94 cm in 3 months period which occur in House No. 1 (point 1C). Some of the settlements are plotted in Fig. 9a and 9b on points indicated in Fig. 1. Most of these damages occur in the houses adjacent to the canal.

Fig. 11a Damage of Sidewalk at NZ Housing No. 1

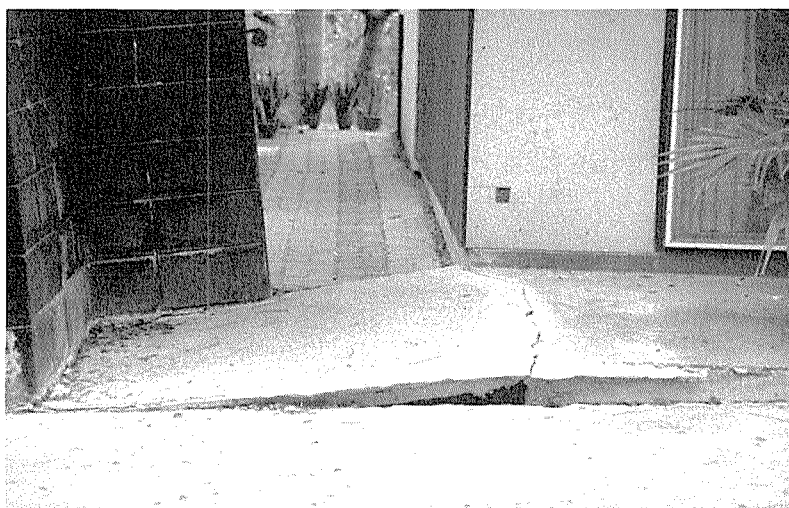
Fig. 11b Damages of Sidewalk at NZ Housing No. 7

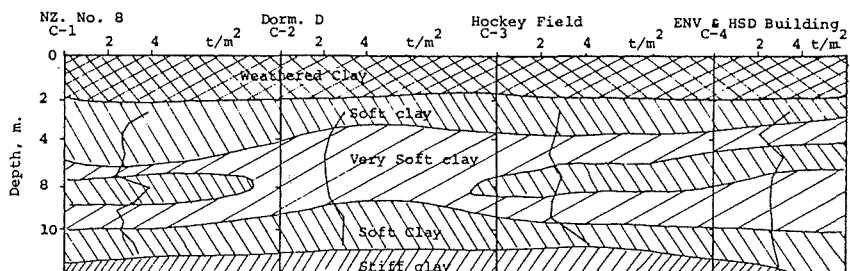
Based on the subsoil vane shear strength profiles (Fig. 12 and Fig. 13) on line C and Line D as indicated in Fig. 1, the areas of large subsidence coincide with weaker subsoil. The vane shear strength profiles are more variable and the presence of a weaker layer pockets (shear strength ≤ 2.5 t/m²) within the soft clay layer is more pronounced (Fig. 15). Line C extends from the NZ Housing Area through the Football and Hockey Fields to

Fig. 12 Vane Shear Strength Subsoil Profile Along Line C (see Fig. 1)

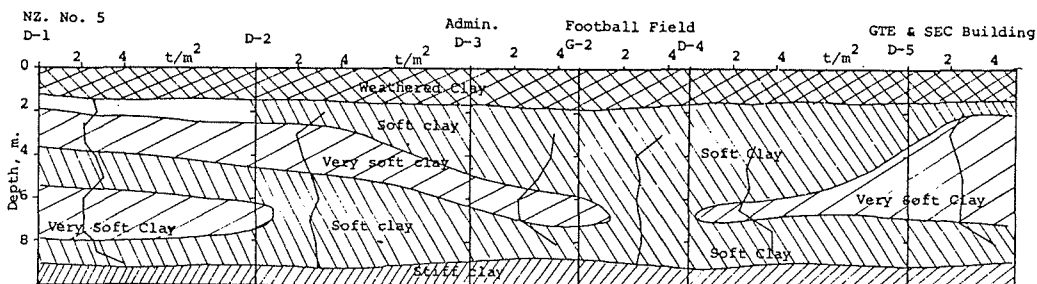
Fig. 13 Vane Shear Strength Subsoil Profile Along Line D (see Fig. 1)
