BLUE MOUNTAINS CUTTINGS

Geotechnical Hazard Assessment

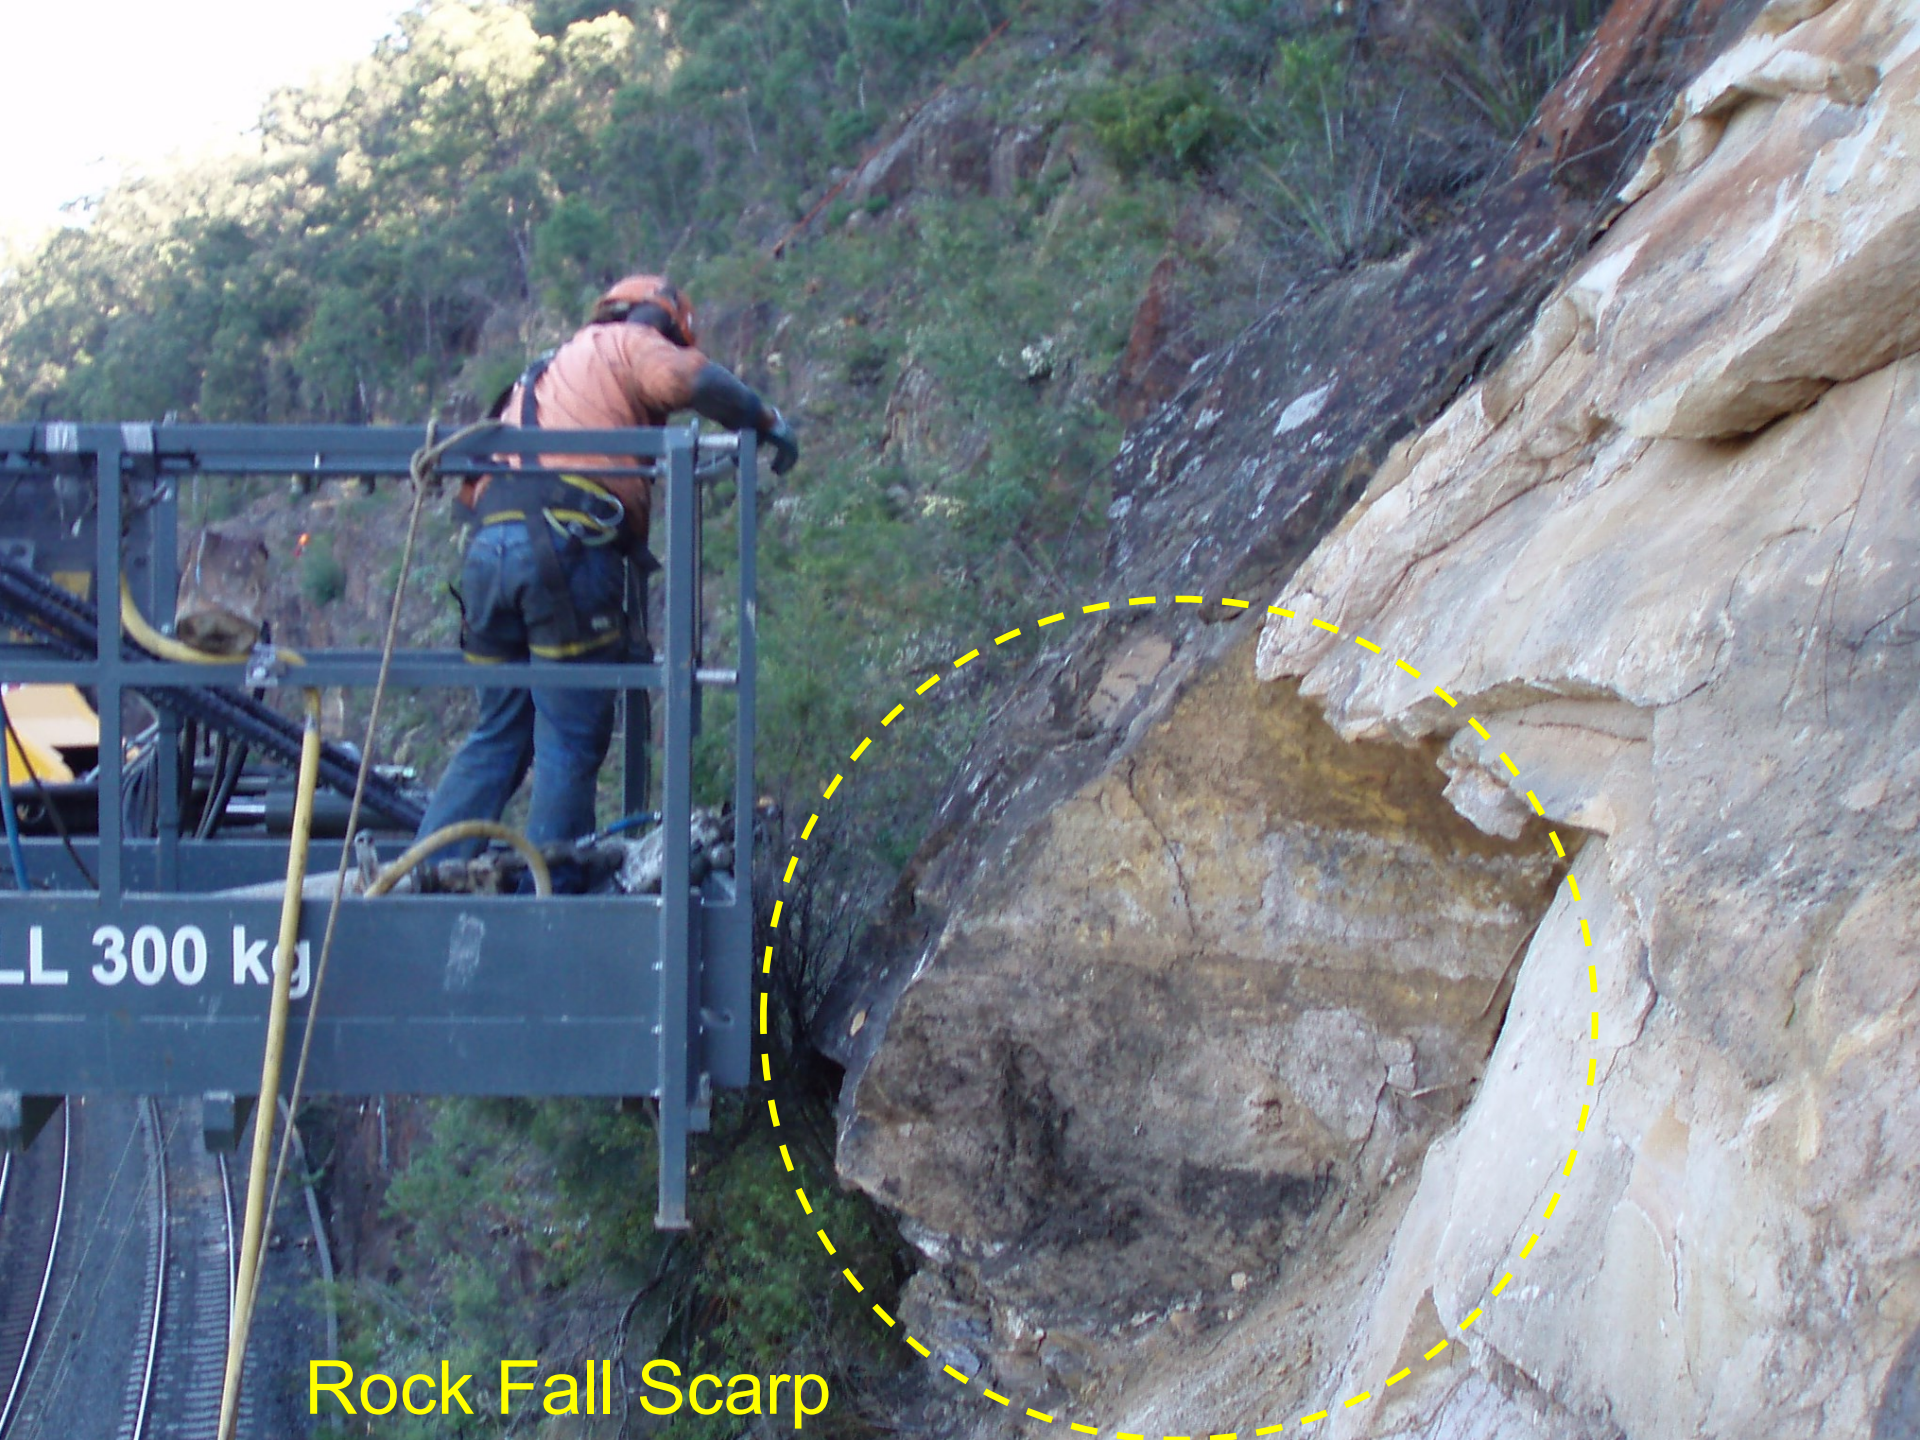
- Rock Fall from lower cut - blocked Up track
- Noticed by driver on Down track.
- 1 tonne rock could not be moved from track by driver
- Area previously assessed from **track level** by geotechnical engineer and no hazard identified

L 300 kg

Rock Fall Scarp

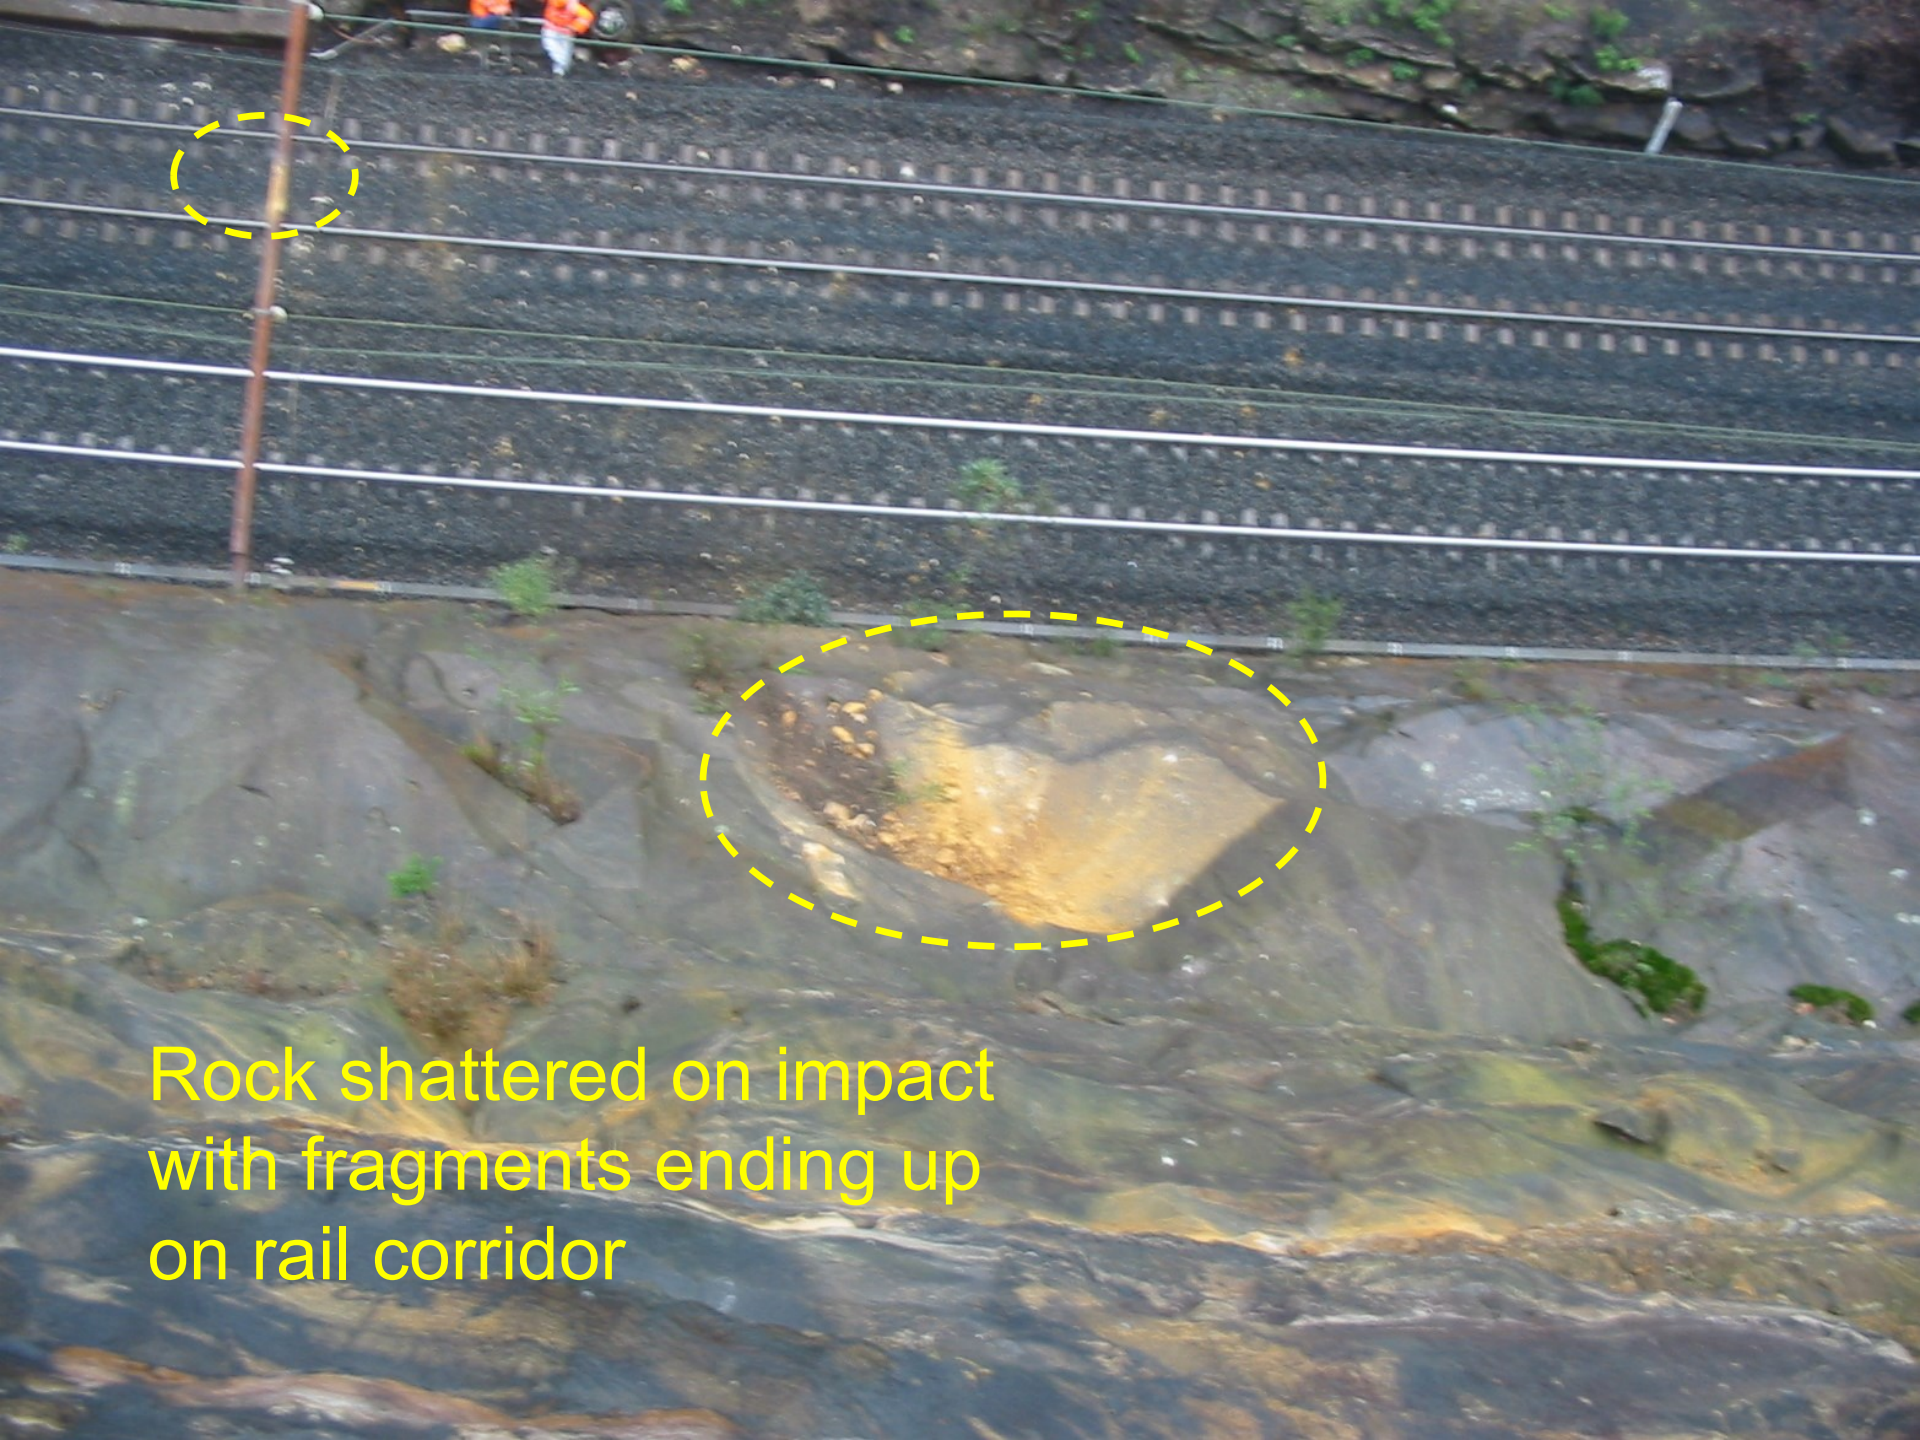
Rock Fall while on site

- While assessments being carried out
- During rainfall

Rock shattered on impact
with fragments ending up
on rail corridor

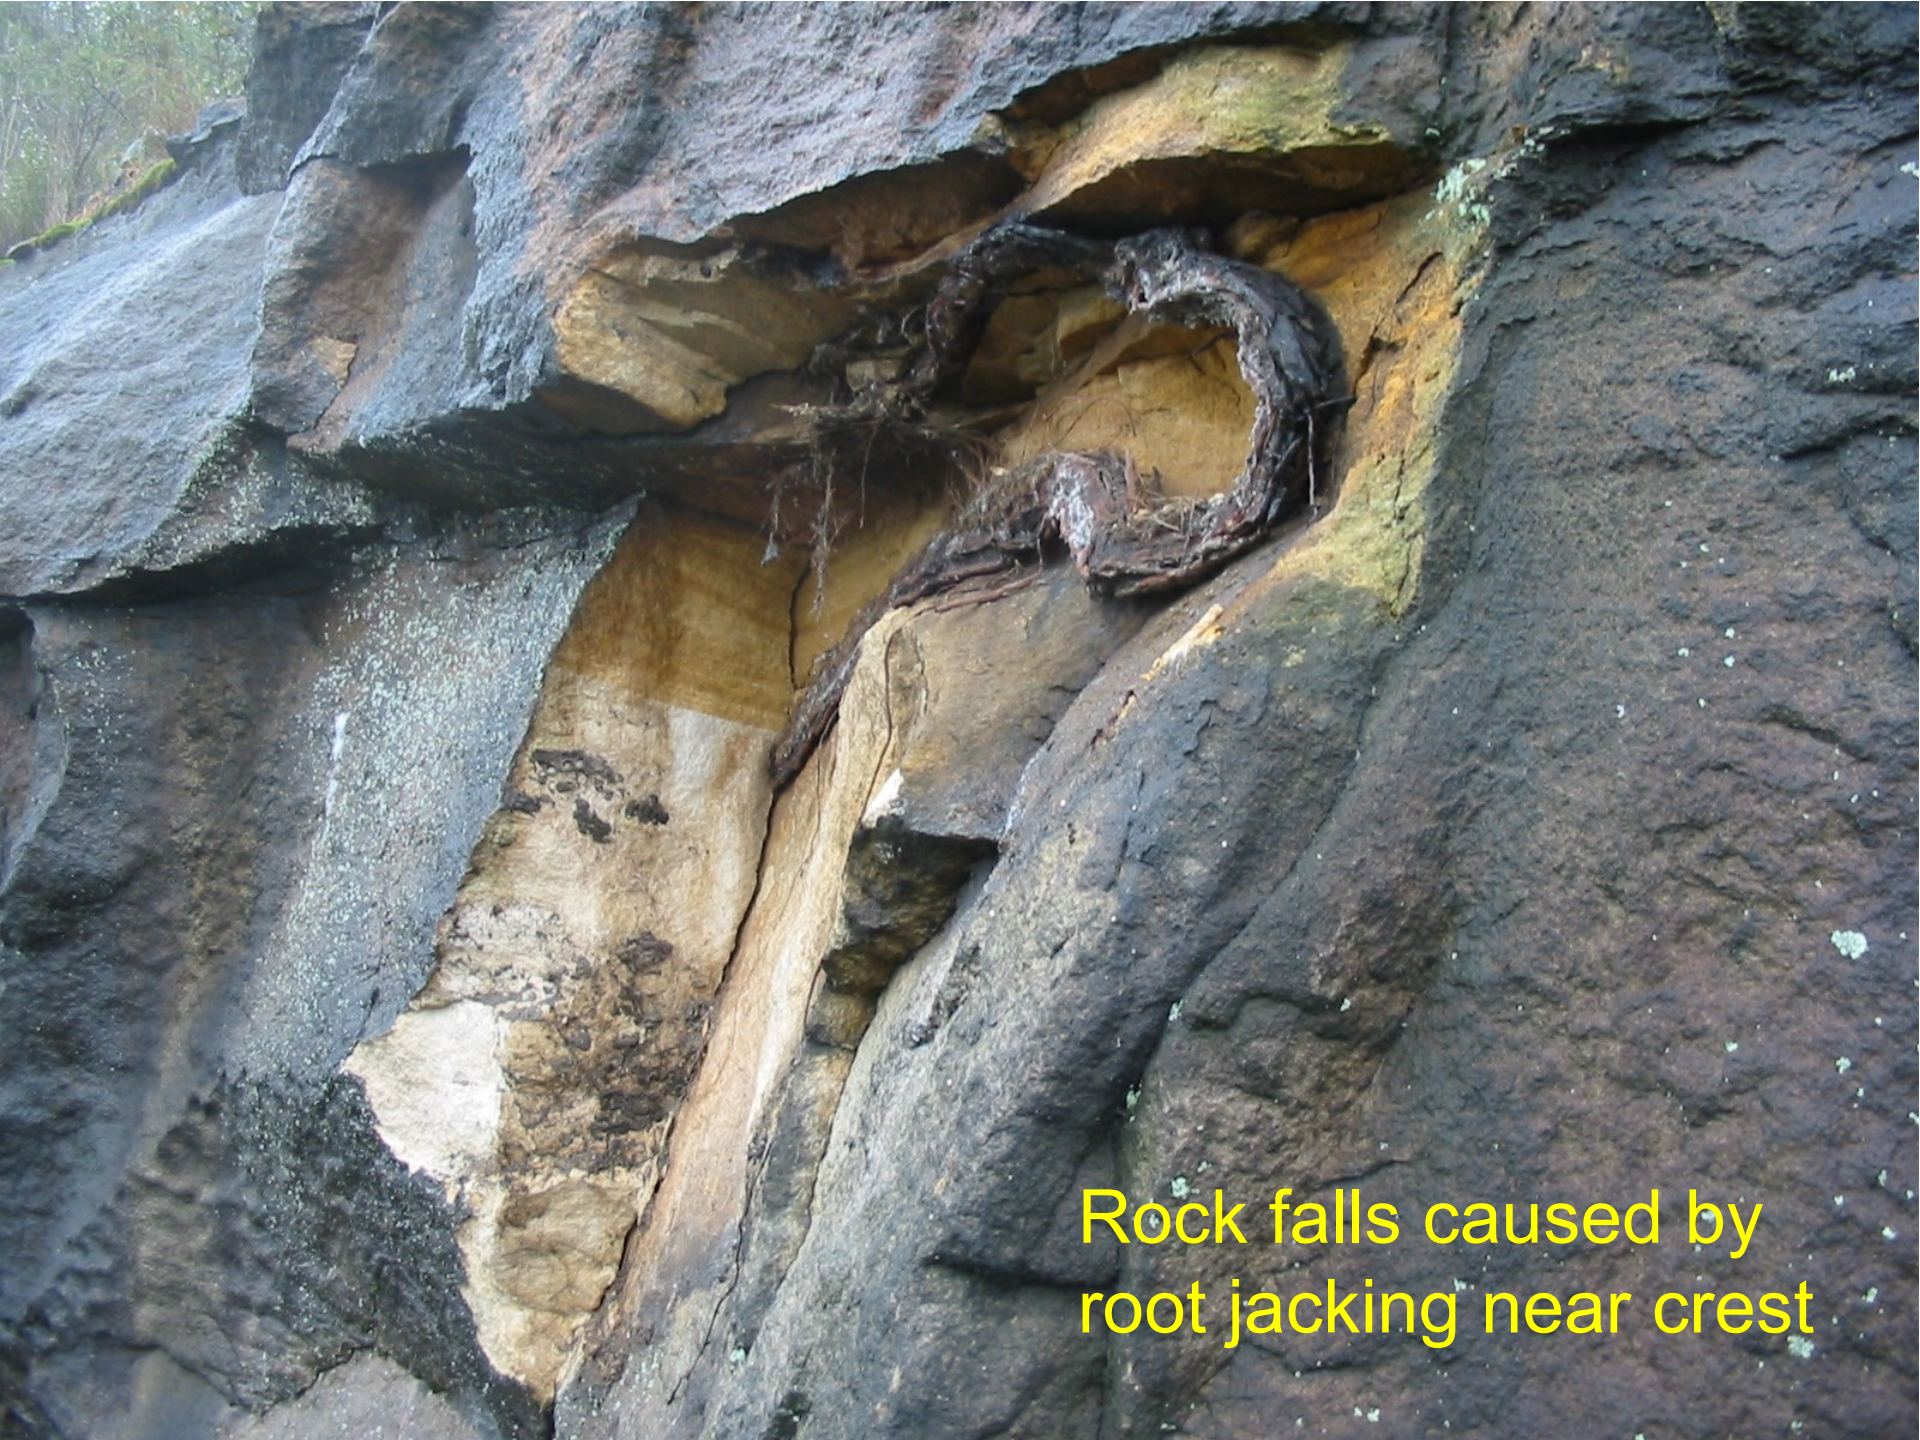
Rock falls caused by
root jacking near crest

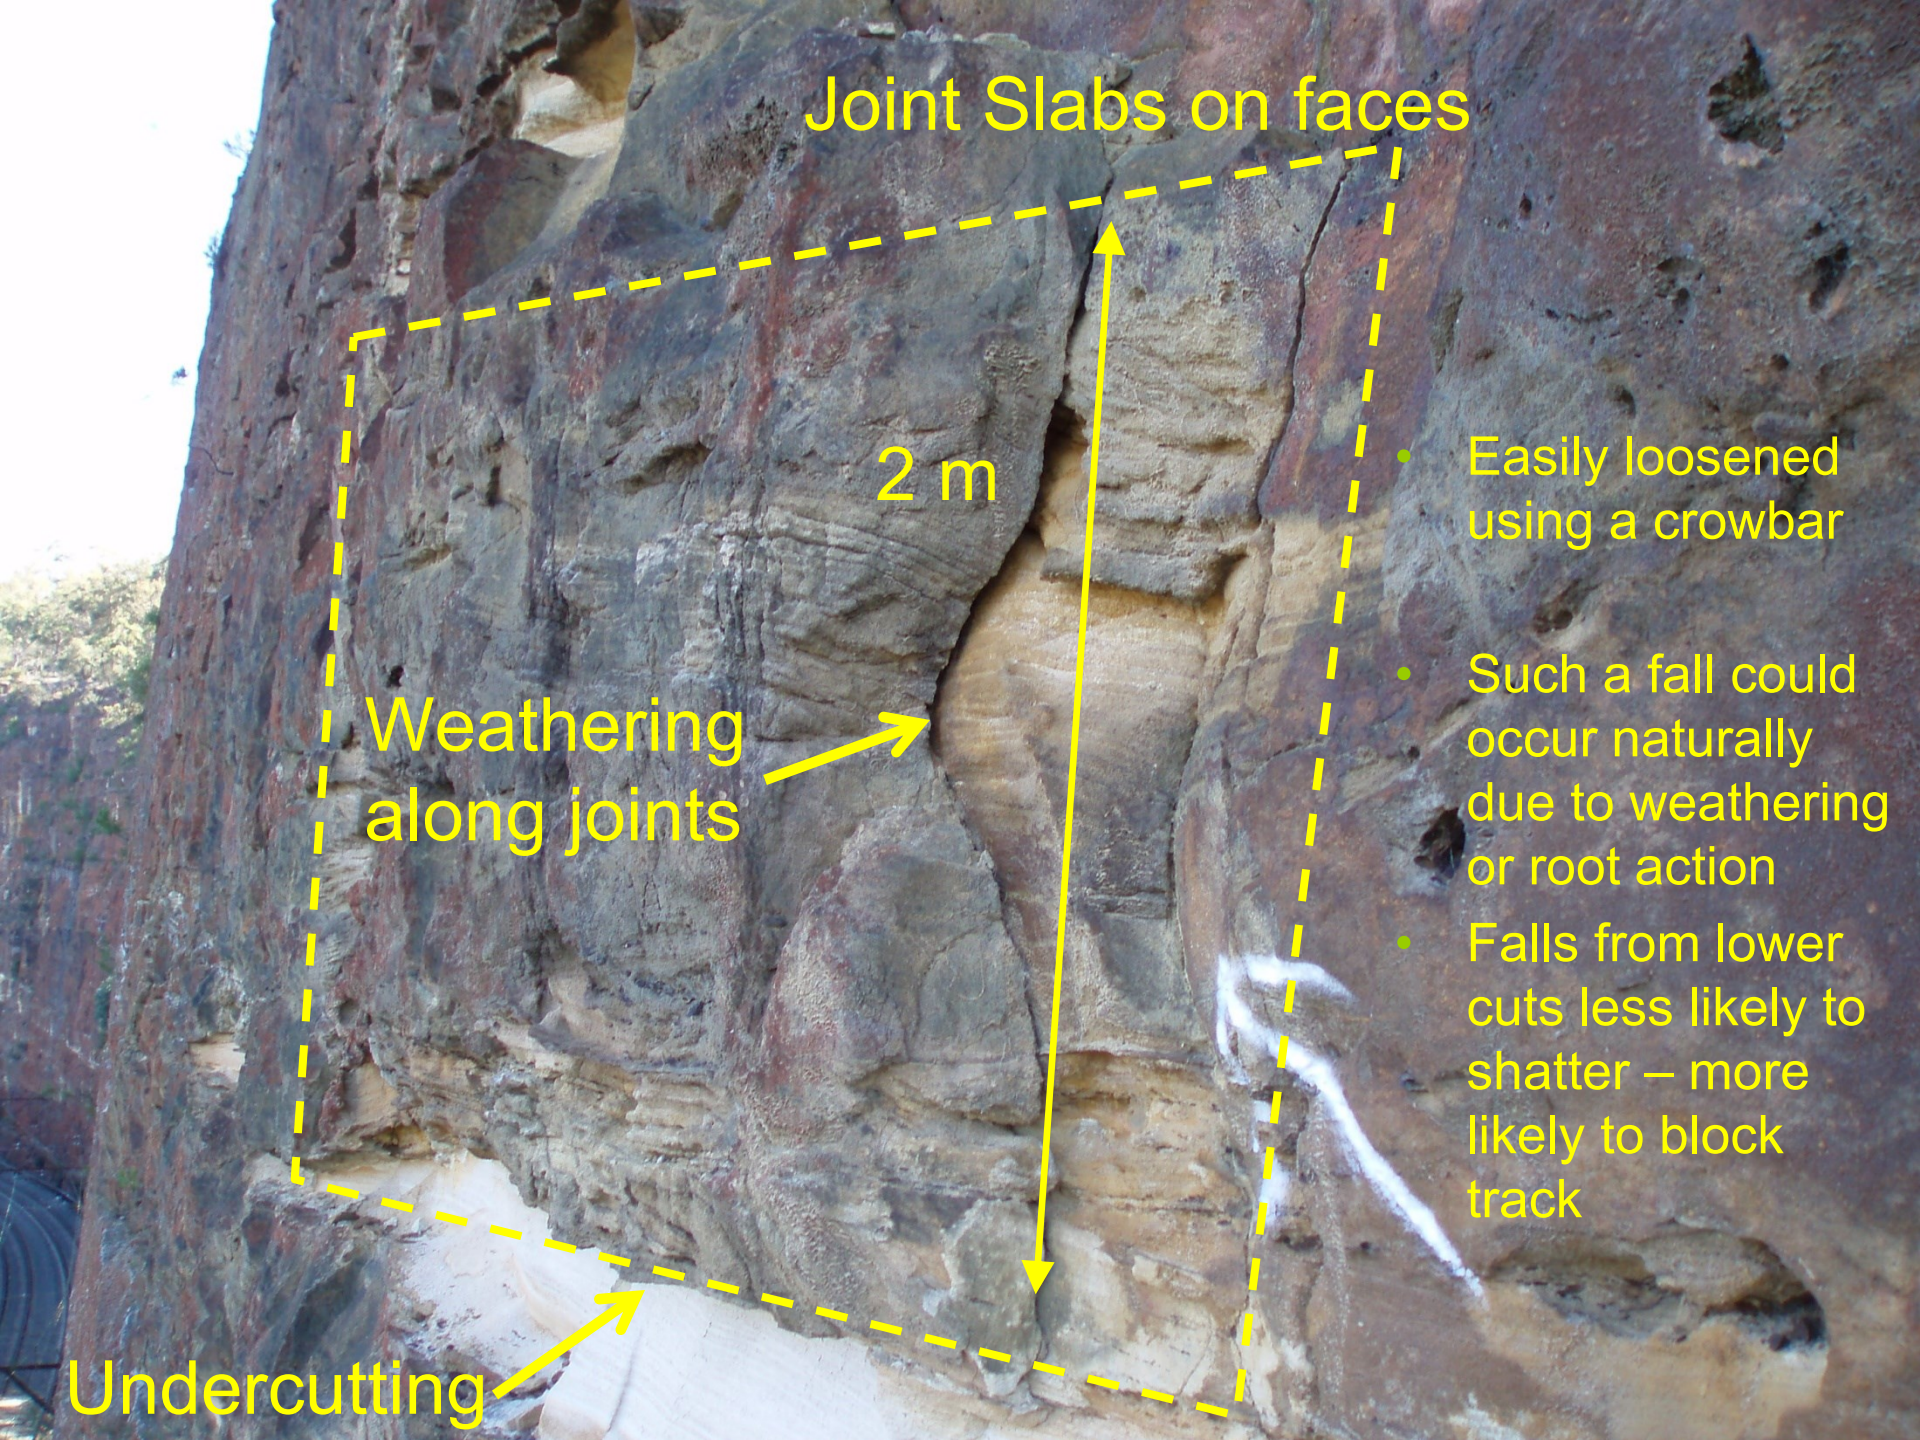
Joint Slabs on faces

Weathering
along joints

Undercutting

- Easily loosened using a crowbar
- Such a fall could occur naturally due to weathering or root action
- Falls from lower cuts less likely to shatter – more likely to block track

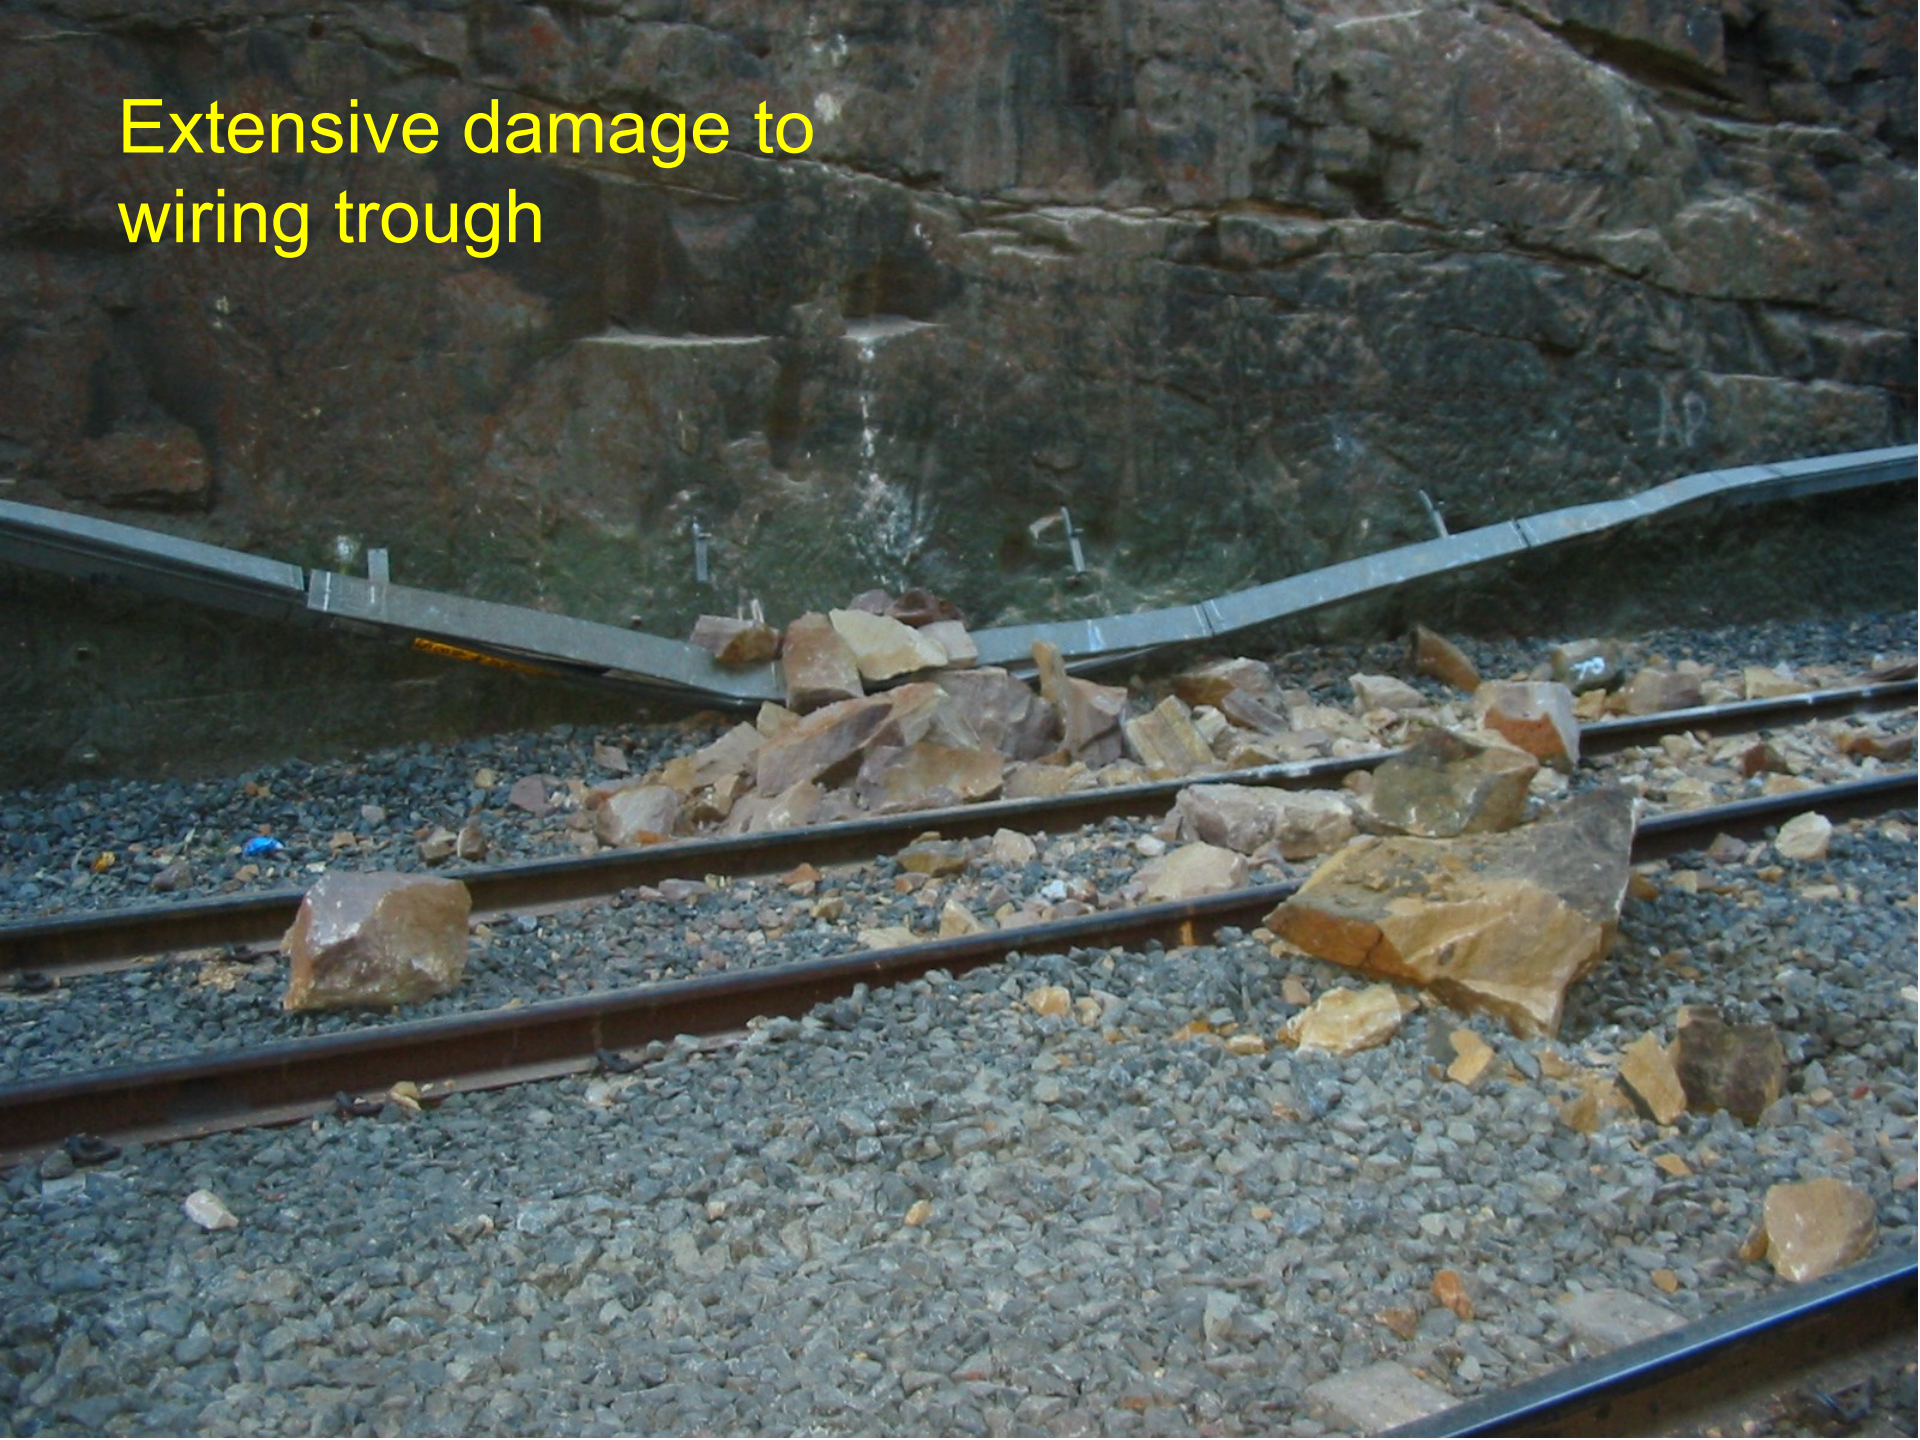
Extensive
damage to
overhead wiring
stanchion during
scaling

Extensive damage to
wiring trough
