# Case Studies on Dam Safety

Dr Gamini Adikari  
Principal Engineer Dams  
SMEC Australia

# Case Studies on Dam Safety Monitoring

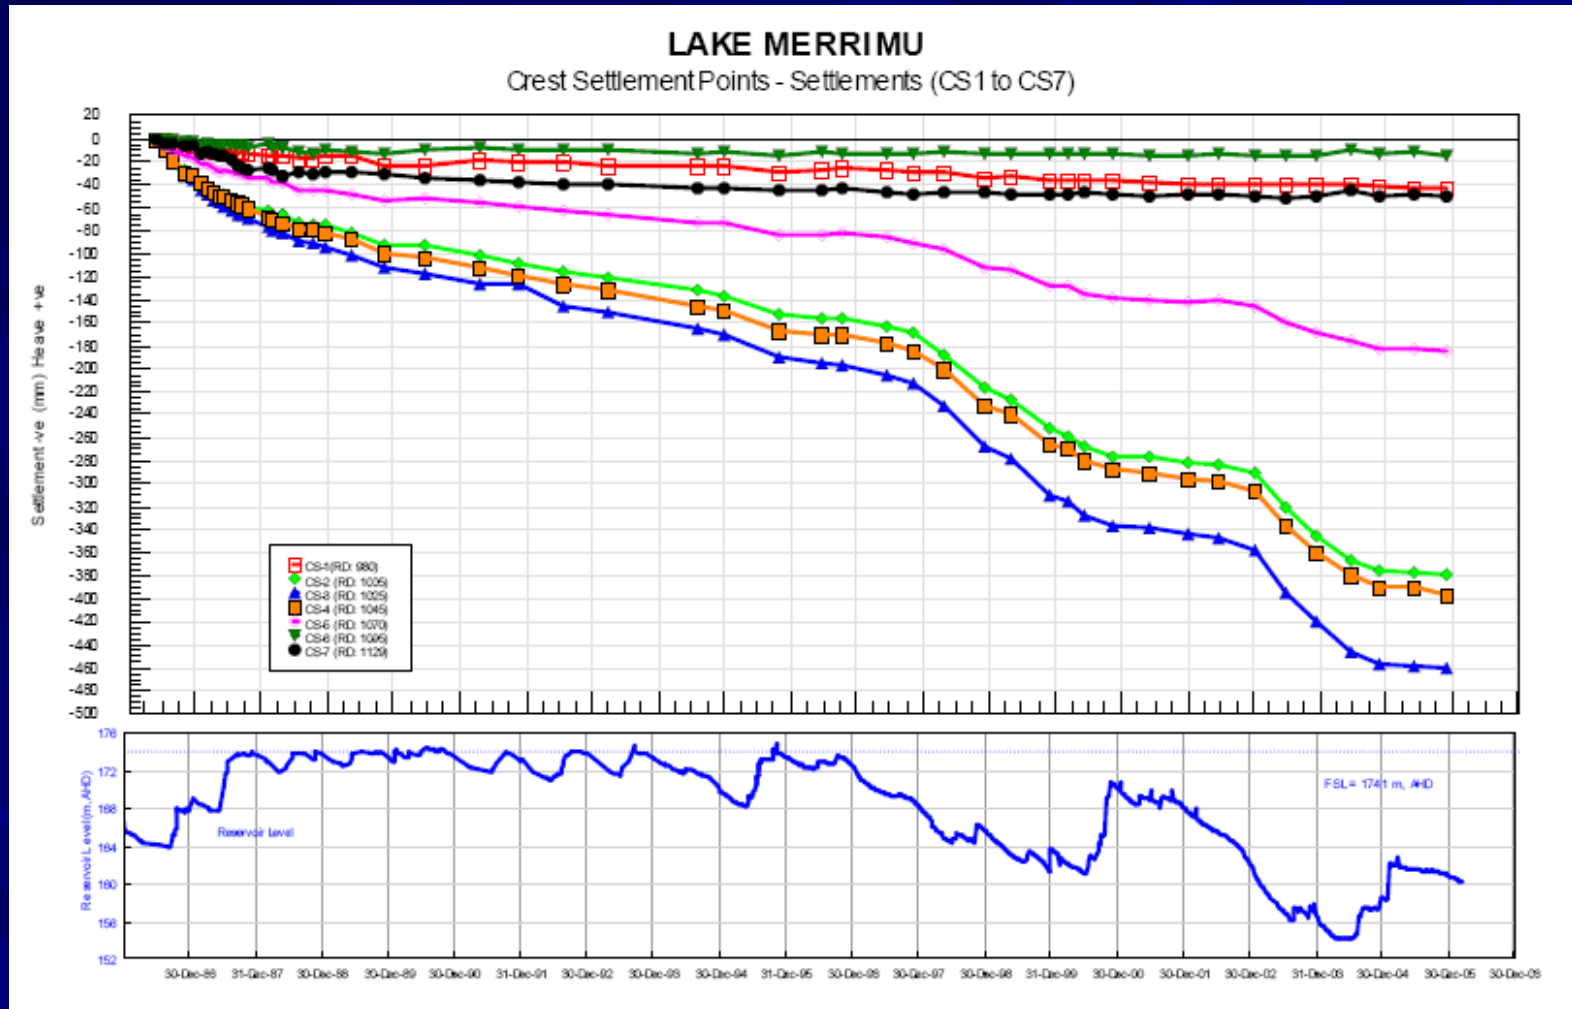
# Merrimu Dam Upstream Rockfill Zone

- Compacted Stage 3 rockfill placed over dumped upstream Stage 1 rockfill
- Substantial crest settlement of up to 250mm over the 10 year drought cycle from 1997 to 2007
- Longitudinal cracking observed in 2004, coinciding with core/upstream filter interface
- Differential settlement on the upstream side of crack

- Increase in effective weight in the upper portion of upstream rockfill zone due to drawdown of water during drought compressing the dumped rockfill in the lower portion
- Upper portion of rockfill settling as a block along the core/filter interface causing cracking and differential movement at the crest of the dam

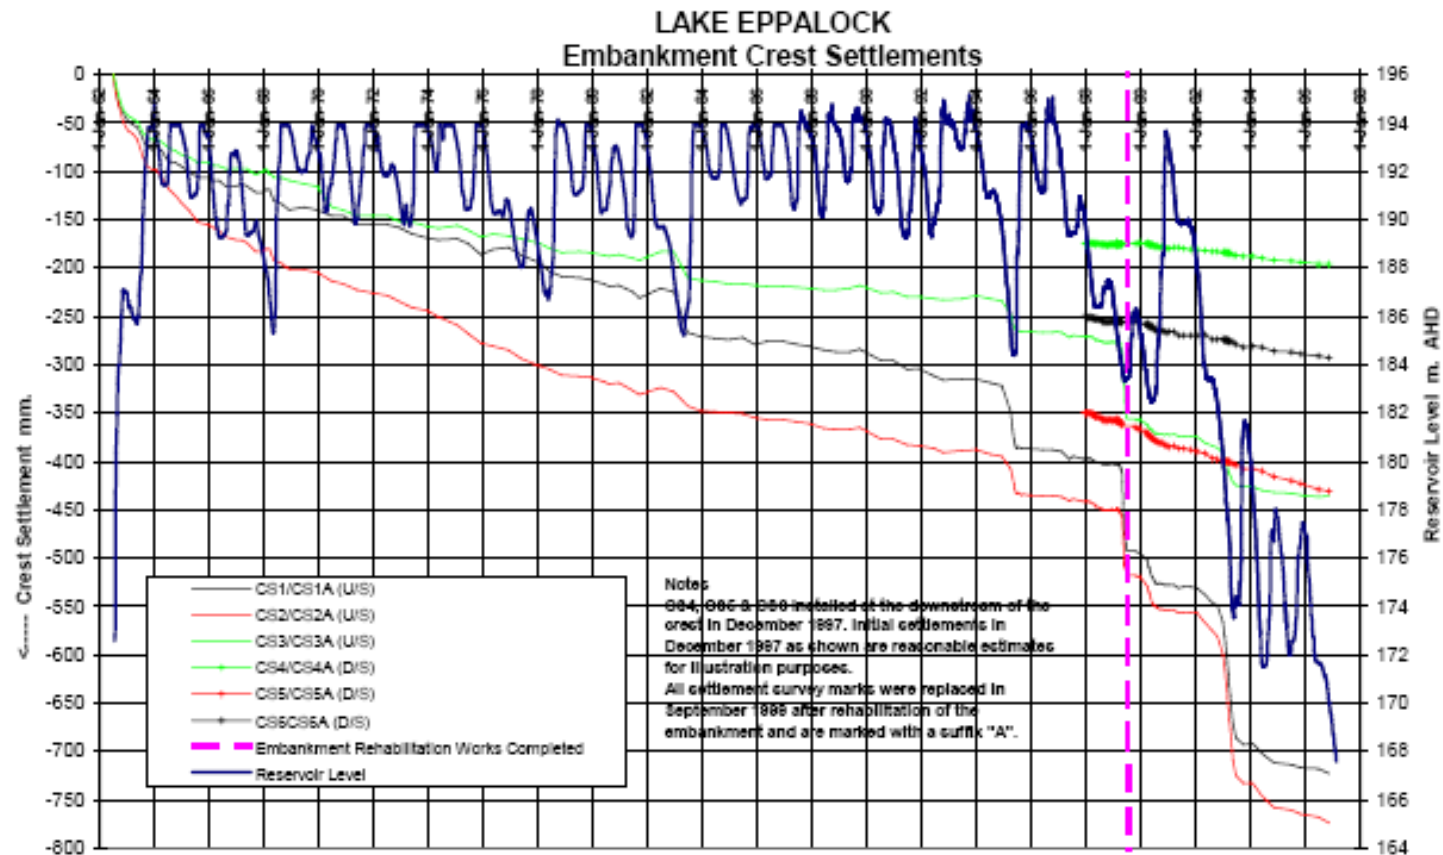
# Eppalock Dam

- 47m high central core dam with dumped rockfill zones
- Largest historical drawdown occurred during the 1997-2006 drought cycle
- Reservoir volume down to 1% with no water load acting on the dam
- Crest settlements of up to 400mm were recorded during this cycle
- Substantial longitudinal cracks opened at crest

- Long term consolidation, creep and outward deformation of the dumped rockfill shells exerting downward drag on the clay core, inducing tensile cracks at the crest
- Water ingress to cracks causing instability, softening of core and slope movement
- Increased effective stress during drawdown causing further settlement of rockfill, accelerating settlement and cracking of the core
- Drawdown continued even after 1999 remedial works causing further crest settlement and cracking

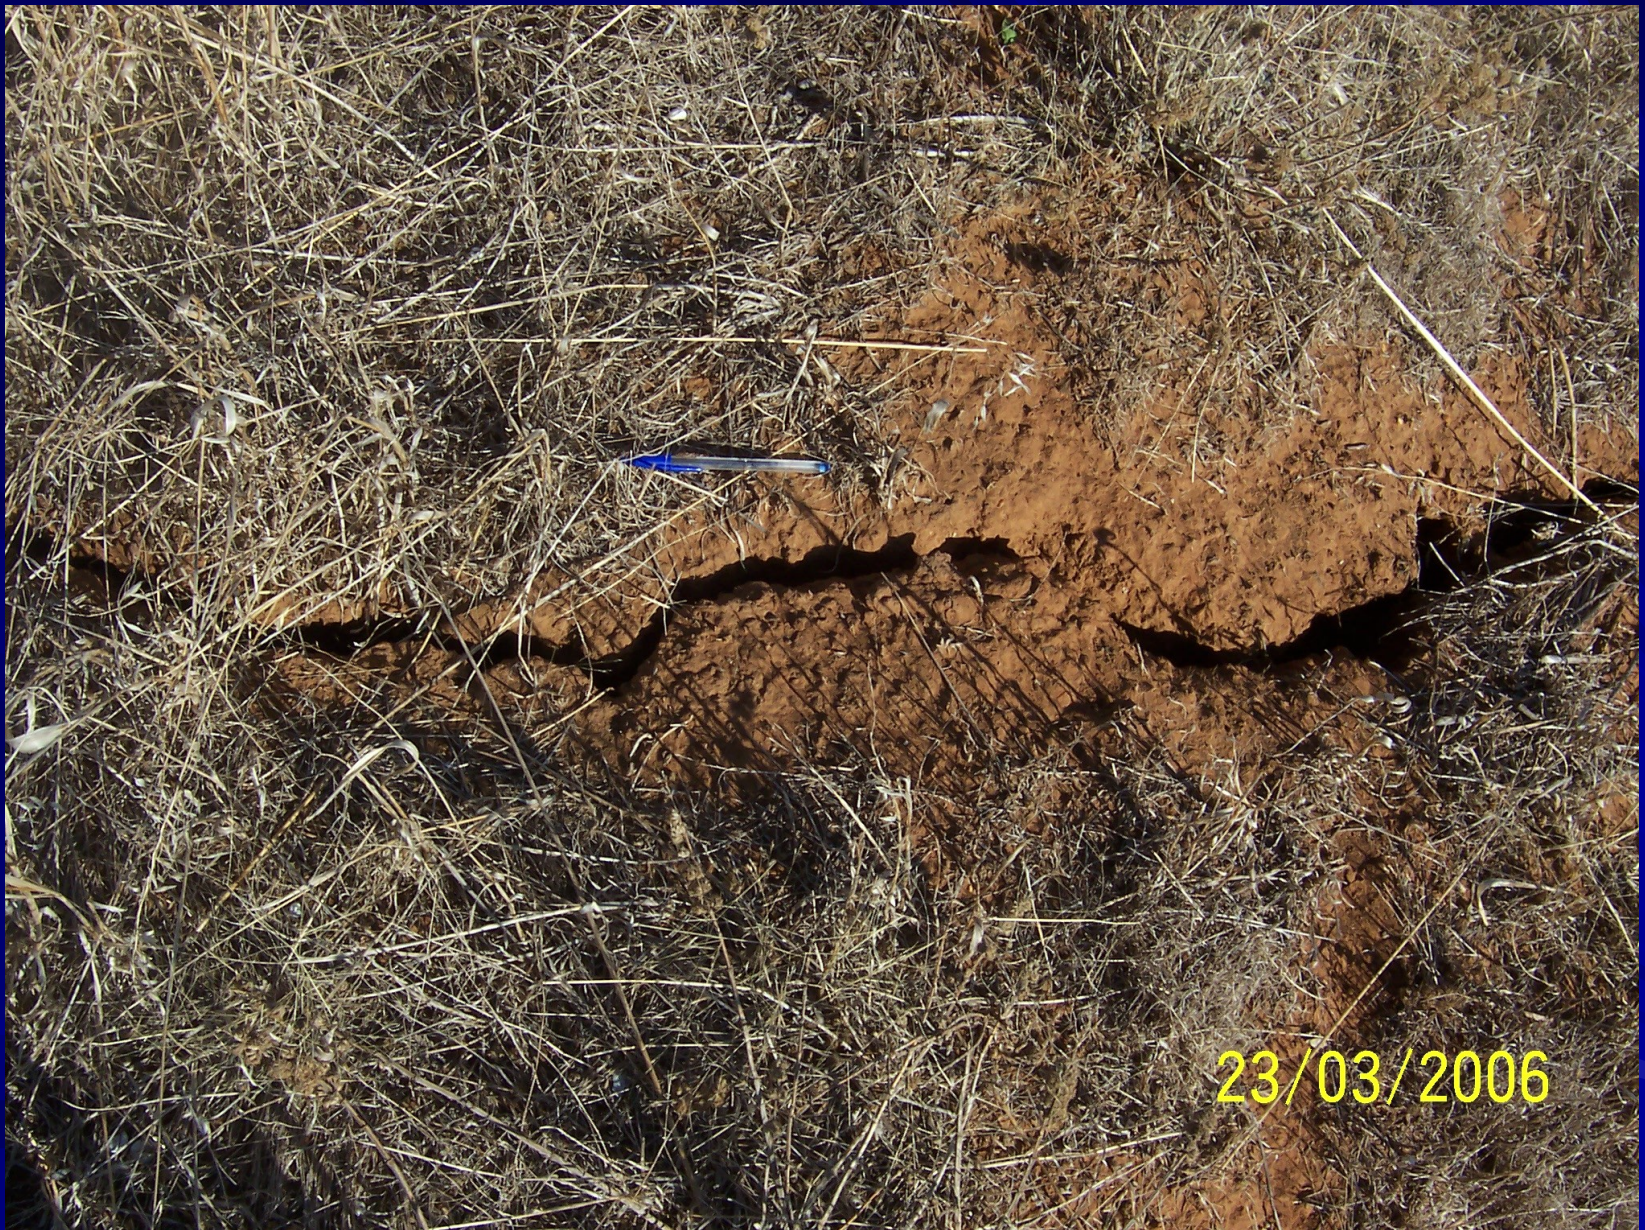
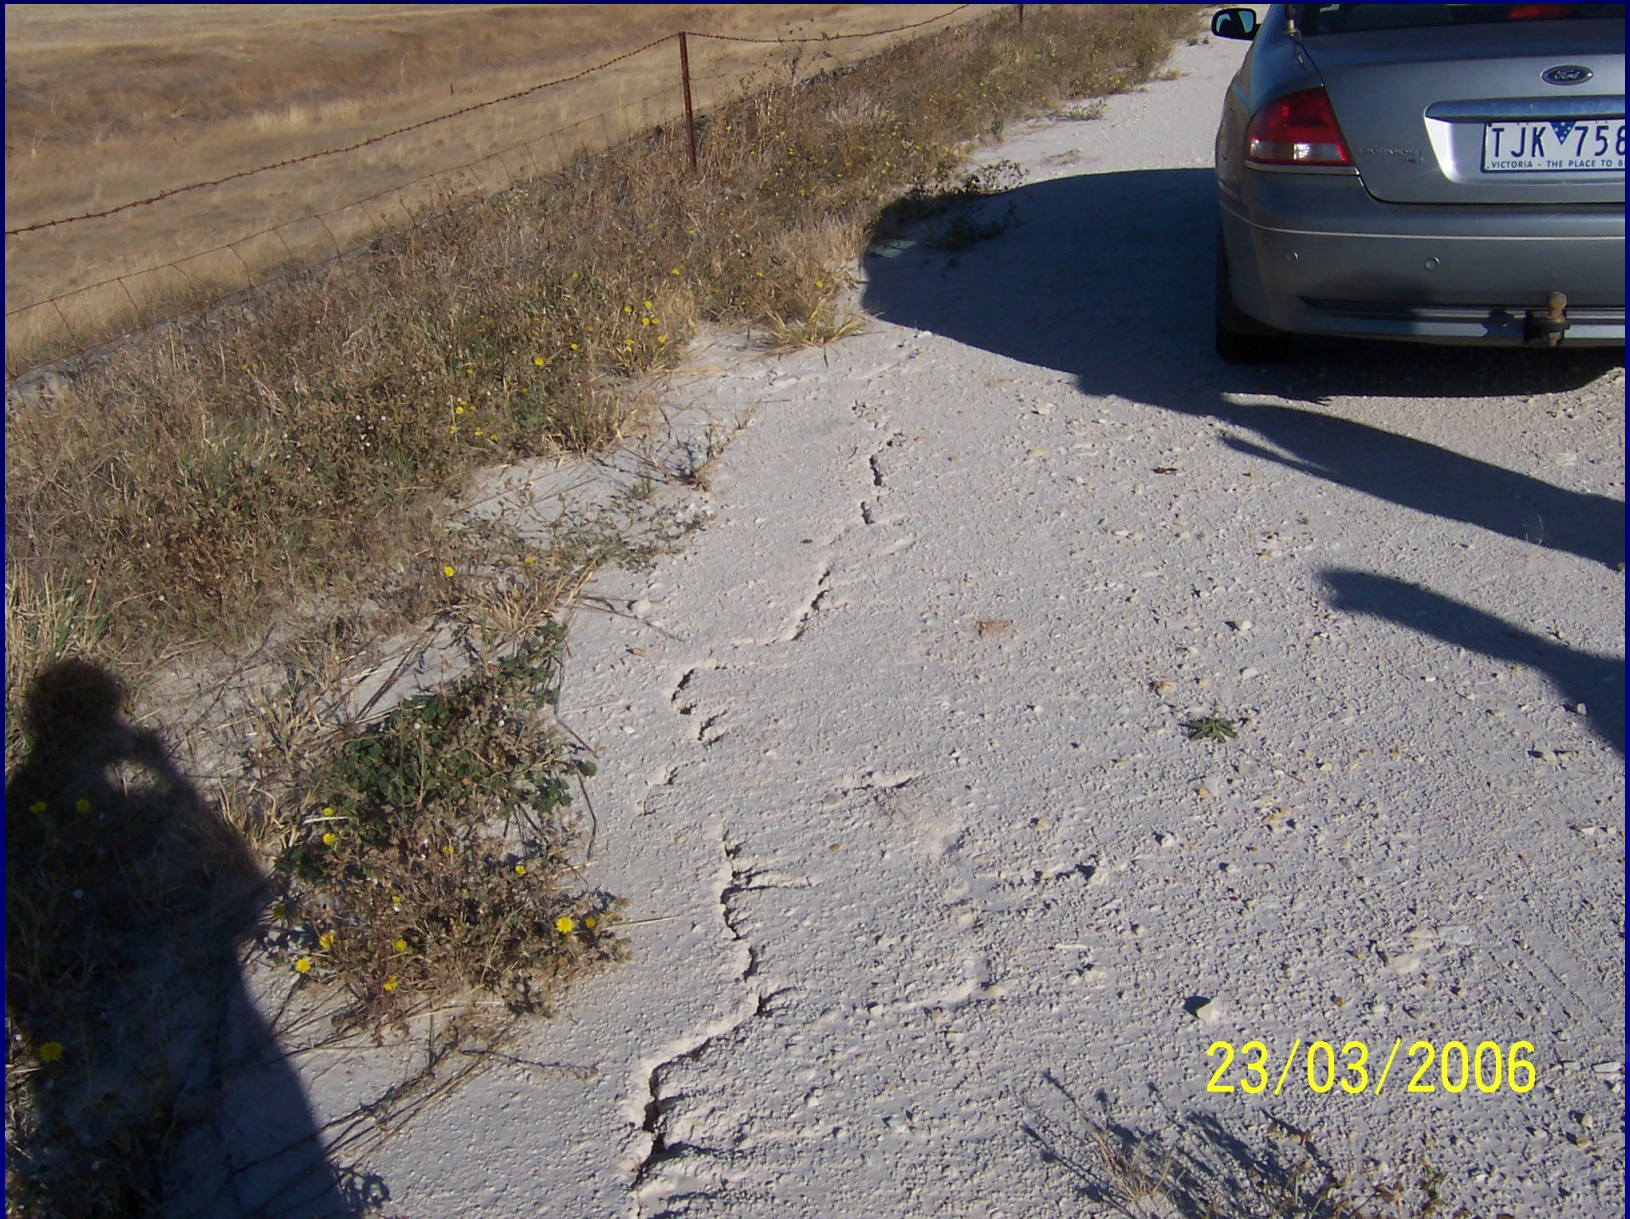
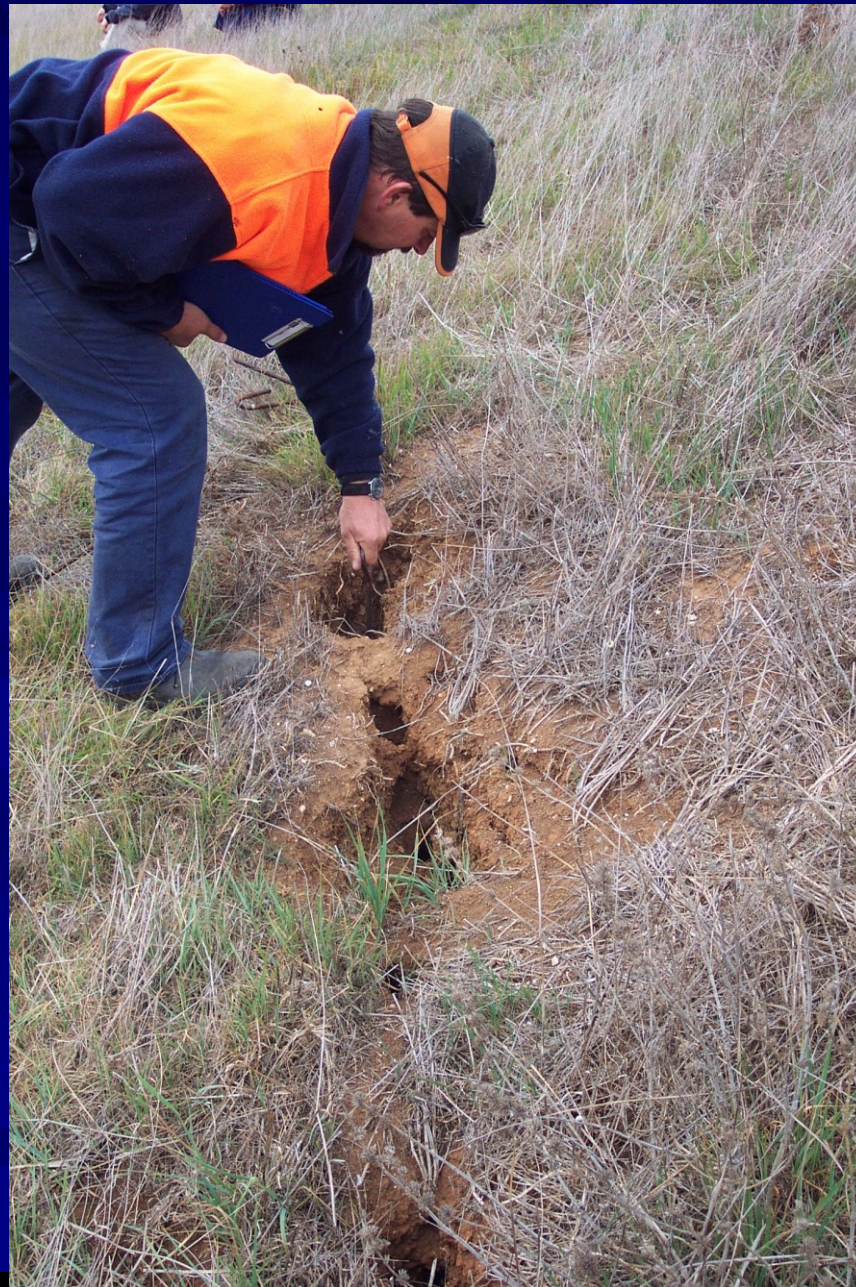
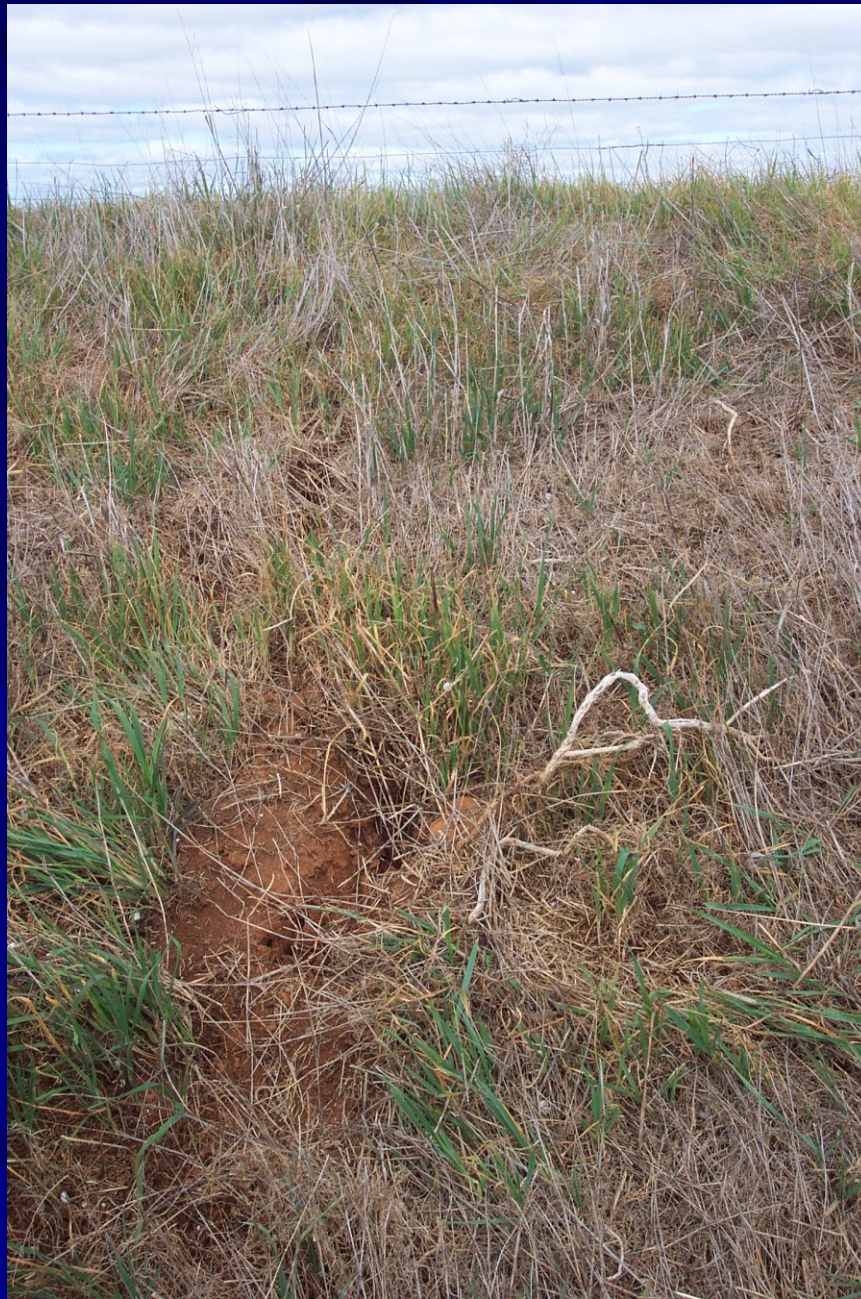
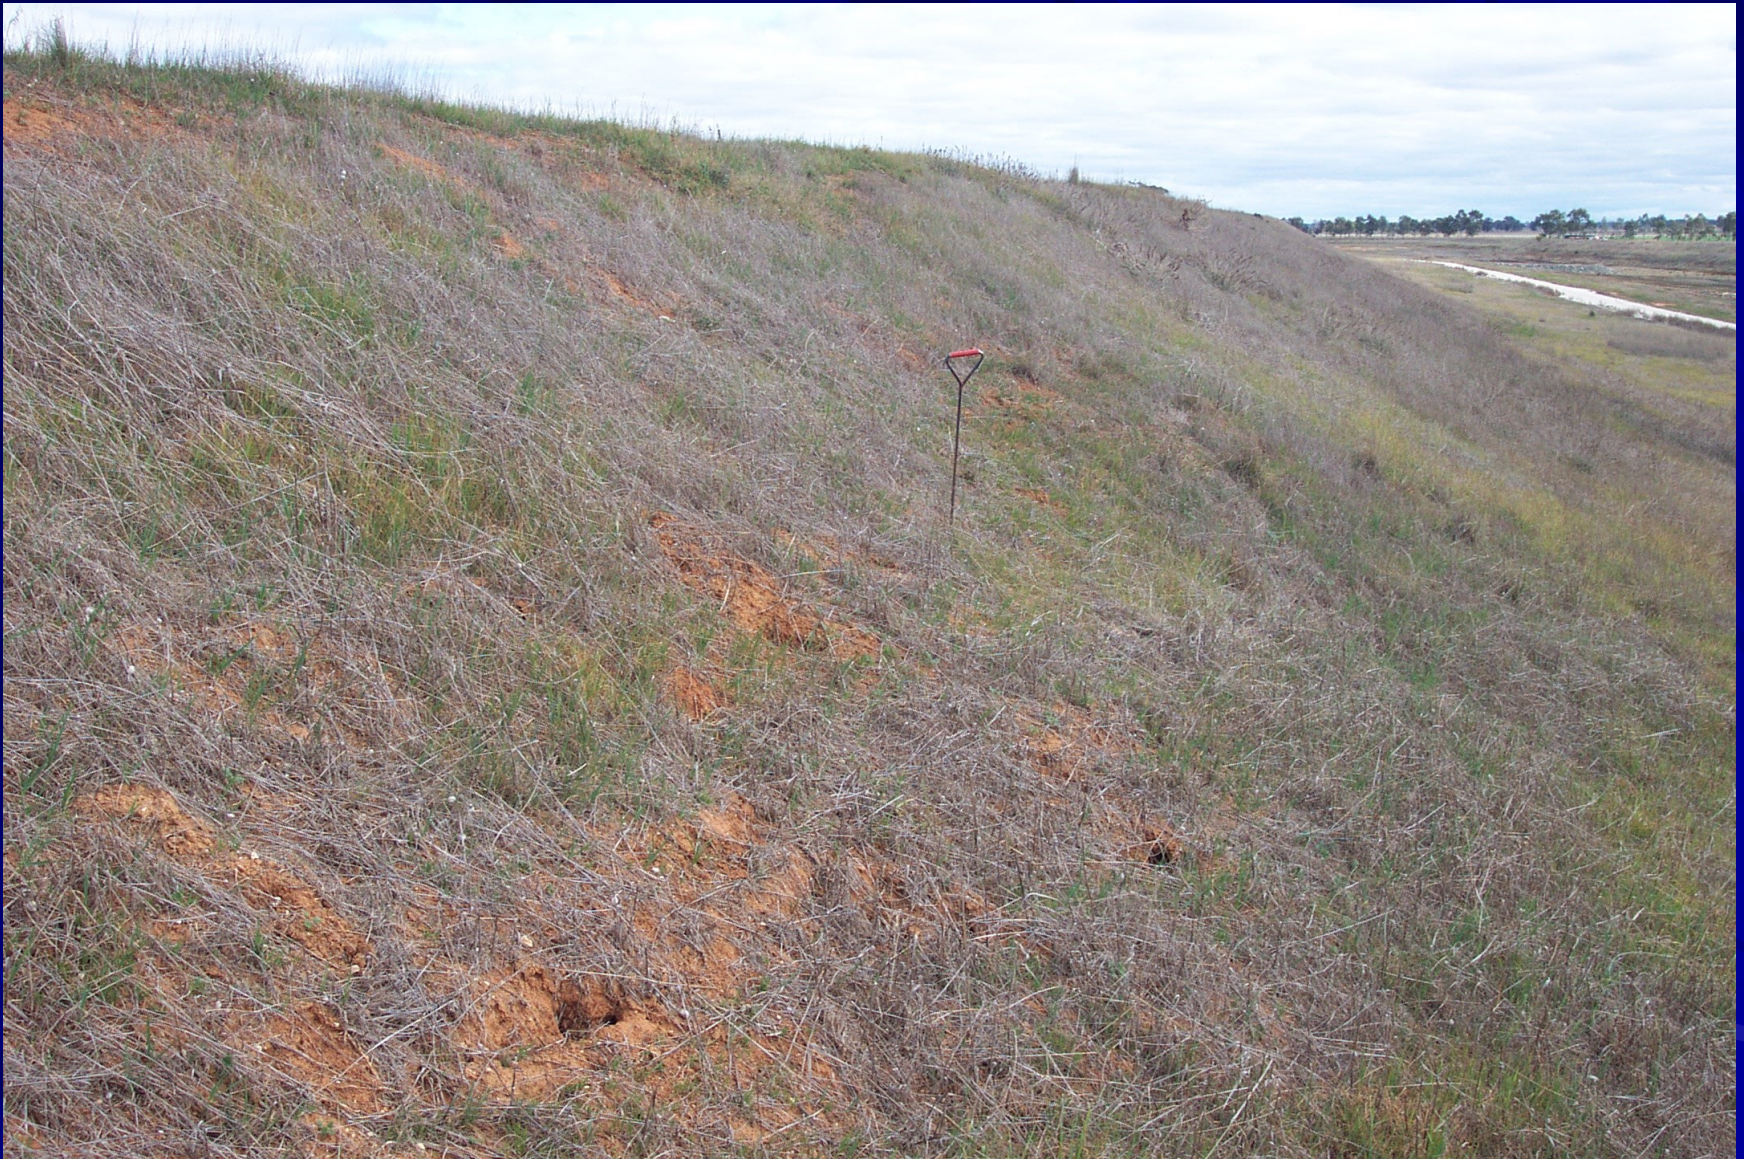
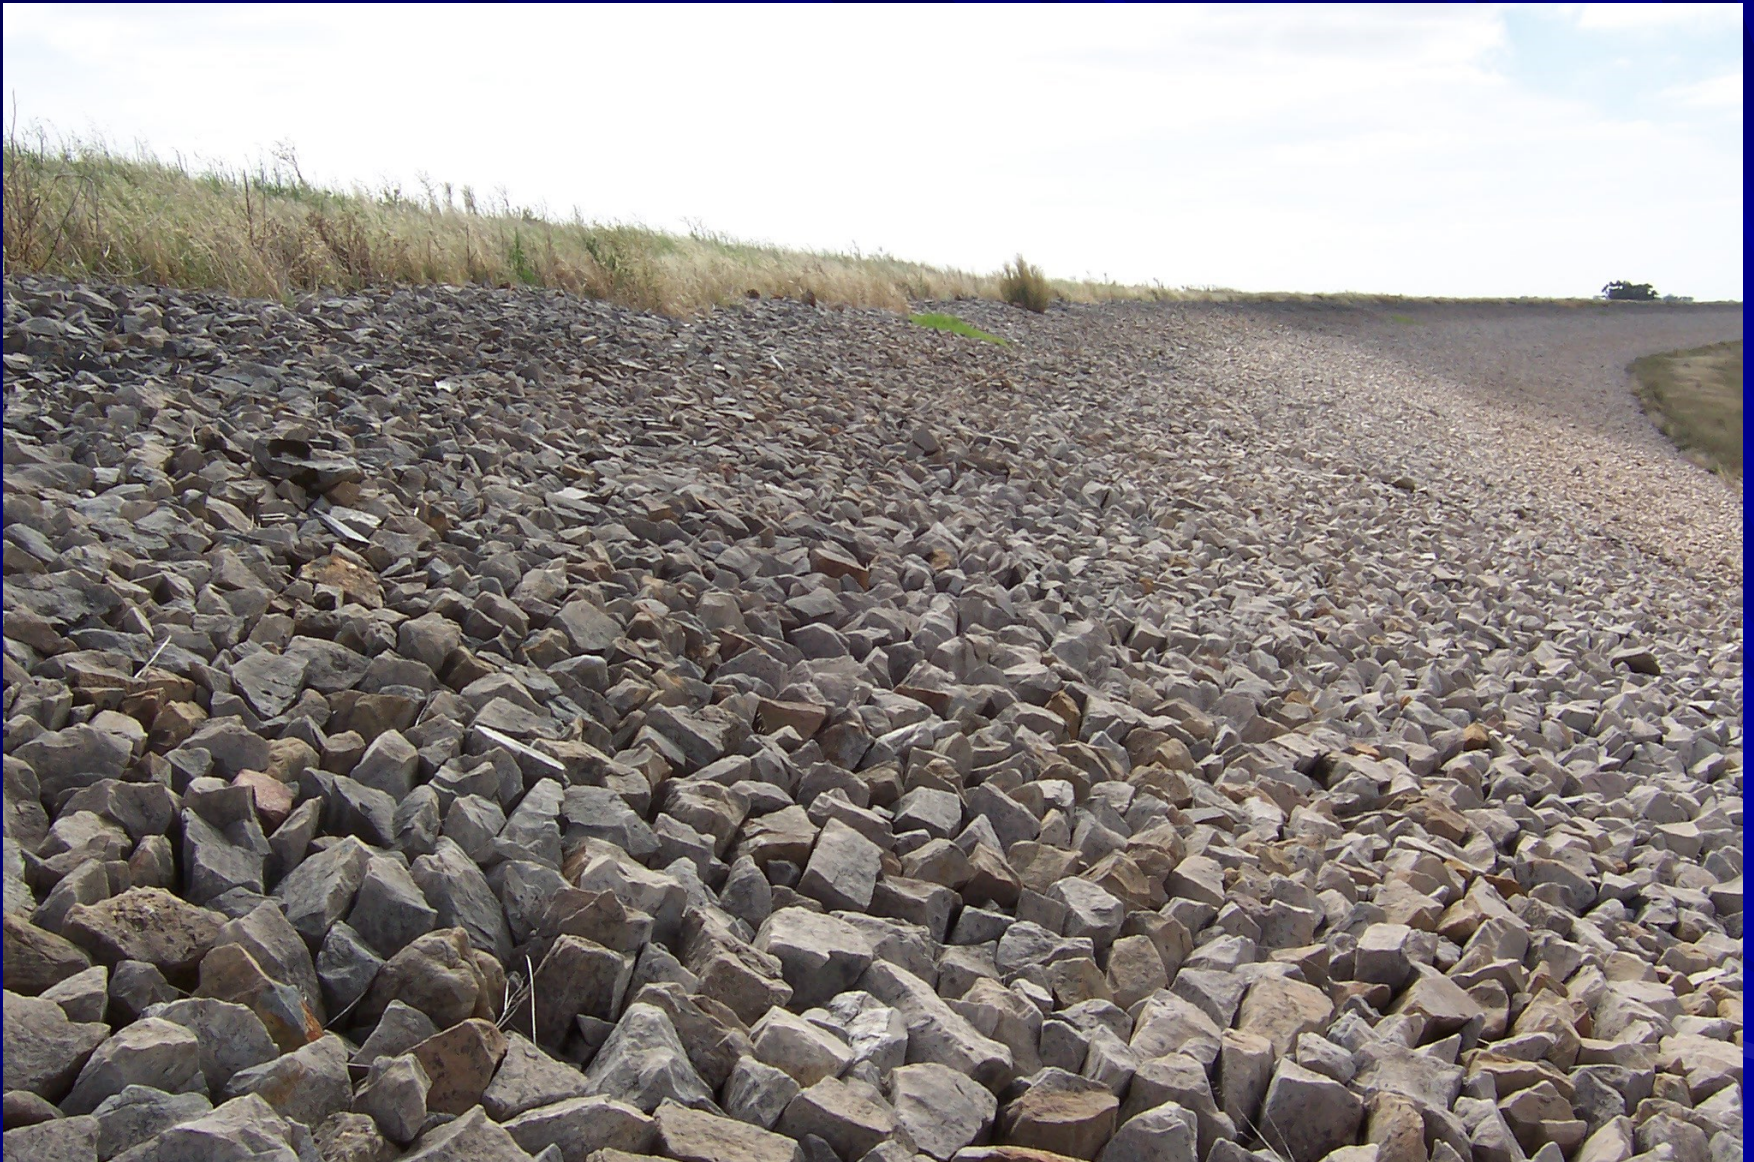
- 15m high, 3.7km long earthfill dam with a central clay core; constructed in 1923
- Reservoir has been empty since late 2003 and the dam embankment has not had water against it since 2000
- Widespread longitudinal and transverse cracking has occurred at the crest and downstream face of the dam
- Settlement depressions are evident on the rip rap protected upstream face

- Combined effects of low phreatic surface within the dam and shrinkage of the unprotected outer earthfill zone are believed to be the cause of cracking
- Increased effective weight combined with loss of strength of earthfill material may be a factor affecting settlement of the rip rap layer on the upstream face

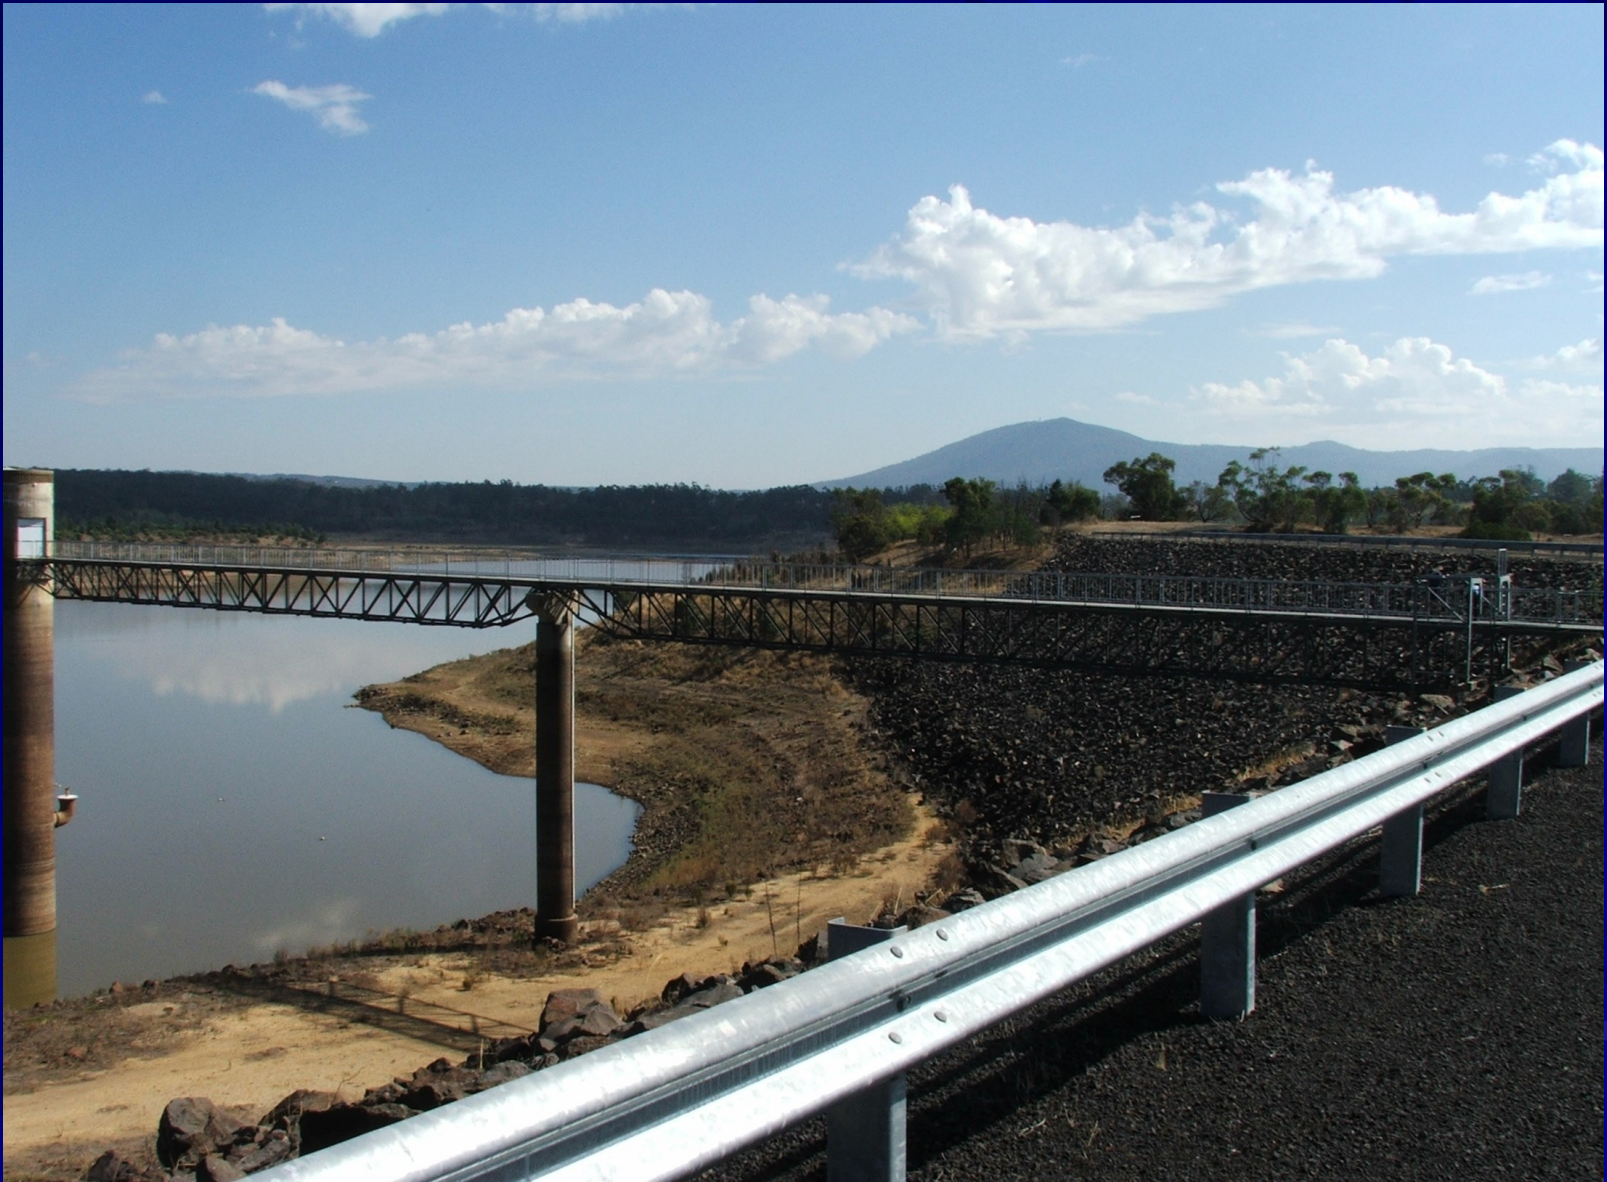
- Movement of the rockfill embankment and the central pier in the upstream direction due to reservoir drawdown has caused the gap at the access bridge rails to close
- Further movement will result in buckling of the rails
- Bridge supports are close to their design travel limits
- Bridge members are now close to the pier

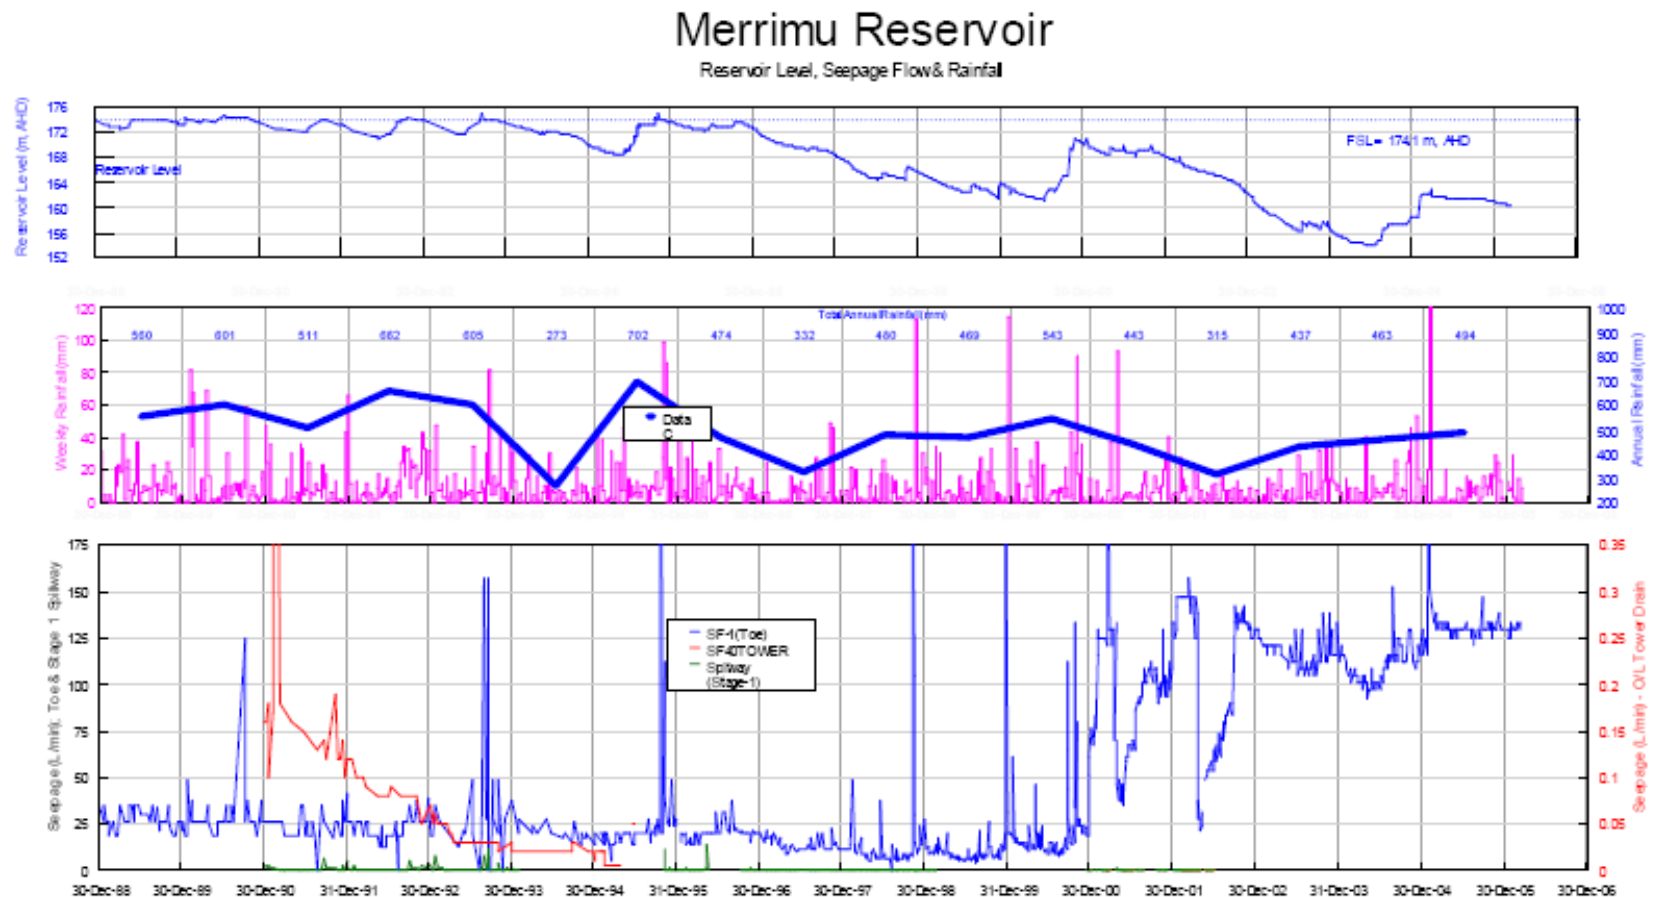
# Merrimu Dam Seepage

- 40m high earth and rockfill dam constructed in 1969 and raised in 1986
- Dam core constructed of dispersive clay, downstream portion lime treated
- 10 year drawdown cycle with a 13m drawdown over 1997-2000 and a 16m drawdown over 2001-2004
- Significant movement occurred in the upstream rockfill zone
- Seepage increased five-fold during the drawdown cycle (from 25 lit/min to 130 lit/min)

- SRW have now identified the cause of seepage
- A test on the pipe from the valve pit to pump station was run by turning off supply during a zero demand period
- Toe seepage levels dropped below those originally recorded, to about 10lit/min
- Leakage in the pipework at the downstream toe was the cause of increased seepage
- Location of the leak has been pin pointed
- Repairs are programmed
