Stability Does not Always mean Embankment Stability!

Case History - Merriespruit Tailings Dam Failure, Virginia, South Africa

Case History - Stava tailings dam failure, near Trento, Italy

Case History - Los Frailes, Spain

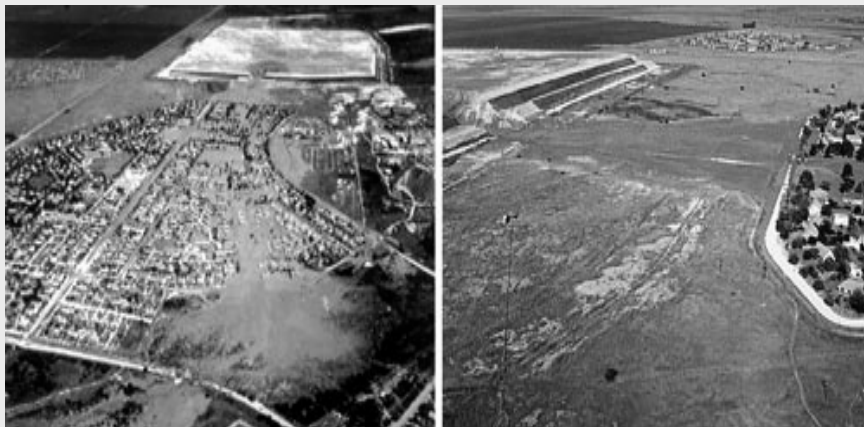
- On the 22nd February 1994 the Merriespruit tailings dam failed by overtopping as a consequence of heavy rains causing a flowslide (static liquefaction) of part of the embankment (Davies 2002). Water mismanagement was to blame that caused 600,000 m³ of tailings (1.2 Million tonnes) to mobilize out of the impoundment where the flow eventually stopped 2 km away in the town of Merriespruit (Penman 1998; Davies 2001). 17 people were killed and scores of houses were demolished (Fourie 2003). Figure 1 shows the extent of the damage to the town and the scale of the breached embankment.

- The failure could have been prevented if a suitable operating manual and emergency plan had existed. The operation of the facility leading up to the major failure was a complete disregard to the designed operating procedures. The facility had been closed as a result of earlier embankment slips but still process water and tailings were being discharged to the impoundment. This suggests that an emergency plan was not in place to implement intervention actions or documented procedures were overridden by an individual making an executive decision. Which ever the case may be, the lack of understanding of the operational procedures and the seriousness of the events prior to the main failure had not been realised. If a well structured and executed operational plan had existed then the tailings operator(s) would have known to implement the emergency plan, continually monitor the closed impoundment for change and prevent further discharge to the facility.

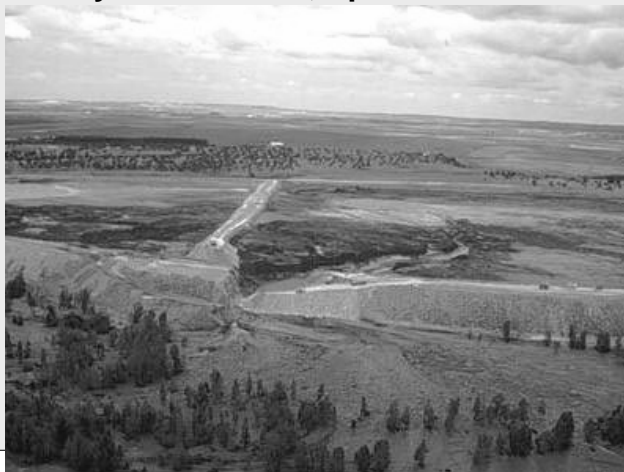
- Minas de Aznalcóllar is located near the town of Aznalcóllar in southwestern Spain and approximately 40 km west of the large city of Sevilla ([Figure 1](#)). It is within the Iberian Pyrite Belt which has a well known mining district for at least a few millennia. The minesite is drained by the Agrio and then Guadiamar Rivers. This river system extends to the south-southwest, under a road bridge near the town of Sanlúcar la Mayor, and into Doñana National Park.
