NICOLL HIGHWAY COLLAPSE

Introduction

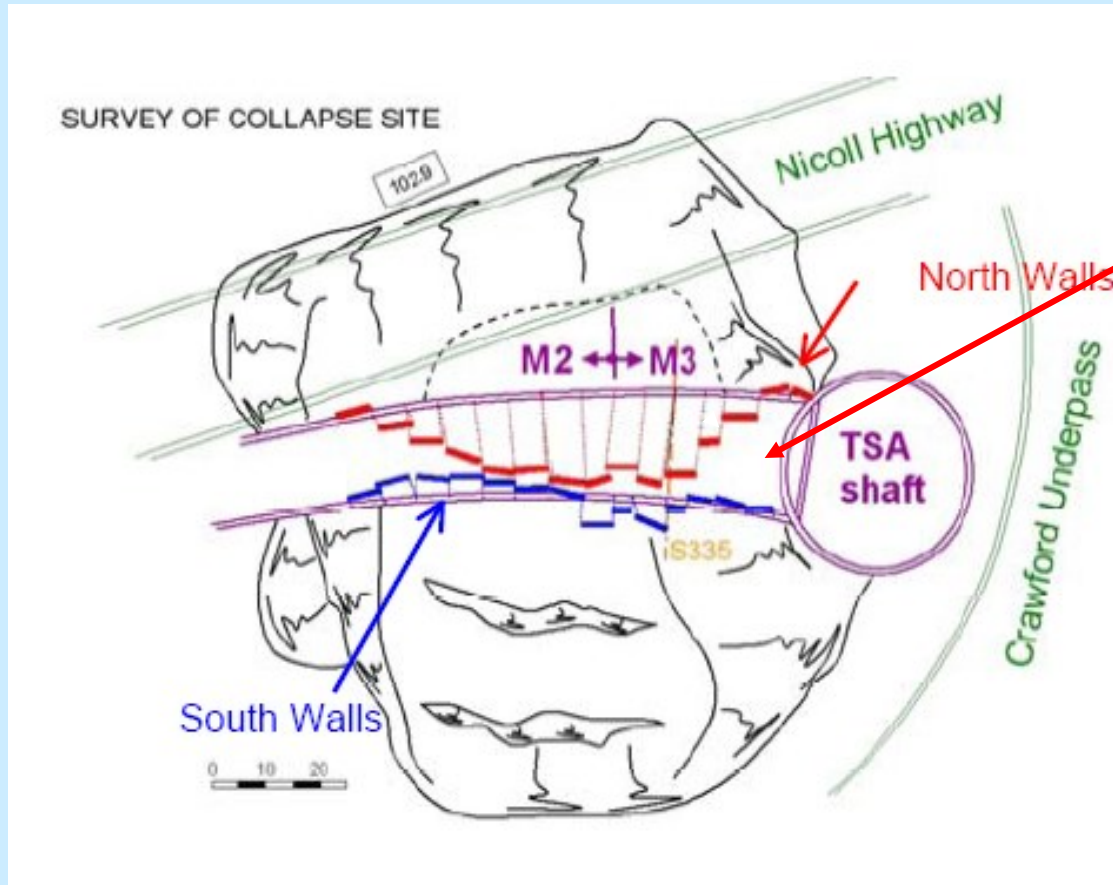
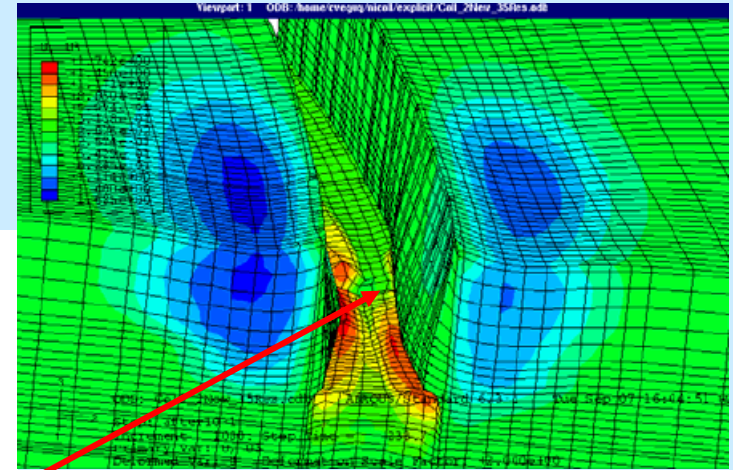
Problems with the curved alignment

Deformation of mesh just before collapse, 3-D FEM

3-D FEM model indicated that some joints between the wall panels would open up, if the walers are not continuous

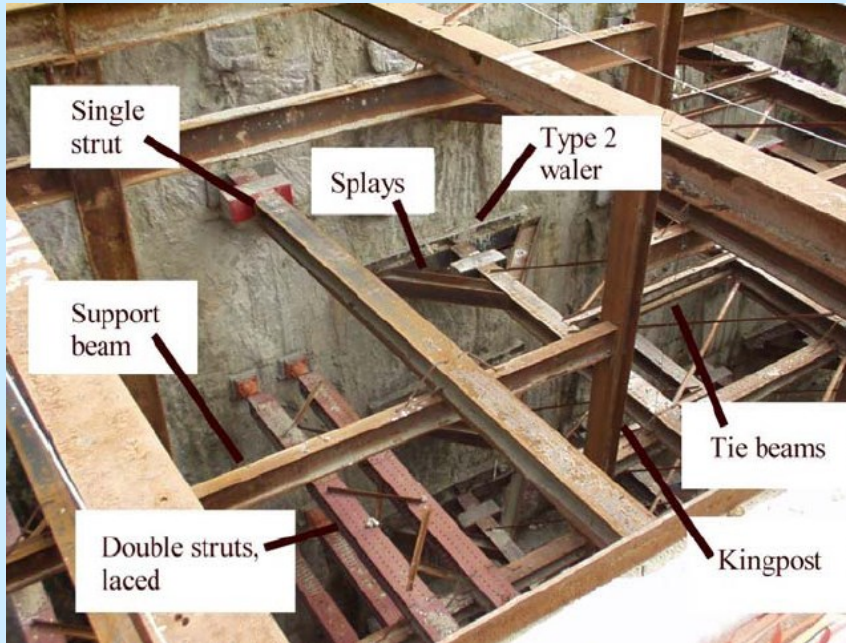
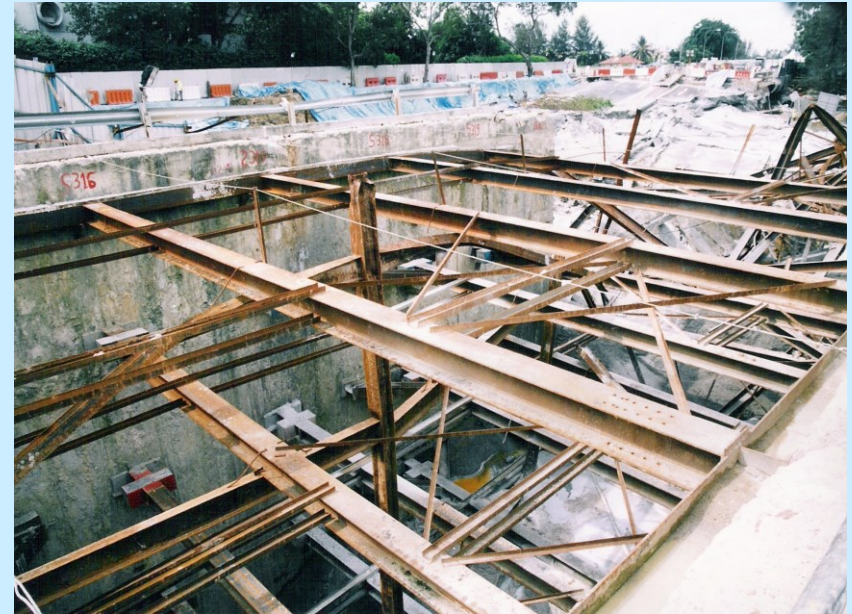
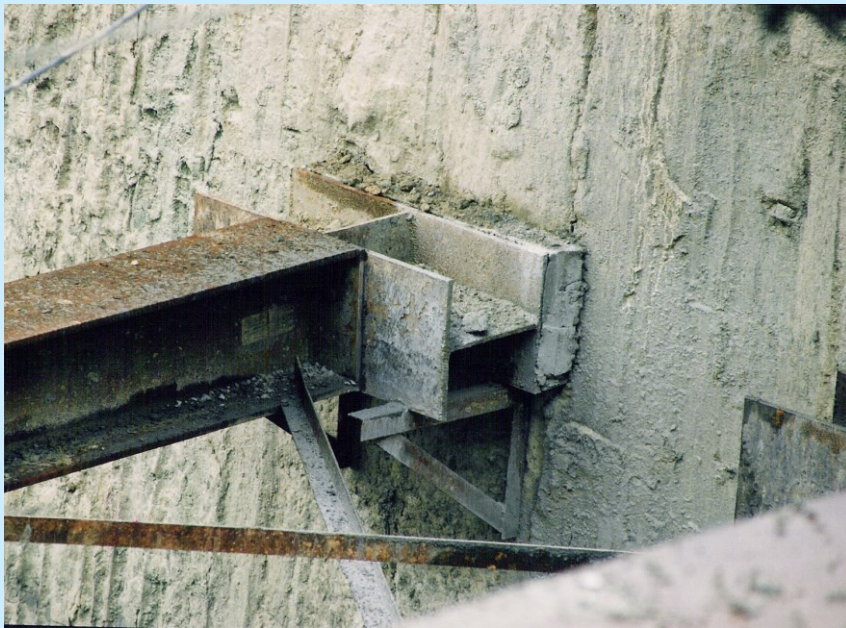
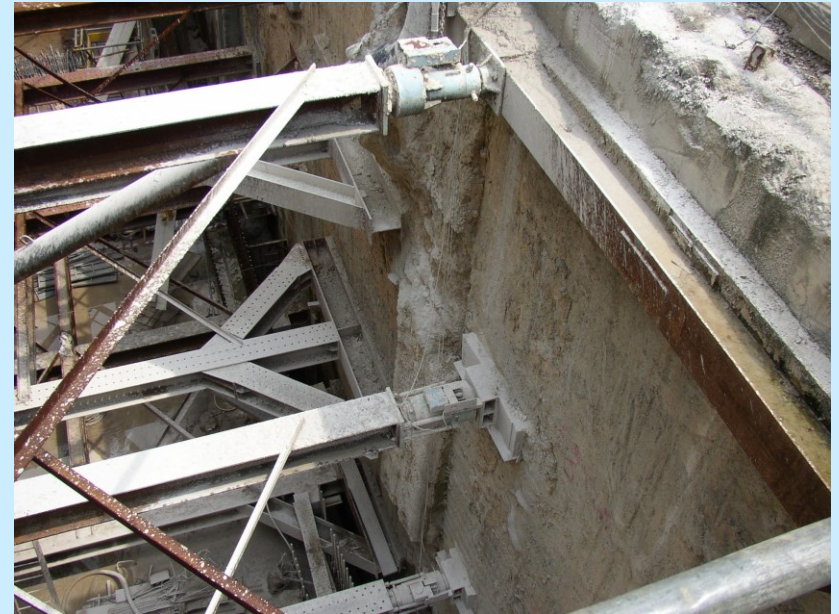
Strutting System Used (discontinuous walers)

Survey of collapse Site

(Diaphragm wall panels moved independently to each other)

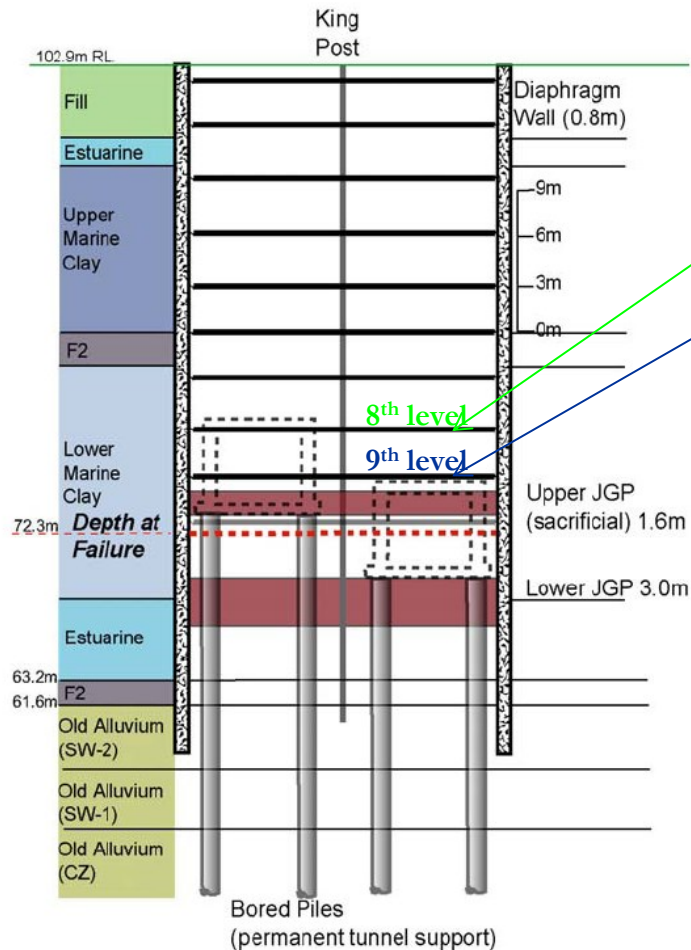
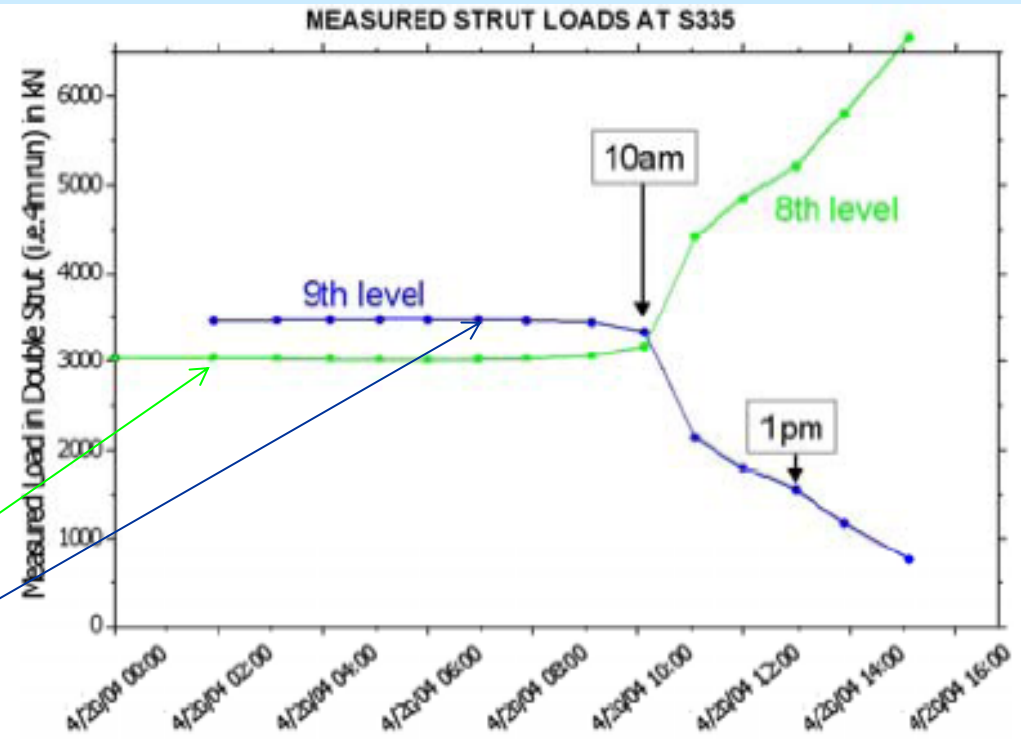
Strut Load

The strut load measurements showed that, on the day of the collapse, load was being transferred from the 9th to the 8th level of struts.

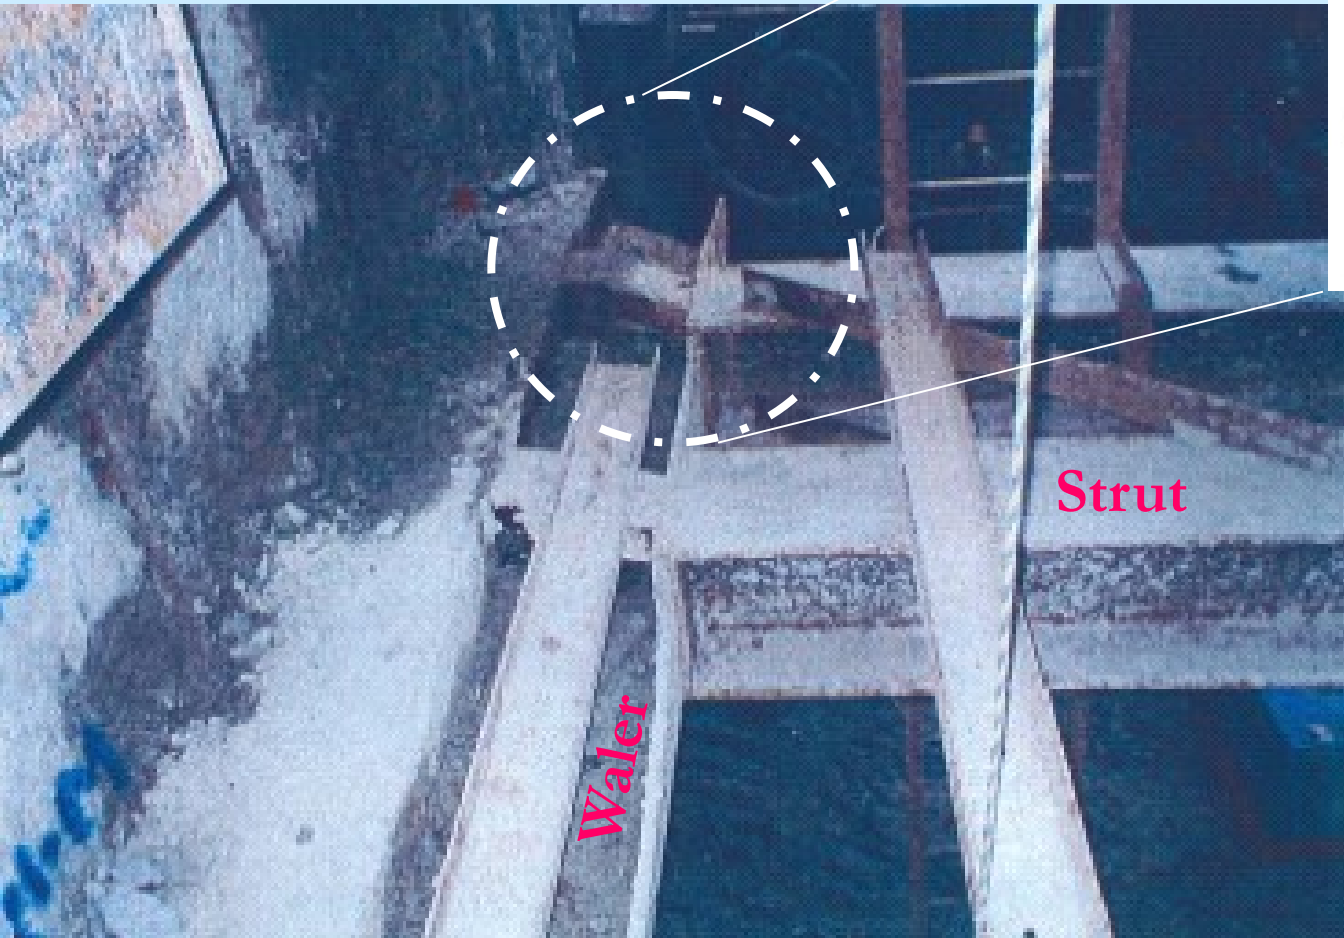
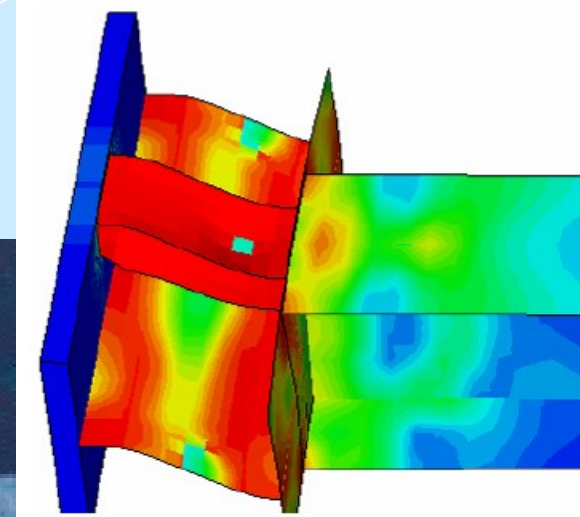
Observed Sway Failure of the Waling

(picture was taken a few hours before the collapse)

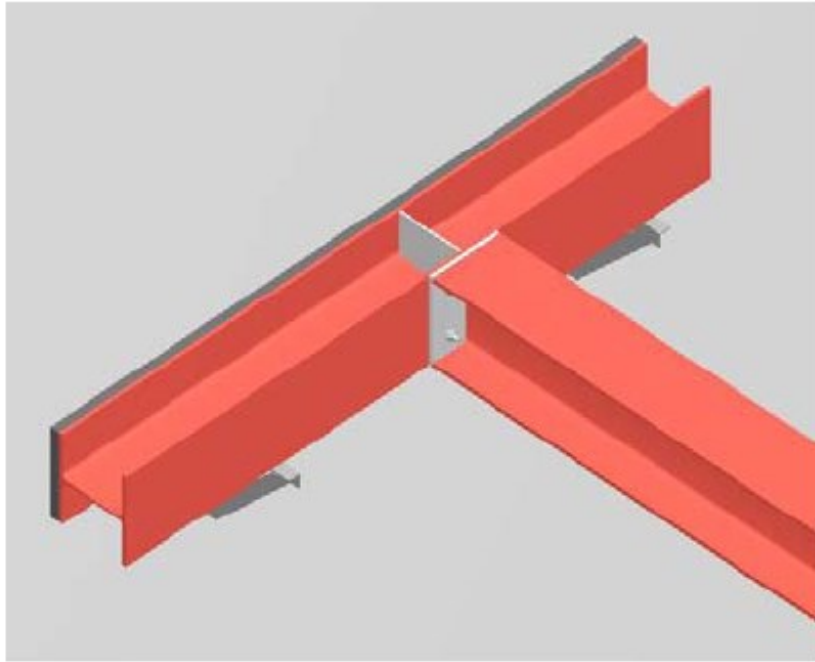
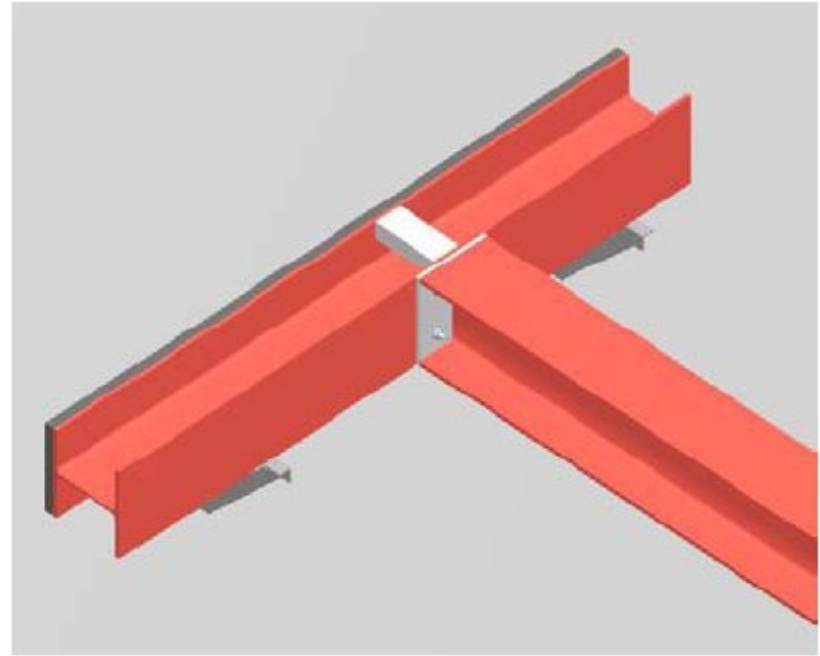
Details of Strut-Waler Connections

Failure is mainly due to the in-plane buckling of the plate and/or web with little or no side sway of the waler flange

C-channel stiffener and web to sway and failure can occur in a sudden manner with drastic reduction in capacity.

More sensitive to the effective length used in calculating the web buckling capacity

- ❖ **Errors in the design of the strut/waling connection resulted in this connection having about one half of the required capacity**
 - ❖ **This happened because of the substitution of ‘C’ channel for plate stiffeners in the waling**
- ❖ **Use of effective stress parameters + Mohr-Coulomb failure + ‘undrained’ analysis, to model soft marine clay in PLAXIS**
 - ❖ **This led to the underestimation of moments and movements of wall by a factor of about 2.**

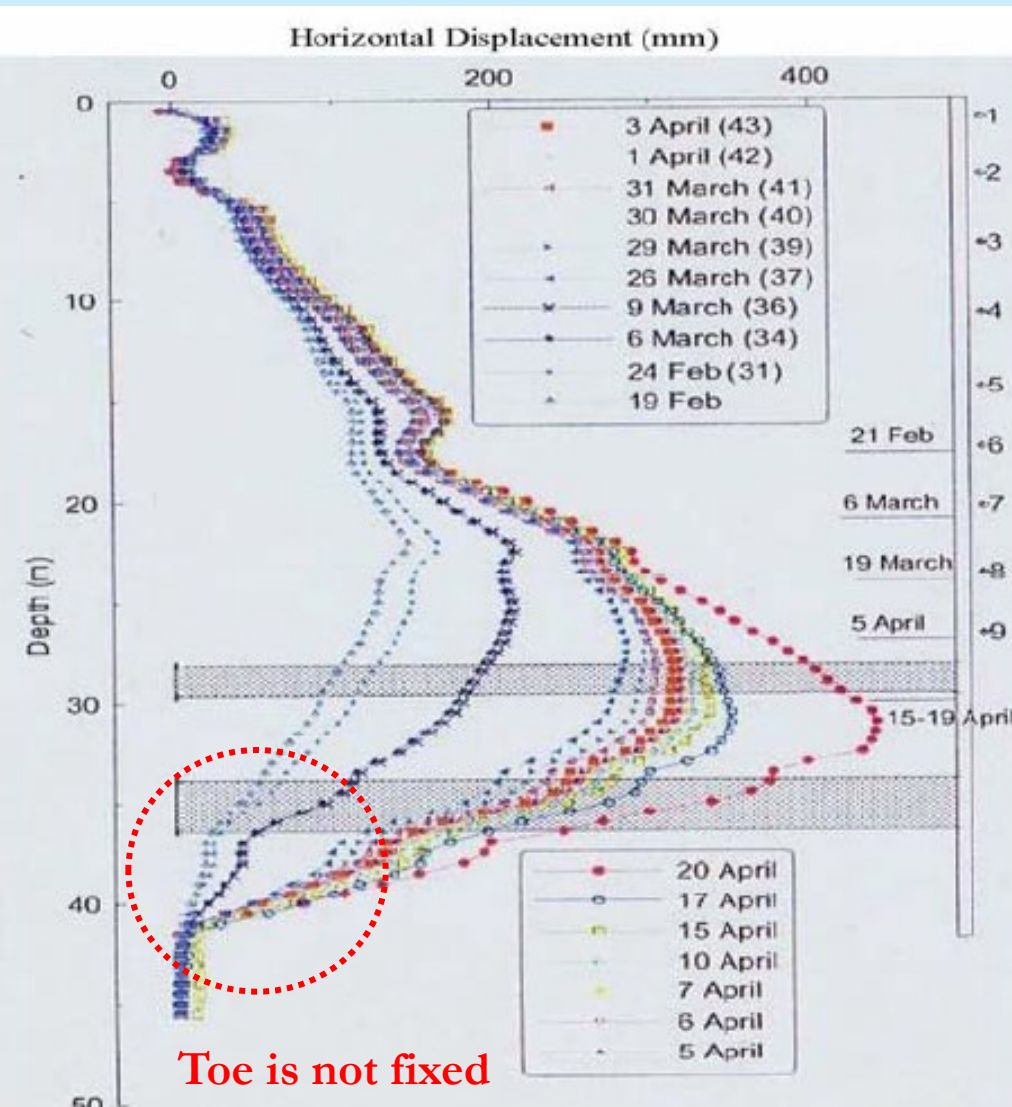
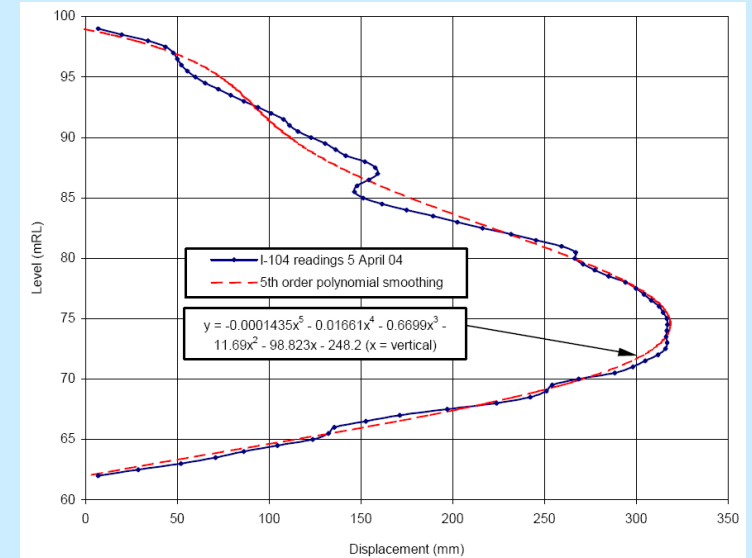
Wall Deflection

Radius of curvature ~ 200 m

Hinge would have formed by 5 April
