ENGINEERING GEOLOGY & GEOTECHNICAL MODELS

## Brickworks Stabilisation

# Geotechnical Overview of the Brickworks Projects

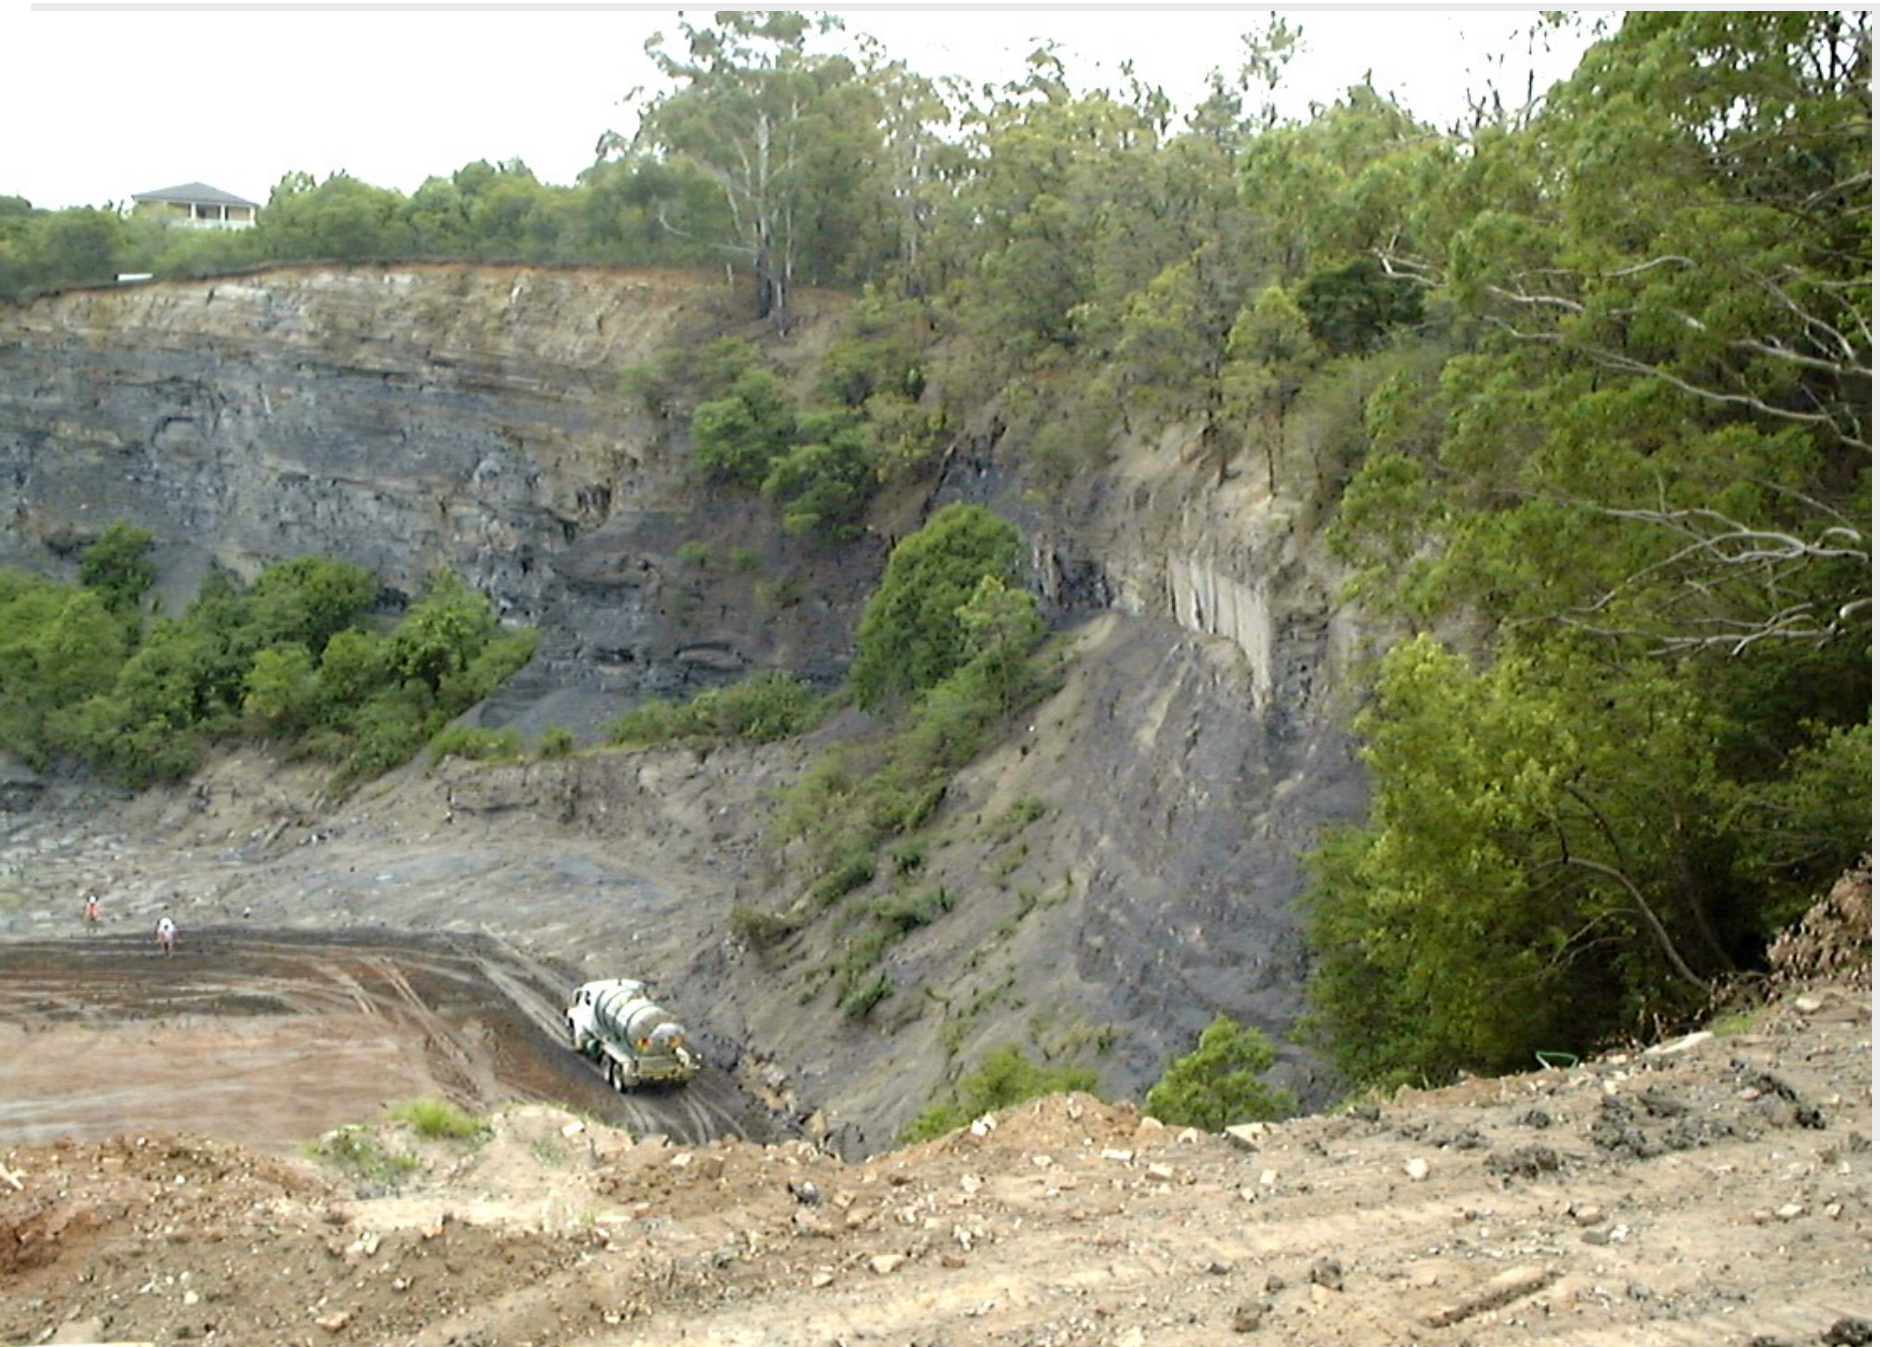
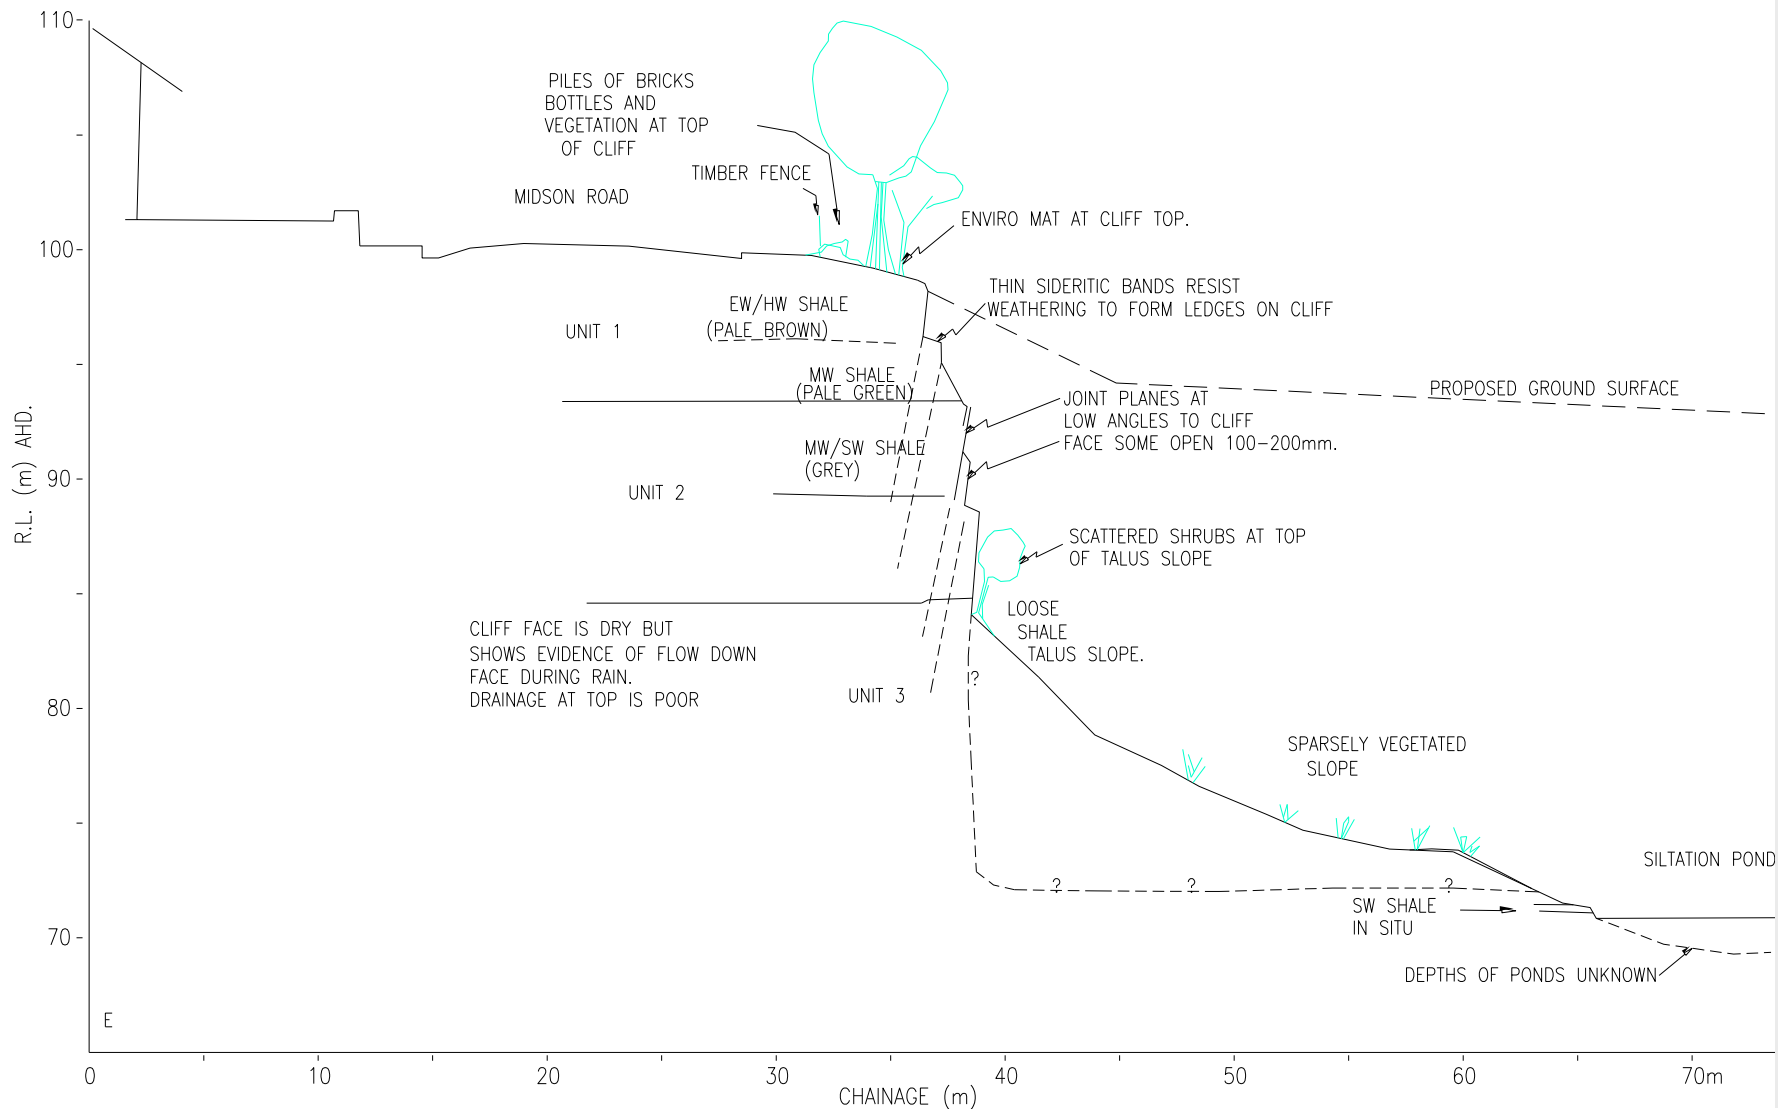
- Near vertical faces that are continually suffering rock falls
- Existing slip at the eastern end of the north face

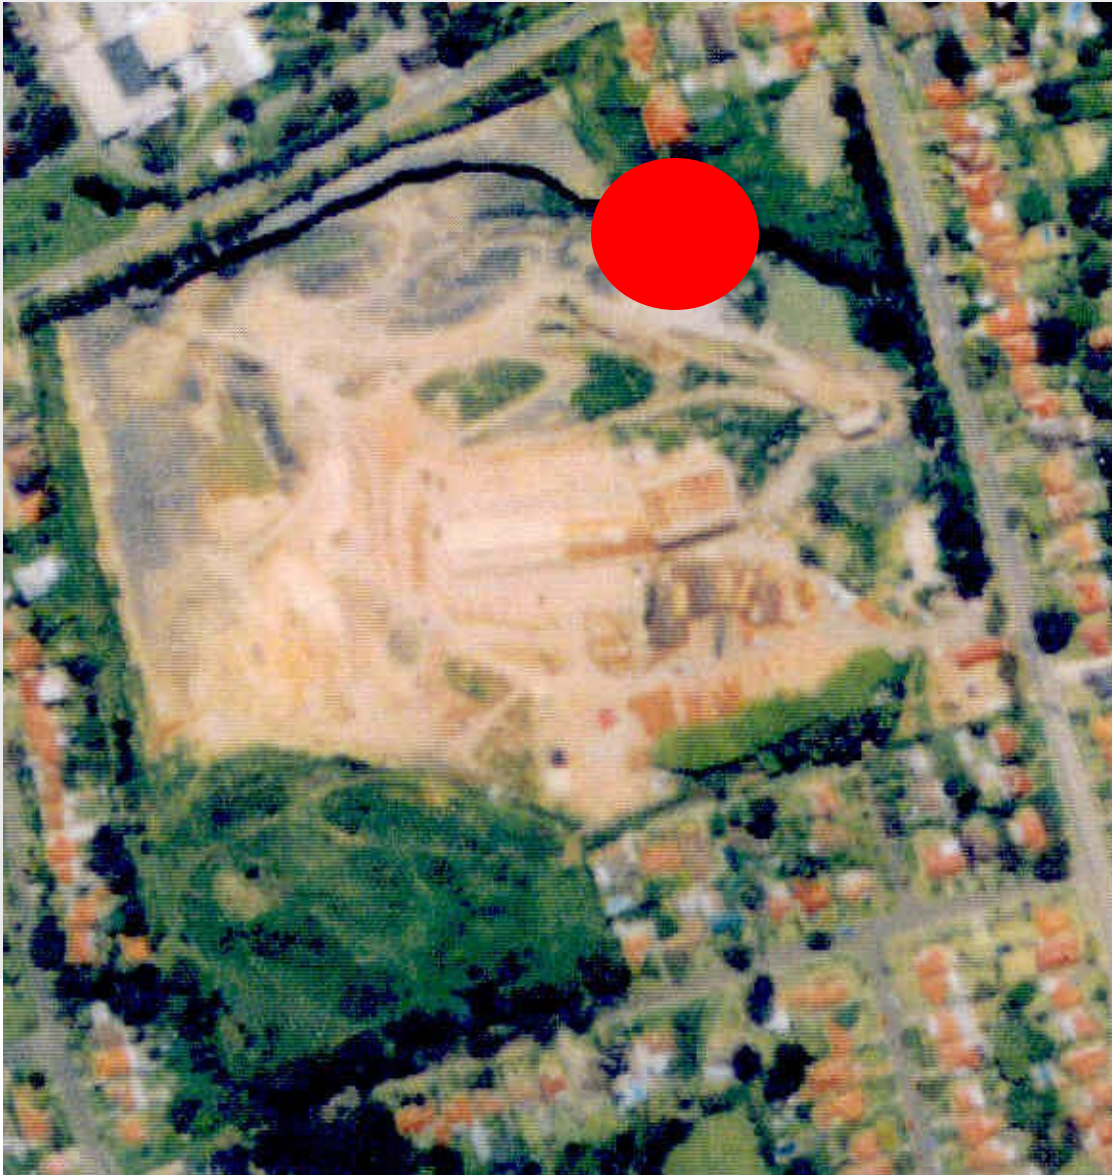
Occurred in 1999

- The failure occurred in September 1999.
- About 40,000 cu.m of material in the slide.
- North east pit wall was 20m from the rear of No.96 Mobbs Lane.
- Poor drainage - Area behind the Mobbs Lane houses.
- Absorption trenches constructed to take roof water when No.96 was built.
- Drainage ditch was excavated at the toe of the north east pit wall in 1996 and deepened in 1998.
- 1998-1999 were wet years.

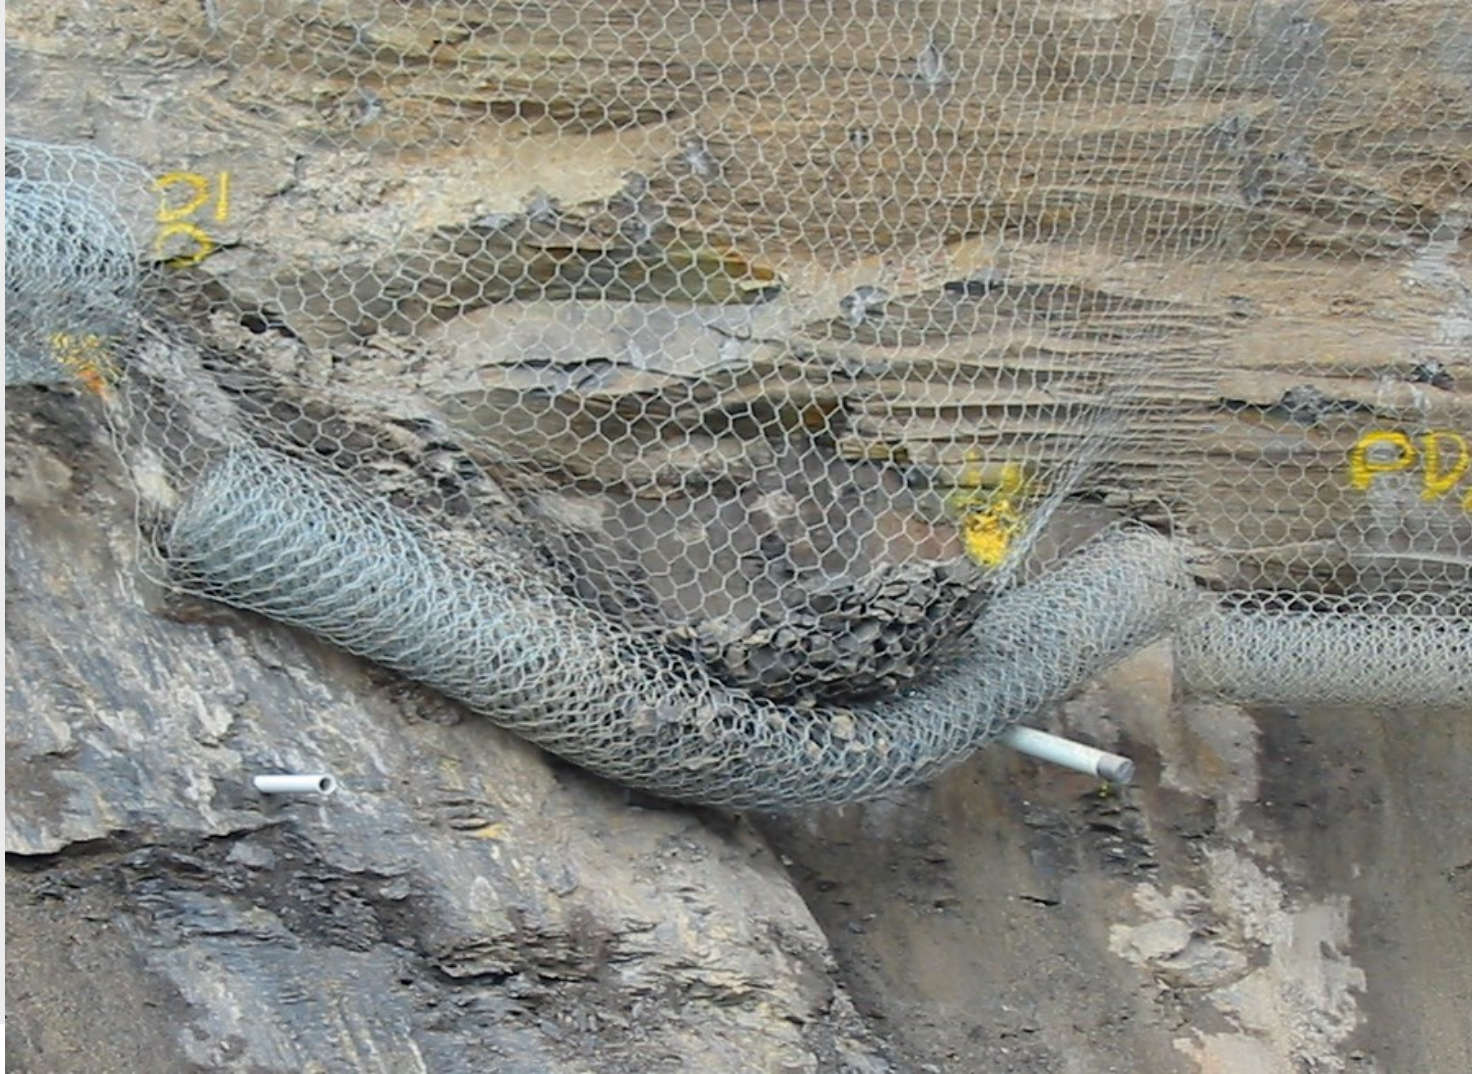
# Does the Batter Mesh Work?

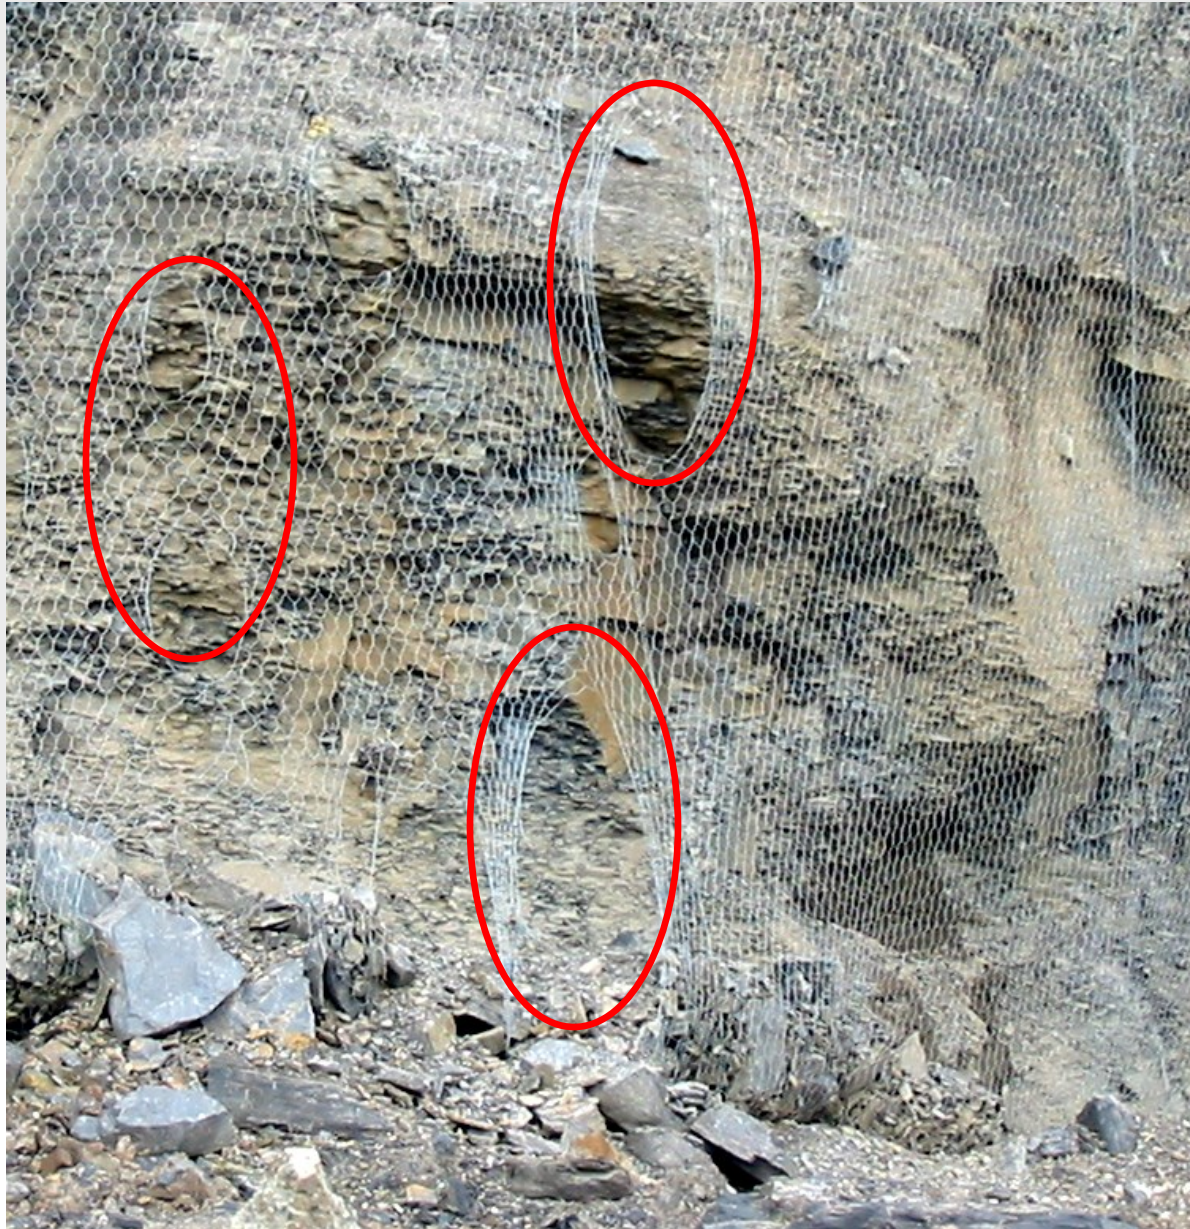
# Does the Batter Mesh have Limitations?

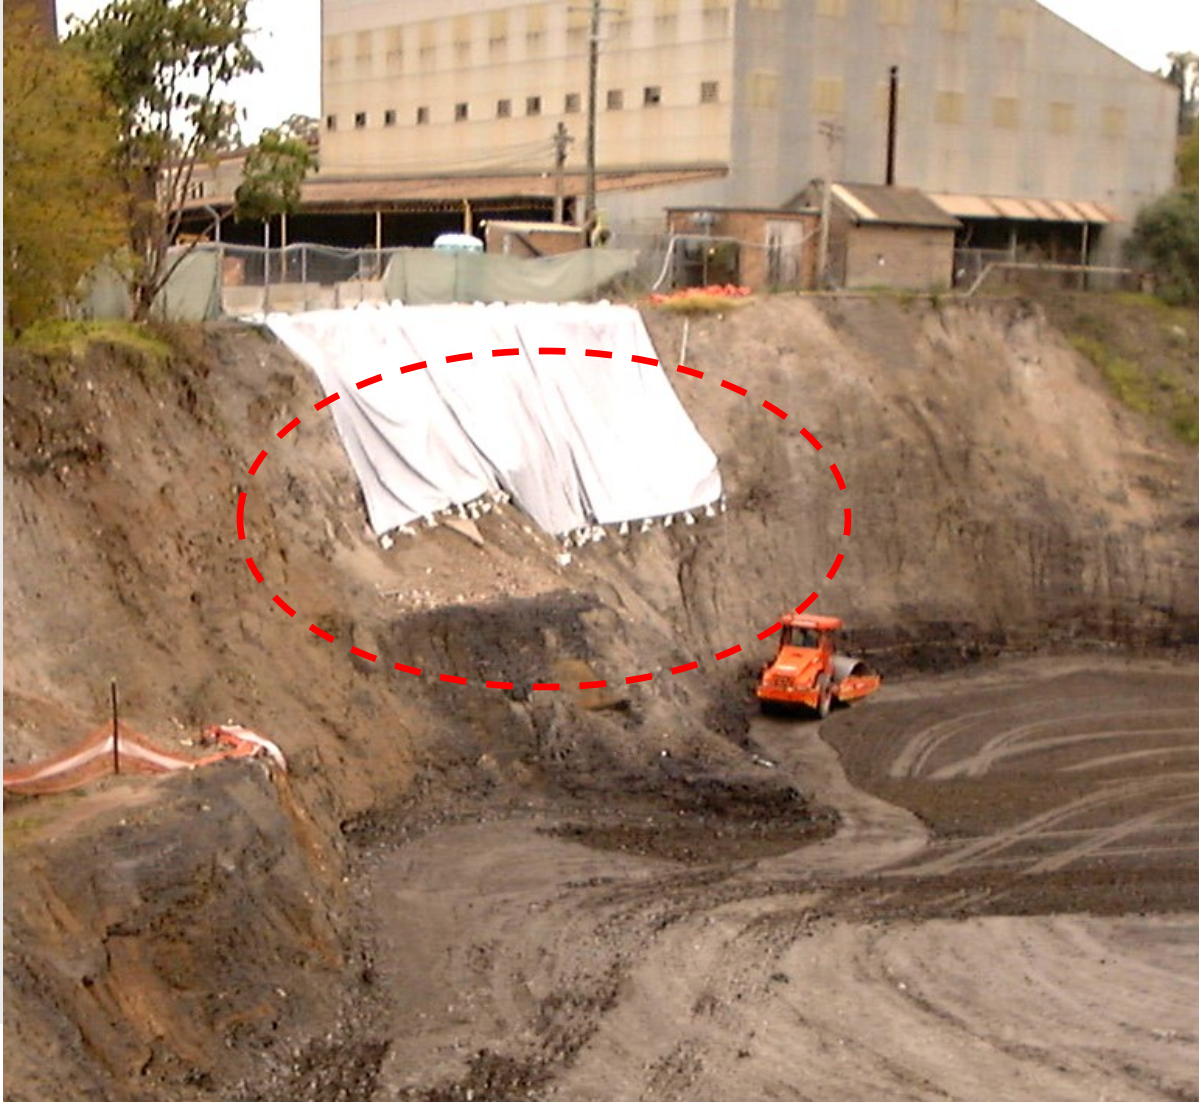
- Slip in Fill
- Occurred after heavy rain
