Rock slope stability problems in Gold coast area, Australia

Shokouhi Ali, Gratchev Ivan, D.H. Kim
Griffith University – Gold Coast campus - Australia

Int. J. of GEOMATE, March, 2013, Vol. 4, No. 1 (Sl. No. 7), pp. 501-504.

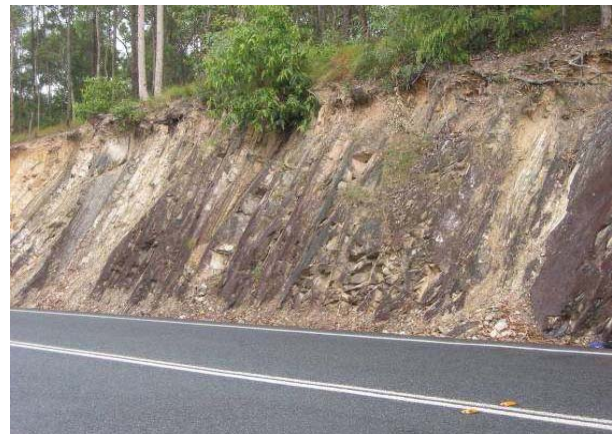
The investigation field was located along Beaudesert – Nerang Road, immediately south-east of the Beaudesert – Nerang Road / Arunta Drive intersection, on the Gold Coast (Fig.1). The approximate length of the existing cut slope is 200m and with the height of approximately 7m (Fig.2).

Fig. 2 – A view of investigated slope

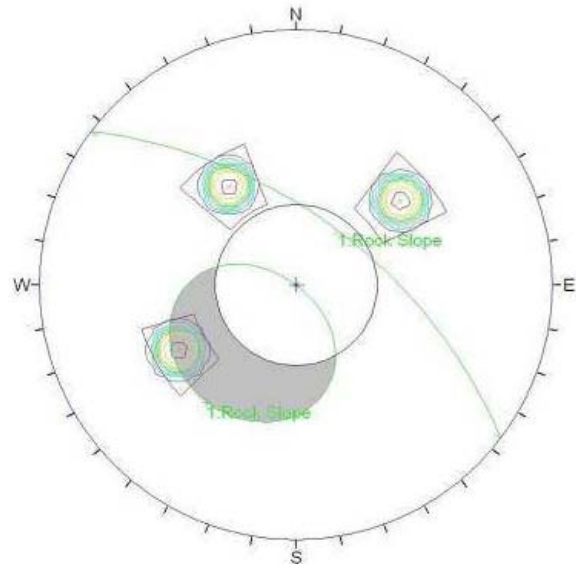
The collected data were analyzed by Dips computer software to identify the potential failure modes of the investigated slopes. The results from kinematic analysis indicate that at location 1, there is only one potential failure mode. Planar sliding is the most likely failure mode that may occur at this location (Fig.3). As can be seen in Fig.3 some of the discontinuities are located in gray shade that shows the potential planar sliding area. Toppling and wedge failure analyses show, there are no toppling and wedge potential failure at location 1.

Fig. 3 – Analyze of planar sliding of location 1

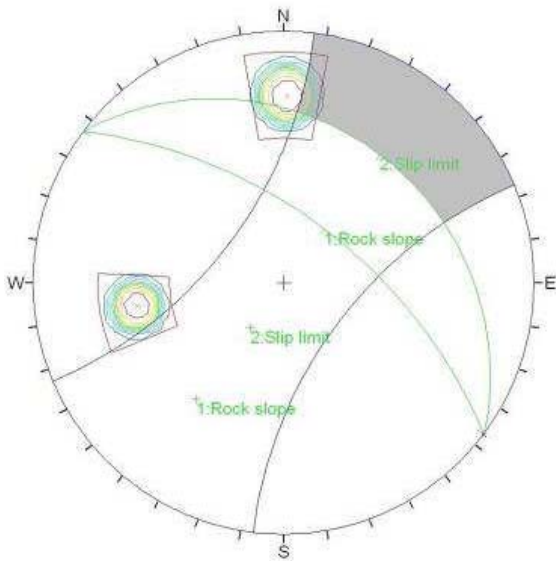
In location 2, the results produced by kinematic analysis suggest that there may be a potential toppling failure (Fig.4). In Fig.4, a part of the contour lines fall within the toppling failure zone that indicates the potential toppling failure.

Fig. 4 – Analyze of toppling failure of location 2

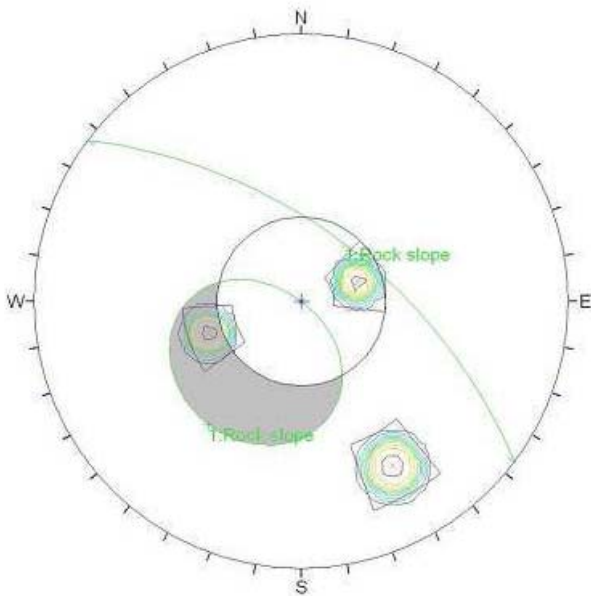
The results of kinematic analysis show that the rock slope at location 3 has two potential failure modes, planar sliding and wedge sliding. In Fig.5, the discontinuity set #3 falls within the failure zone (grey shaded area) for planar sliding analysis. This means that planar sliding may occur along this failure plane.

Fig. 5 – Analyze of toppling failure for location 3

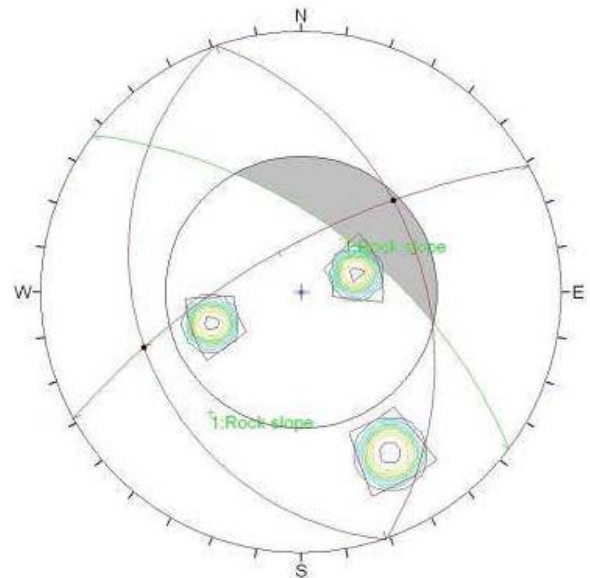
Fig.6 shows that there is a mean joint set orientation (shown by black dots) that falls within the wedge failure zone (grey shaded area). This indicates that a wedge failure may potentially occur at location 3.

Fig. 6 – Analyze of wedge failure of location 3
