LAWRENCE HARGRAVE DRIVE

Risk Assessment and Hazard Reduction

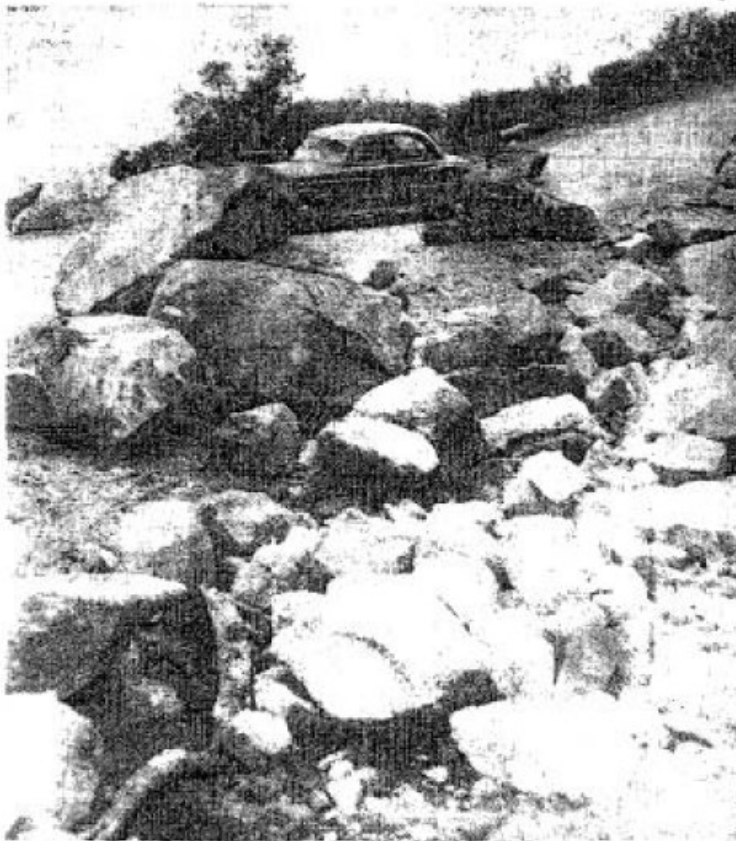
● SOME of the boulders which hurtled down on the south coast ocean road yesterday. Motorists who waited for graders to re-open the road said the rock-fall would have crushed a car.

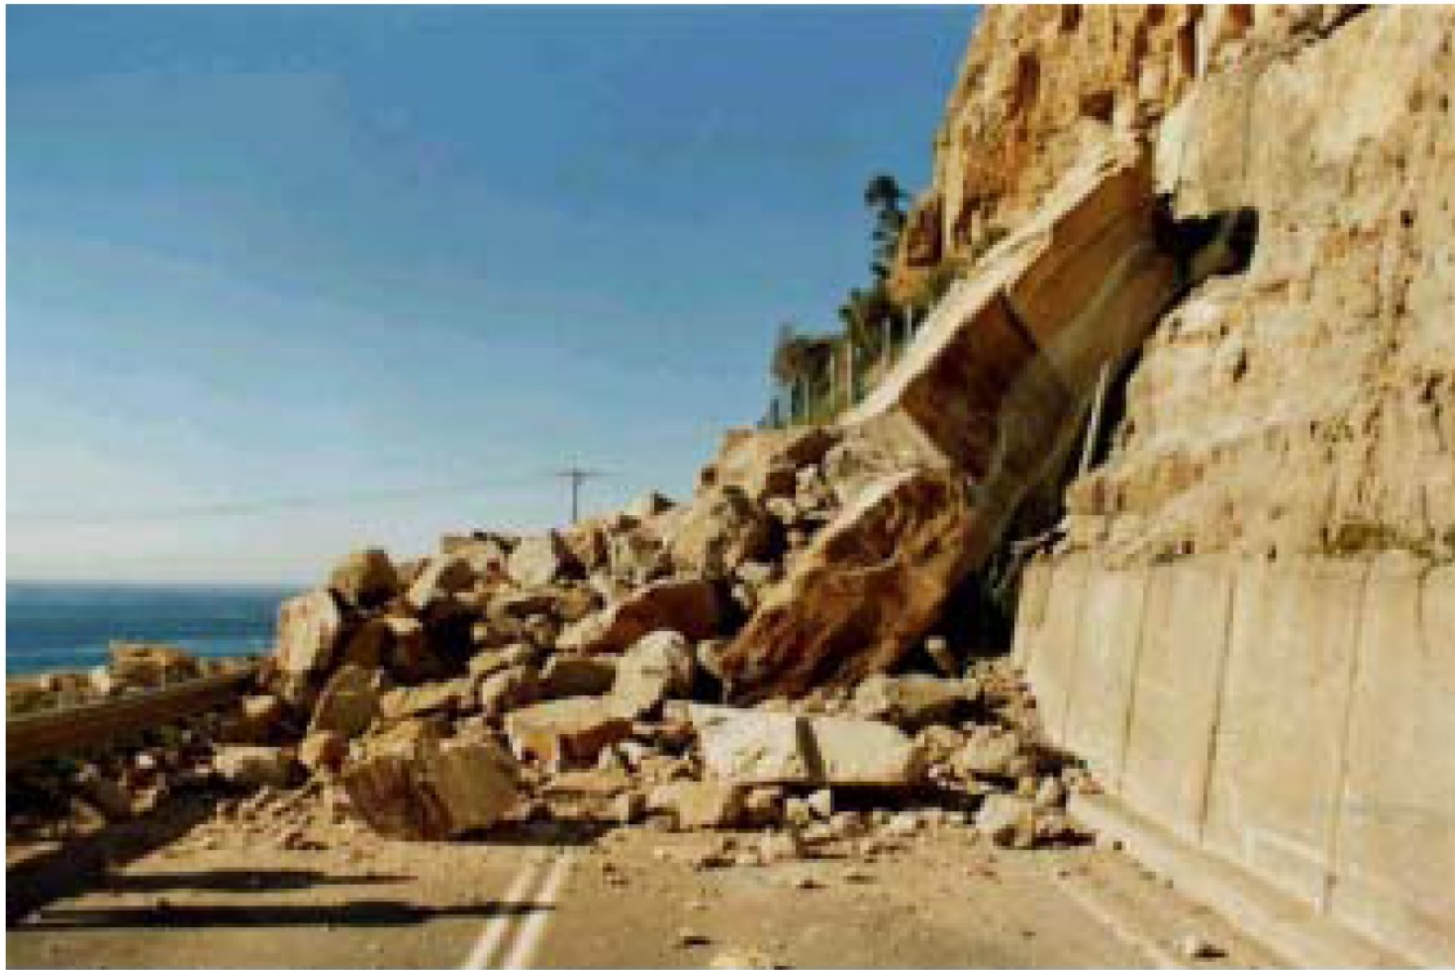
Figure 6. Toe failure below a large slab of Scarborough Sandstone from cliffs in GD1 in 1987 about 90 t of rock.

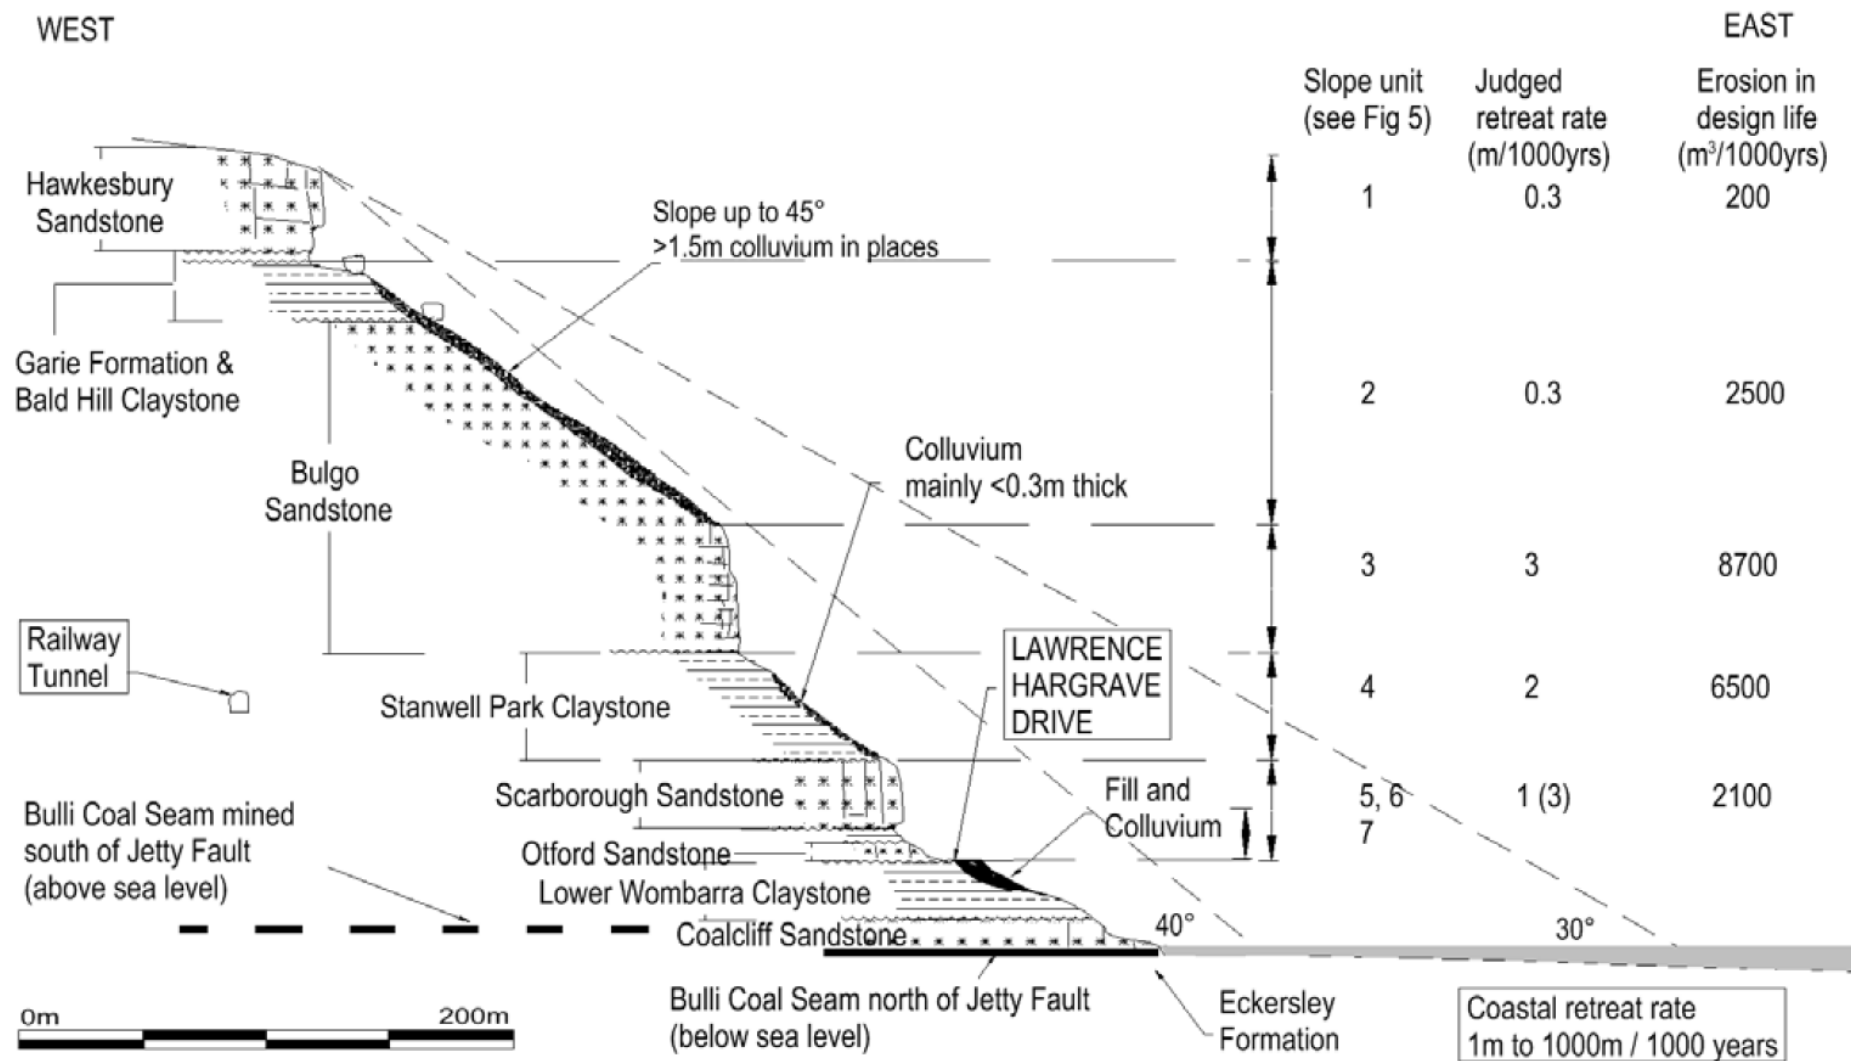
Cliff collapse Bulgo
Sandstone up to 6000m³

Rock falls to 20m³ from
Scarborough and Otford
Sandstone

Slab failure
Scarborough
Sandstone
~2000m³

Debris flows from
Stanwell Park Claystone
slope up to 3600m³

Shallow
embankment
failures

Figure 4. Cross section through GD2 that illustrates the landforms, geology and slope retreat rates

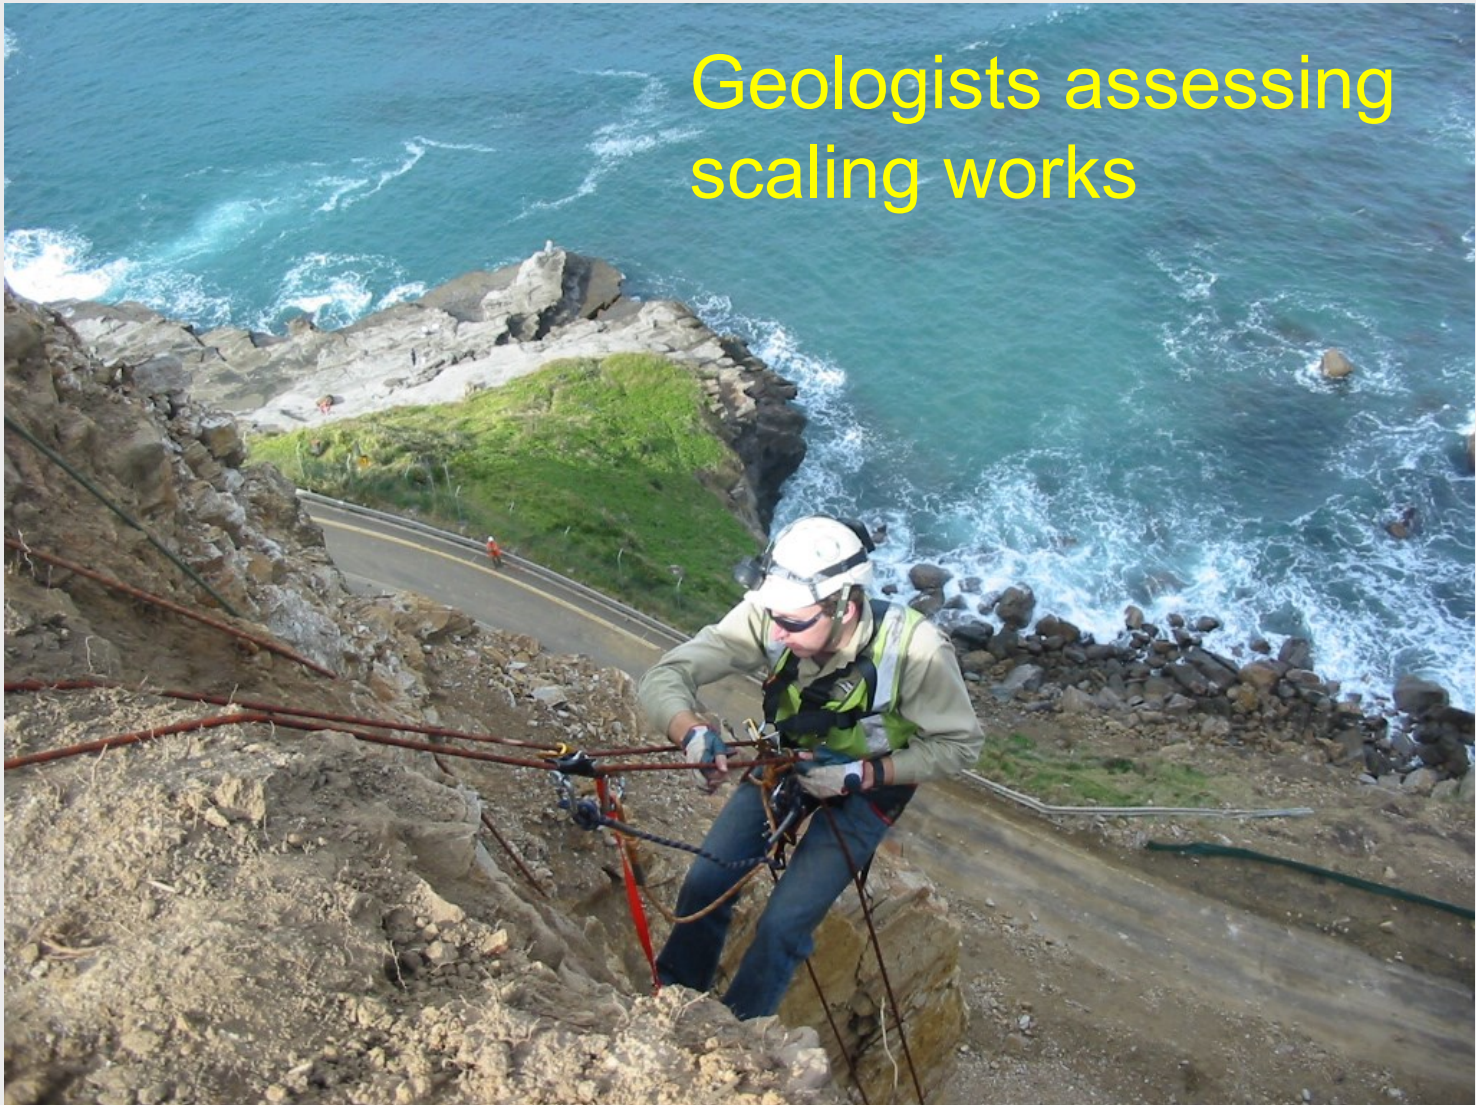
Geologists assessing scaling works

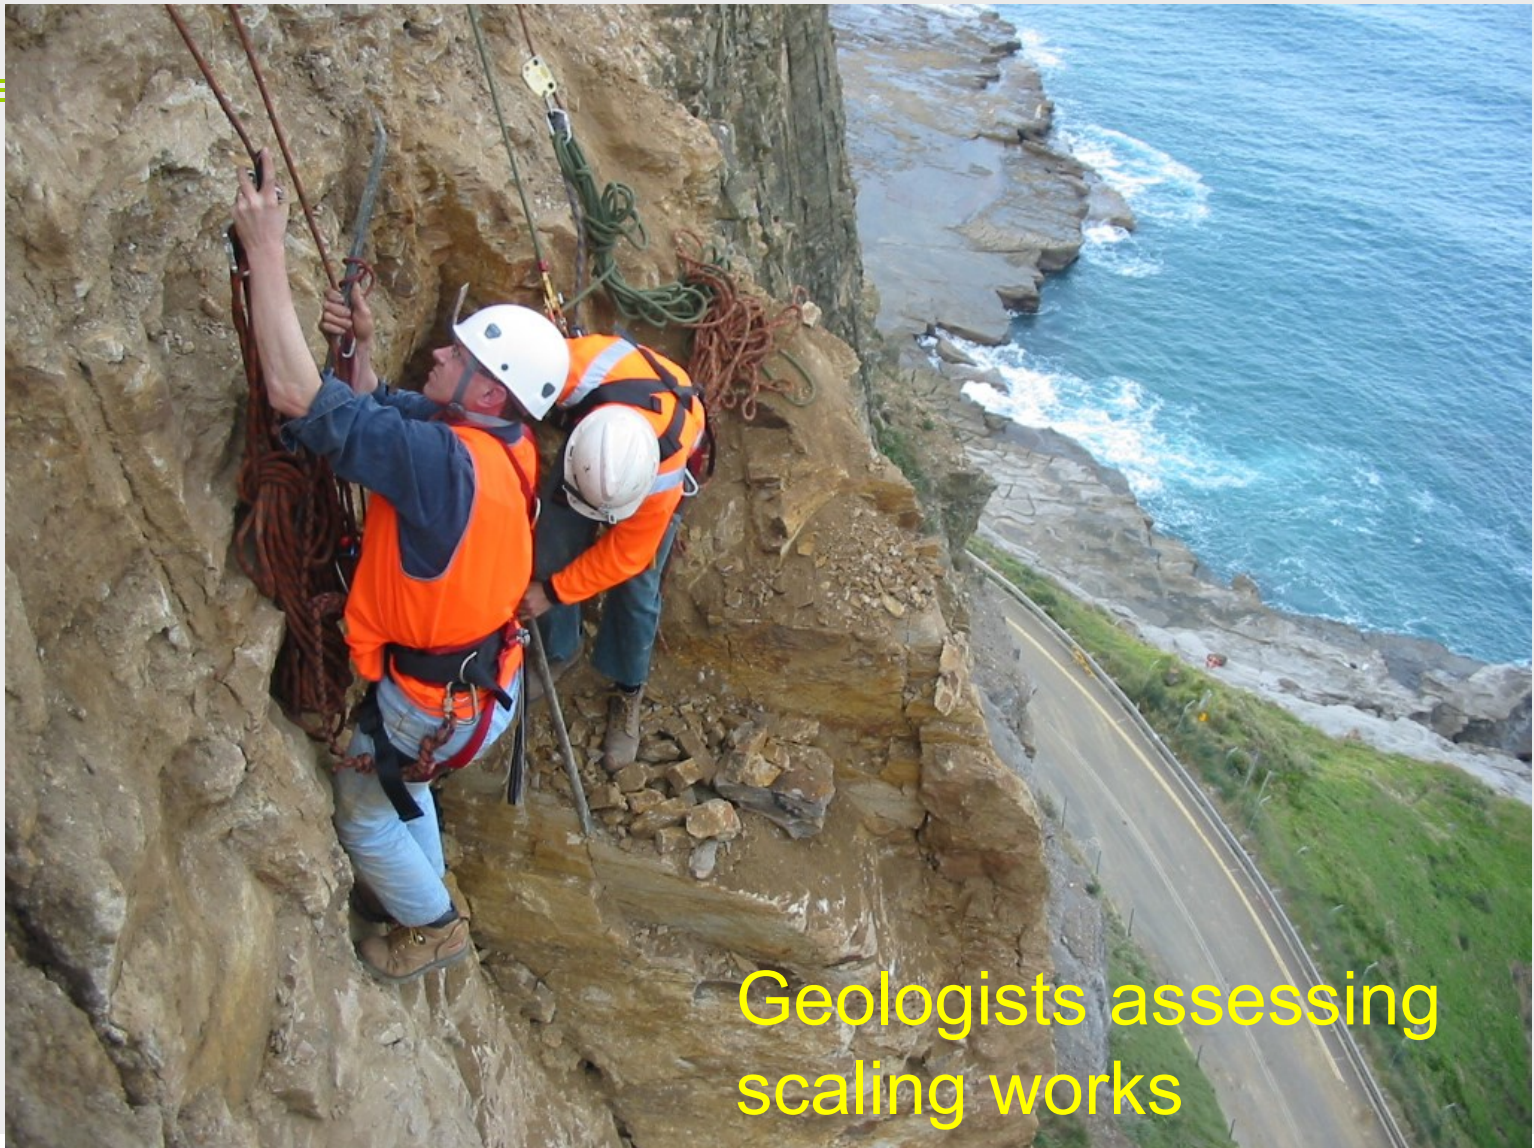
Geologists assessing
scaling works
