ENGINEERING GEOLOGY & GEOTECHNICAL MODELS

Lake George – Federal Highway Slope Stability

SH3 - FEDERAL HIGHWAY. ROCKFALL INCIDENT ON 20 JUNE 2005.

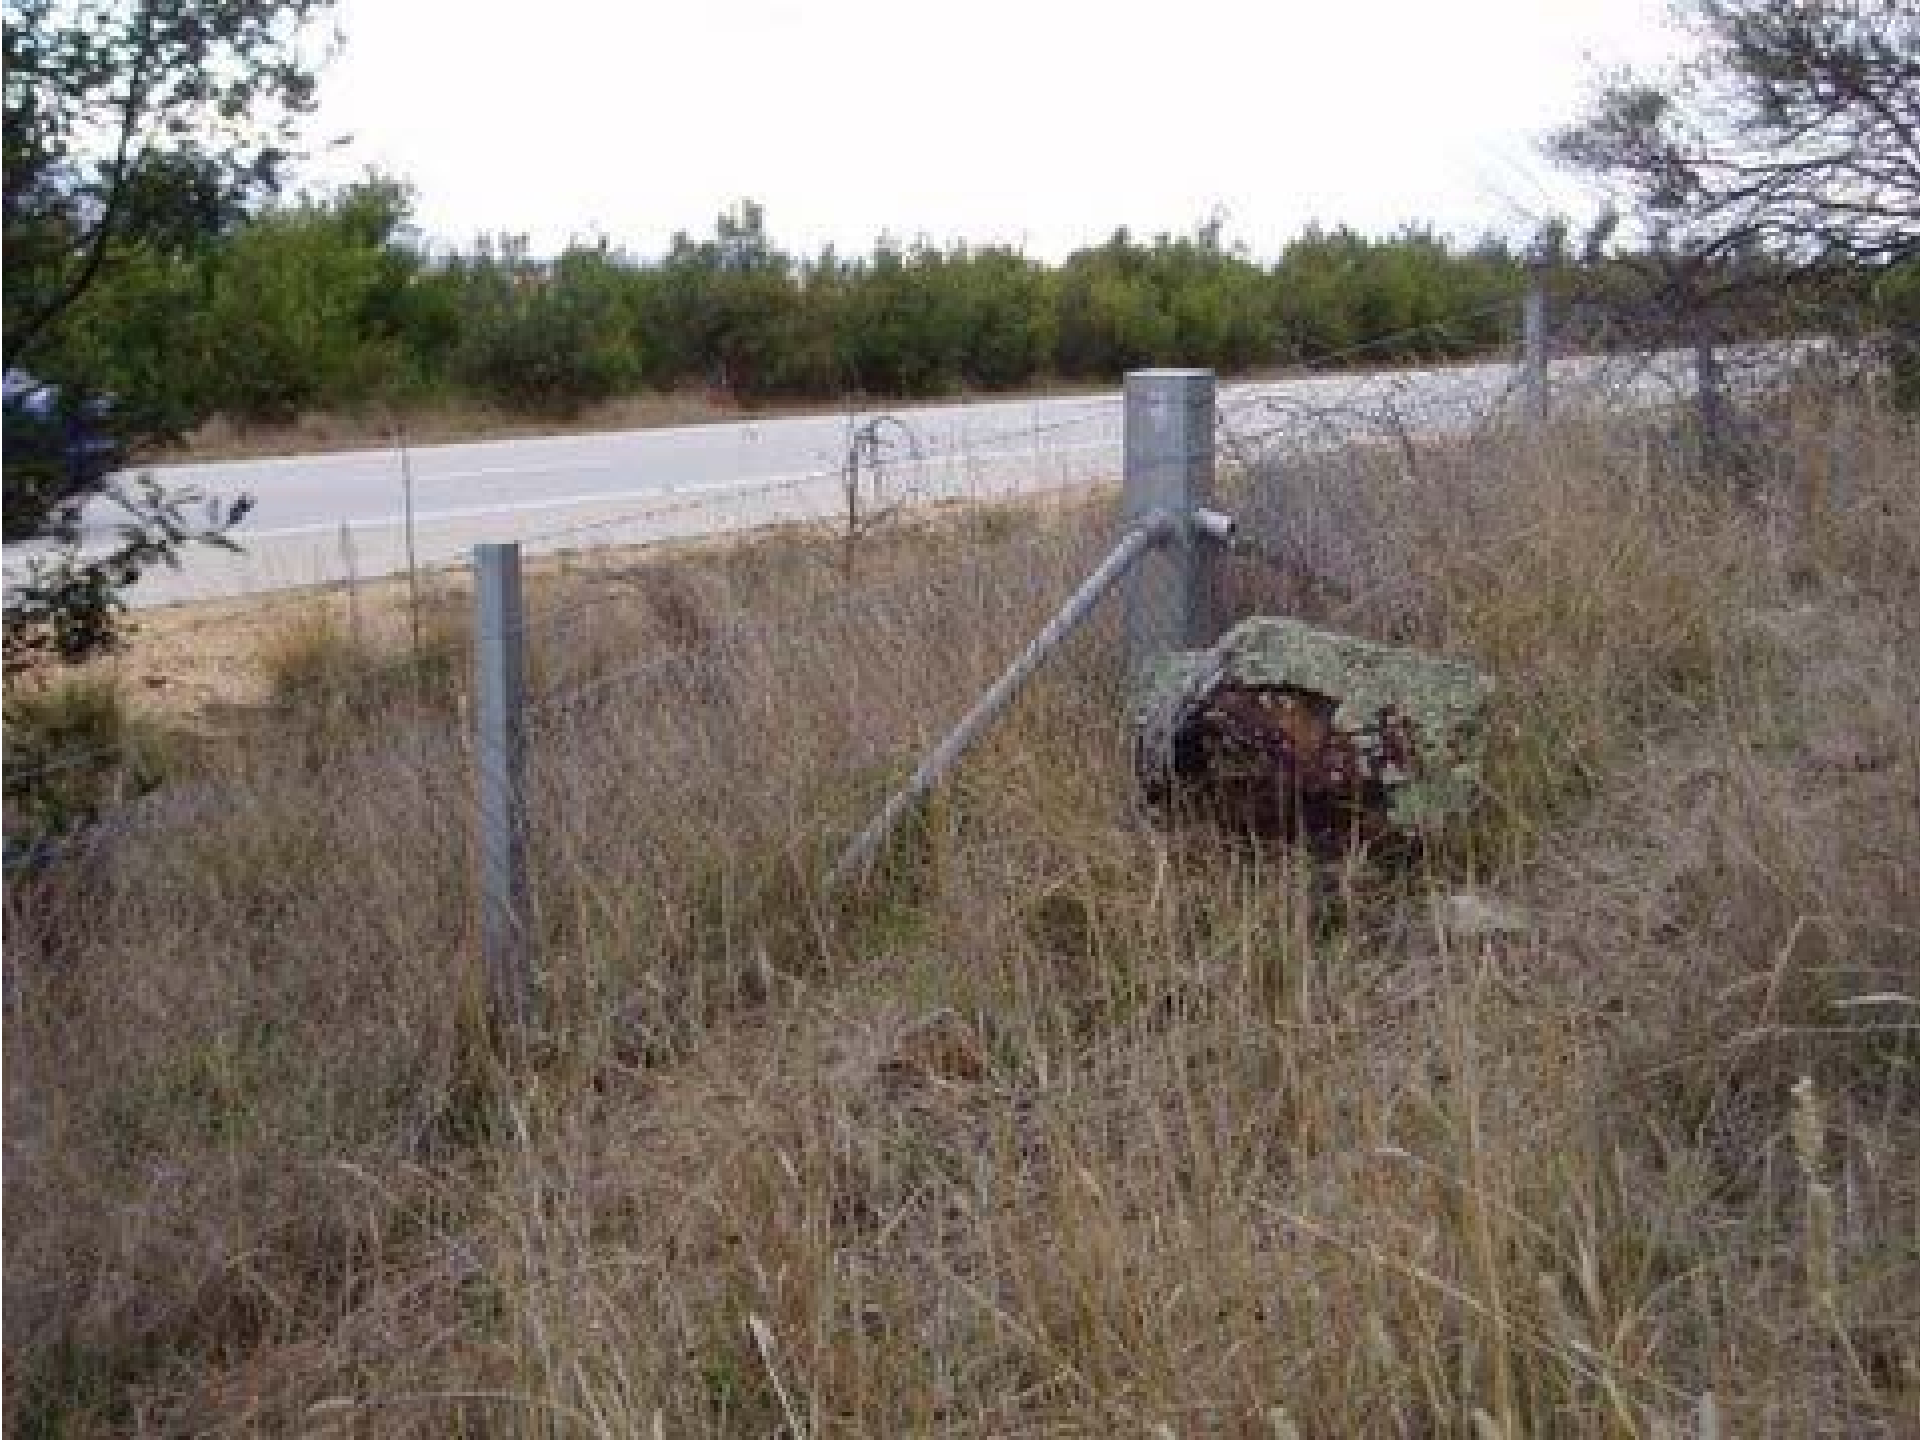
- The preliminary site inspection commenced at 12:00 hours on the 20 June 2005. The rockfall incident occurred near and prior to 4 am and involved a loaded semi-trailer and 2 passenger vehicles. The semi-trailer was still on site, however, the rocks had been pushed from the road and the 2 vehicles, one of which had rolled and caught fire, had been taken away. It is understood that the rocks were already on the carriageway before the vehicles arrived. There were no skid marks visible at the site, although sight distance is good. The site was wet following recent rainfalls and water was ponding at many locations.*

- The largest rock which reached the roadway was 0.75m^3 ($1.5 \times 1 \times 0.5\text{m}$) which along with other rocks bounced over the boundary fence (approx. 1m high). The rock impacted at several locations which were clearly visible as it crossed the northbound carriageway and came to rest in the middle of the southbound carriageway. This rock was not involved in any incident or vehicle damage.
- The rocks pushed from the northbound carriageway which may have been involved in the accident comprises a total volume of approximately 0.65 m^3 . The size of any original boulder is unknown, however, the maximum dimension of the largest remnant block is 0.95m with a minimum dimension of 0.3m. As the rocks would most likely lie on their minimum dimension, the maximum height of all the remnant boulders is 0.4m.

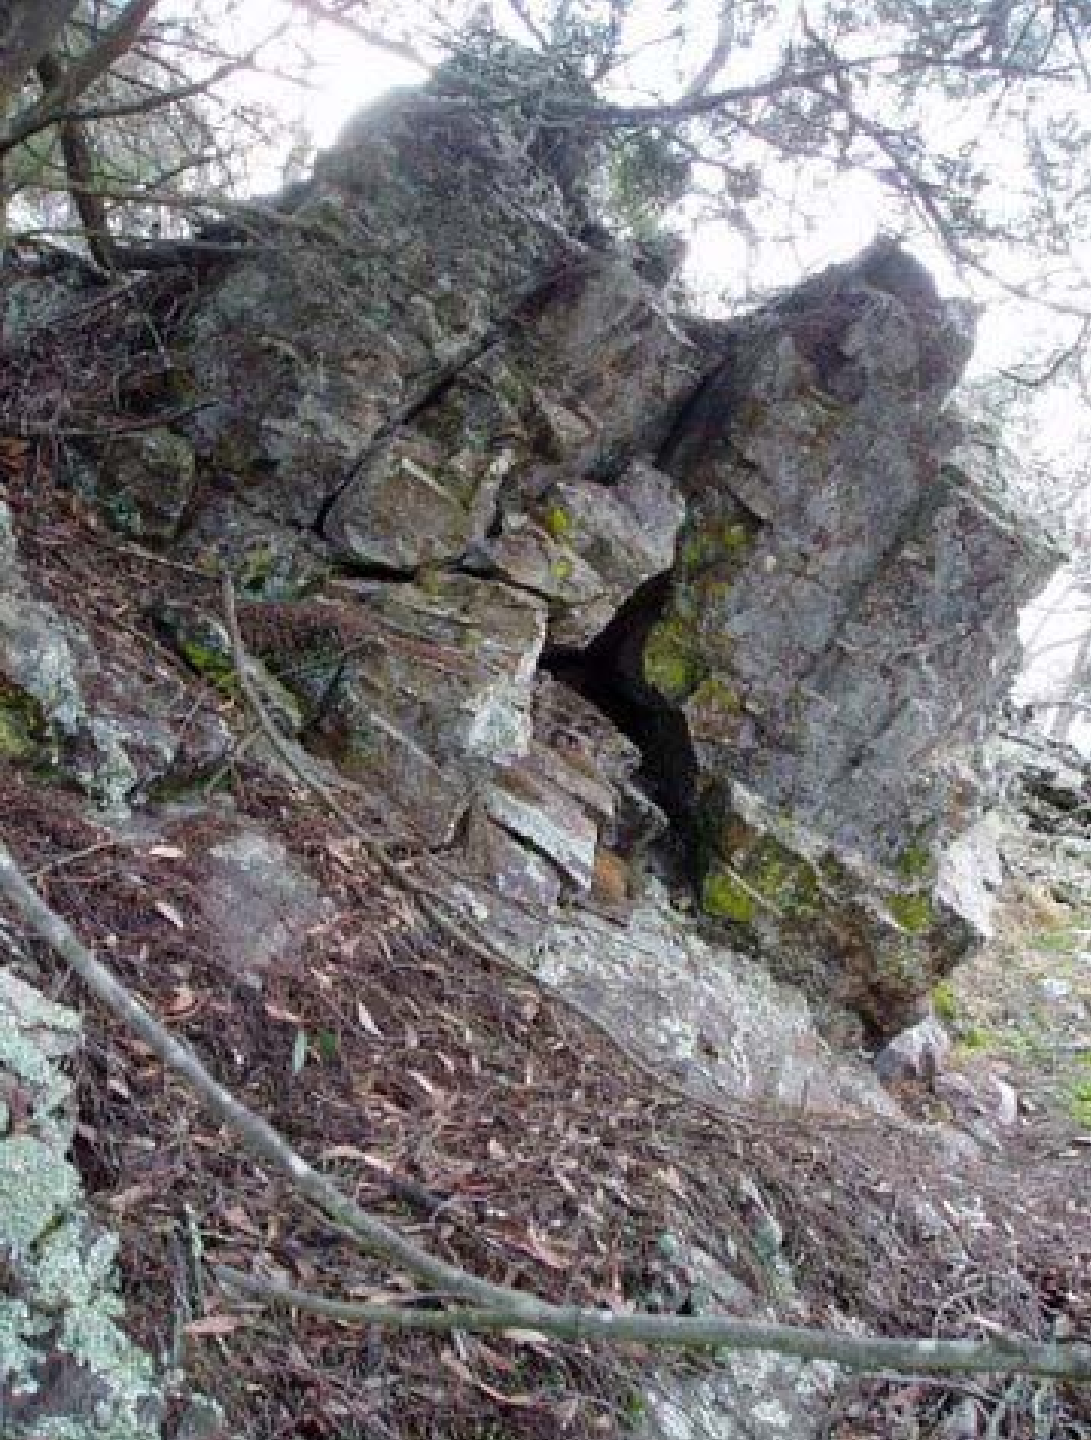
Teetering Blocks

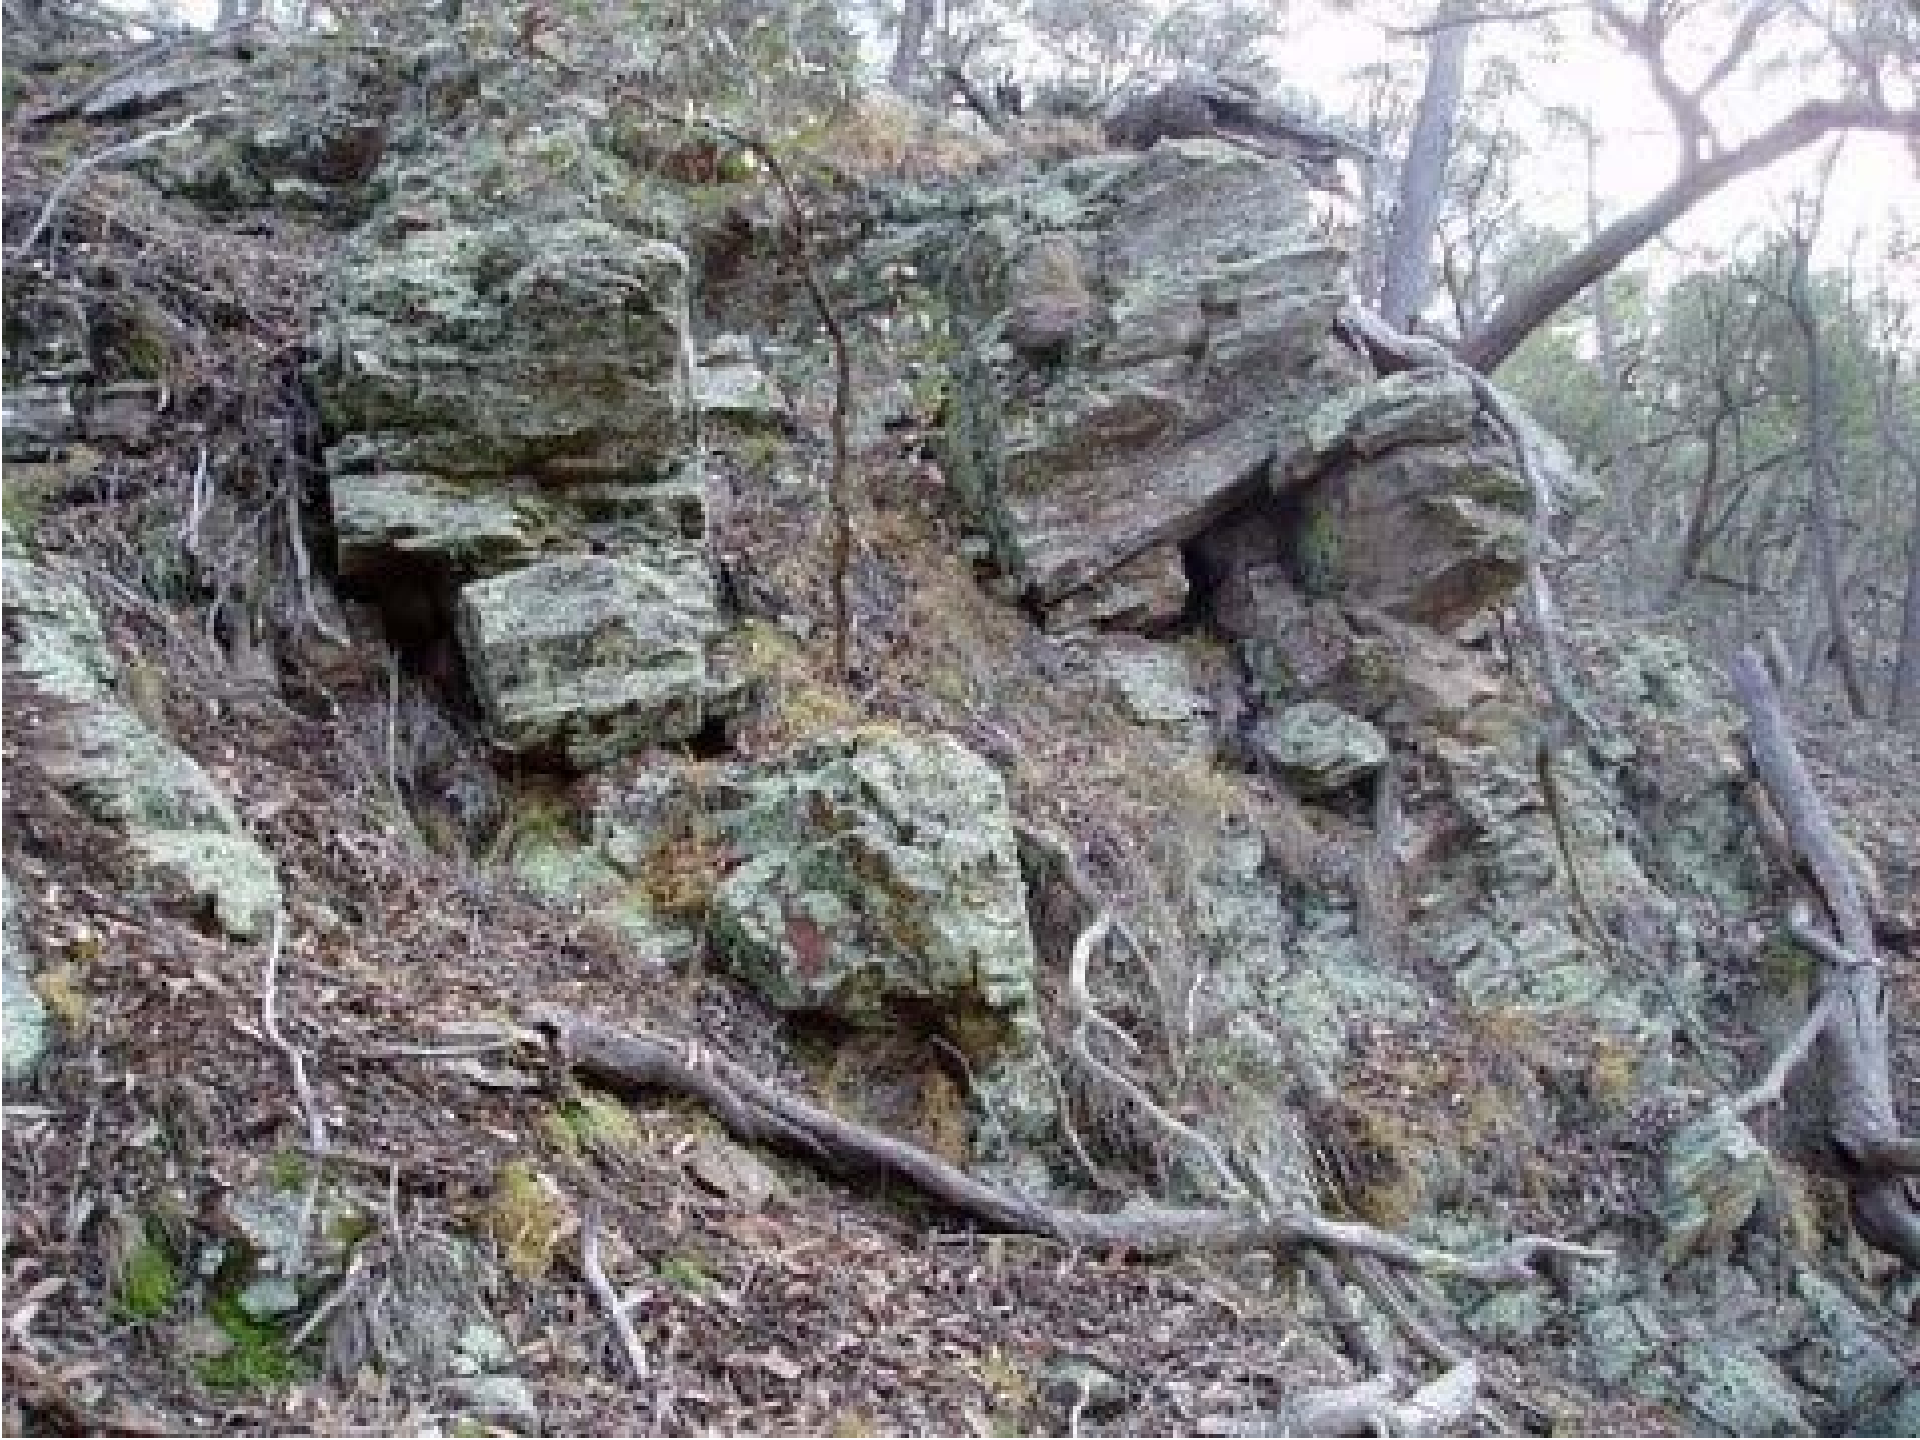
Precarious Blocks

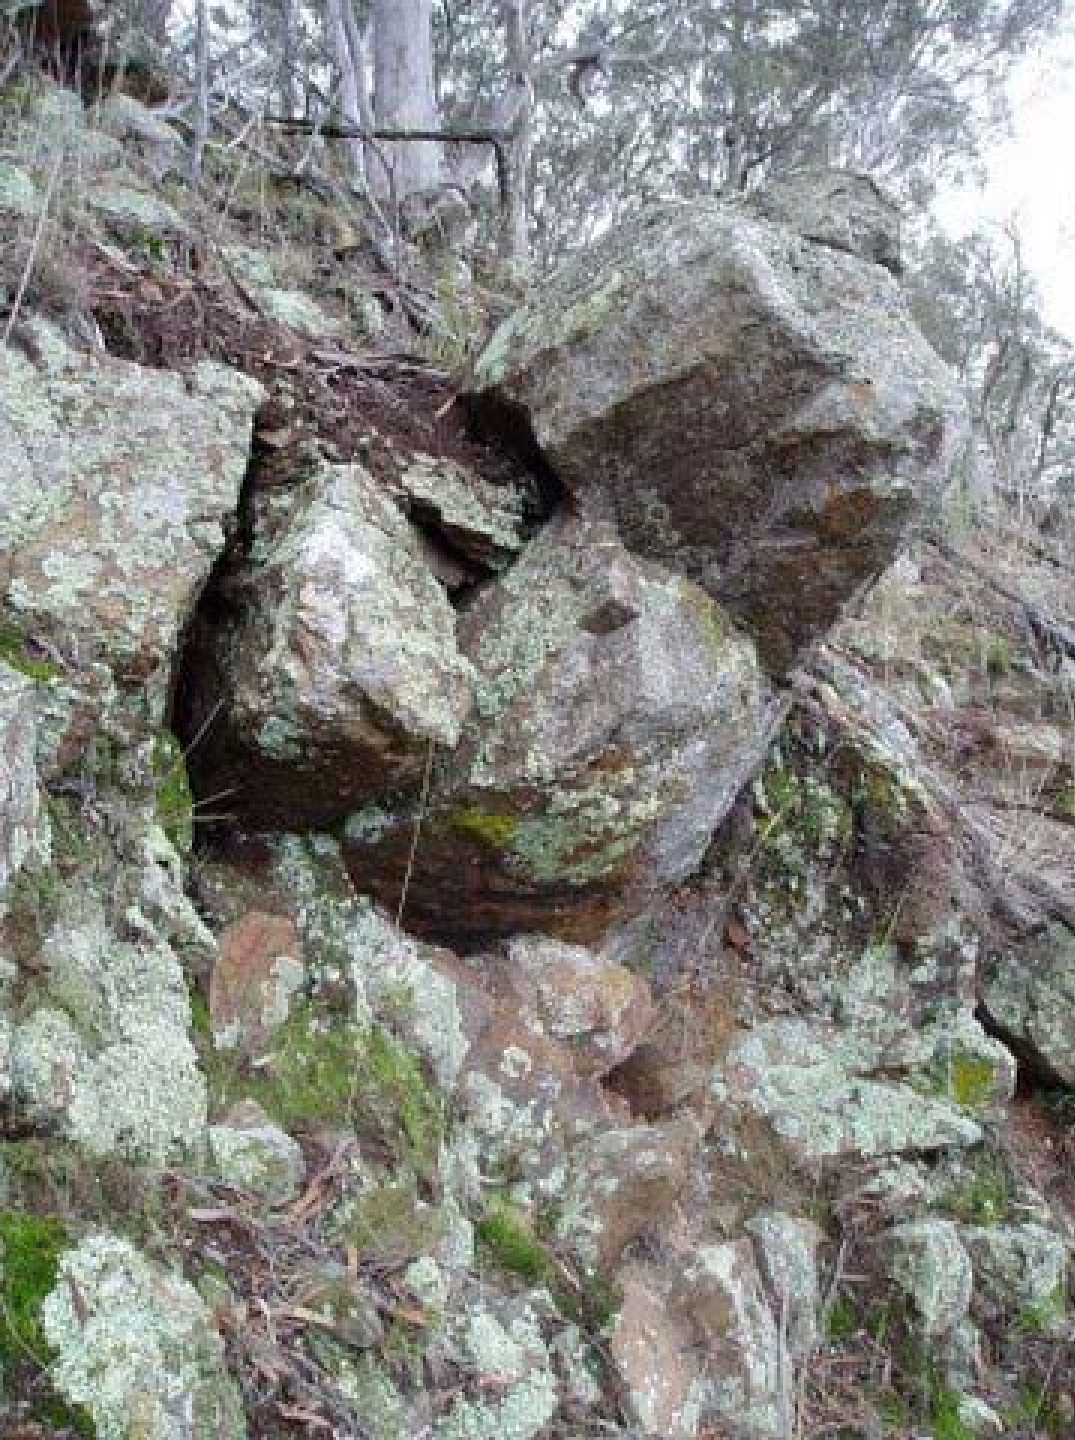
- Launching platforms
- **Stacked Precarious Boulders**
- Stacked Precarious Blocks

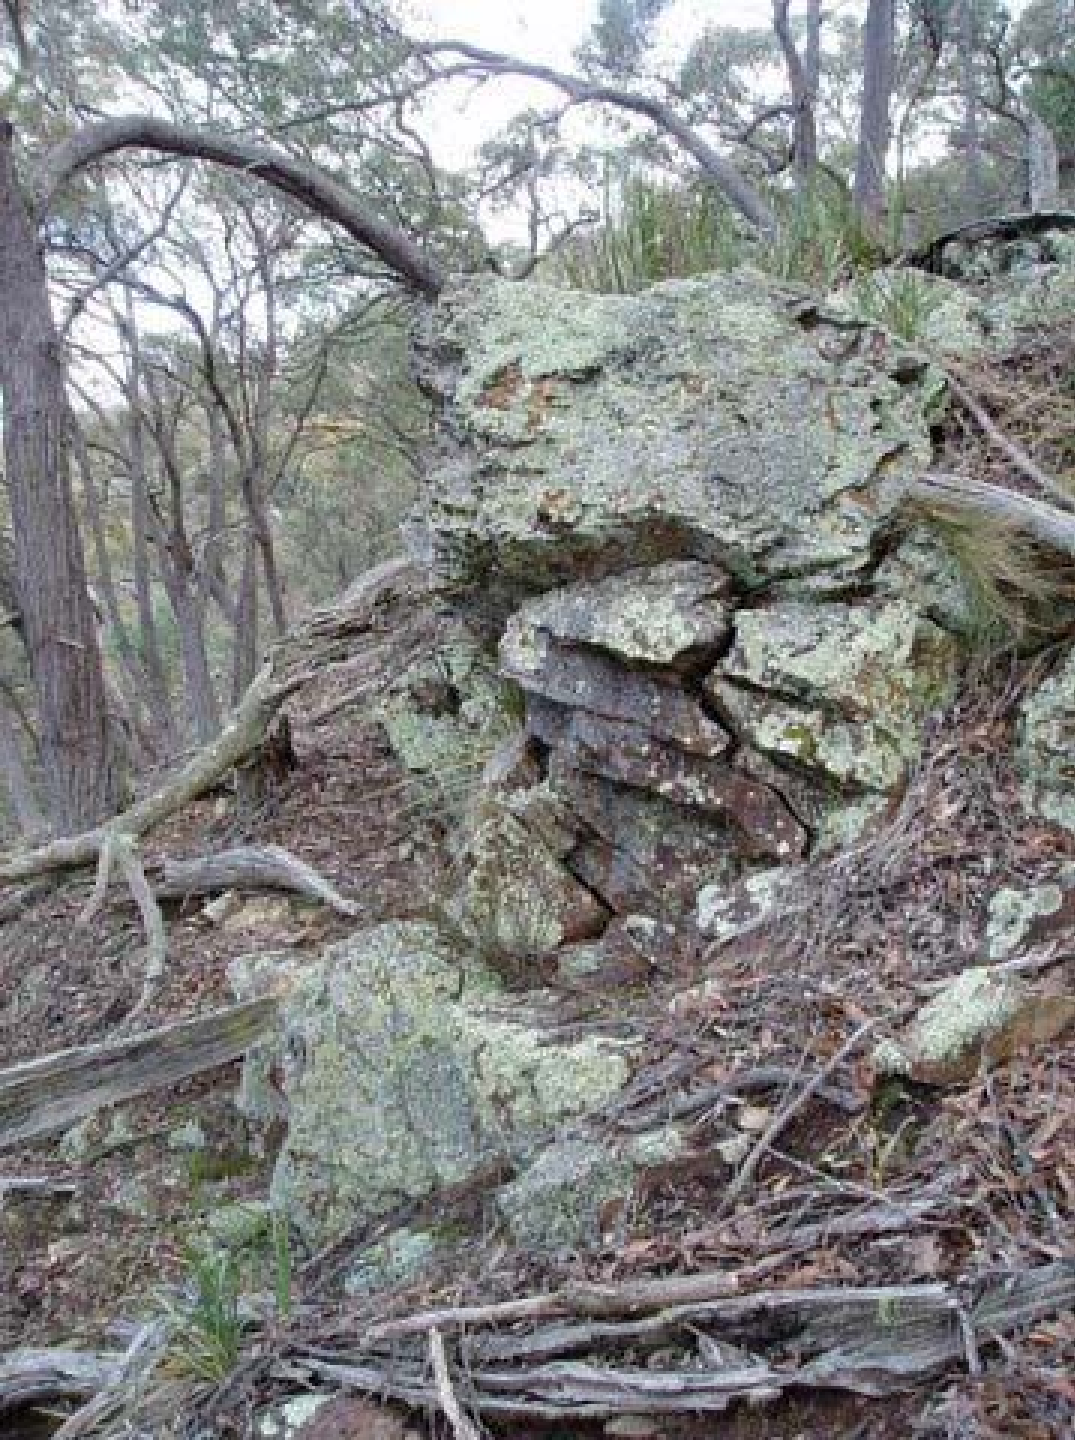
- The site of the rockfall release and surrounding slope condition on 27 June 2005.
- The release area was found to be just above the upper cliff line from where it is estimated at least 2-3m³ of rock was destabilised.
- It is likely that the impact of these rocks dislodged other unstable rocks on the slope surface adding to the over all quantity of the rock fall.

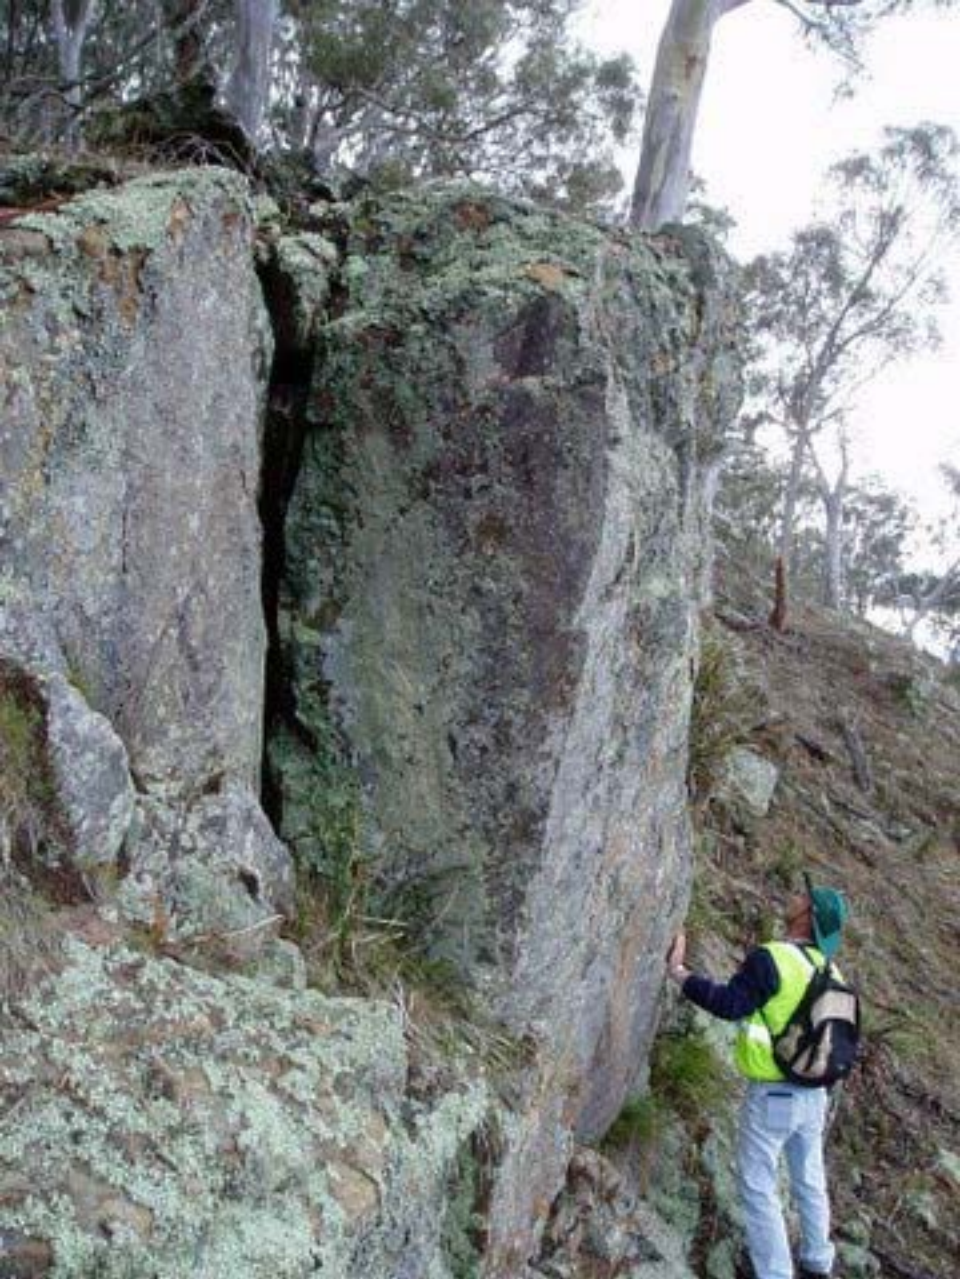
- Generally the slope was found to contain numerous potential rock release areas of varying sizes
- Several of the boulder sites could be easily triggered by heavy rain, erosion, progressive weathering, falling trees, bushfire, animal movement and or an earthquake.
- An inspection of the boundary fence also revealed the presence of rocks from recent falls along its length, indicating that the frequency of rock release is relatively high with falls generally contained on the slope or behind the fence.

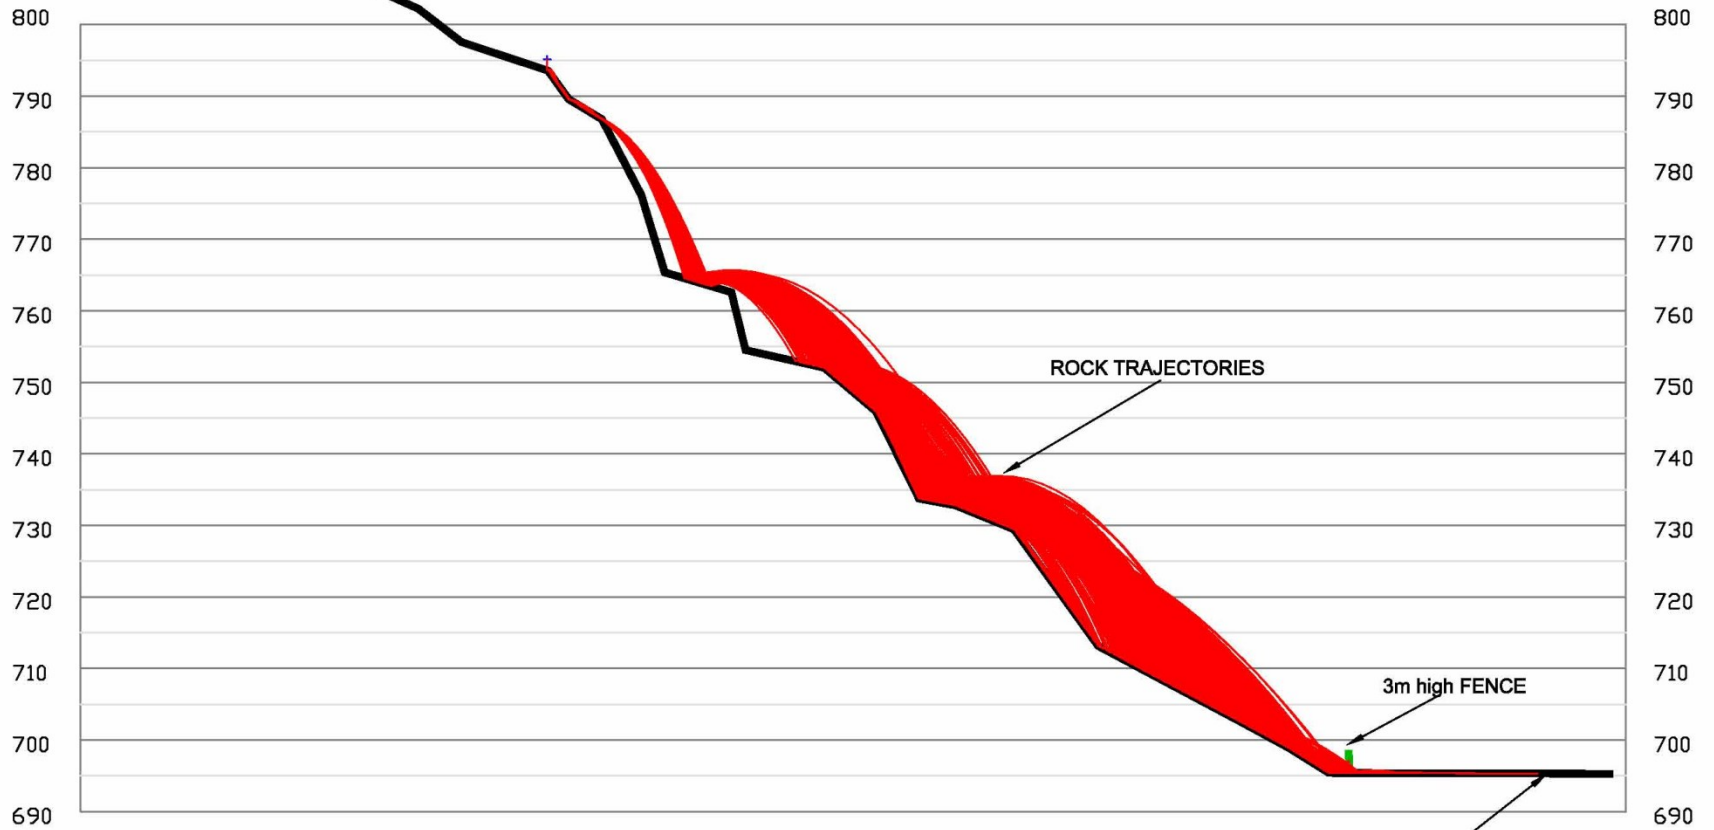
No. of Boulders - 500
 Boulder mass - 2000kg +/-100kg (Std devn)
 Fence 2m High - 300kJ Capacity
