# Performance of Asphalt Concrete-faced Rockfill Embankment at Lam Ta Khong Pumped Storage Project, Thailand

# Features

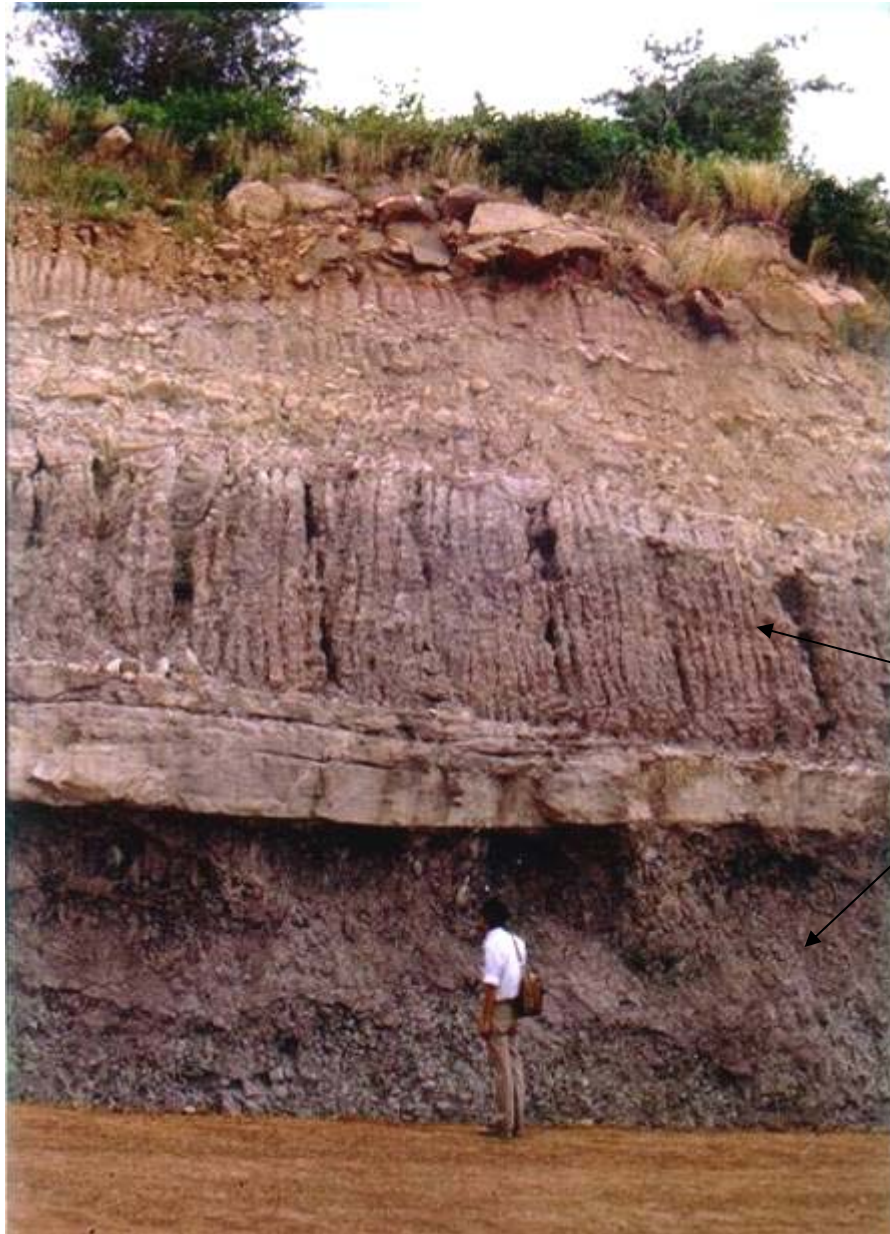
Condition of outcrop of siltstone  
beds and their slaking condition  
after exposure to atmosphere

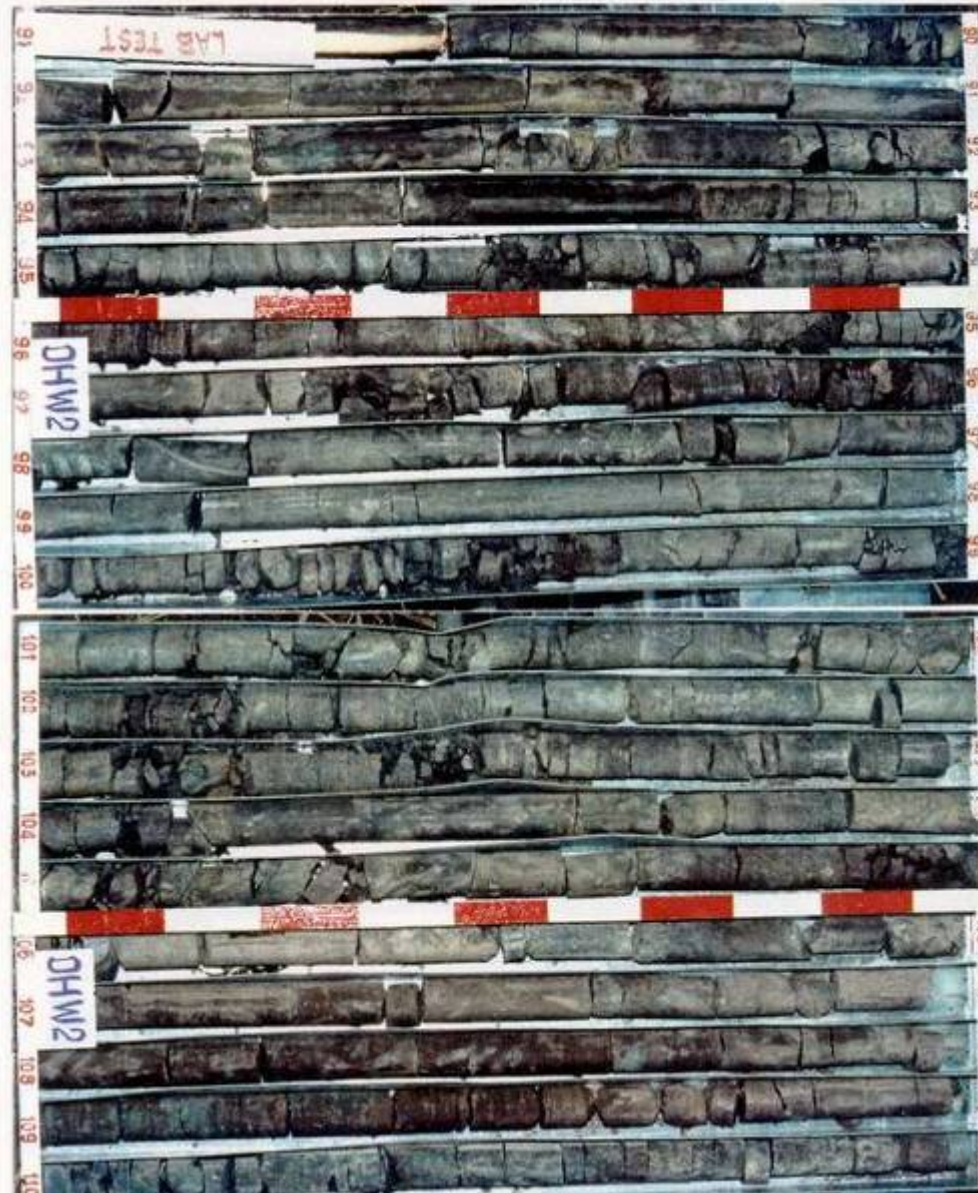
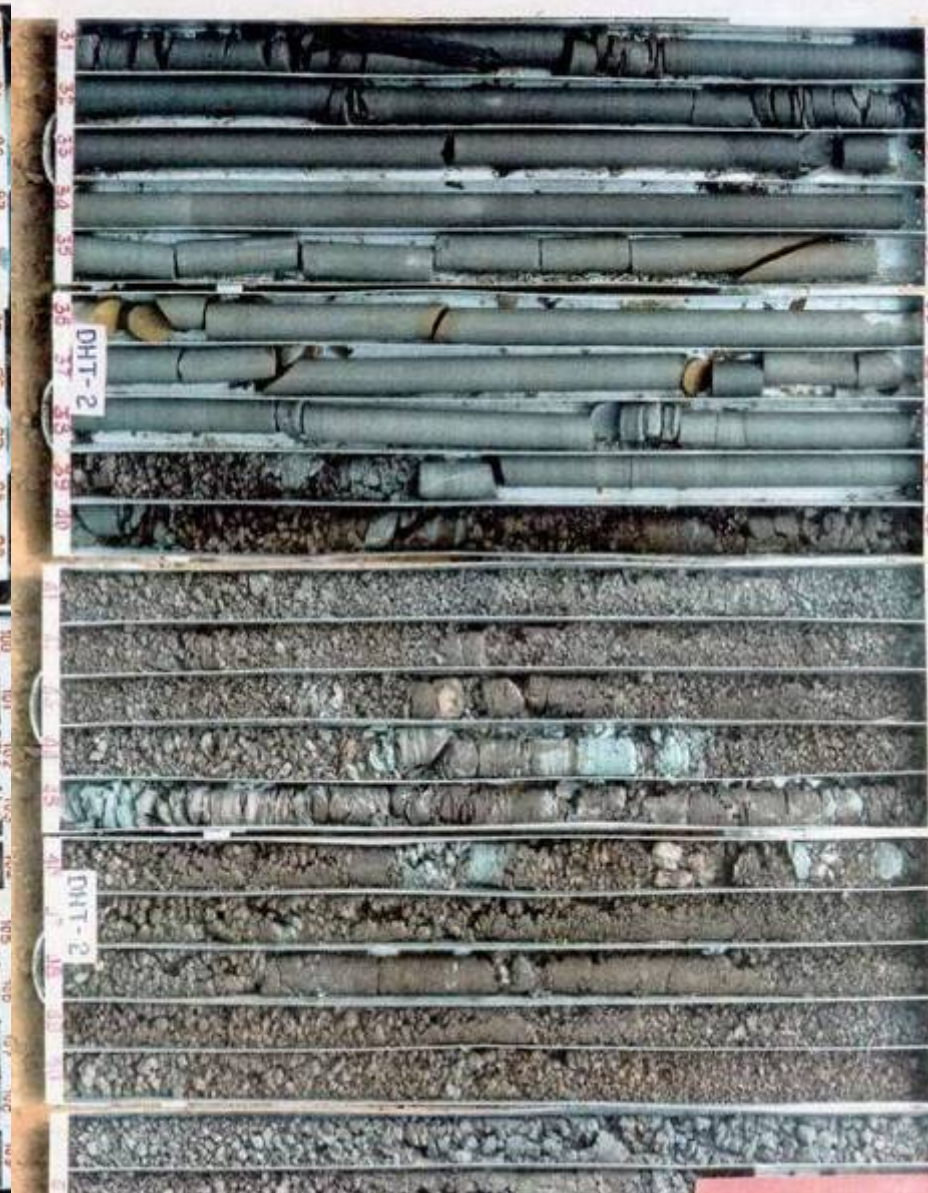
# Slaking of siltstone left unattended in core boxes

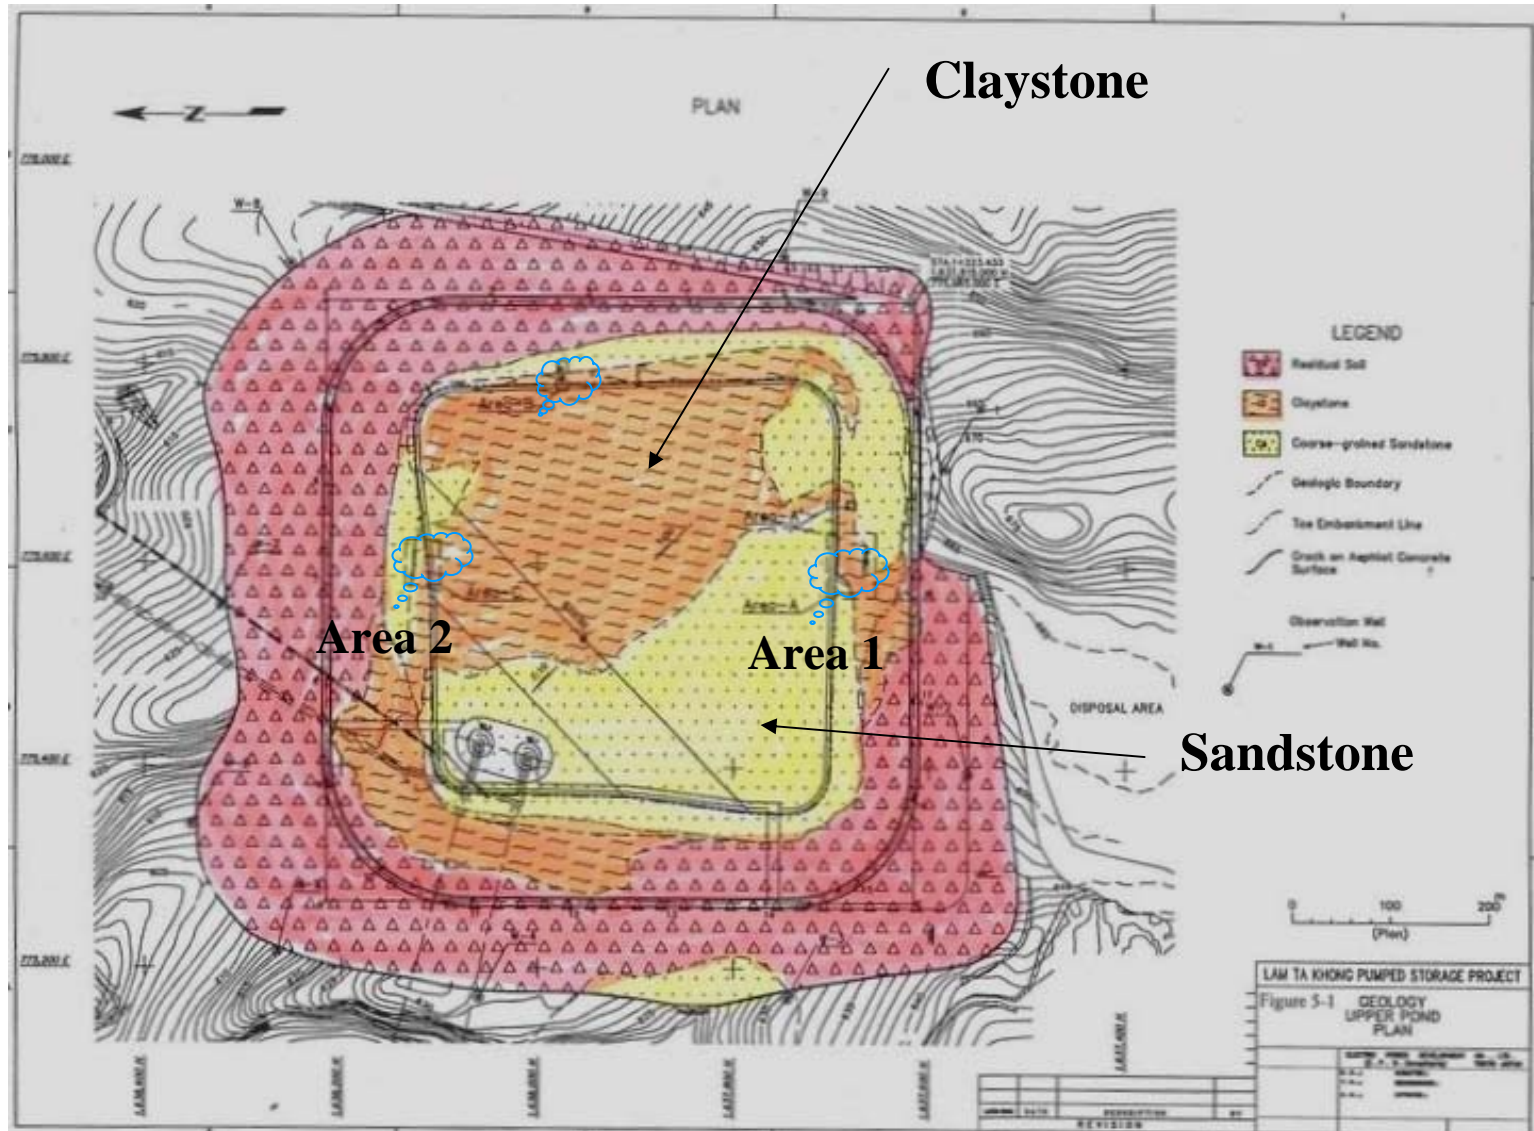
- Increased leakage rate was detected during the trial pond filling up to about a half full.
- The inspection after emptying the reservoir revealed cracks, bulges and heaves of asphalt facing near toe of slope at three areas of cut slope.
- All three areas were located in zones of claystone where a special treatment using geotextile covering was adopted underneath the facing layers to avoid a problem of deterioration and piping of claystone in contact with water.
- Inspection trenches were excavated to investigate the cause of the failure.

Locations where slippage and cracks of the asphalt facing on cut slope occurred.

- Thickening asphalt lining in toe areas of slopes in the damaged zones to serve as buttress and improved shear resistance.
- Avoided using geotextile sheet as the separator over claystone ( Geotextile sheet created planar sliding surface between claystone and transition layer).

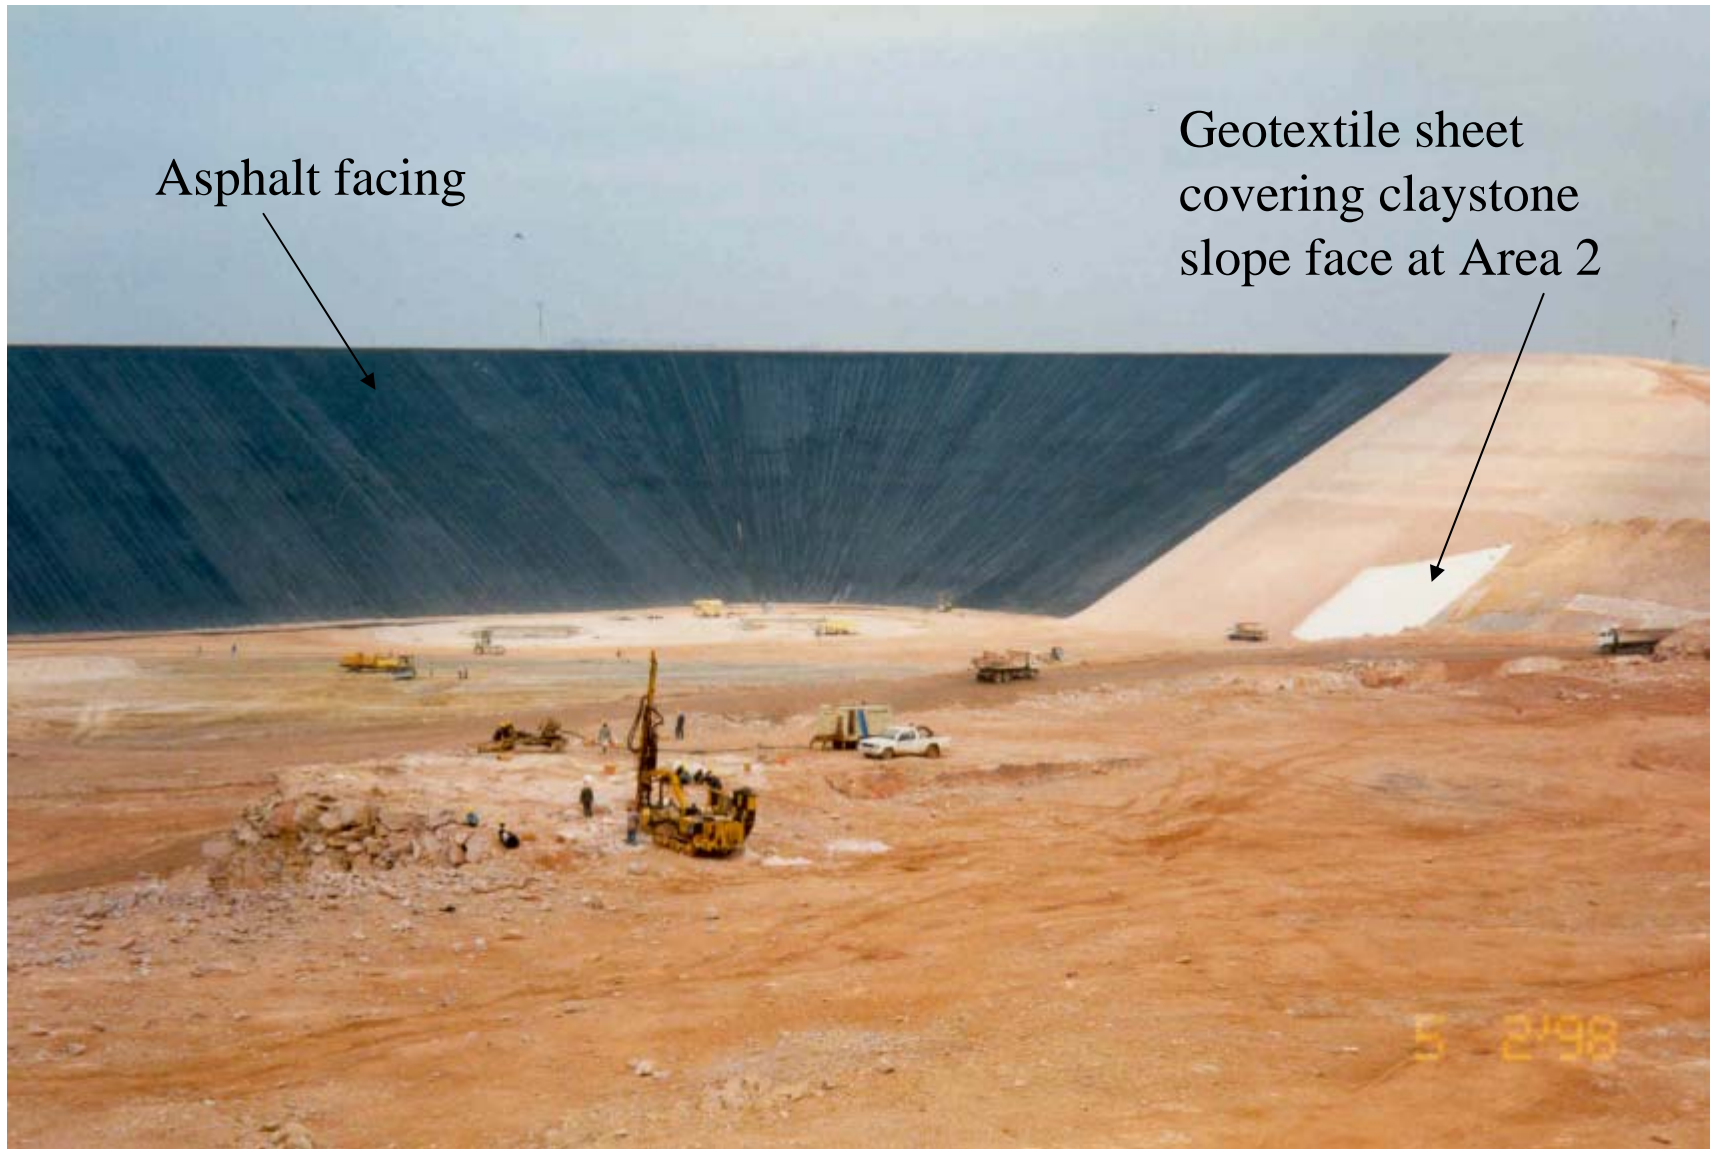
Geotextile sheet  
covering claystone  
slope face at Area 2

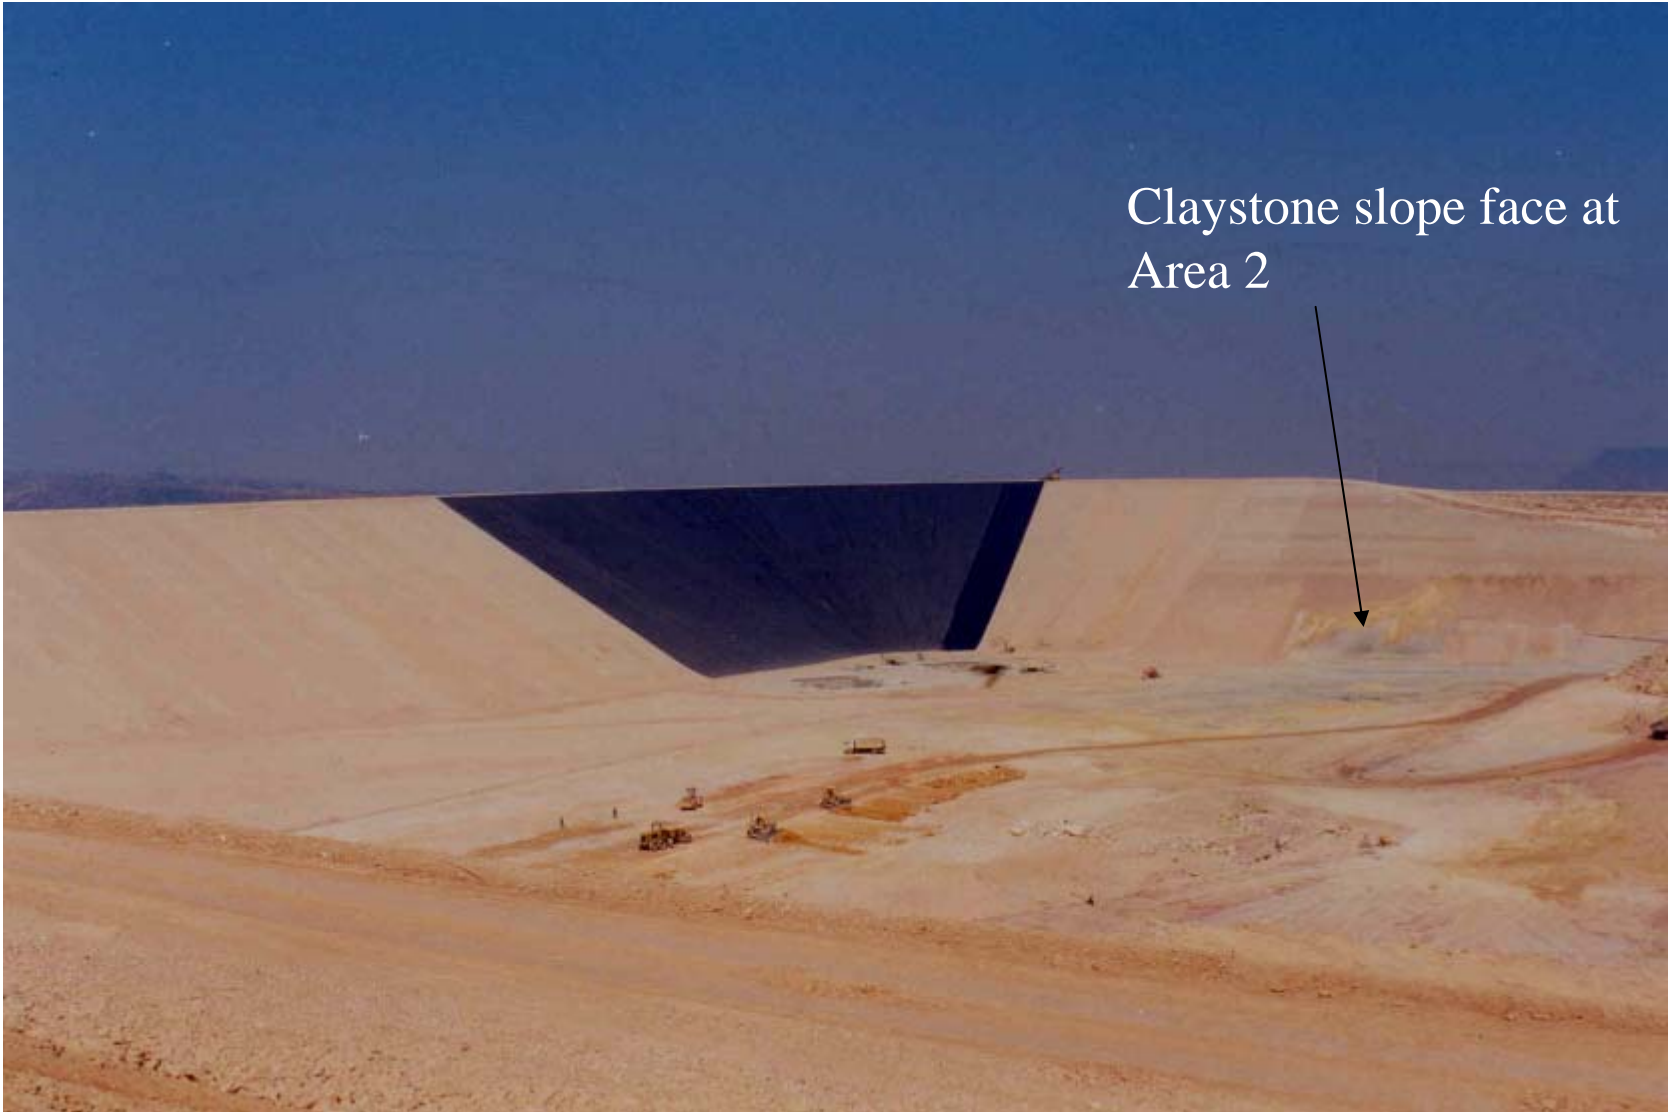
Claystone slope face at  
Area 2

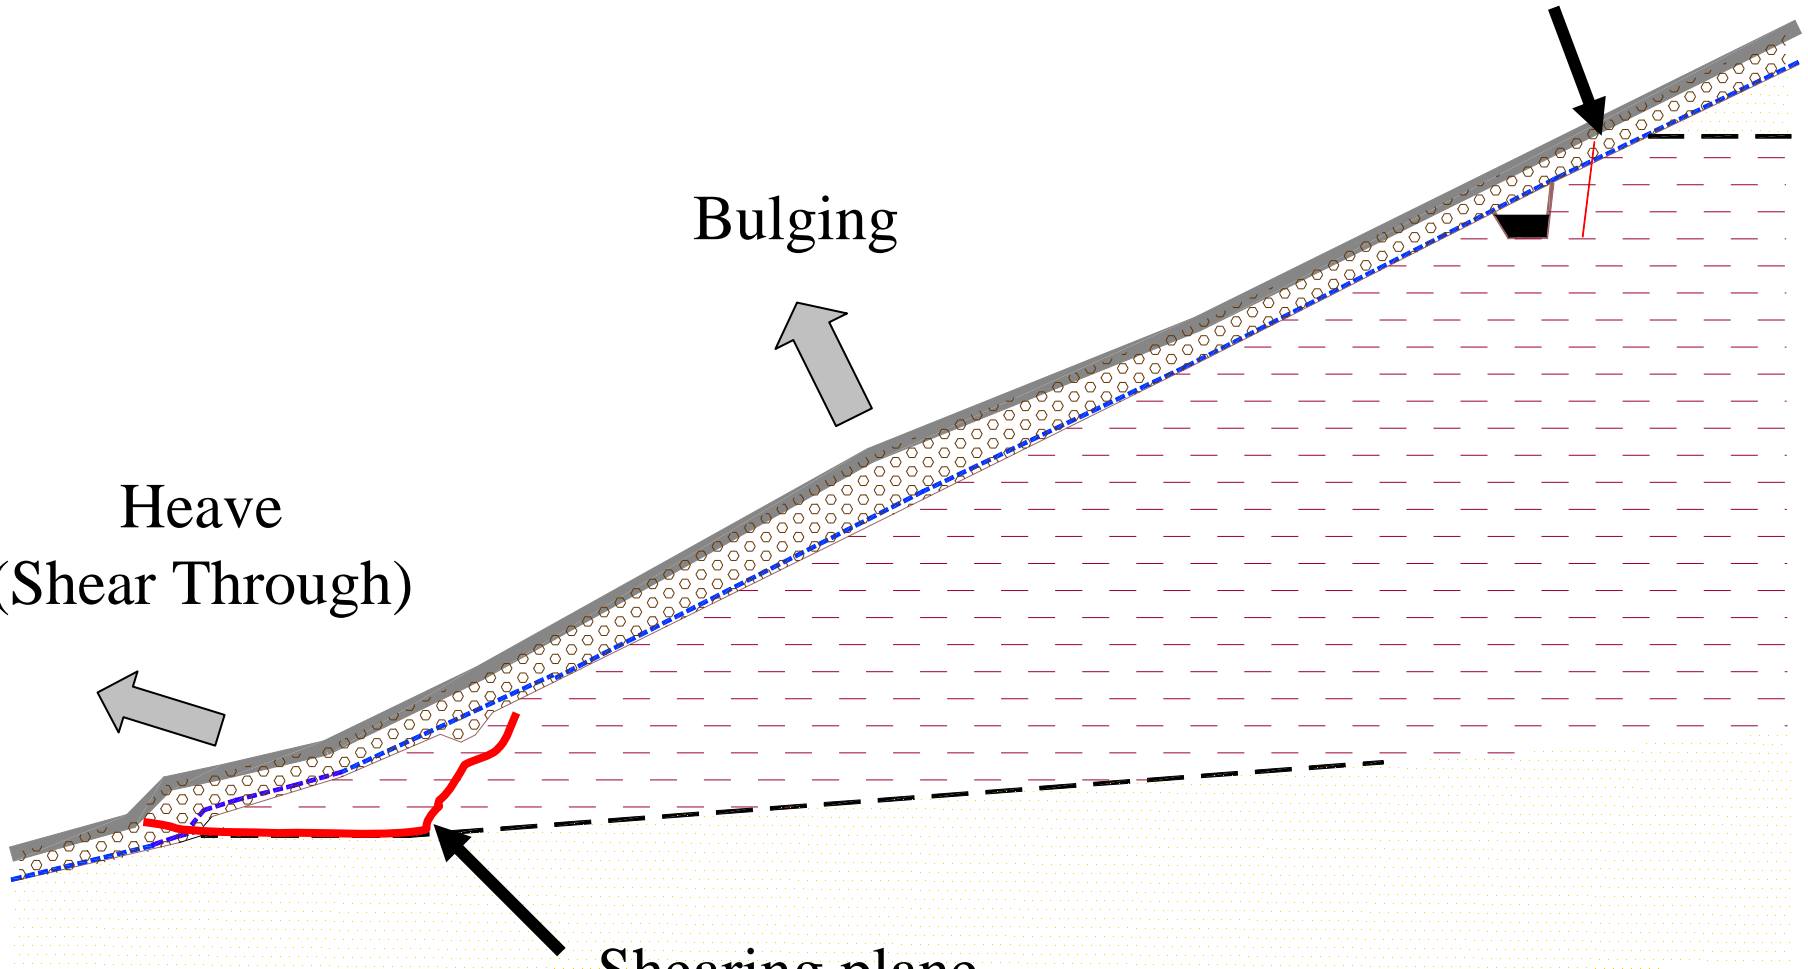
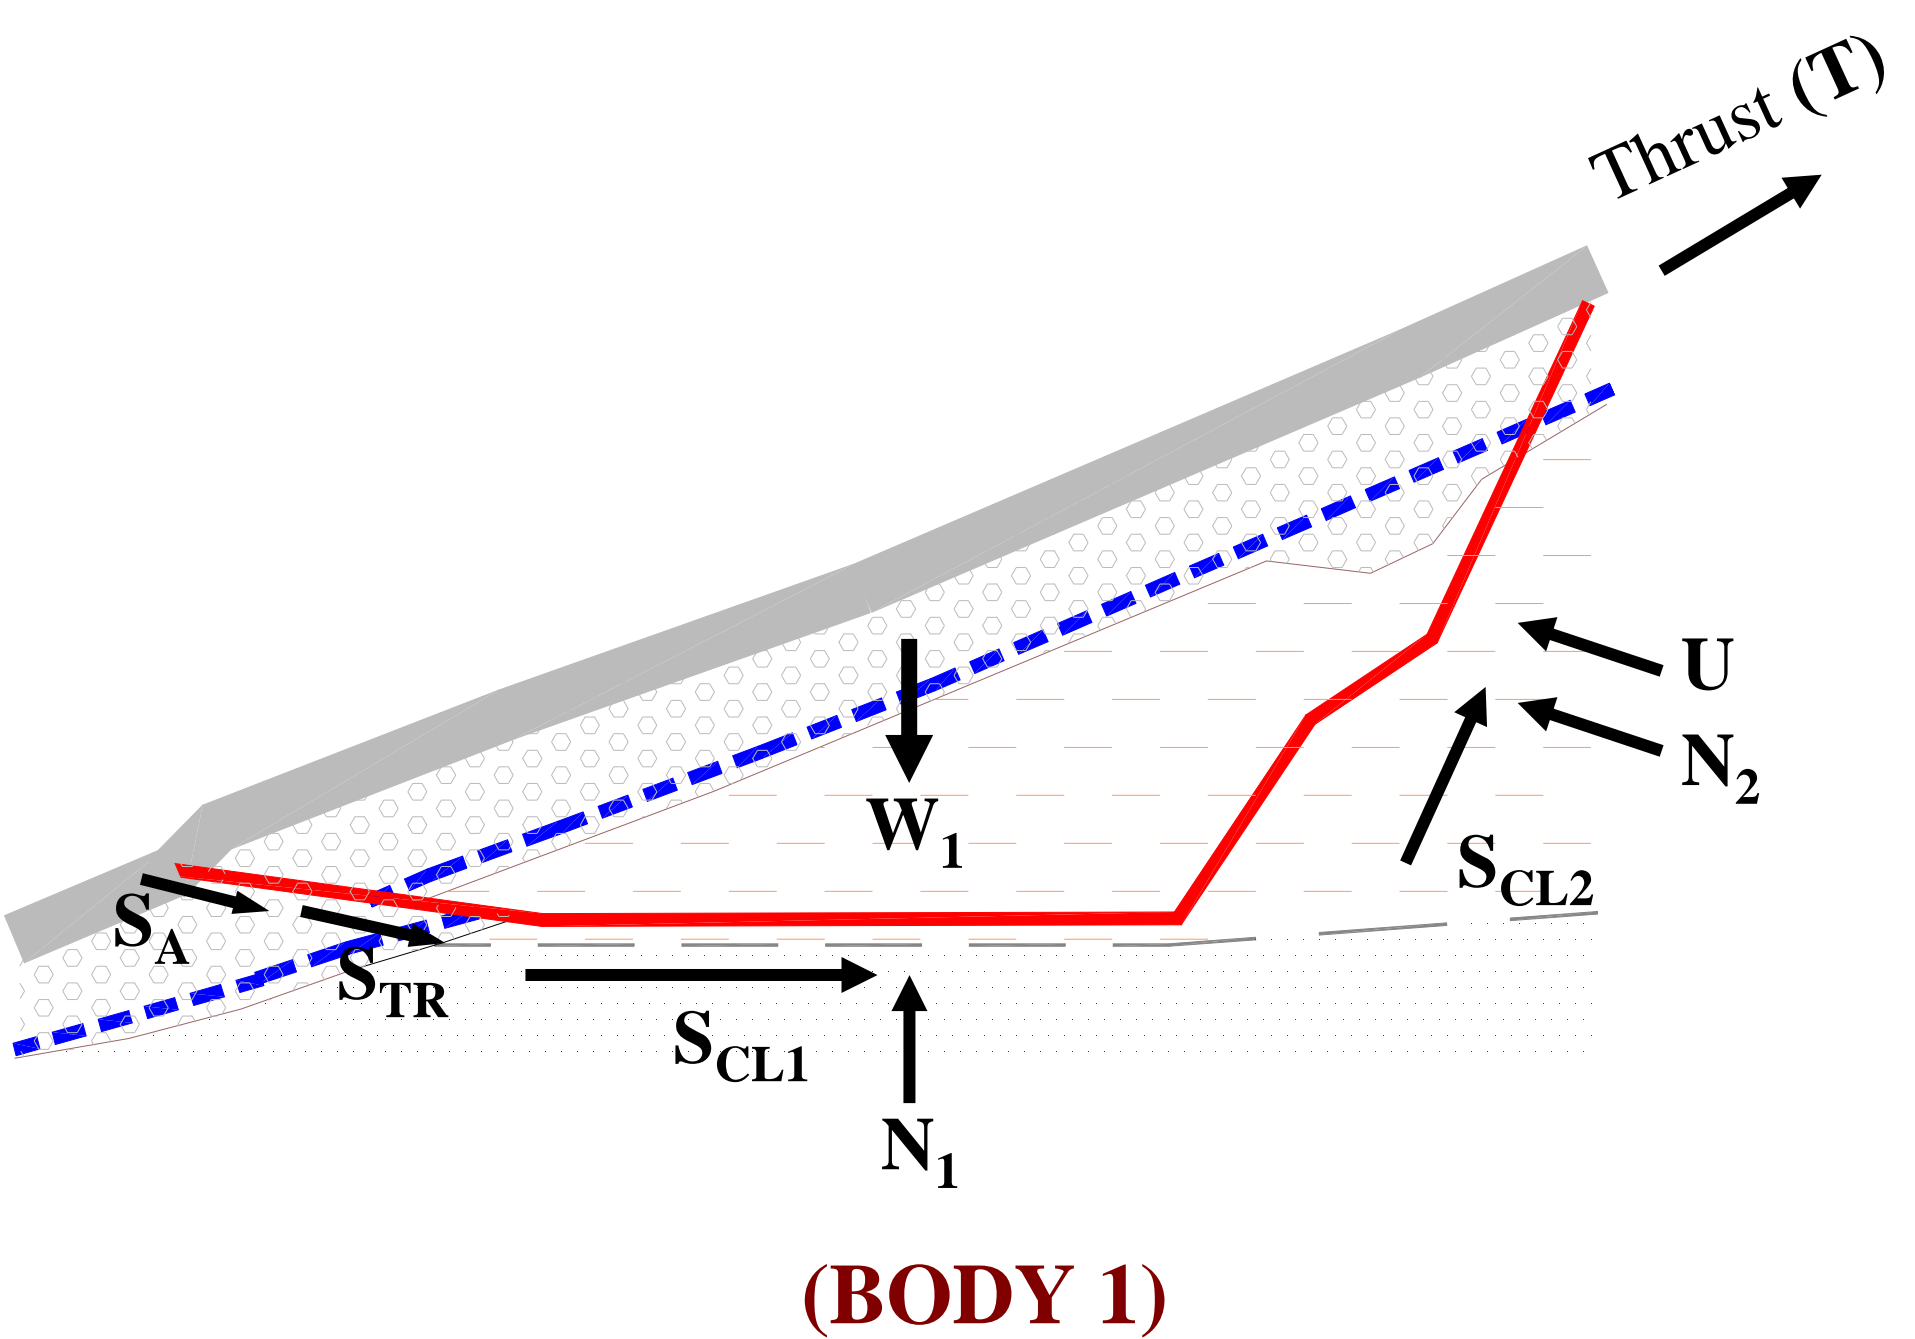
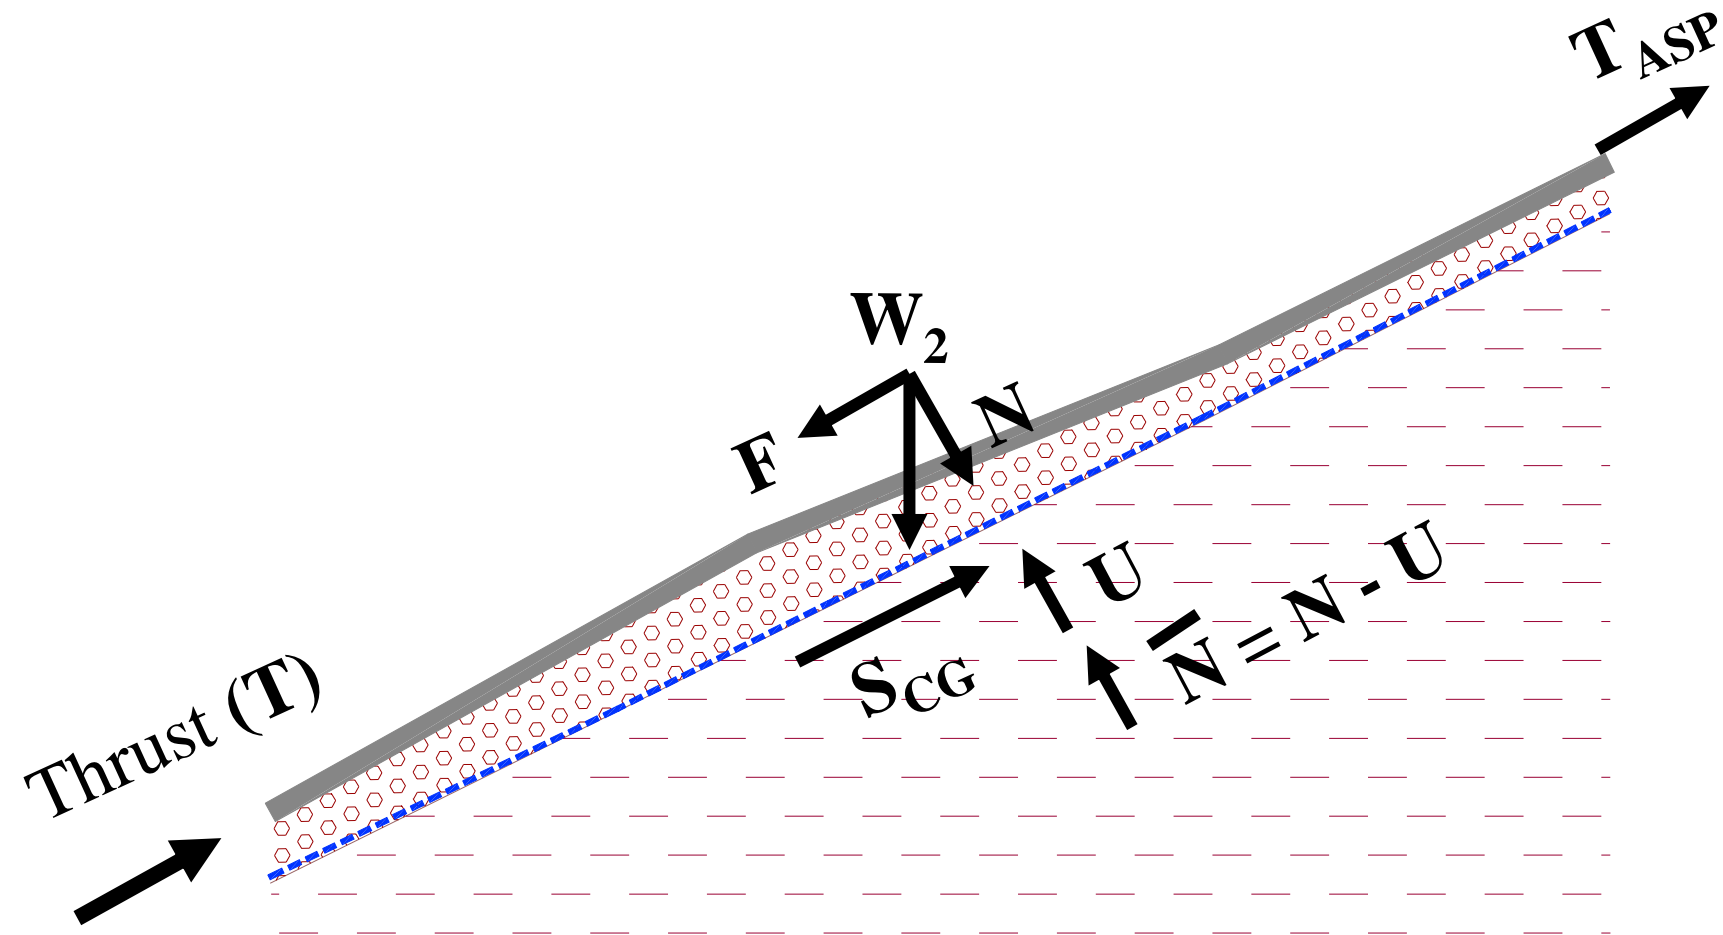
# Slippage Mechanism

Tension Crack

Bulging

Heave  
(Shear Through)

Shearing plane

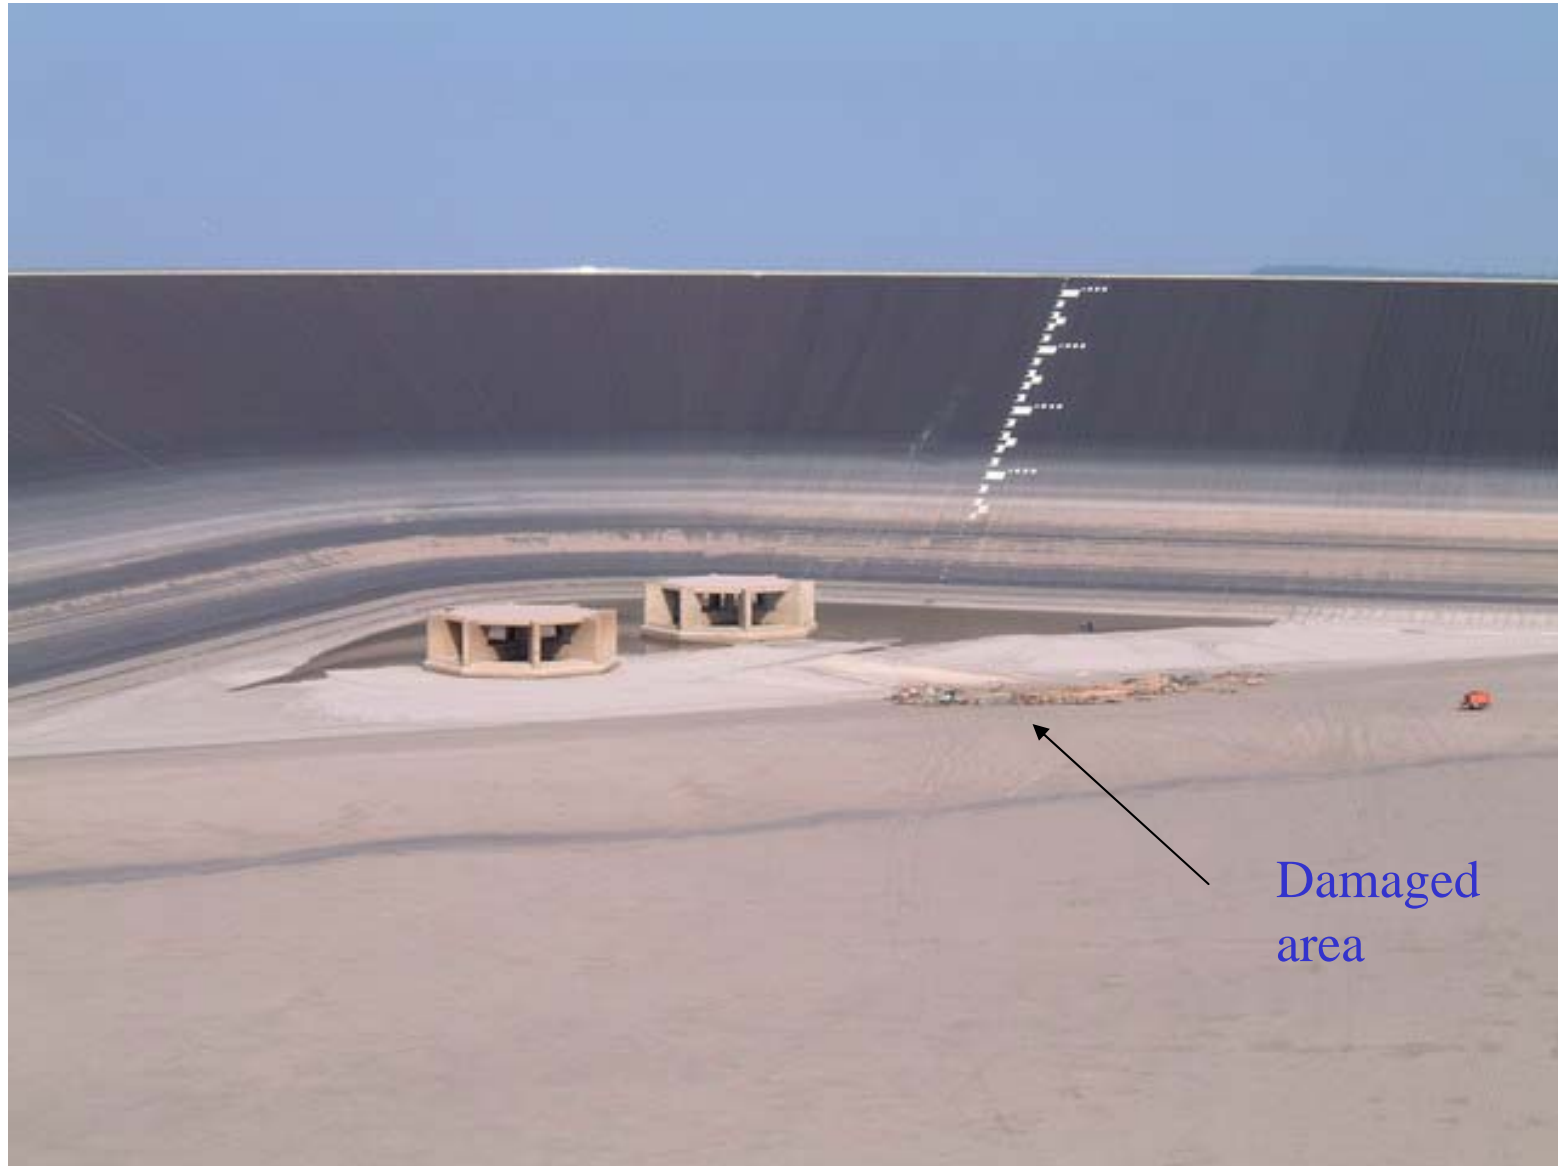
- Upon emptying the pond, severe deformation, depression and cracking were spotted on the asphalt floor lining near the intake shaft of the penstocks.
- Voids were created below the asphalt lining at the location resulting in severe subsidence and cracking of the asphalt layer from heavy water pressure above it.

# Rupture of asphalt lining in pond floor

- It was judged that the condition and extent of the problem was so severe beyond repair using the original design concept having the asphalt lining as the reservoir sealing. Similar piping could progressively occur in any areas below the pond floor owing to false design the under drainage system that did not match with the foundation rock condition.
- It was then decided to adopt the relining of the entire pond floor and slope face with a layer of high strength geomembrane sheet which was expected to give a functional duration for 10-15 years before replacement.

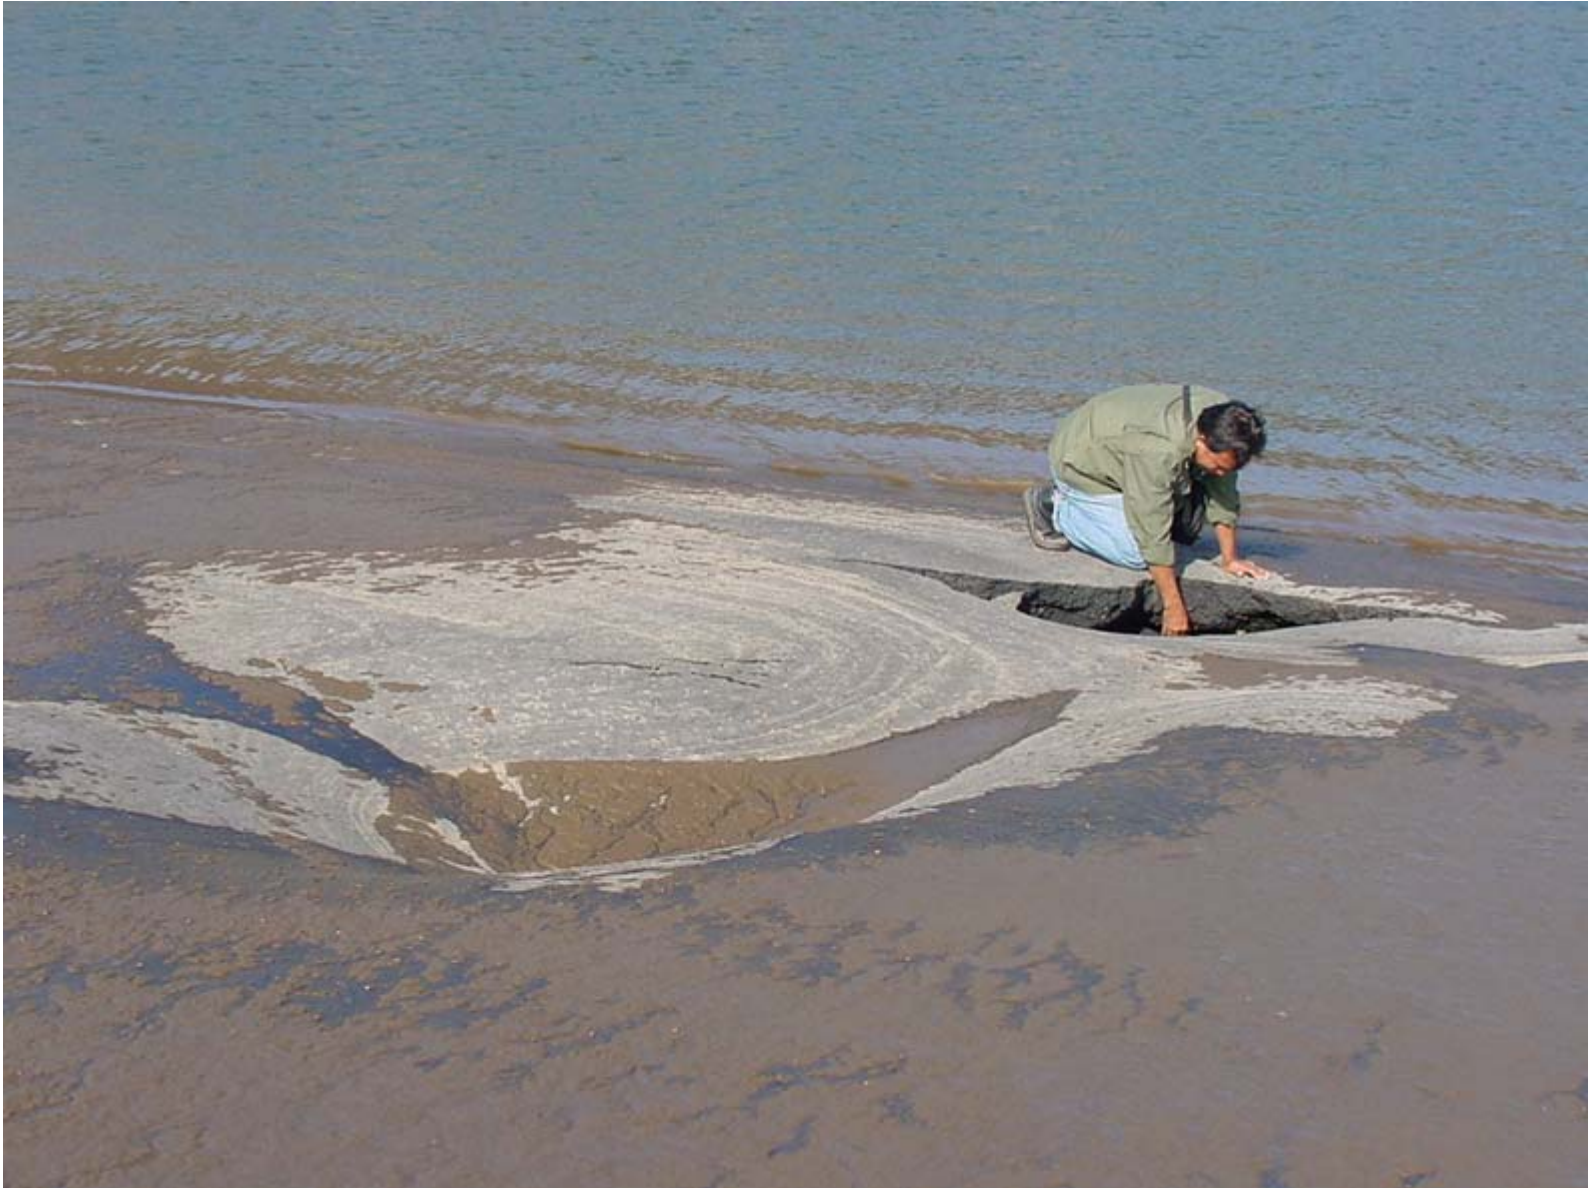
# Depression and rupture of asphalt lining in pond floor

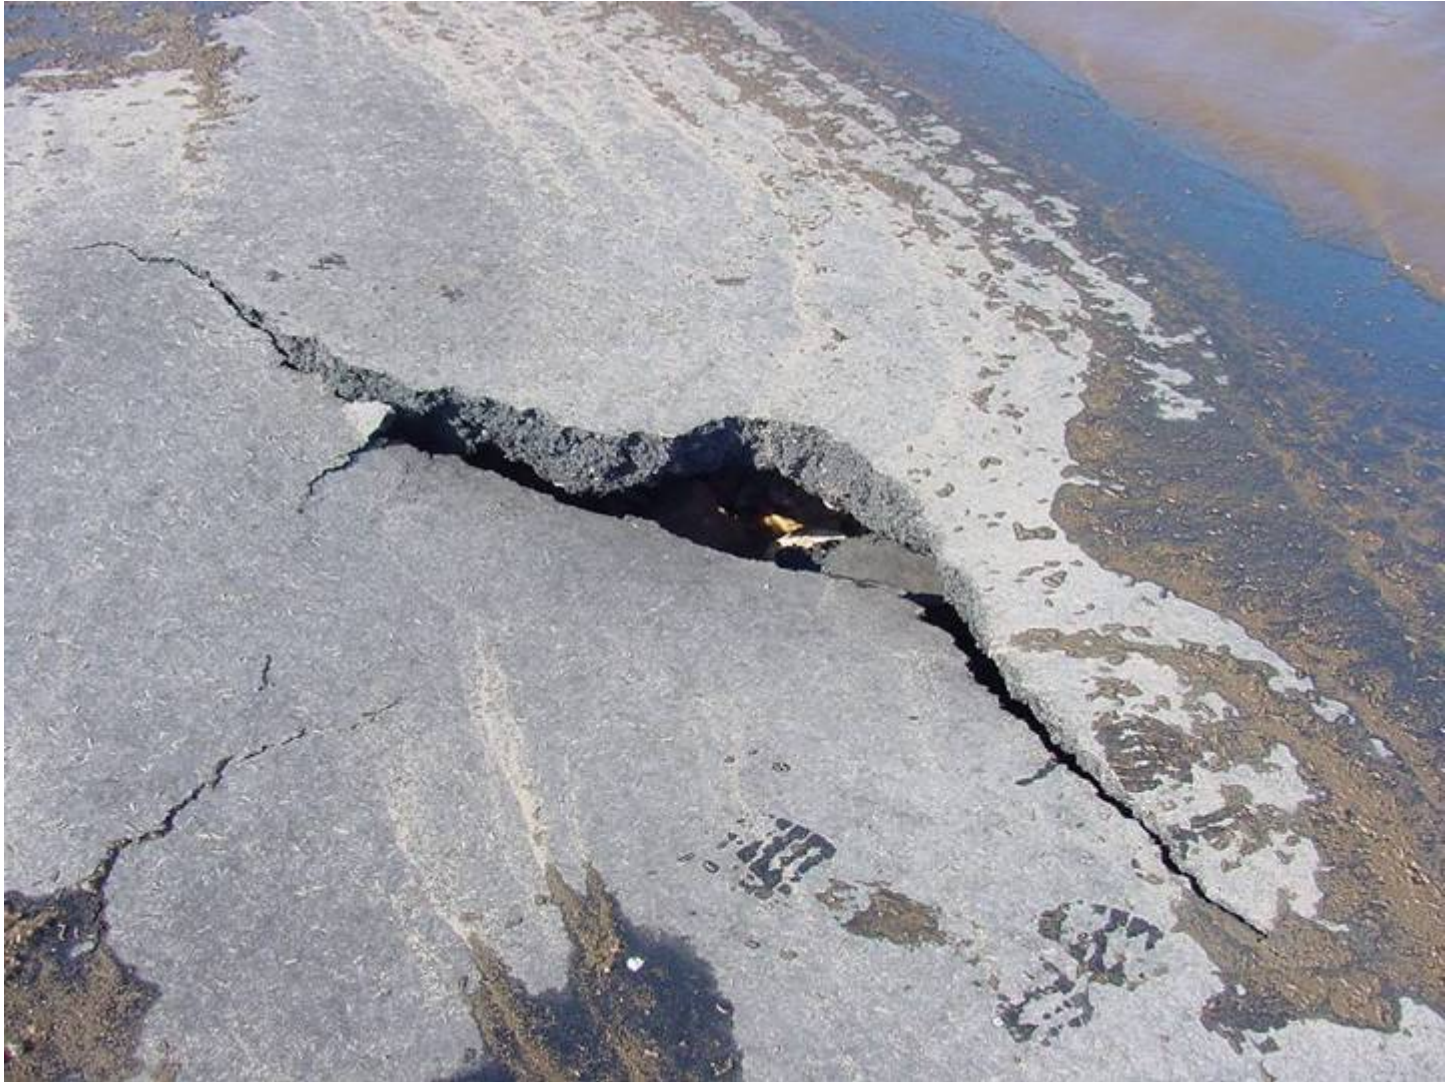
# Rupture of asphalt lining in pond floor

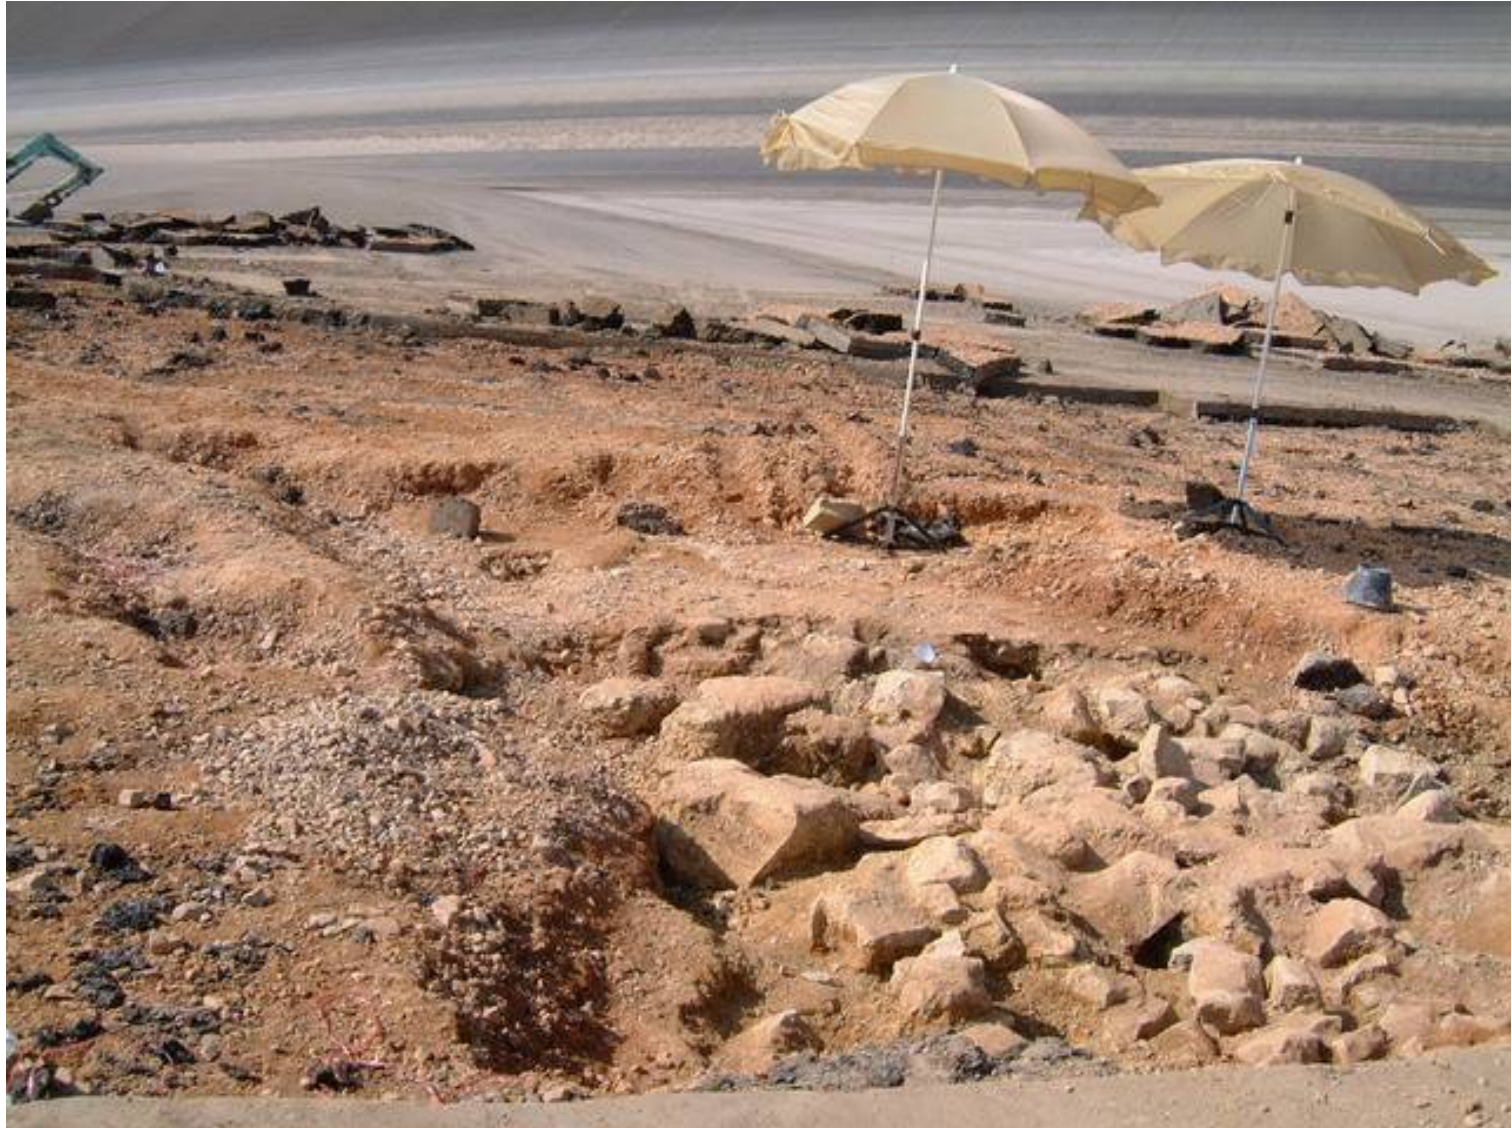
- Leveling layer made with mixture of sandstone and weathered materials over claystone bed had low resistance to piping from leakage water underneath the asphalt lining.

**Bedding layer in the damaged area showing piped out condition of fines between sandstone fragments**
