# Performance of Asphalt Concrete-faced Rockfill Embankment at Lam Ta Khong Pumped Storage Project, Thailand

# Features

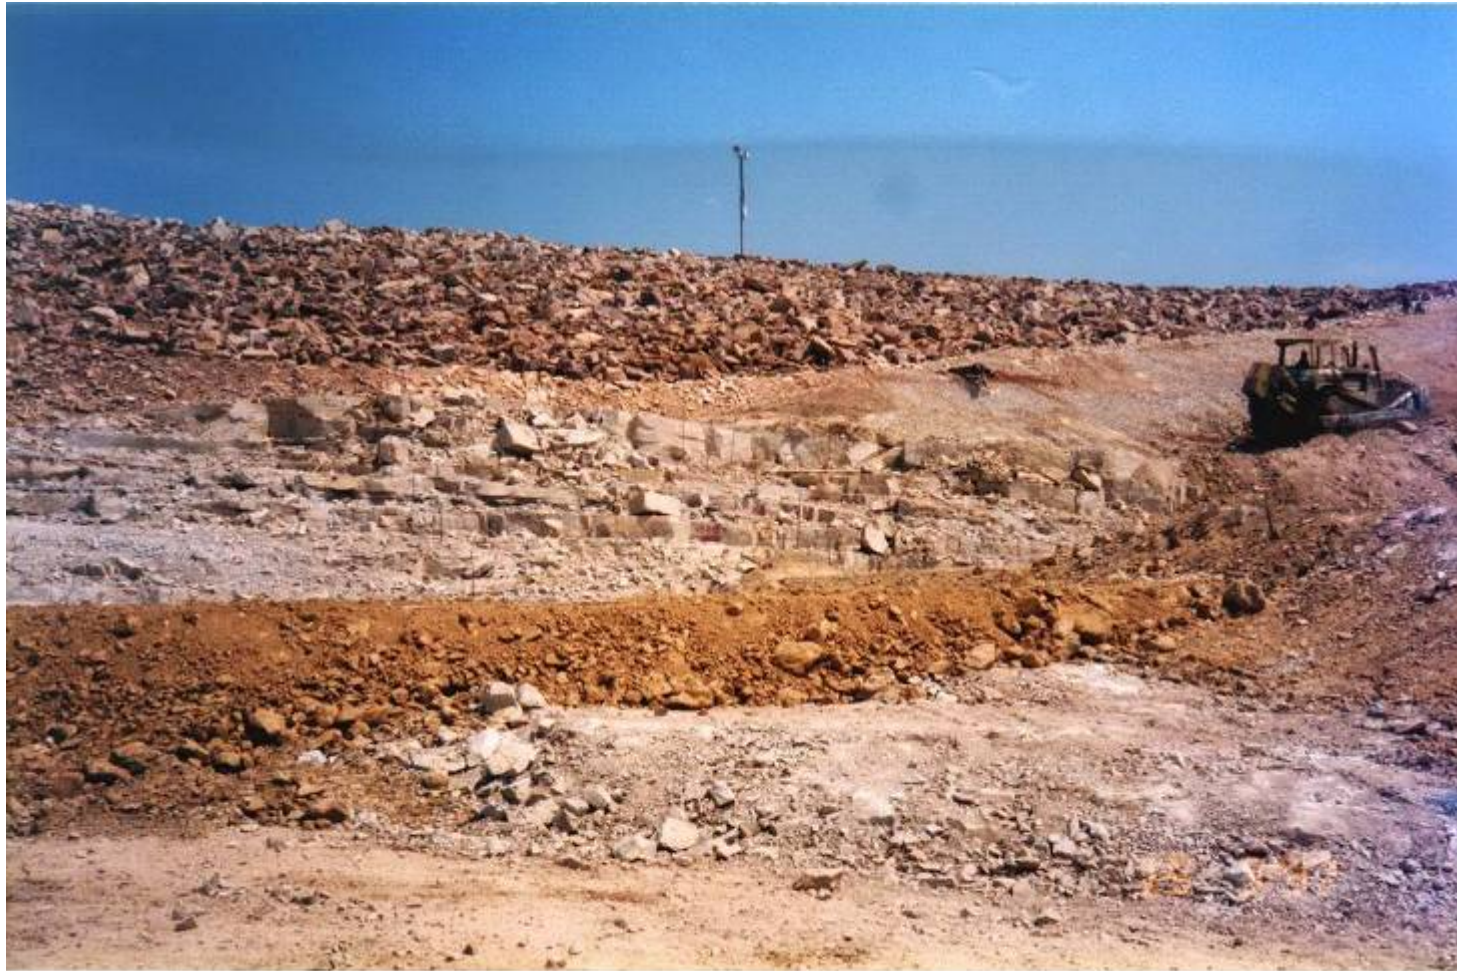
**Highly jointed sandstone bed created difficulty in preparation of smooth surface to start placement of a good transition (levelling) layer for asphalt lining. Levelling of the surface by filling with fines over the rough and angular surfaces resulted in unstable layer against piping.**

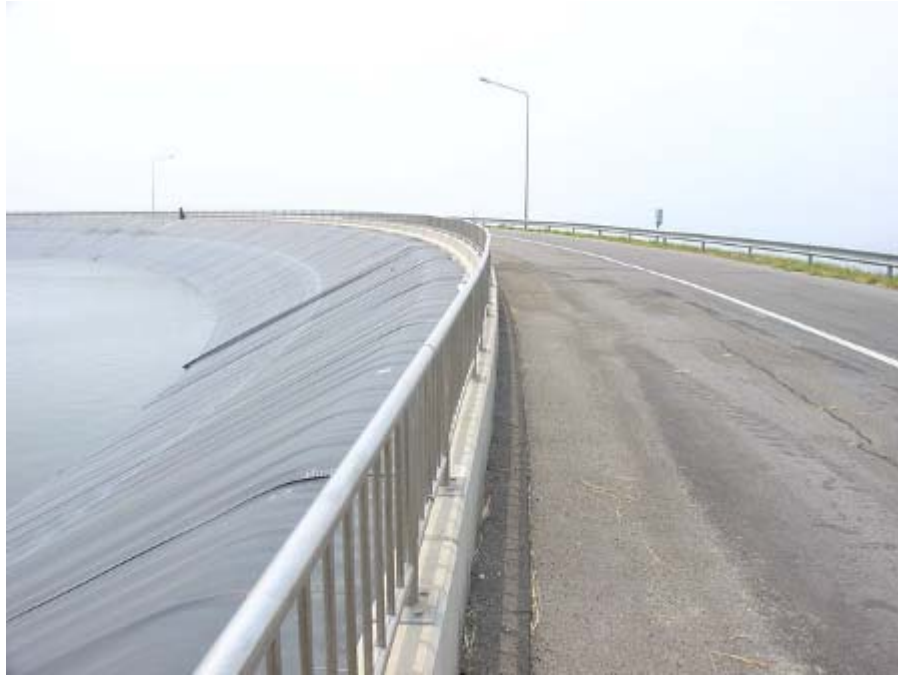
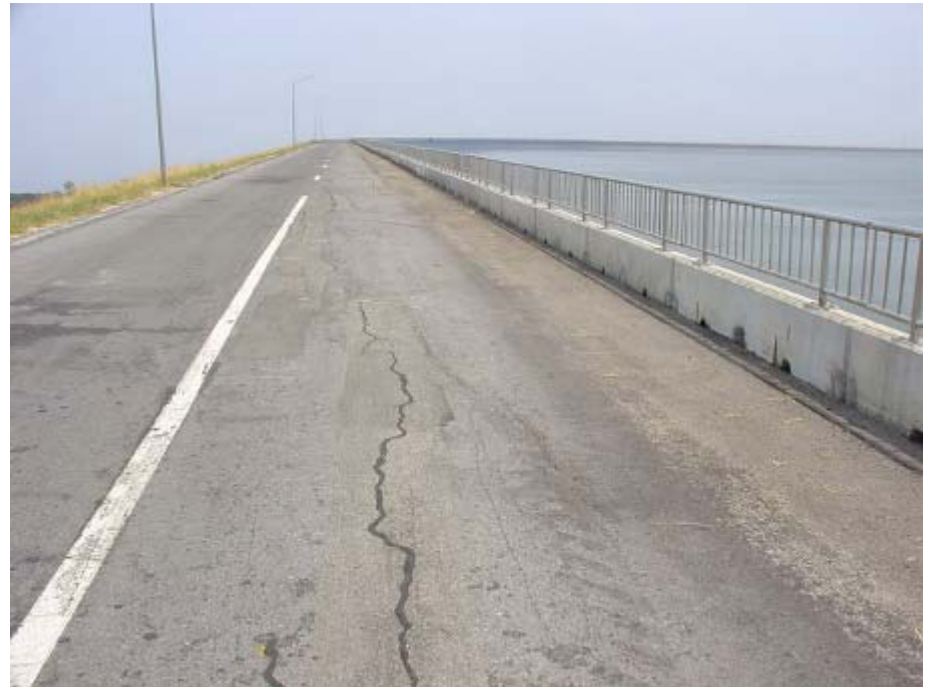
- Pronounced progressive cracking and settlement of dam crests occurred on west and north rock fill embankment over the years.
- The problem was more pronounced on the cliff side embankment (west embankment). Cracks occurred along the crest as well as on the bench of the downstream slope.
- Possible causes of the problem were investigated including high compressibility or low strength of the rock fill materials, and planar sliding along claystone bed being pushed by the embankment toward the cliff face.
- Up to present the exact cause has not been determined but it is likely that the problem is attributed to the progressive deterioration in the strength and compressibility properties of claystones and siltstones used in zone 3C of the embankment. The Zone 3C was not heavily compacted.

## Severe Cracking and Settlement of Dam Crest

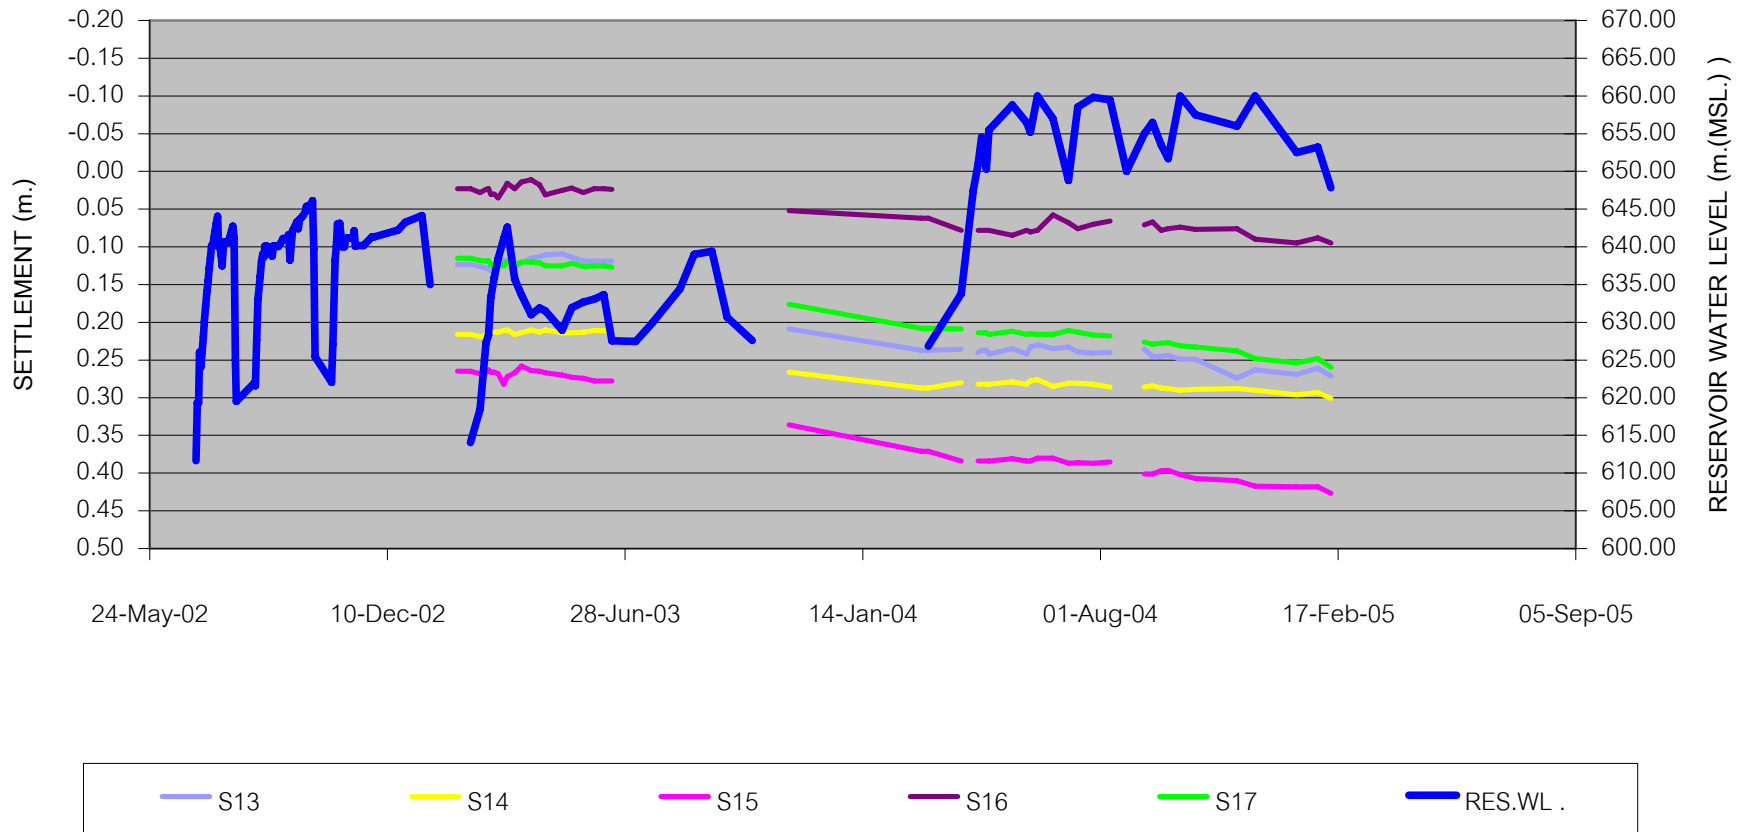
LAM TA KHONG (UPPER POND)  
SETTLEMENT ( Start of Pond Filling 26 June 2002 )

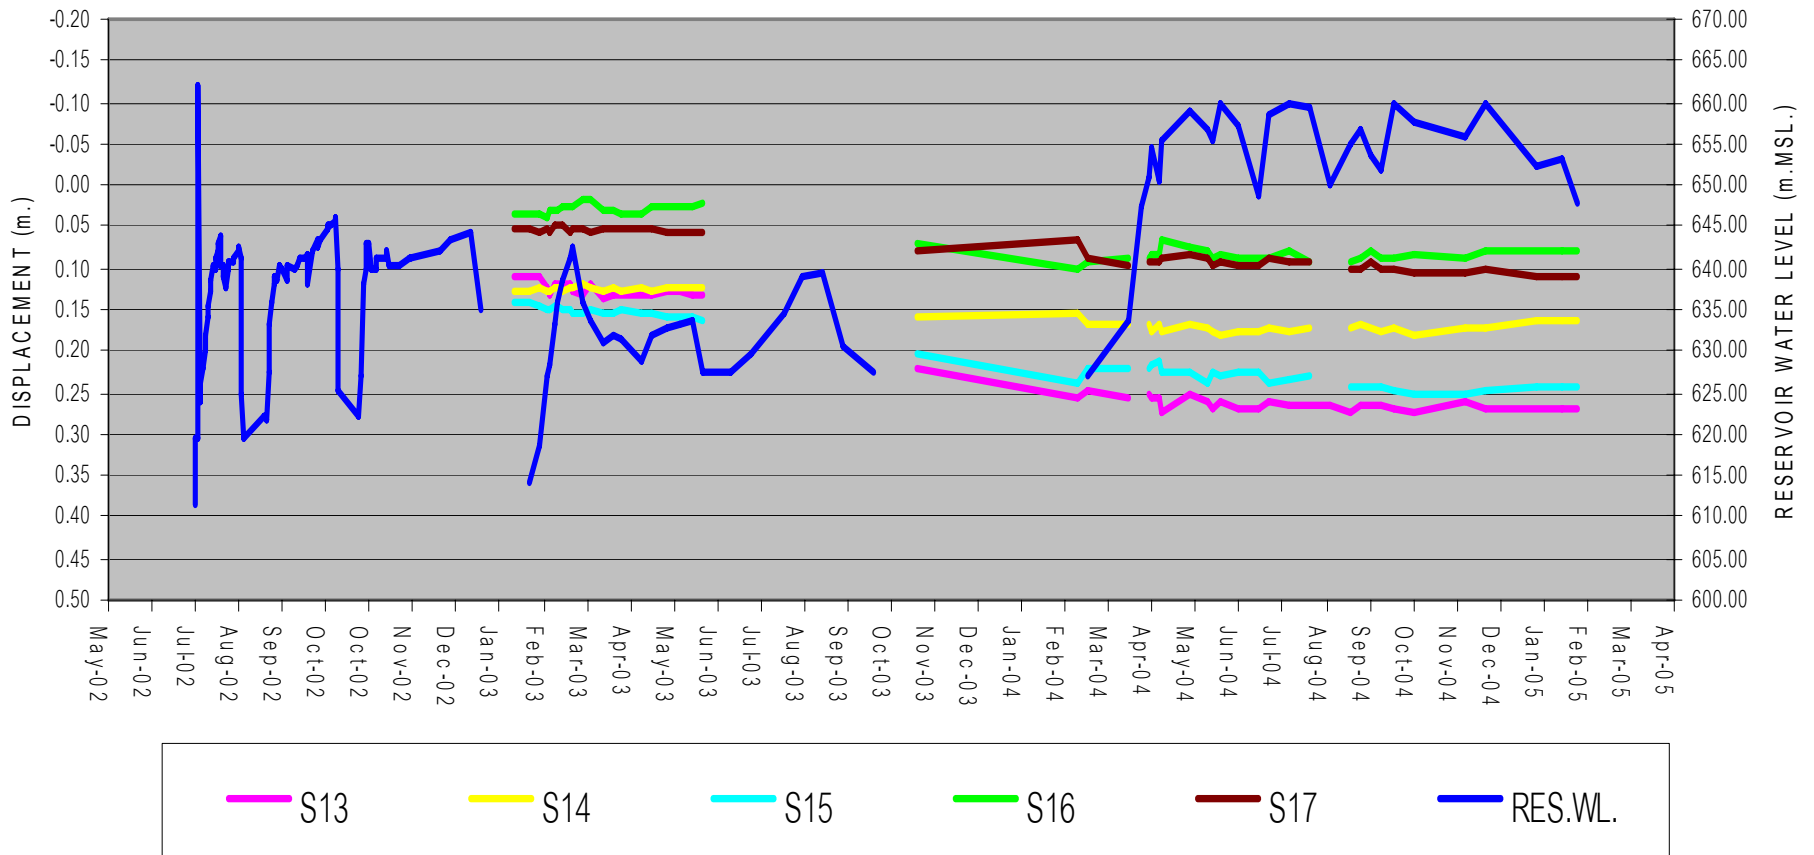
## DISPLACEMENT

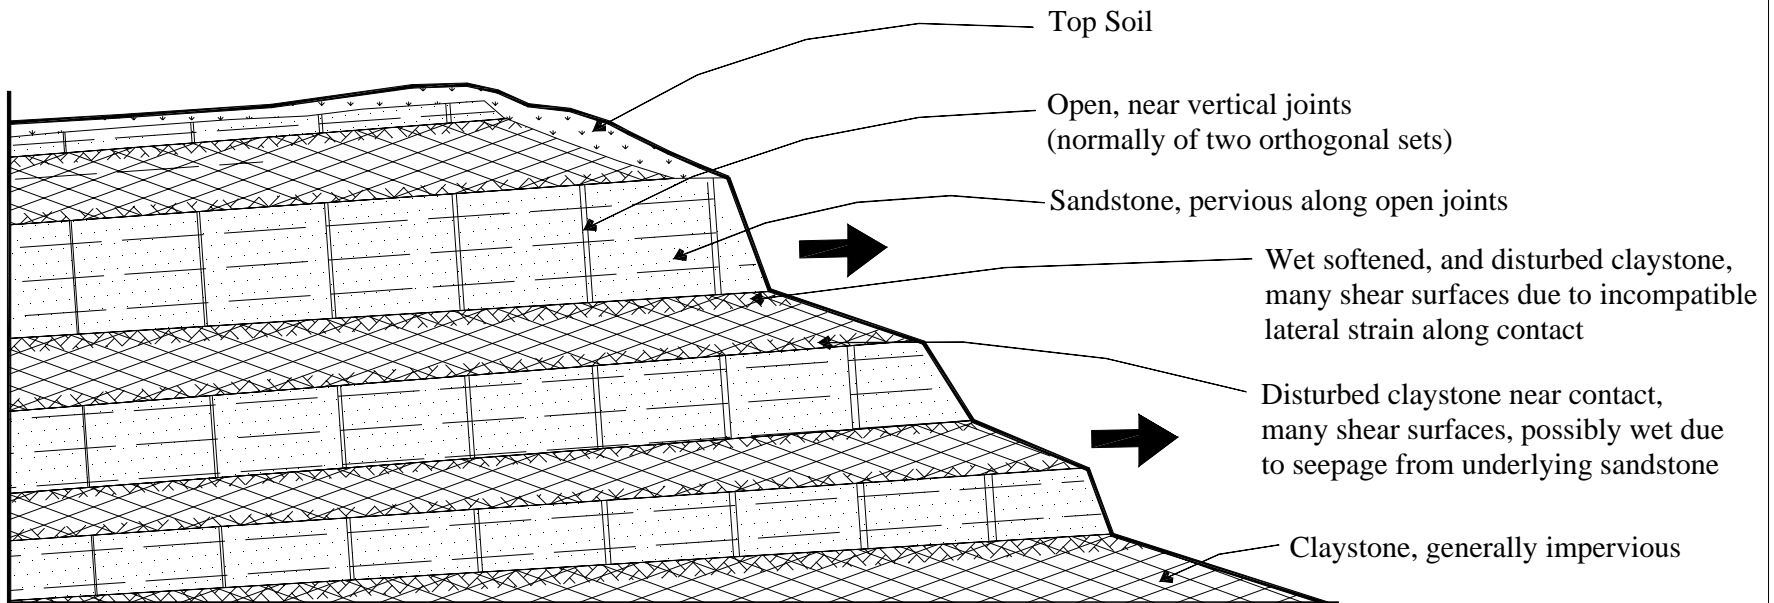
## Weak zone of siltstone or claystone beds at along contact with harder sandstone beds.

SCHEMATIC DEPICTING DIFFERENT JOINT CONDITIONS IN THE NEAR HORIZONTAL  
ALTERNATING BEDS OF SANDSTONE (COMPETENT ROCK) AND CLAYSTONE  
(INCOMPETENT ROCK) IN THE VICINITY OF A VALLEY WALL

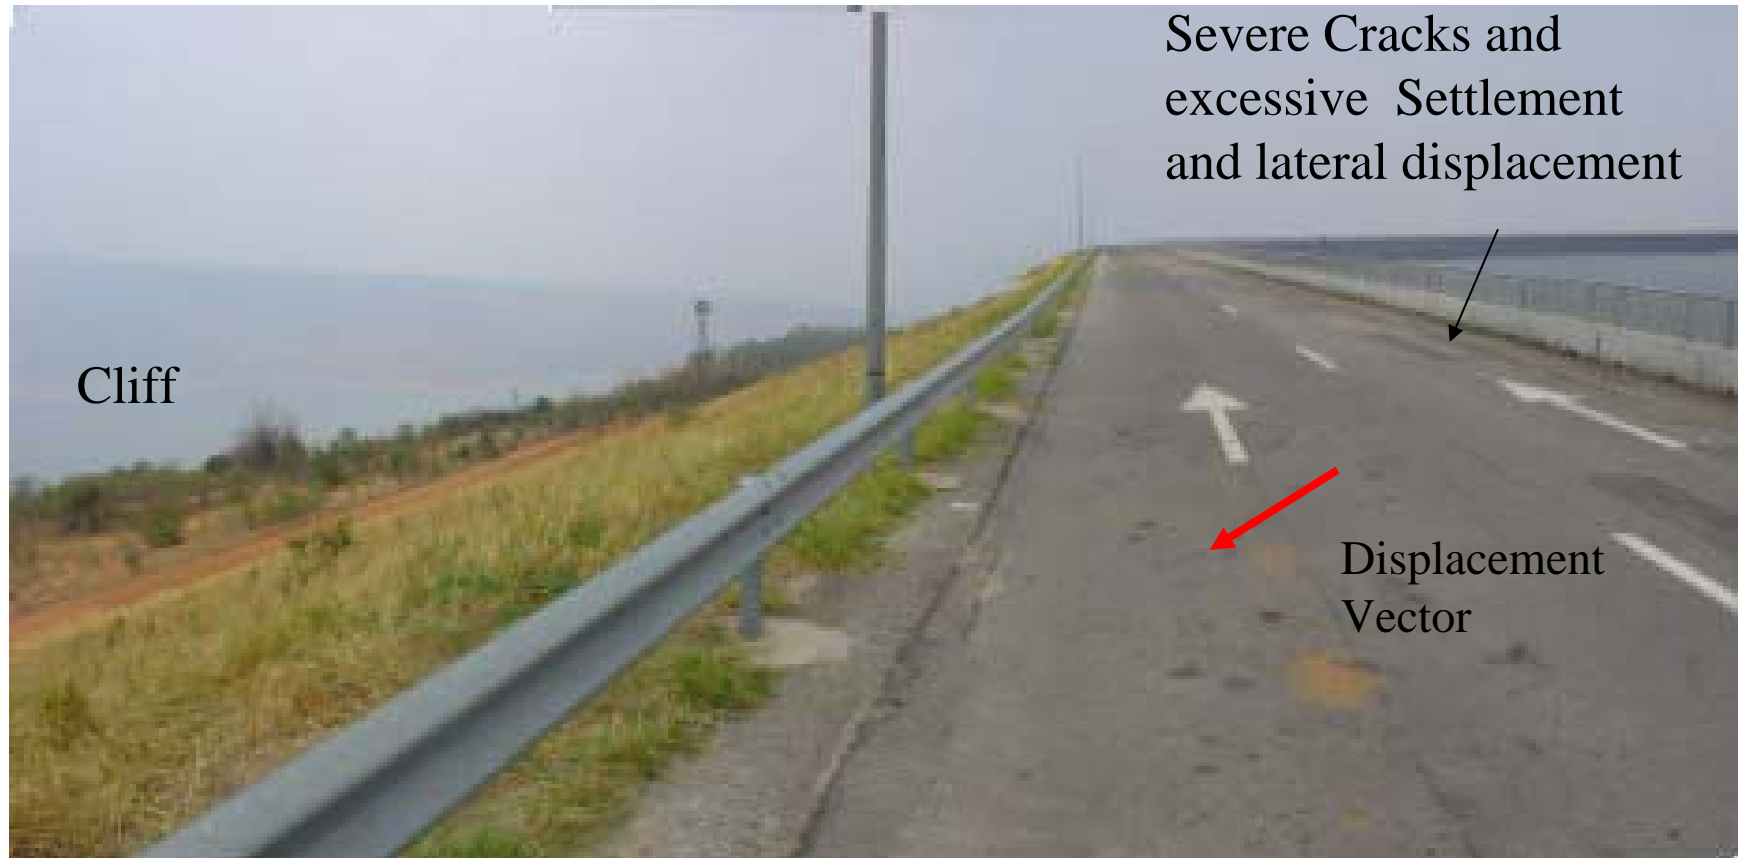
## West Side Embankment

Cause of the problem: Possibly time-dependent troubled properties of Zone 3C Materials
