# Geophysics Case Studies: Road & Embankment Collapses

**Prof. Bob Whiteley**  
**Senior Principal**

## Case studies

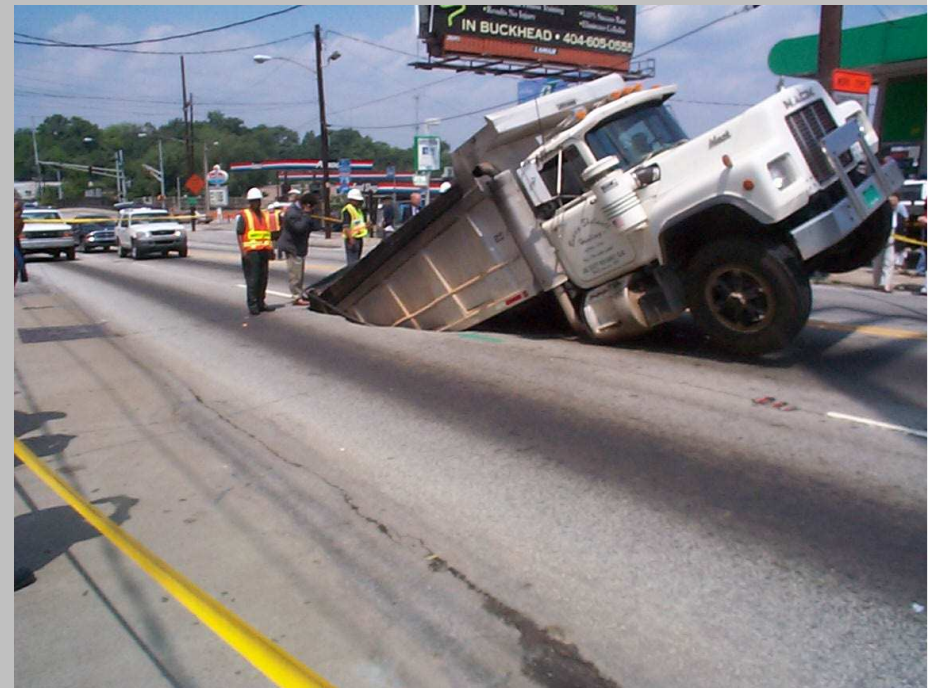
**Distressed  
Buried Sewers**

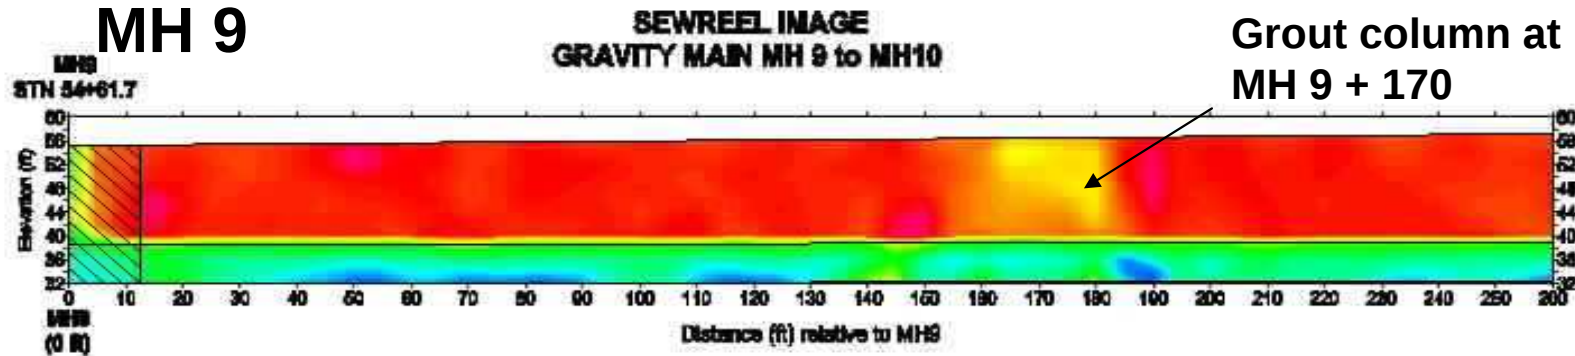
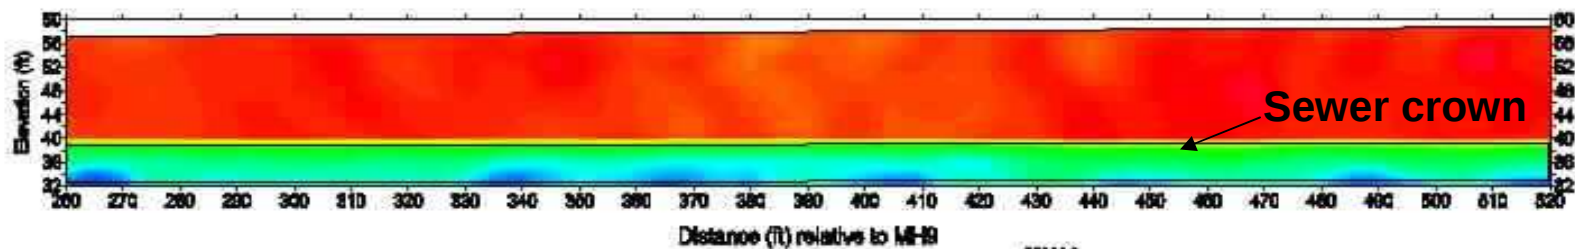
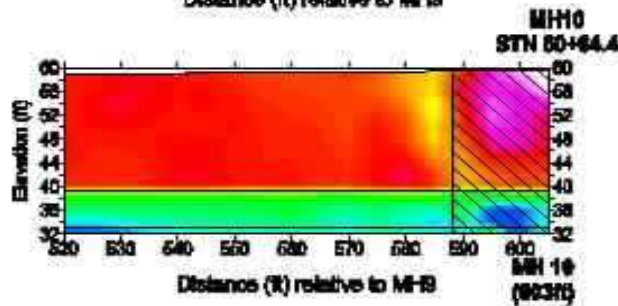
MH 9

# SEWREEL Images of Grout Affected Soils

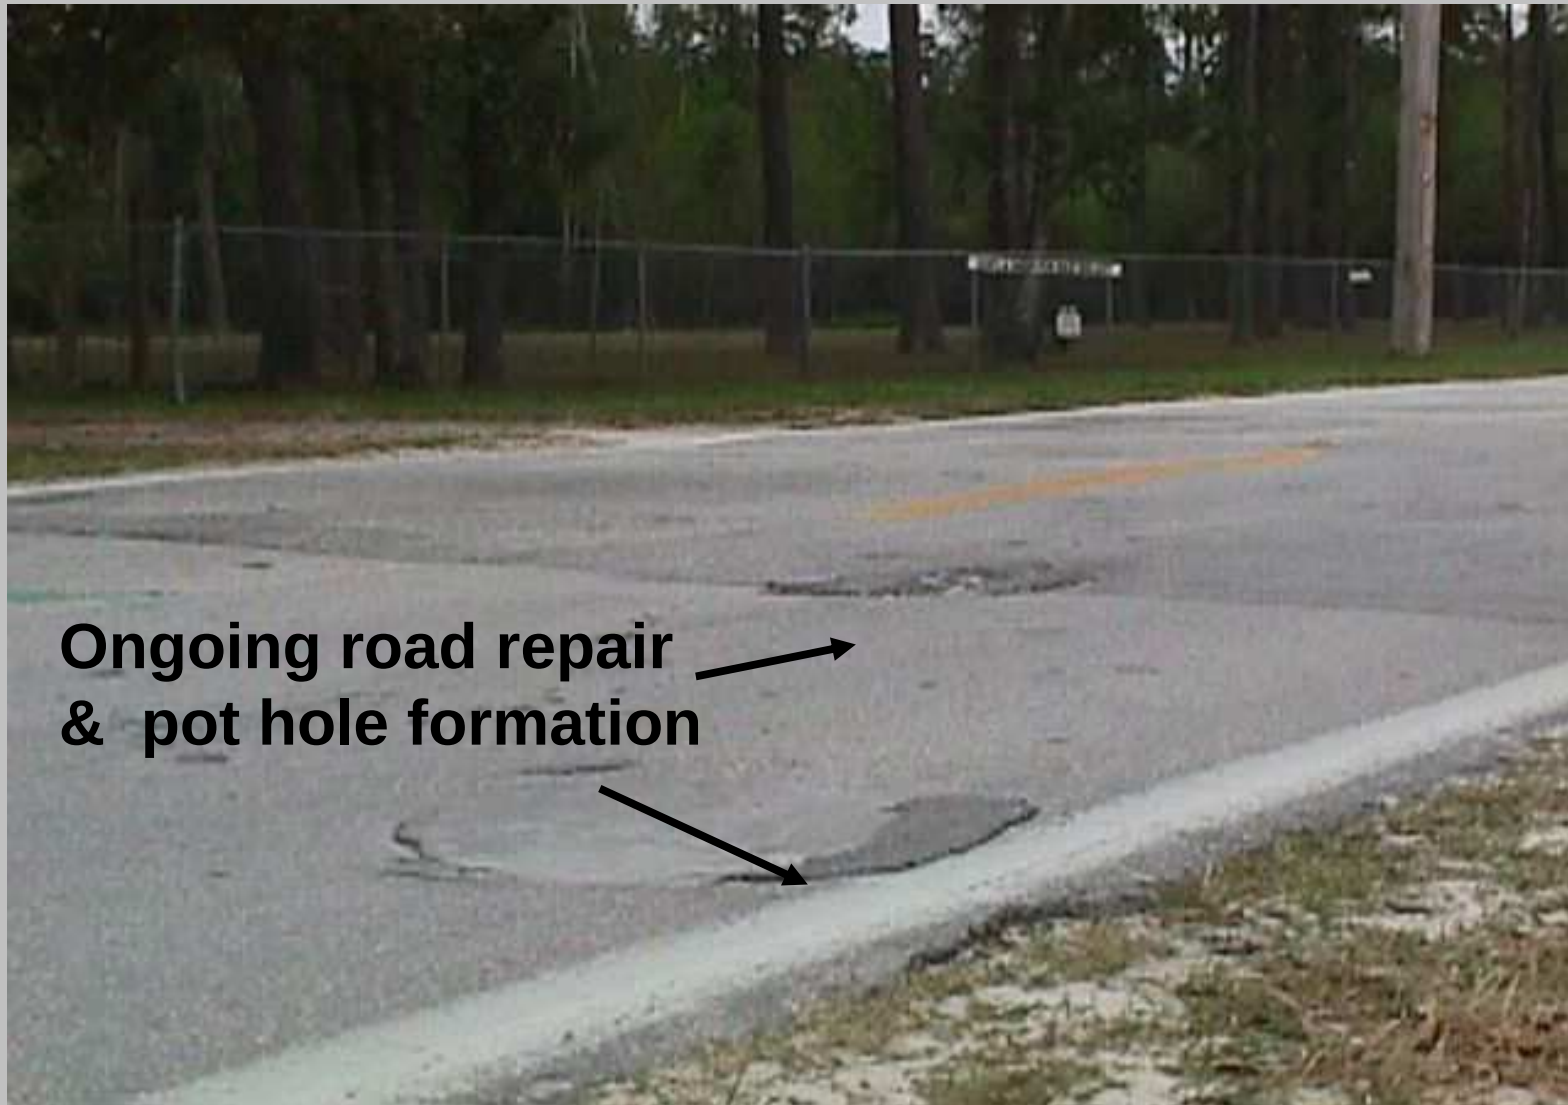
## Post-Grout Settlement: MH 11 + 480 ft.

Ongoing road repair  
& pot hole formation

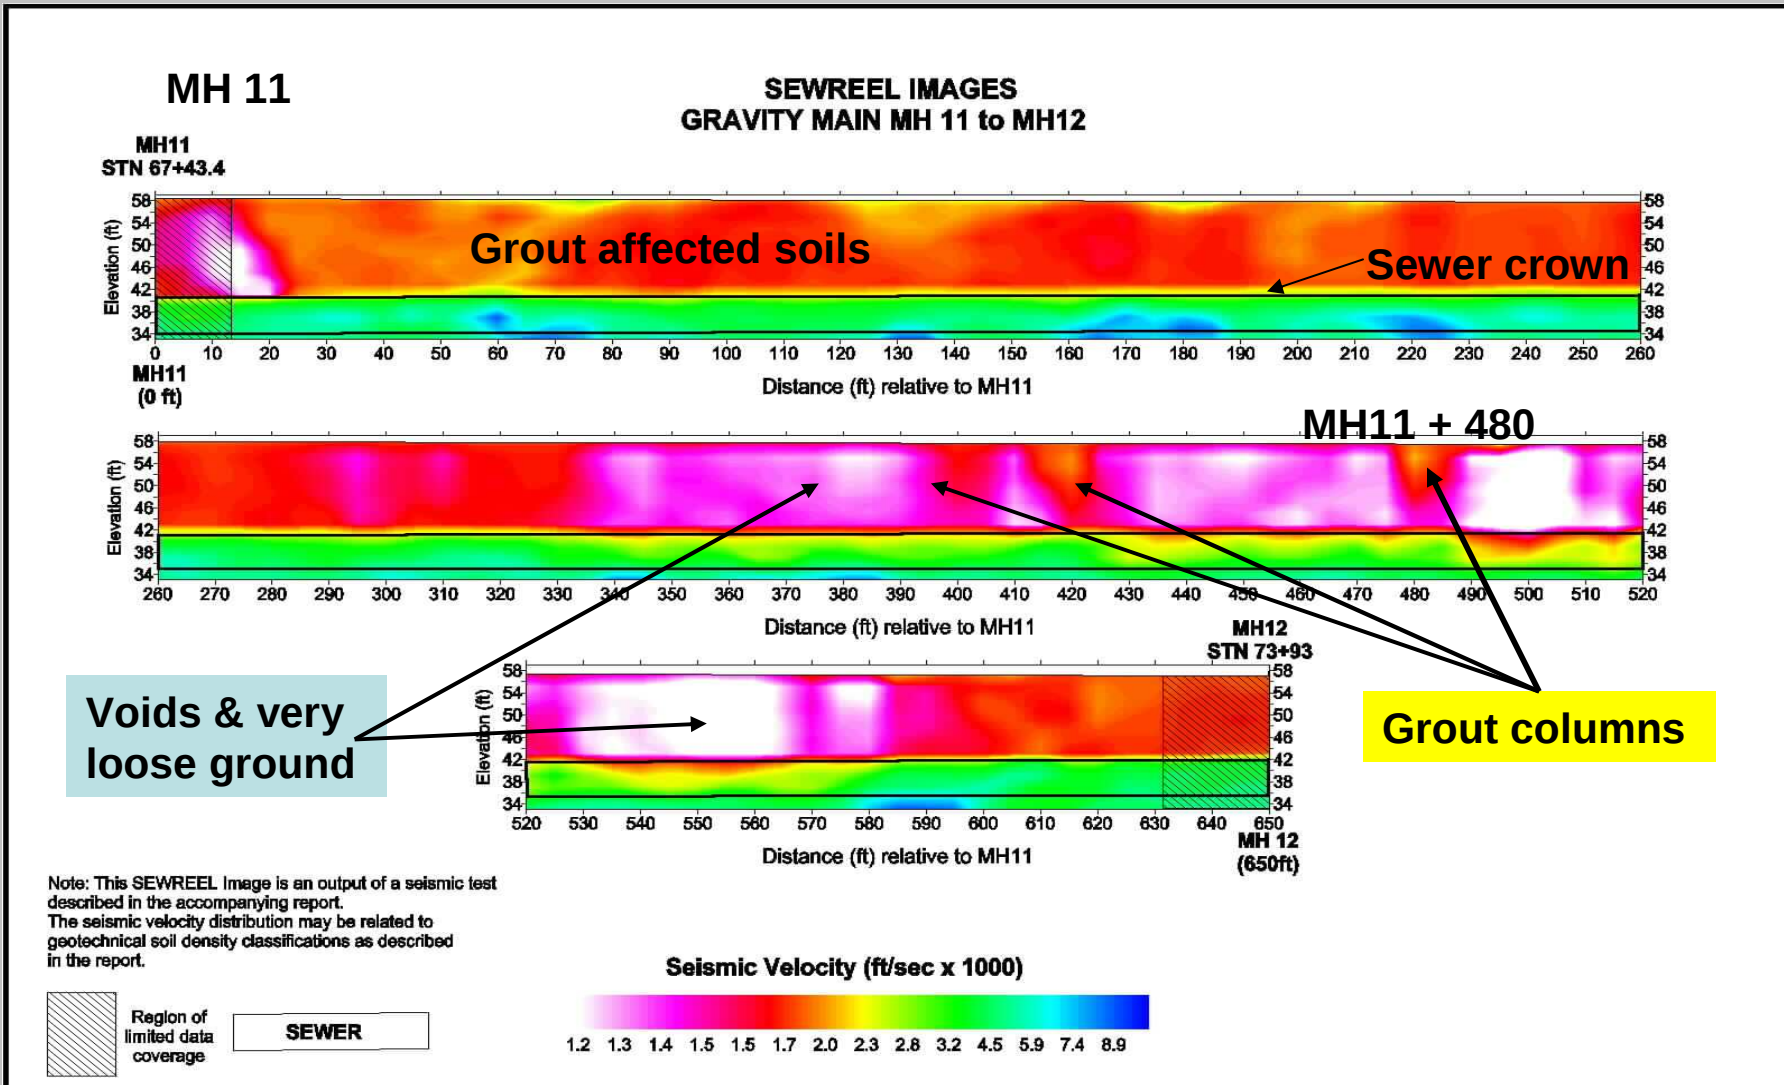
# SEWREEL Images of Voided Soils
