Learning from Slope Failures in Hong Kong

H. N. Wong & K. K. S. Ho

Geotechnical Engineering Office, Civil Engineering Department, Hong Kong

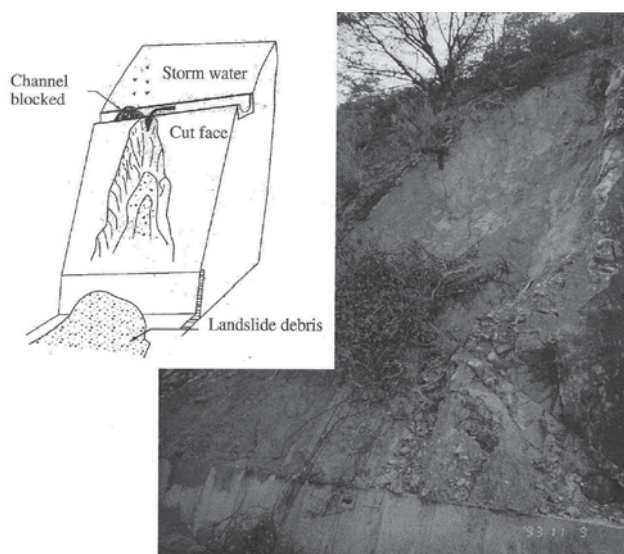
Inadequate maintenance generally takes the form of blocked or disrupted drainage channels, damaged hard surface cover (e.g. shotcrete), or poorly maintained vegetation. Many of the landslides involved washout failure due to overspill from blocked or damaged crest drains (Figure 5), infiltration into oversteep slopes through bare or poorly maintained vegetated ground or cracked surface protective cover, build-up of water pressure behind hard surface cover with blocked weepholes, or leakage from poorly maintained

Figure 5. Washout failure due to overspilling from blocked crest drain

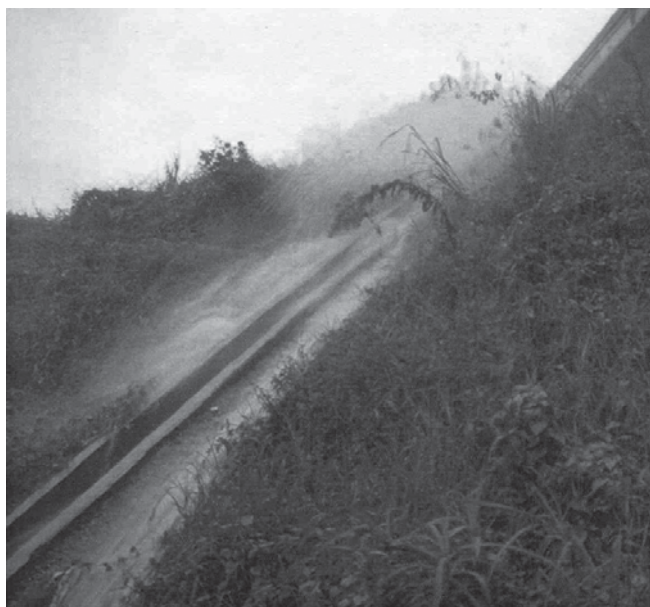
Inadequate attention to proper detailing may involve drainage channels that are undersized or with inadequate fall for self-flushing and hence are vulnerable to blockage, drainage detailing which is prone to over-spilling, etc. (Figure 6). Sometimes, surface water flow or ponding due to the adverse site setting or topography (e.g. slopes below the low point of a crest platform or a road bend can be subjected to concentration of surface water flow during intense rain) are not properly addressed in the design (Figure 7). The identification of surface water flow paths requires tracking all the possible pathways outside the immediate site environs since the sources of surface water concentration may be at a considerable distance away from the site. However, studies of landslides have revealed that the assessment may not have been done properly in practice.

Figure 6. Over-spilling due to inadequate surface drainage detailing

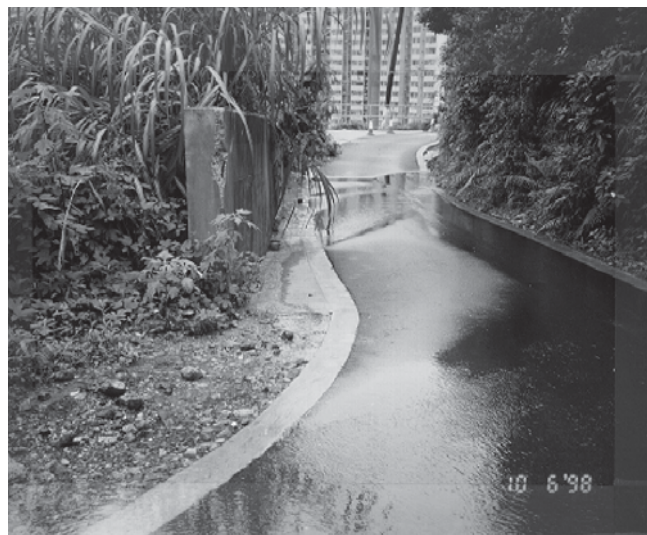
Figure 7. Ponding due to poor surface drainage provision

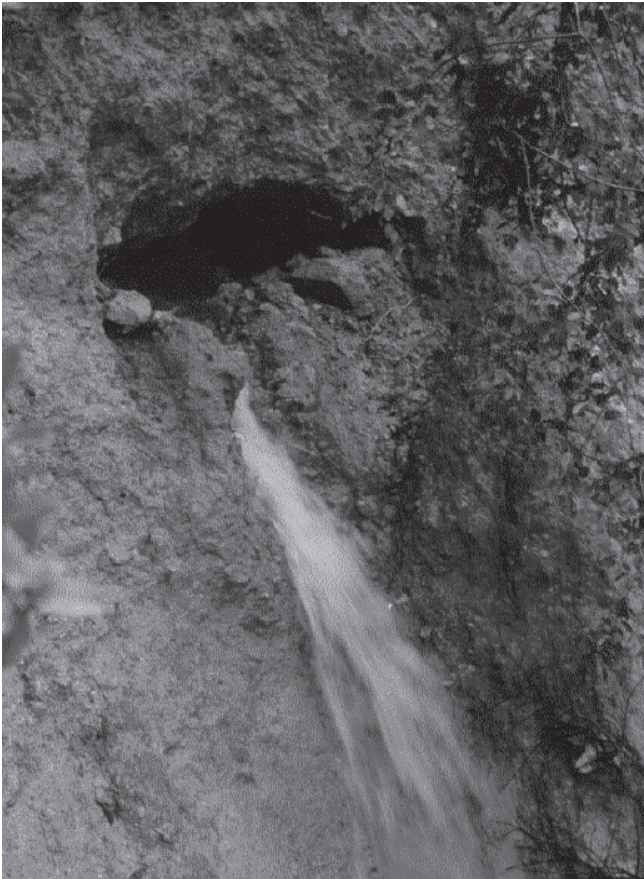
Figure 8. Erosion pipe with heavy seepage

One common cause of failure involves a shallow perching phenomenon. This can occur where there is a surface layer of thin colluvium overlying less permeable saprolite. Perching is also possible at the interface of loose (younger) colluvium and dense (older) colluvium. Loose colluvium can be prone to the formation of erosion pipes which act as conduits resulting in rapid rise in groundwater pressure during heavy rainfall (Figure 8). The geometry of the failure

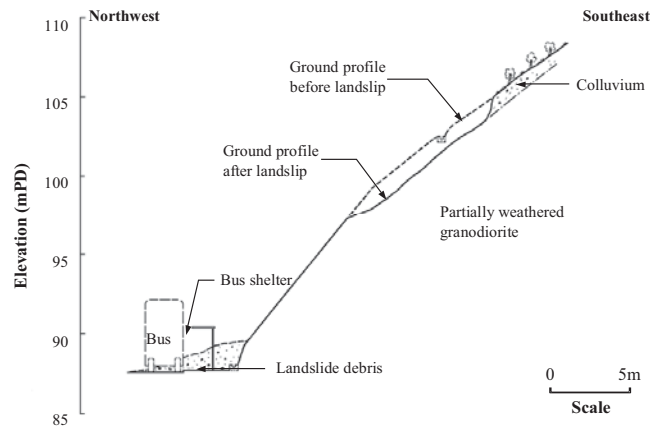
Figure 9. Cross-section of the 1993 Cheung Shan landslide

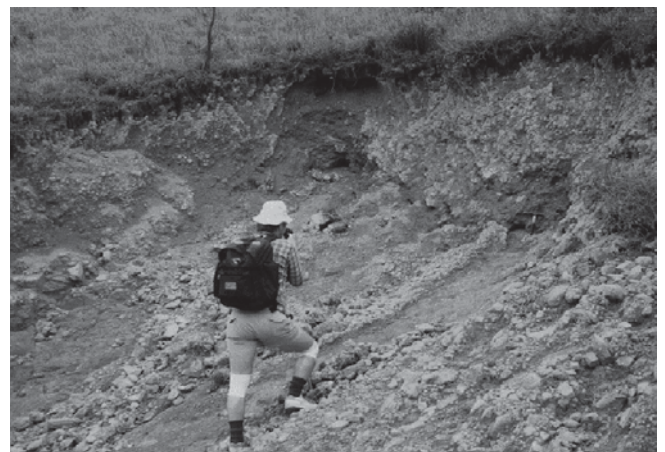
scar associated with the above adverse hydrogeological setting is typically confined to the shallow depths within the upper portion of a cut face and can extend uphill for some distance. Because of this, such failure mode can result in serious consequences in the case of a high cut slope, even though the scale of failure may be small. To illustrate such failure mode, a cross section through the 1993 Cheung Shan landslide is shown in Figure 9. In the study of more than 250 failures of cut slopes along roads and catchwater caused by a severe rainstorm in November 1993, Wong & Ho (1995) reported that up to about 25% of the failures involved a perched water table in the surface mantle of colluvium (Figure 10).

Figure 10. Failure involving surface mantle of colluvium

Figure 11. Prescriptive drainage provisions for possible shallow perching

(Wong et al, 1999), as contingency design provisions (Figure 11).

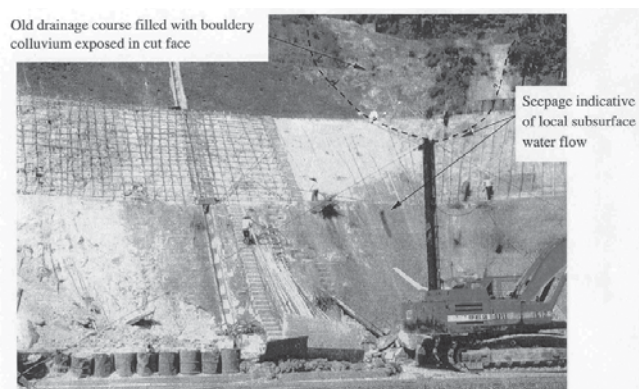
Figure 12. Old drainage course with subsurface water concentration (This processed slope failed in 1997)

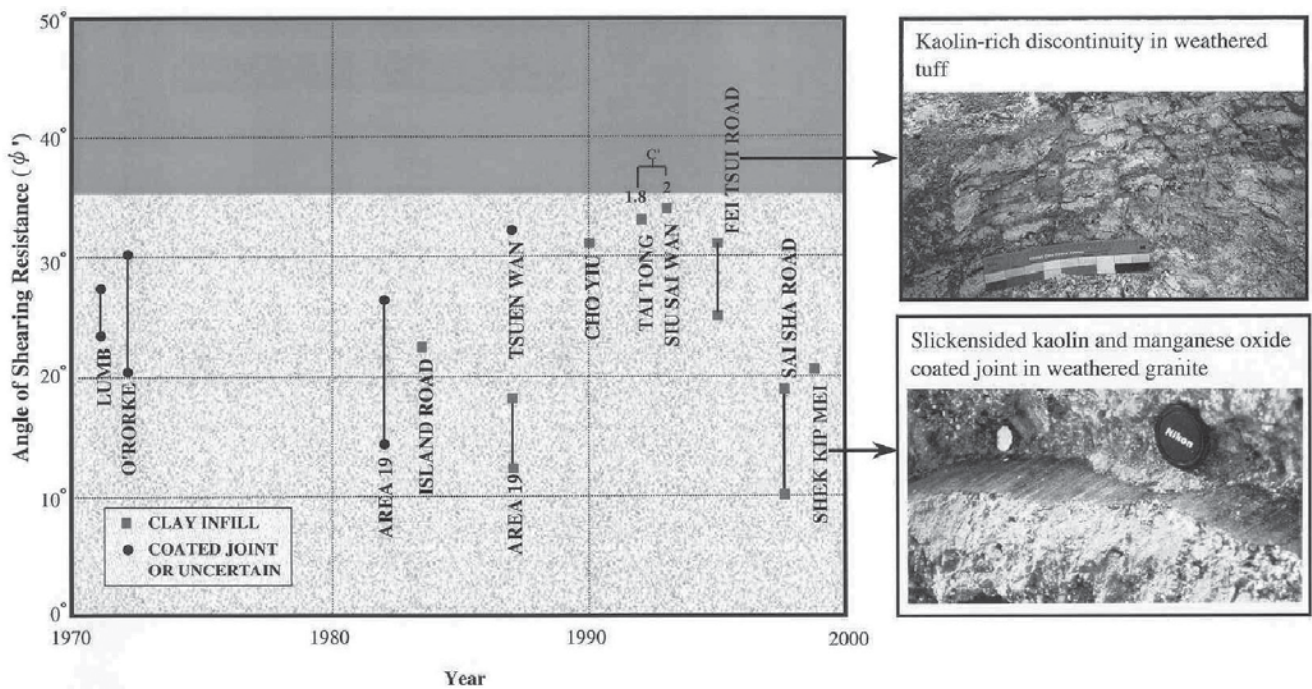
Figure 13. Selected landslides involving relict-jointed saprolite

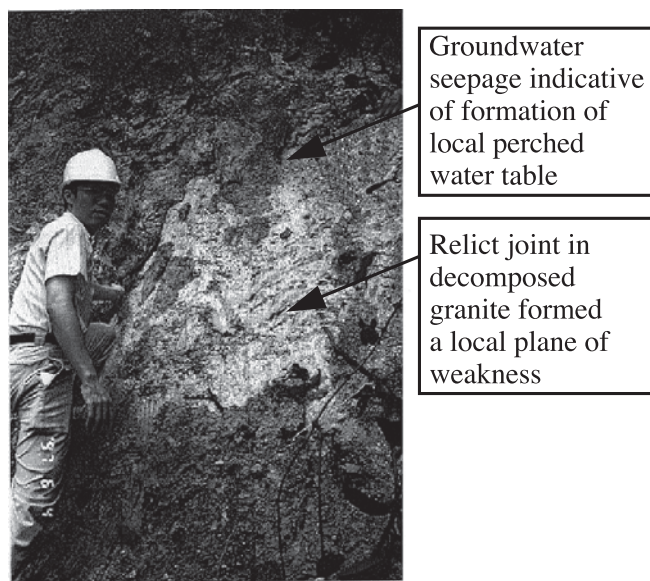
About 70% of the landslides at engineered soil cut slopes were small scale failures controlled mainly by the local geological and/or groundwater conditions (Figure 14). This gives an indication of the annual defect rate (about 0.15%) associated with such localised failures given the current state-of-practice in Hong Kong.

Figure 14. Landslide controlled by local adverse geological and hydrogeological conditions

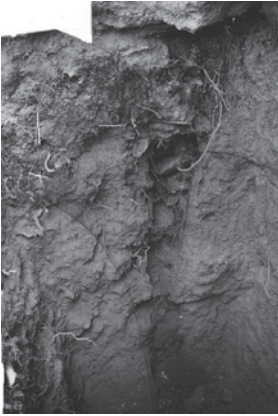
Figure 15. Infilled tension crack

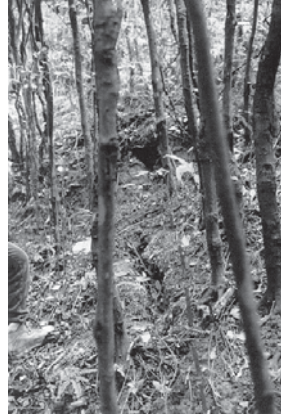
Figure 16. Prolonged slope deformation before full detachment

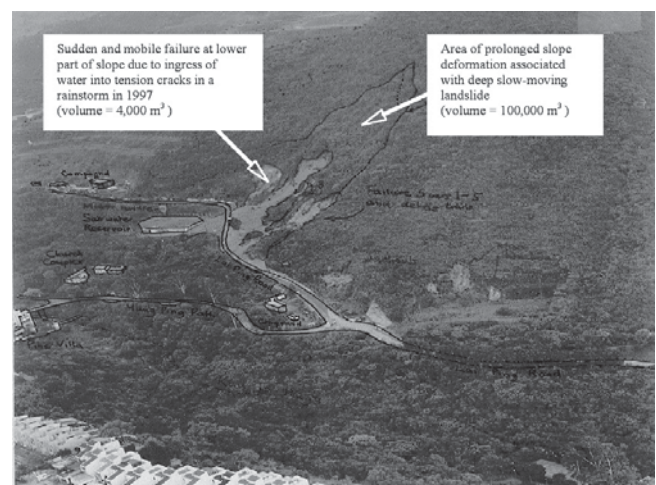
A scenario that is of particular concern and great practical significance is where an apparently ductile failure with limited mobility turns into a brittle, mobile failure with fast-moving debris. There are reported landslides in Hong Kong which exhibit an apparent change in failure mechanism, e.g. the 1997 Lai Ping Road landslide as shown in Figure 18 (Sun & Campbell, 1999). This is usually related to the

progressive deterioration of the distressed ground which promotes increased water ingress and brings about detachment of material, possibly via a different mechanism (e.g. cleft water pressure) than that operating in the slow-moving ground mass.

Figure 18. The 1997 Lai Ping Road landslide

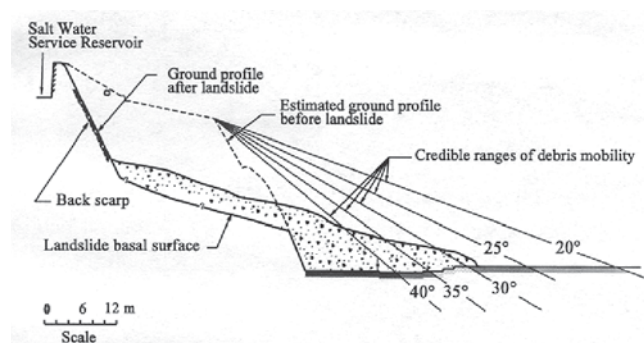
The second example concerns a site-specific QRA. The generalized consequence model was used to back-analyse the Fei Tsui Road landslide, which occurred in the early hours of 13 August 1995 with a failure volume of some 14,000 m³. The road in front of the slope was totally engulfed by landslide debris of up to about 6 m thick (Figure 20). The incident resulted in one fatality and one other person narrowly escaped injury. The theoretical consequence model predicts an average number of four fatalities arising from the given landslide. This illustrates the near-miss nature of the incident with only one fatality. The f-N curve derived from QRA calculations (Figure 21) shows the level of societal risk posed to the community by the Fei Tsui Road landslide.

Figure 20. Cross-section through the 1995 Fei Tsui Road landslide
