Influence of low permeability capping layers on liquefaction induced ground failure

Divyesh Rohit¹, S.M.K. Pasha¹, H. Hazarika¹, T. Kokusho², A. Arsyad³, and S. Nurdin⁴

Keywords: excess pore water pressure, capping layer, flow failure

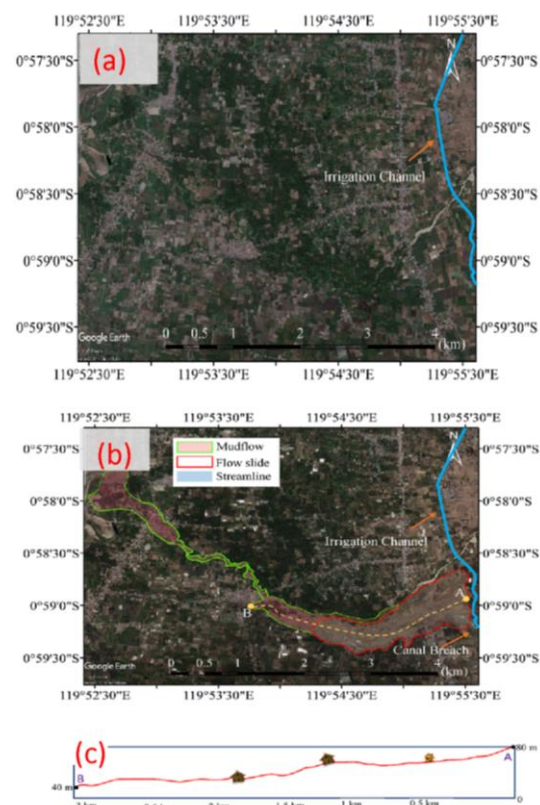
The study area was located in Sigi Regency in Juno Oge village. Fig. 2 shows the condition of the investigated site at Juno Oge before (Fig. 2(a)) and after the event (Fig. 2(b)). The site consisted of agricultural fields with a sparse population and an a very gentle sloping ground of less than 2% (Fig. 2(c)). Furthermore, an irrigation channel was located at the eastern side of failure zone as shown in Fig. 2(b). Due to the presence of irrigation channel, the ground water level was very high (< 5m from ground surface). This also contributed to the flow failure at the site. Earthquake induced liquefaction triggered massive flow slide which breached the water channel discharging a large volume of water into the already failed zone thereby causing massive mudflow as depicted in Fig. 2(b).

Figure 2: Lateral flow area in Juno Oge due to Donggala Earthquake, (a) before flow failure, (b) after flow failure with mud flow and water channel and (c) slope profile of the flow area (modified from Google Earth).

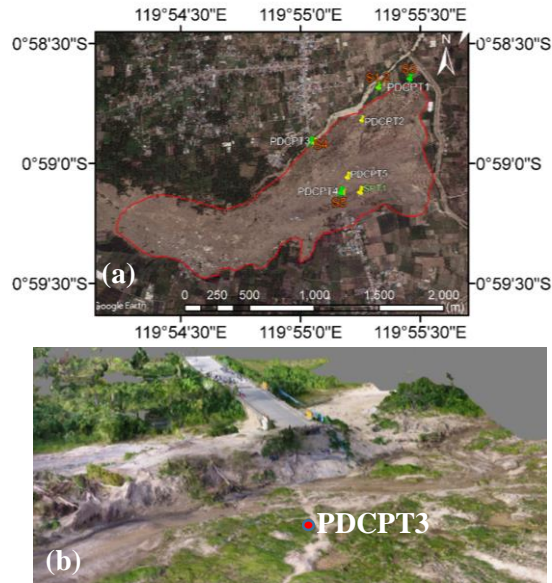
Fig. 3 shows the location of PDCPT tests (PDCPT1 to PDCPT5) and location of soil samples (S1 to S5) collected at depth of 0.5 to 2m. Except PDCPT 1 which was conducted in out of failure zone, the rest of them were conducted within the failure zone.

Fig3. (a) Location of PDCPT tests and soil samples (b) UAV3D map of PDCPT3

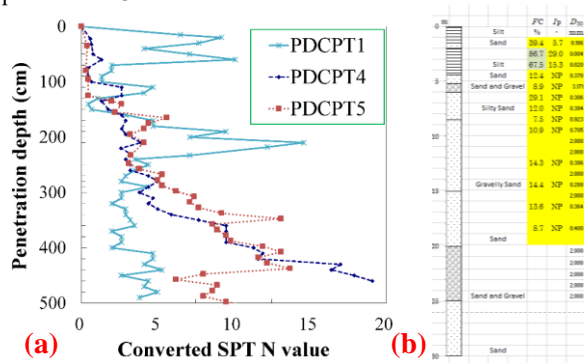
Ground water level was observed within a meter of ground surface in failed zone which indicates high risk of reliquefaction at susceptible areas in the future events. The results of PDCPT 1, 4 and 5 are plotted in Fig. 4(a). Ground water table was seen at depth of 2.3, 0.9 and 0.75

m from ground surface. Results of PDCPT1 (out of flow failure zone) indicates presence of a 2.5 m of layered loose to medium dense sandy soil deposit on top of relatively loose layers (SPT N value<5) of sandy-silt soils.

Comparison between results of field tests at PDCPT1 with that of PDCPT4 and 5 shows similarity between N values for very first 1-2 m of soil below the ground surface at PDCPT 4 and 5 with that of PDCPT1 at depth 2.5m below ground surface. This may explain the possible contribution of underlying loose layer of sandy-silt soil in flow failure of gentle ground. Grain size distribution of soil samples and Scanning Electron Microscopy (SEM) image of sample S2 as representative sample are shown in Fig. 5. All the samples were classified as silt with low liquid limit (ML) according to JGS 0051-2009. Furthermore, specific gravity of samples range between 2.62~2.65.

In order to better understand stratigraphy of soil deposits at the failure zone enclosed by red line, borehole data of a Standard Penetration Test (SPT) performed at location SPT1 (in Fig. 3a) is plotted in Fig.6. As seen from Fig. 4b layers of silt and silty sand are placed over and between the sandy layers which may increase the liquefaction susceptibility of deposit. Therefore, it is necessary to further investigate the effect of low permeable capping layers in liquefaction induced flow failure in Jono-Oge.

Fig4. (a) PDCPT test results (b) Soil condition at SPT1

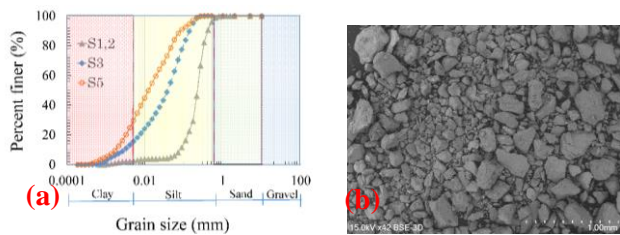
Fig5. (a) grain size distribution of soil samples (b) SEM image of sample S2

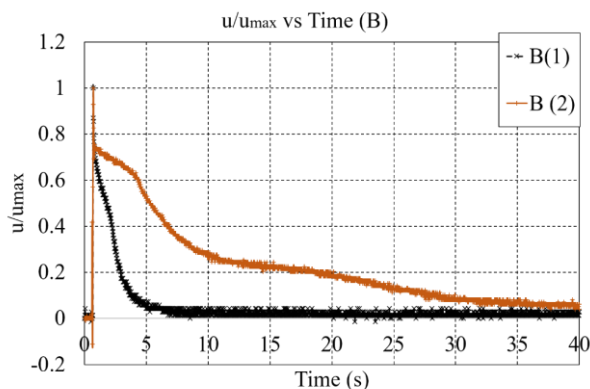
The results for 1D test after a single impact of hammer have been plotted and shown as a ratio of excess pore water pressure to maximum excess pore water pressure (u/u_{max}). The u/u_{max} value has been plotted against the duration to show the effect of clay seam on development and dissipation of excess pore water pressure in saturated sand under impact loading. Here in Fig. 8, the excess pore water pressure B (1) is for no seam condition while B (2) is for condition with a sandwiched clay seam. The location of pore pressure transducer is just below the clay seam. From the figure it can be

observed that ratio u/u_{max} for B (2) takes longer duration to dissipate after reaching peak and still has a higher value while that for B (1) is dissipated. This implies the capping effect of clay seam which inhibits the dissipation of excess pore water pressure in the sand layer below. Further in Fig. 9 the plots for u/u_{max} versus duration for pore pressure transducers A and C are shown, where A is located above the clay seam and C is located at a distance of 15 cm from the bottom of the sand layer with D_r 70%. Here for both the transducers the duration for dissipation of excess pore water pressure for sand with clay seam is higher than the condition without clay seam. This shows that the presence of a low permeability layer can not only hinder the dissipation of pore water pressure in adjacent areas but also in regions at a higher distance from the layer vertically.

Figure 8: Dissipation of excess pore water pressure versus duration for pore pressure transducer B just below clay layer with/without clay layer.

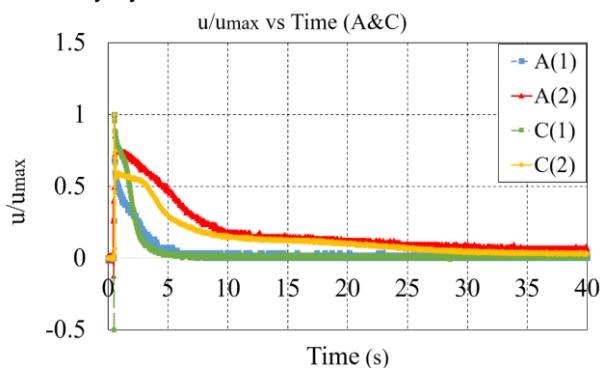
Figure 9: Dissipation of excess pore water pressure versus duration for pore pressure transducers A and C above and far below the clay layer, with and without clay layer.

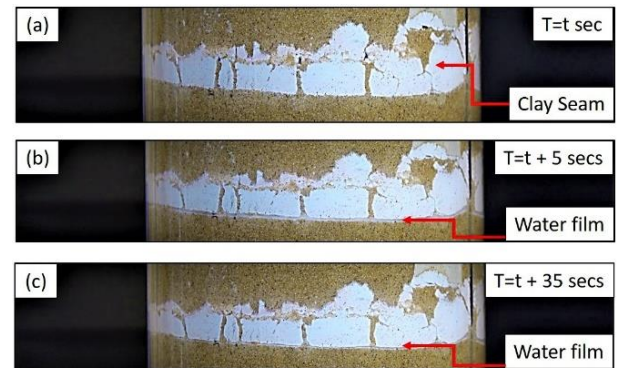
Further Fig. 10 depicts the development of water layer below the clay seam. Fig. 10(a) is recorded at $T = t$ seconds when the hammer impact was made. Fig. 10 (b) depicts the maximum thickness of the water film at $t + 5$ secs while Fig. 10 (c) shows the decreased water film thickness at $t + 35$ secs. This shows how the water film dissipates slowly in turn influencing the dissipation of excess pore water pressure from the below sand layers by forming an impermeable capping layer.

Figure 10: Formation of water layer under the clay seam at different time durations: (a) Time (T) = t secs, (b) $T = t + 5$ secs and (c) $T = t + 35$ secs.
