Forensic studies of a touch pile system failure in Cochin, India

Anil Joseph¹ and B.T. Jose²

ABSTRACT

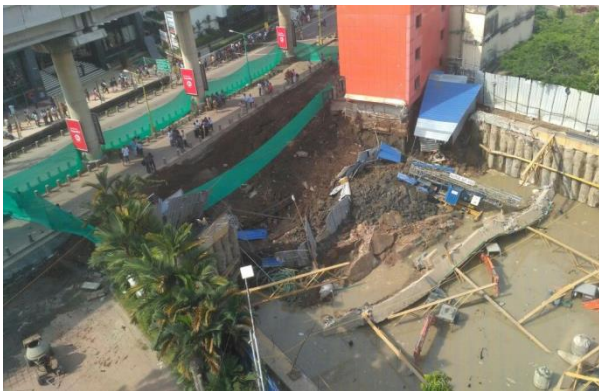
When the excavation reached a depth of 9.5 m at 5.30pm on 19/04/2018, a slight deflection of 20 mm was noticed on the shoring walls towards the north (excavated area) and the deflection increased to 100 mm by 7.00pm. Excavation was completely stopped and workers were evacuated. Further shift increased to about 200mm by 8.30pm along with some creaking sound and water jets were noticed on the shoring walls and by 9.30pm the shoring piles on the southern side came down suddenly.

Fig. 1. Failure of Touch Pile System at Kaloor, Cochin

- i) Due to the collapse of the touch pile system, the nearby road and earth had sunken by approximately 3.0 meters on the south side of the excavated area.
- ii) Due to the lateral shifting of the piles the nearby earth was sunken on the south west side of the excavated area.
- iii) The building near the south west corner had a slight tilt towards the east side and cracks were noted in the building and part of the foundation was exposed. This is indicative of progressive failure and may lead to sudden collapse of the building.
- iv) Cracks were noted at ground level in all the other three sides of the excavated area.
- v) The roads with pavement of interlocking tiles had differential settlement.

i) As per the geotechnical and structural analysis, the failure is due to the fact that the strut system was inadequate to take up the lateral thrust from the touch piles and to provide the required stability. The soil at the dredge line has turned out to be very soft and has caused considerable loss of strength of the interface soil, high thrust from the shoring pile at the interface has caused yielding of this soil. Subsequent increase in unsupported length of pile is also a reason for the failure of pile in bending. A second tier of strut system at a lower depth could have been helpful in retaining the touch pile system in position.

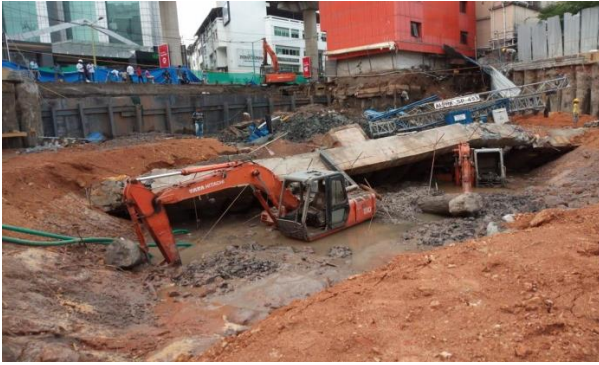
Fig. 2. Refilling of soil after touch pile collapse

- i) The southern portion which is excavated up to 10.0 m has to be immediately refilled up to 5.0 m below ground level by using red earth in order to prevent the progressive failure of the surrounding area.
- ii) The sunken portion of the road has to be strengthened by providing coconut timber piles extending up to 6m depth at 1m centre to centre and to be filled with red earth in layers and proper compaction has to be done up to the original level.
- iii) Coconut timber piles to be driven for strengthening and protection of unaffected main water lines and public utilities such as electricity, telephone lines, water supply etc which were damaged have to be immediately restored.
- iv) Double layer braced sheet piles to be provided to protect the sides of the road and the soil to be filled up to formation level.

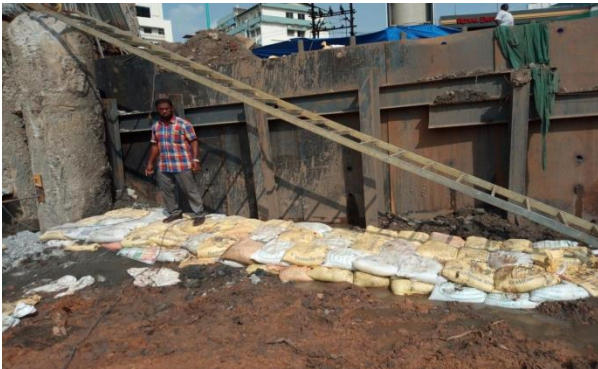
Fig. 3. Two layer sheet pile adopted near public road

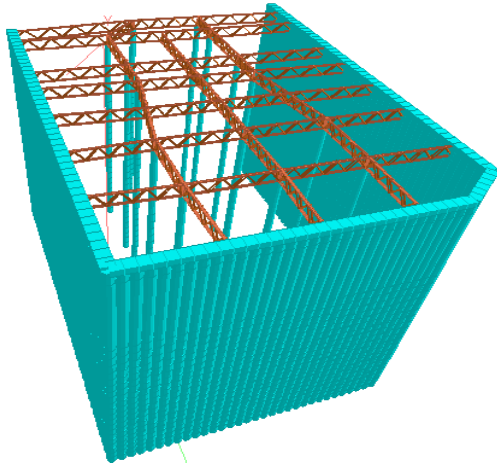
- i) The shoring pile with single strut propping system used in this project is found inadequate to take the lateral forces for the proposed depth of excavation of 10m.

- ii) The reinforcement of the shoring piles is found inadequate against bending with single strut propping system at top provided for the proposed depth of excavation of 10m.

- iii) The strutting system currently used is a series of trussed beams in grid pattern, but not orthogonal to each other. This will have a tendency to make the grid system skewed and to facilitate further yielding of the props.

- iv) The soil at current depth of excavation has turned very soft on account of water seepage. This has caused considerable weakness of the interface soil. High thrust from the shoring pile at the interface has caused yielding of this soil. Subsequent increase in unsupported length of pile is also a reason for the failure of the pile in bending.

Fig.6. 3D model of provided touch pile system for 10 m retention

iii) With regard to the suitability of touch pile system for further construction, the present touch piles installed can take up the lateral earth pressures due to the excavation up to the proposed depth of 10m, provided adequate bracing system with higher sections and proper balanced geometry is adopted. Diagonal cross bracings especially at the corners have to be provided to bring in the required rigidity.
