Features and mechanism of slope failure induced by the 2017 July Northern Kyushu torrential rainfall disaster in Japan

Shigeo Yamamoto¹ and H. Hemanta²

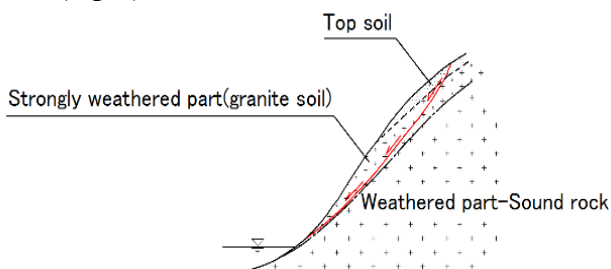
The most common failure form found along the basin occurred in the so-called strongly weathered “decomposed granite,” which transformed into soil (Location 1 and 5 of Fig. 1). The failure was roughly from 1 to 2 m deep, and many traces of springs are thought to be due to piping. Gully erosions had formed on the failure surface. Since there was little colluvial deposit at the toe of the slope, the base of the undercut slope had likely been eroded by the flowing water and it had lost the balance of clod. Later, it had been led to the failure (Fig. 3).

Fig. 3. Schematic profile (Surface failure of granite).

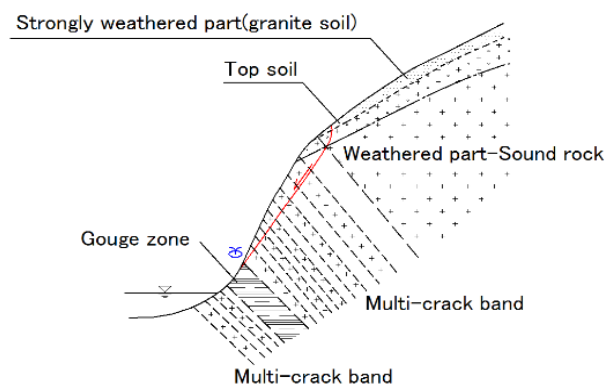
formations were observed in the northwest-southeast direction, as well as the north-northeast-south-southwest and northeast-southwest directions. In some, fault fracture zones strongly crushed by fault gouge could be observed. In this location 2, at the end of the slope failure zone, a 1 m-wide gouge zone and a fault fracture zone with a crack zone with a large opening of around 5 m wide were verified. The direction of the fault was N54°W, 70°SE, and it worked as a receiving board to the slope. Furthermore, a substantial volume of groundwater was flowing from the crack zone on the slope side (around 50 l/min). A geological analysis of this failure mechanism based on the characteristics of the crush zone and flowing water suggests that the gouge zone, which normally indicates low permeability, became a cut-off wall, and the groundwater flowed from the crack zone. However, during the torrential rainfall event, a large volume of groundwater that accumulated in a short period of time likely raised the groundwater level inside the slope resulting in the increase of pore water pressure, and eventually led to a bedrock failure that included the crack zone (Fig. 4).

Fig. 4. Schematic profile (Bed rock failure of granite).

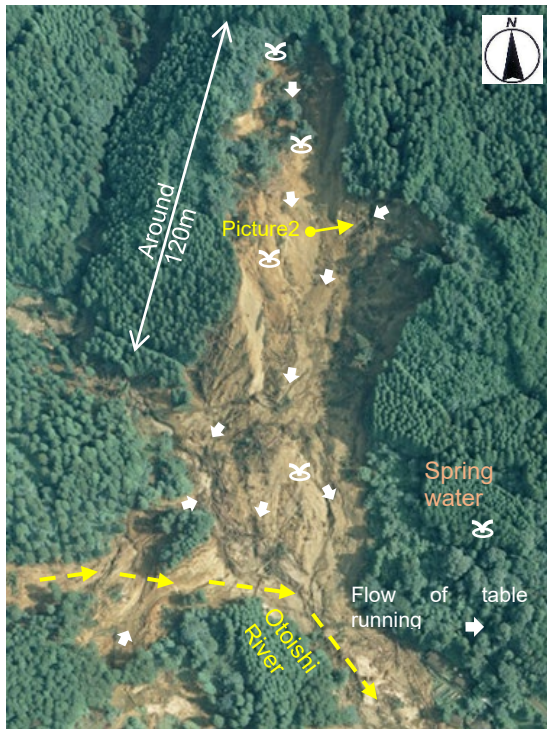
In the upstream area of the Otoishi River with crystalline schist, a landslide with a length of approximately 120 m (landslide scarp to clod end), width of 110 m, and average depth of 15–20 m occurred. This landslide formed large landslide scarp, and a landslide clod that still remains in the slope. The frontal part of the landslide clod traversed the road below, reached the Otoishi riverbed and stopped, blocking most of the river channel. However, there was no evidence that this moving clod turned into a debris flow (Fig. 5).

Fig. 5. Large-scale landslide in the crystalline schist-distributed area (Source: GIJ).

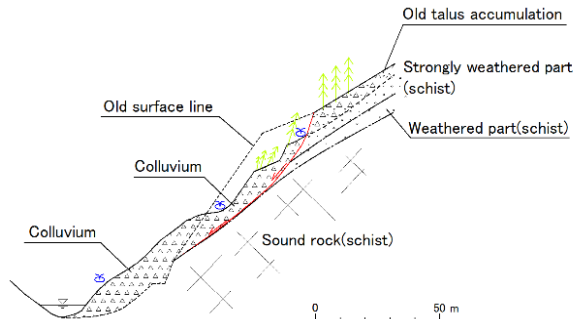
The thickness of this landslide mass was estimated to be 15–20 m on average, with a maximum of 25 m. However, because landslide clods remained on the failure surface, there was no geological weak line that could act as a sliding surface. Multiple points of outflowing water were observed in the area from the landslide scarp to its end, where the flow increased. Such outflowing water gushed out after the landslide clod yielded. Since it has been estimated that the landslide occurred at a depth of approximately 20 m, the deep

groundwater likely contributed to the landslide movement (Fig. 6).

Fig. 6. Schematic profile (landslide of crystalline schist).

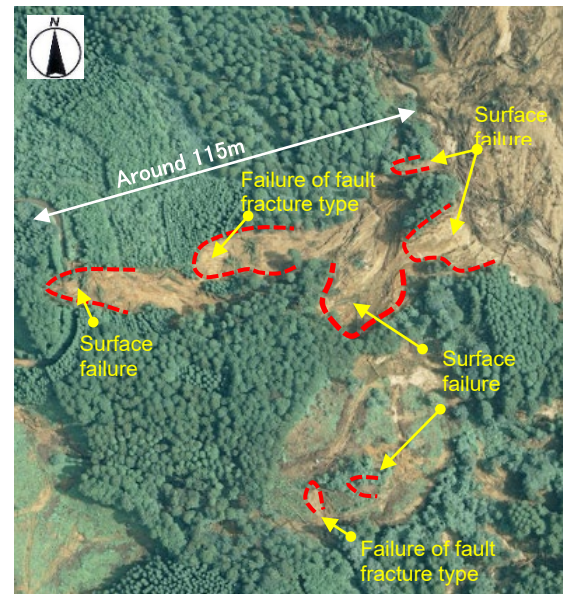
In location 4, multiple slope failures occurred opposite to the landslide in location 3 of the Otoishi River bank. The failures were smaller than the landslide of the opposite bank (left side of the bank) and around 5 m deep, but different types of failure forms were found, including failure of colluvial deposit that filled the valley, failure of schist that weathered and transformed into soil, and failure dominated by a fault fracture zone (Fig. 7).

Since there were fault fracture zones of almost the same formation as in the granite-distributed areas, as well as schists full of cracks and aplite formations in some parts of the failure surface, the primary cause of the failure was likely controlled by these complicated geological structures.

Fig. 7. Group of slope failures on the right side of the upstream bank (Source: GIJ).

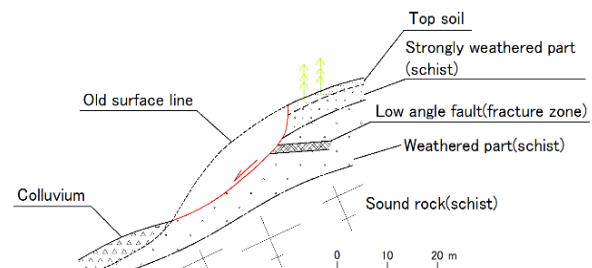
In this way, the failure mechanism in this location can be classified into two groups. The first failure mechanism (Fig. 8) is caused by fault fracture zones, where the bedrock around the fault fracture zone weakened, likely resulting in the failure in this part. The second failure mechanism (Fig. 9) is caused by highly

Fig. 8. Schematic profile (Bedrock failure of crystalline schist: fault fracture type).

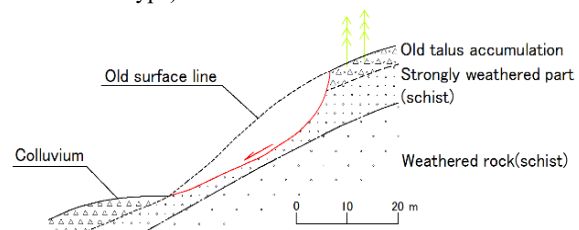
weathered rock. Soft sedimentation of bedrock from aging due to weathering likely caused the failure of highly weathered rock due to the heavy rainfalls.

Fig. 9. Schematic profile (Surface failure of crystalline schist).

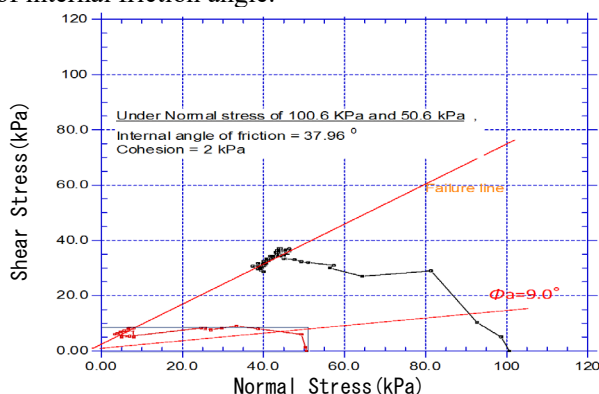
The failure form observed the most along the Akatani River and the basin of its tributary; the Otoishi River was surface failure of Granite (Table 1: type Ia). In order to elucidate this mechanism of surface failure, the soil samples were collected in the surface failure area (Fig. 1: Loc.5), where the same geological features can be seen, and then constant volume direct shear test was conducted. Figure 10 showed the results of constant volume direct shear test under normal stress of 100 kPa and 50 kPa. The trend of curve represents undrained and saturated state. When each curve moves to the left, it means that the pore water pressure in these samples is increased. Finally, slope failure occurred with 38 degrees of internal friction angle.

Fig. 10. Results of constant volume direct shear test.

According to the definition of apparent internal friction angle, if the slope with 20 m height is collapsed, its mass movement may move 130 m horizontally (9.0 degrees of apparent internal friction angle). As a result, it is assumed that the slope failure occurred in the region of granite is fluidized failure with long travel distance.
