Successful mitigations of riverbank slope stabilizations and road failures caused by excessive rainfalls due to climate change at national road 1B (NR 1B) in Laos PDR

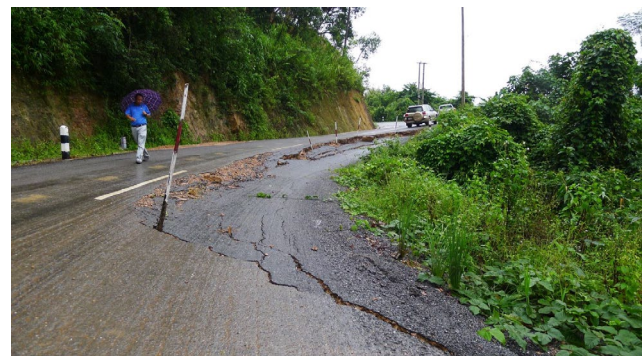
Fig. 2. Embankment failure due to underground water seepage and internal erosion at KM 49 to 50 (Case 1).

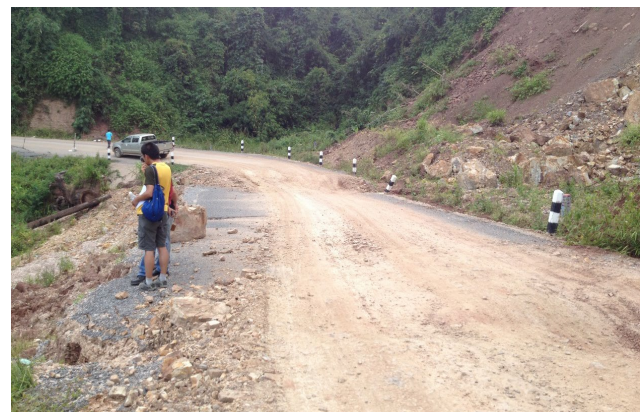
Fig. 3. Pavement failure due to wetting and large volume of water seepage under road pavement at KM 39 to 40 (Case 2).

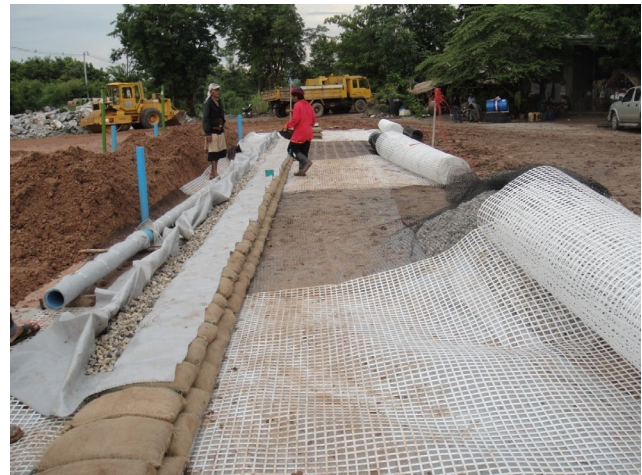
Fig. 5. Construction of reinforced slope involving jute bags as facing.

The slope repairs were designed with geotextile reinforcements using PEC-150 consisting of nonwoven geotextiles combined with woven polyester yarns. The ultimate tensile capacity of the geotextile reinforcements PEC-150 was 150 kN/m and were laid out with vertical spacing of 0.5 m. The wrapped around geotextile facing were installed using jute or plastic bags with as illustrated in Fig. 5.

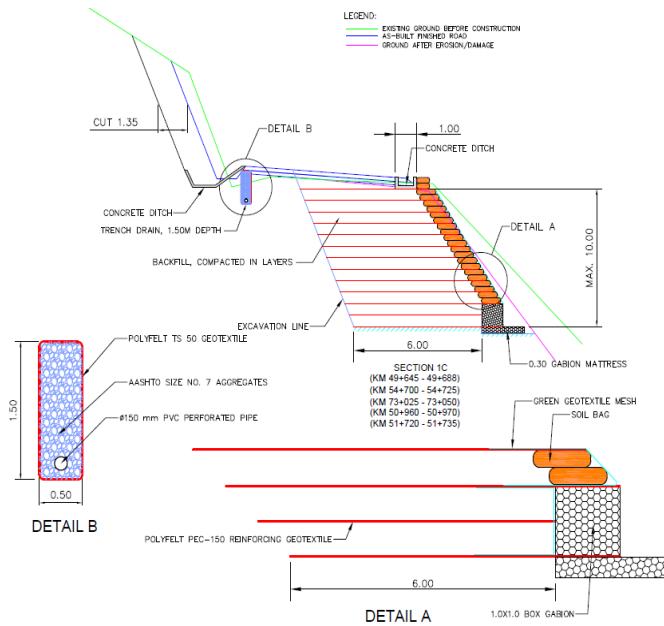
Fig. 6. Road embankment failure and internal erosion remedial works at KM 49 to 50 (Case 1).

The combination of 10m high geotextile reinforced lower slopes with gravel filled gabions or soil bags facing and trench drains (1.5m deep and 0.5m wide) was proposed at KM 49 to 50 with deep deposits of weak soil layers as shown in Fig. 5. Figure 7 shows the road embankment condition at KM 49 to 50 after 5 years.

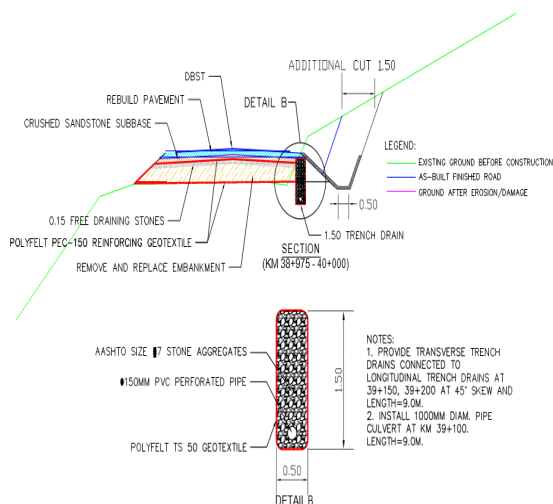
Fig. 7. Remedial works for pavement failure at KM 39 to 40 (Case 2).

Combination of geotextile reinforced free-draining gravel subbase and trench drains (1.5m deep and 0.5m wide) was used. The reinforcement consisted of PEC150 geotextile. Details of this scheme are given in Fig. 7. This scheme is intended for KM 39 to 40 where widespread damaged in the whole road sections were observed. Figure 9 shows the repaired pavement at KM 39 to 40 after 5 years.

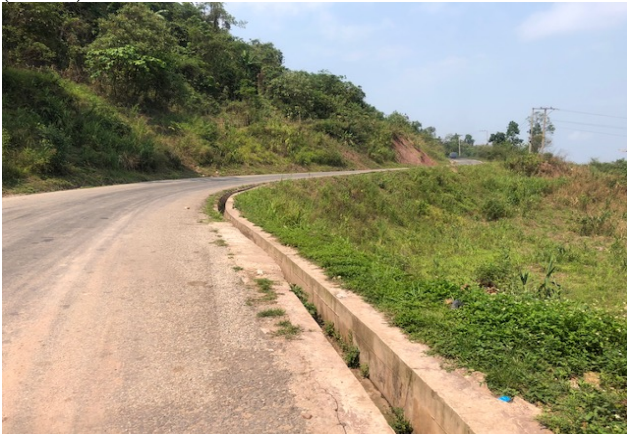
Fig. 8. After repair of pavement and slope failure at KM 49 to 50

(Case 1).

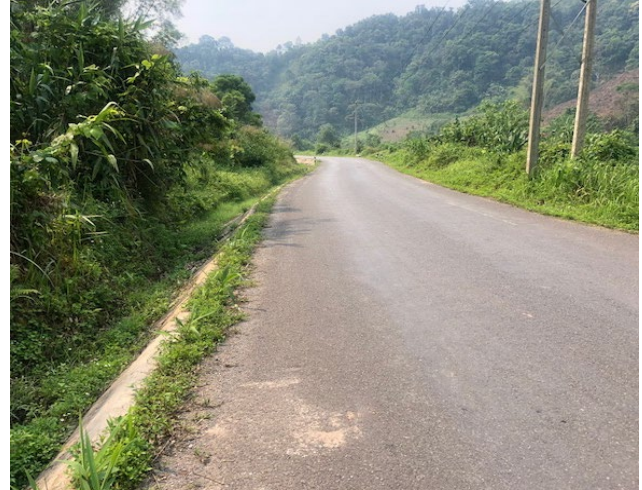
Fig. 9. After repair of pavement failure at KM 39 to 40 (Case 2).
