## Analyses to elucidate the mechanism of the grabens that formed in Aso during the 2016 Kumamoto Earthquake in Japan

### ABSTRACT

The 2016 Kumamoto earthquake caused many grabens, approximately 50 m wide, in the caldera of the Aso Volcano in Japan. The authors conducted detailed site investigations to determine the mechanism of the grabens. The measurement of the displacement by SAR from satellites showed horizontal displacements of about 2 to 3 m occurred. Deep borings, microtremor array observation and reflection survey showed that soft clay is deposited from GL-17 m to GL-51 m and the bottom of this soft clayey layer is inclined. The analysis by ALID showed that the soft clay flowed due to the earthquake, causing the horizontal displacement of the surface soil layer and the graben at the ground surface.

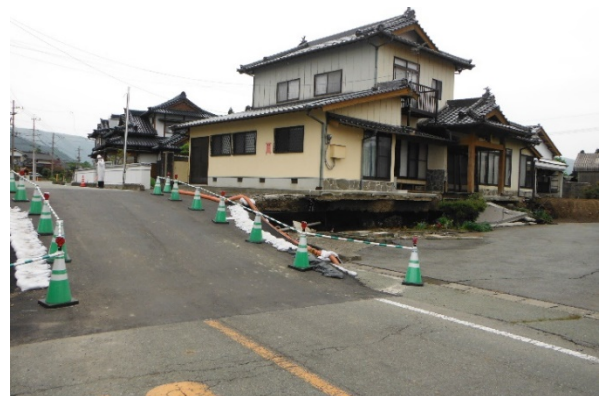
In the Aso Valley, grabens occurred in many districts such as Kario, Uchinomaki, Ozato, Matoishi and Yakuinbaru. The damage situation in Kario districts is depicted in Figure 1. A 1.3 m deep and 50 m wide graben appeared in this district. Two people in this district testified as follows:

- i) houses settled without much feeling of shaking;
- ii) a garden lantern and furniture did not topple over, and window glasses did not break; and
- iii) approximately 50 cm wide cracks occurred on the ground, and a rod could be inserted down to a depth of approximately 6 m.

Figure 1. Damage due to the grabens at Kario district.

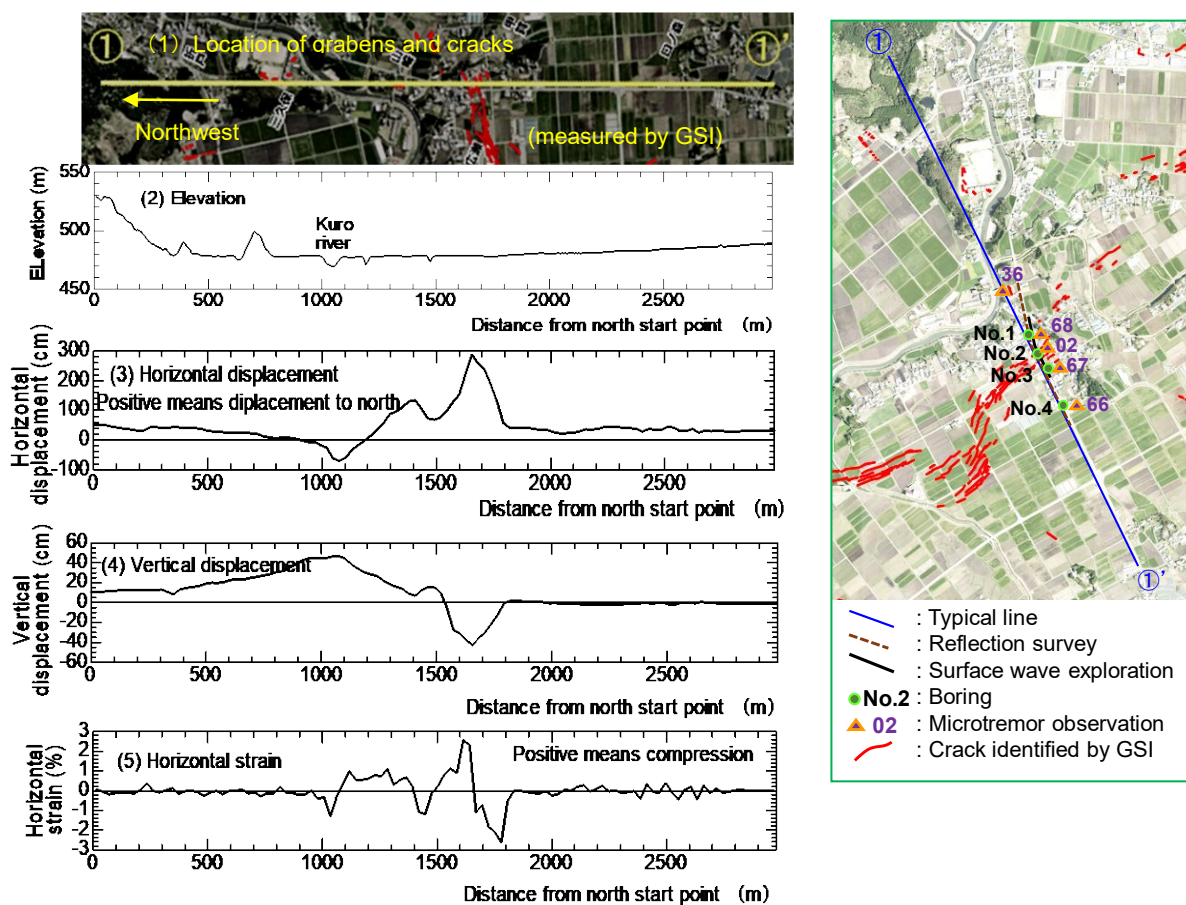
(1) Horizontal displacement and settlement sharply increased from 1800 m to 1700 m, and large tensile strain was generated. After the horizontal displacement reached a peak value of approximately 2.5 m (a value obtained by subtracting the displacement amount of the entire district), and the tensile strain reached a negative peak value of approximately 2.5%, the horizontal displacement decreased to approximately 1450 m.

Figure 2. Distribution of displacement and strain along a line in Kario district.

(2) From 1400 m to 1050 m, the horizontal displacement gradually decreased, and the vertical displacement

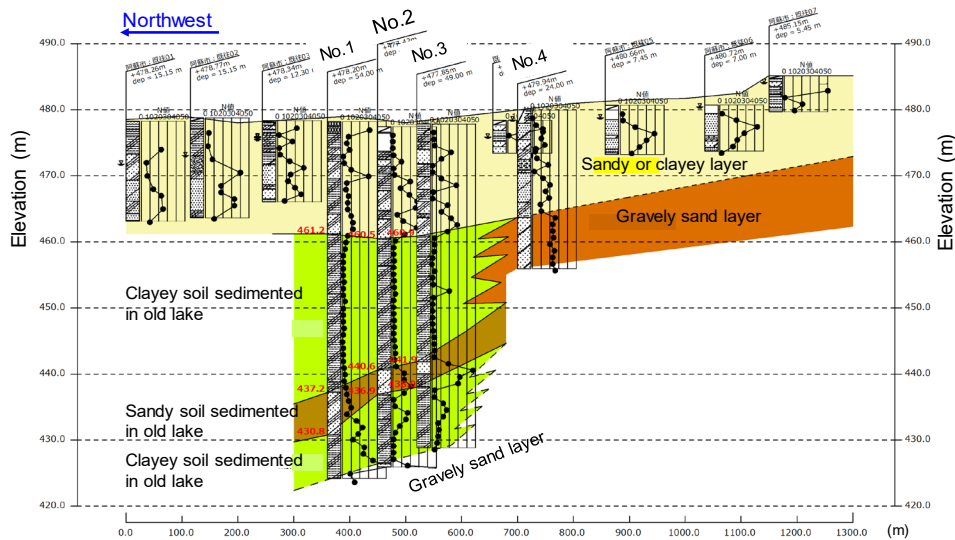
Borings, SPT, sampling, and PS logging were conducted at four sites in order to thoroughly investigate the condition of deep soil layers at Kario district. Figure 3 is an estimated soil cross section under and around the graben. A sandy or clayey layer with a thickness of approximately 17 m deposited from an altitude of 478 m to 461 m. In the north zone from the graben, clayey and sandy layers deposited alternately. The SPT  $N$  values of the clayey and sandy layers are approximately 5 or less, and 10 to 30, respectively. In the south zone, a dense sandy layer with SPT  $N$  values of 15 to 40 was deposited. On the other hand, the soil sediment in the old lake ranges from clayey silt to silty clay with SPT  $N$  values of 1 to 3. Moreover, it was found that a sandy layer interposed in the lake deposit at approximately 430 m to 440 m altitude. The upper surface of the lake deposit is almost flat. On the contrary, the bottom of the lake deposit is inclined with a gradient of approximately 3% toward north. The interposed sandy layer is also inclined with almost the same gradient.

Figure 3. Soil cross section at Kario district.

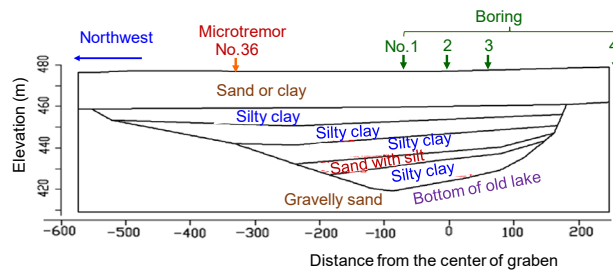
Figure 4. Estimated cross section of soil layers at Kario.

Based on the studies by microtremor array and reflection survey, the authors confirmed that the bottom of the old lake is V-shaped as shown in Figure 4 and assumed that the lake deposited soil flowed due to the earthquake as schematically shown in Figure 5. The authors also believe that the flow of the lake soil may be simulated by the "ALID," residual deformation analysis (Yasuda et al., 2017), same as the simulation conducted for liquefaction-induced flow.

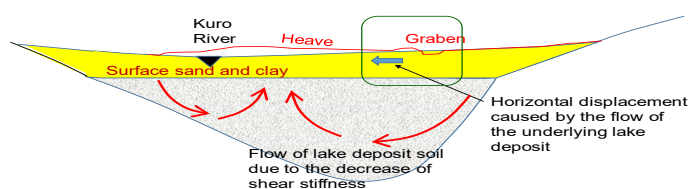
Figure 5. Diagram of the mechanism of graben formation.

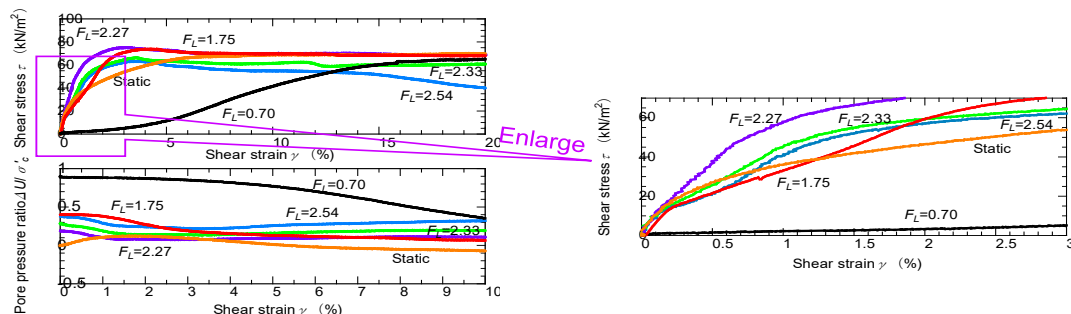
Figure 6. Stress strain curves after cyclic loading in different  $F_L$ .

using undisturbed samples taken at the No.2 site in the Kario district. In the tests, cyclic shear stress was applied under undrained condition identical to the cyclic shear stress applied in conventional liquefaction tests at pre-determined cycles. Finally, a monotonic load was applied to the undrained specimen. The stress-strain behavior at this stage was considered post-liquefaction (post-failure) behavior. Figure 6 shows stress strain curves after cyclic loading for the lake deposited clay at the depth of about 25 m.  $F_L$  value in the figure is the ratio of shear stress amplitude to the shear stress amplitude just failure. Namely, if  $F_L < 1.0$  the sample failed. If the shear stiffness of the soil is defined as the ratio of shear stress by shear strain at 1%, the stiffness of the sample  $F_L = 0.7$  is about 1/100 of the stiffness of the samples at  $F_L > 1$ . Therefore, the authors estimate that the stiffness

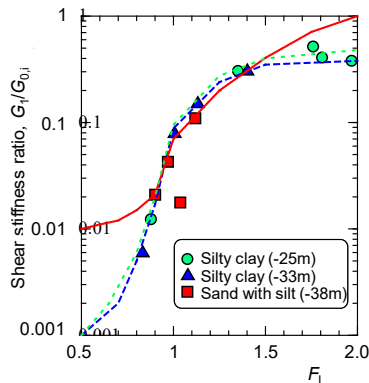
of the lake deposit soil decreased due to the shaking of the Kumamoto Earthquake, resulting in large deformation and the grabens. Figure 7 shows the relationships between  $F_L$  and  $G_1/G_{0,i}$  for three samples, where  $G_1$  is the stiffness of the samples of after cyclic loading and  $G_{0,i}$  is the stiffness of the samples without cyclic loading.

Figure 7. Relationships between  $F_L$  and  $G_1/G_{0,i}$  for three samples.

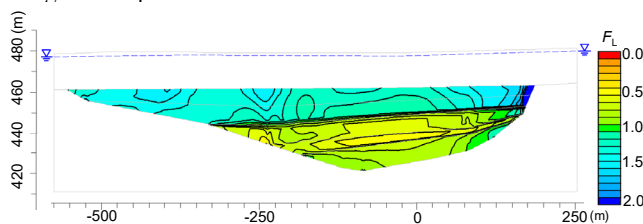
Figure 10. Distribution of  $F_L$ .

distribution of peak acceleration and  $F_L$ , respectively. Figure 11 shows analyzed deformation. Based on these figures, it can be concluded that lake deposited soil has flowed due to the decrease in shear stiffness, resulting in horizontal displacement of the ground surface and graben as assumed in Figure 5.

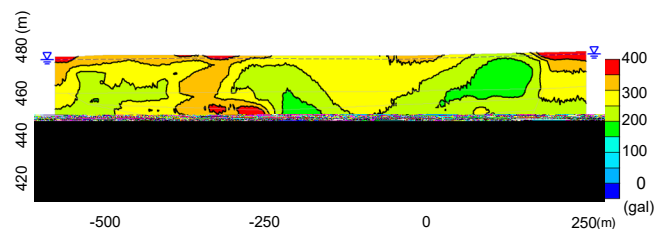
Figure 9. Distribution of peak acceleration.

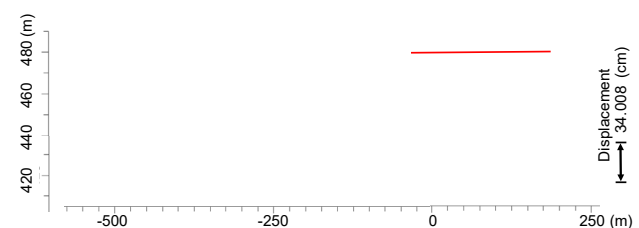
Figure 11. Analyzed deformation.
