## Underpinning the foundations of the Aura Brewery Castle, Turku, Finland

Kari C. Avellan<sup>1</sup>

<sup>1</sup> KAREG Consulting Engineers, Toolontorinkatu 11B, Helsinki, 00260, Finland

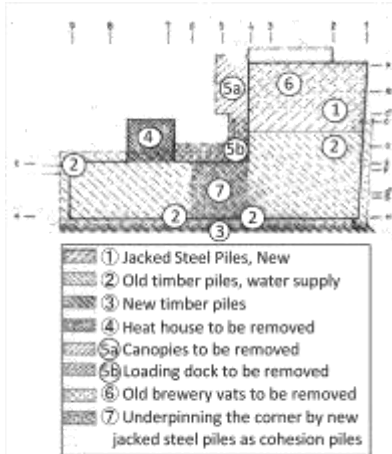
Fig.3. Removed parts of the building and pile types throughout the building sectors (KAREG internal archives)

period, onsite studies and pile load tests were performed. Designs were implemented for foundation work, including, jacked steel piles, pit work, shotcrete, filling concrete, and temporary anchors (Fig. 3.). An important part of the work consisted in a design solution for maintaining the water table consistently over the existing wooden pile heads. Overall, KAREG was responsible for the project as technical consulting engineer and acted occasionally as onsite supervising specialist.

This main corner of the building at Westbank street and Wechter alley presented special conditions which had to be dealt with separately. There is one main entrance door at this corner, and pressure (negative skin friction) coming from the street is an important consideration all along the Westbank due to the progressive lowering of the water table and consolidation process. This corner is the only sector of that building which was designed to be underpinned with new jacked steel piles as cohesion piles. (Fig.3).

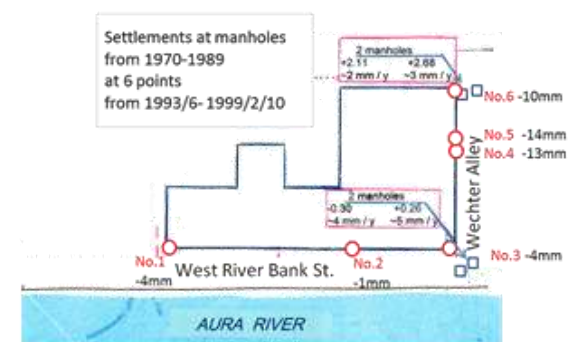
More specifically for this project, monitoring the building was realized using six reference points which were in use for observation since 1993 (Fig.5.). Observed settlements were from 4 mm to 14 mm over a 6 years period, shown in Table 1. During the monitoring period 1993-1996 the biggest settlement was 14 mm. The medium water level, which is in this case the upper ground water level for the extended part on Wechter alley, decreased under the wooden raft and under the tops of the timber piles as in Table 1.

Fig.5. Position of 6 reference points (Maa ja Vesi Oy) and settlement rates mm / year, taken from manholes of rainwater pipes under Wechter alley (City of Turku surveys, 1970-1989)

The water running level of the stormwater drain Wechter alley side, area 6 (Fig. 3) was lower than the wooden rafts. According to the measurements taken from manholes at the corner of Westbank and Wechter alley, there is a significantly bigger settlement locally, of about 4.5 mm per year (Fig.5).

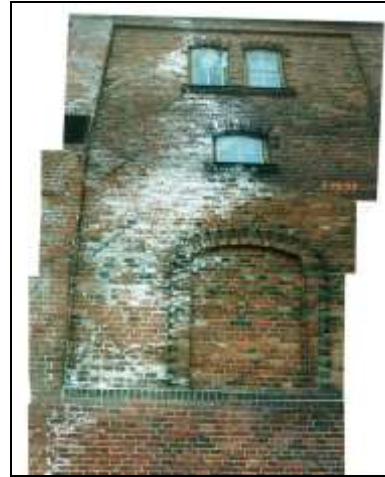
The estimated horizontal movements and cracking of the buildings brick façade were cause for concern (Fig. 6). The main inclinations as shown in Table 2, were observed on the Aura River (Westbank) façade of the building, were the façade itself, sitting on old wooden cohesion piles, is settling due to the consolidation process.

It was however determined that the settlement for the extended part on Wechter alley was more significantly progressive, as shown in Table 1. Should the settlement had continued there, part of the building could have been in imminent danger of collapse.

Fig.6. Observed cracks in facade of building extension on Wechter alley (KAREG internal archives)

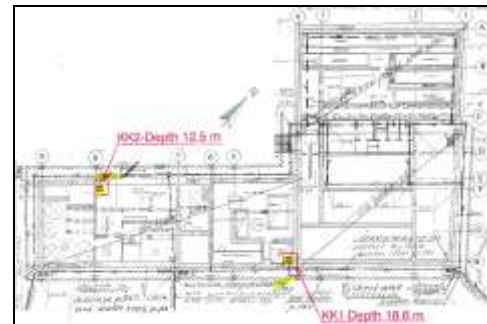
To determine the condition of the foundations, several test pits were realized under them, the main ones being test pits KK 1 (Westbank, exterior wall, lines 4/H) and KK 2 on courtyard side (exterior wall, lines 8/E, Fig.7,8 and 9). The timber piles in KK 1 were between  $\varnothing$  22...24 cm each, with lengths between 7.0...8.0 m, 4 piles in a row, c/c ~0.55 m. The timber piles in KK 2 were from  $\varnothing$  19...23 cm each, with lengths varying between 8.5...10.0 m, 4 piles in a row, c/c ~0.55 m. Wood samples were taken from piles, which were then examined for resistance and strength properties. Some old timber piles were test-jacked for 24 h period for creep load tests, as described in ISSMFE Axial Pile Loading Test-Part 1: Static Loading, to determine the pile settlement properties.

Fig.7. Foundation wall plan with test pits KK 1, KK 2, water supply pipes, drains, perimeter sheet-pile fencing and clay depths (KAREG internal archives)

For this reason, a design solution to keep the water table consistently over the wooden rafts was decided, which consisted in fencing the perimeter of the buildings with a Sheet Pile Wall (Fig. 7.), creating a water table pool, thus maintaining the cohesion support of the existing timber foundation system of the old building block and warehouse, the water level to be

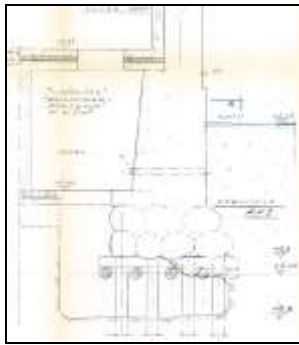
Fig. 9 Exploration pit

Fig.8. Section of pit KK I on Westbank side (KAREG archives)
