The strengthening and renewal of damaged reinforced concrete structures by pre-stressed fiber reinforced plastics

A. Bespaev, V. Khomyakov

Kazakh research and design Institute of construction and architecture. 21, Solodownikov Street, 050046, Almaty city,
Kazakhstan

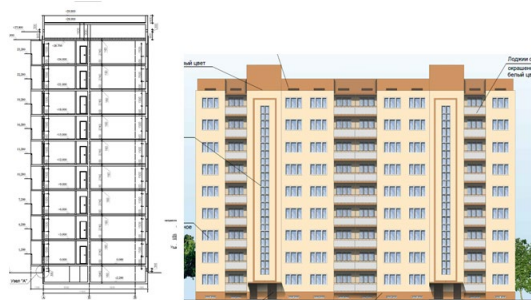
Fig. 1 - Cross section and facade of the building on Spot 16

Buildings on spots 14 and 16, respectively, have dimensions in terms of 21.6 x 11 m and 43.2 x 11 m. The buildings are interlocked and oriented north-south. The base plate of the building at spot 14 was 1.0 m higher than the base plate of the building at spot 16. A detailed examination of the condition of the supporting structures of the residential building on spot 16 revealed the following:

- the building foundation is made in the form of a flat reinforced concrete foundation slab with a thickness of 1000 mm protruding beyond the contour of the building by 1000 mm, for concrete preparation with a thickness of 100 mm and a soil cushion of gravel-sand mixture with a thickness of 1000 mm;

- bearing external and internal reinforced concrete walls are made with a thickness of 200 mm;
- floor slabs and coatings are made with a thickness of 1600 mm;
- reinforcement and concrete strength in the supporting structures of buildings corresponds to the project;
- uneven settlement of the foundations did not cause additional damage to the load-bearing reinforced concrete structures.

The verticality of the building on spot 16 was restored by the local softening method, which was made by artificial excavation of loamy soil under an unpaved cushion at a depth of 5-7 m. The excavation was carried out vertical and deviated wells in increments of 2 m. The diameter of deviated wells is 156 mm, and the diameter of vertical wells is 500 mm.

The reinforcement of the bases was carried out by the device of bored piles with a diameter of 500 mm, a depth of 14-16 m, located in increments of 1.2 m.

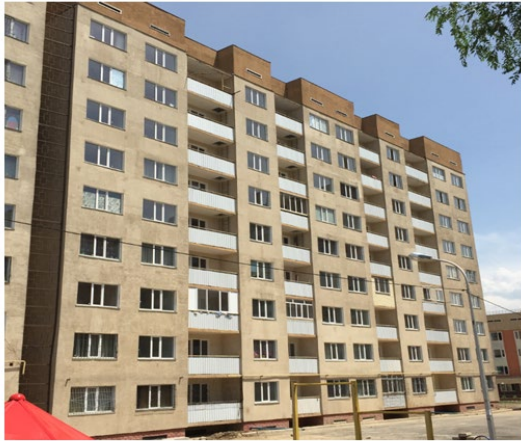
Fig. 2 - Facade of the building on Spot 26

Residential building on spot 26 is oriented in the north-south direction and received unacceptable deviations from the vertical. The deviation of the northwestern corner of the house was 340 mm, and the top of the southwestern corner was 420 mm. The eastern side of the building did not receive noticeable vertical deviations. The basement floor is inclined from the eastern longitudinal wall towards the western wall by 196-225 mm.

- bearing external and internal reinforced concrete walls are made with a thickness of 200 mm; horizontal cracks were found in the transverse walls of the basement floor, spreading over the entire width of the building, with an opening width of 0.20-0.25 mm; such cracks exist in all transverse walls of above-ground floors, and the width of their opening is in the range of 0.05-0.20 mm;

- floor slabs and coverings are made with a thickness of 1600 mm: In floor slabs on all floors there are cracks with an opening width of 0.05-0.20 mm, and in the floors of the 8th and 9th, the crack opening width reaches 0.35-0.45 mm; in addition, the angle of the ninth floor floor slab is separated by a crack with an opening width of 0.8-0.95 mm;

- the walls of the stairwells and elevator shafts are dissected at the level of the staircases, dissected by horizontal cracks with an opening width of up to 0.35 mm;

- dynamic tests of the building showed that damage to the supporting structures from uneven settlement led to a decrease in the horizontal stiffness of the building in the transverse direction of the building by 50%, and in the longitudinal direction by 25%.

The restoration of the serviceability of the building on spot 26 included the restoration of the verticality of the building, as well as the strengthening of damaged load-bearing reinforced concrete structures of the building.

The verticality of the building is restored by the method of local soil softening.

To prevent gravel-sandy soil from sinking the soil cushion along the perimeter of the foundation slab, an 800 mm wide anti-filter screen was made by injection with vertical and inclined wells to the height of the gravel cushion. The injection was performed with a cement solution on sulfate-resistant cement with the addition of water glass in an amount of 25 kg per cubic meter of solution. A solution with a water / cement ratio of 1 / 10-1 / 3 was supplied with a pressure of 0.3-0.5 MPa.

To moisten the loam to a moisture content above $w_p \geq 0.80$, water was pumped through deviated wells. The decrease in the strength of the base soil was provided by an increase in its porosity. To do this, an artificial excavation of loamy soil was made below the soil cushion. Excavation by inclined and vertical wells. Inclined wells with a diameter of 156 mm were drilled to a depth of 3 meters, and vertical wells with a diameter of 500 mm were drilled to a depth of 5 m. The marks of the building were controlled by geodetic methods using control benchmarks located on the outer walls. The marks of the building were controlled by geodetic methods using control benchmarks located on the outer walls. Monitoring the condition of the building was carried out for several months.

After vertical alignment of the building, reinforced damaged reinforced concrete structures of the building were reinforced. For this, surface reinforcement was applied by gluing composite fiber reinforced concrete onto concrete surfaces.
