Damage assessment of an ancient fort in India

Tamali Bhowmik¹, H. Haridasan¹, A. Menon¹, and S. Banerjee²

¹ National Center of Safety of Heritage Structure, Department of Civil Engineering, IIT Madras.

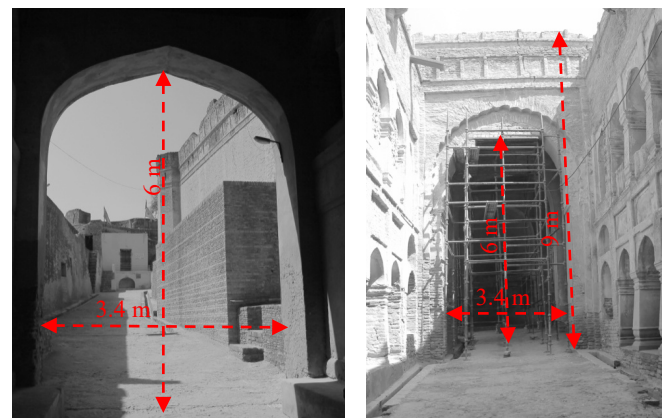
Figure 1. Gateway 1 (L) and Gateway 3 (R)

This structural is compromising the safety of adjoining structures as well as the users of this space. All arches in gateway 3 along with the vault roofs and terrace shows signs of distress. The current paper presents a detailed geotechnical and structural investigation to find out the cause of the distress in the fort.

(A) Cracks on arches and vaults of gateway 3: Arches are structural systems which are highly sensitive to any lateral movement of the support of the arch. Such movement compromises the line of compressive forces (or thrust) which keeps the arch together and resists superimposed loads. Lateral movement of supports induces tensile stresses along the cross sections of the arch and masonry subsequently develops cracks in these sections as the tensile strength of masonry is very low. The prominent crack on the roof indicates significant structural movement causing cracks in horizontal structural system. The distressed area is provided with temporary steel props.

1. The preliminary structural analysis concludes that the distresses shown on the structure especially at Gateway 2 and 3 are due soil settlement.
2. The gateway 3 has been adequately propped. Gateway 2 should be propped since it shows signs of distress similar to those seen in gateway 3.
3. From the geotechnical analysis, it can be inferred that it is critical to understand the sources that contribute to the flow of water through the fort. The preventive measures towards further failure seems to largely depend on controlling the percolation of water into the soil which is capable of inducing undesirable water pressures on the fill side, settlement of foundation soil and result in loss of structural integrity.

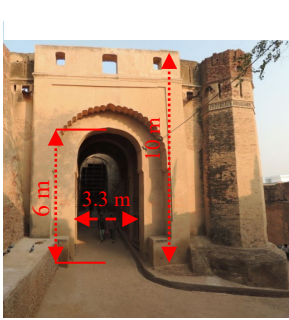
Figure 2. gateway 2 (L) and

(C) Cracks on arches of gateway 2: A similar pattern of cracks can be observed in gateway 3 is visible in gateway 2. It is also a resultant of the lateral movement of the support of the arch.

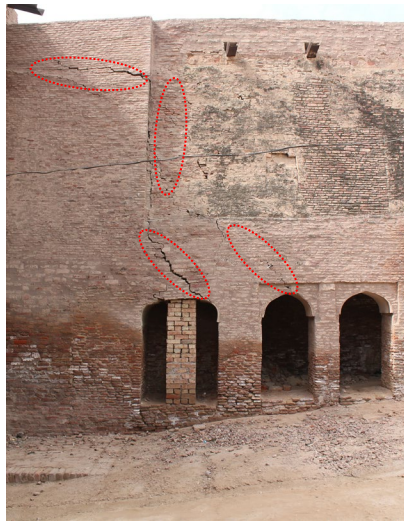
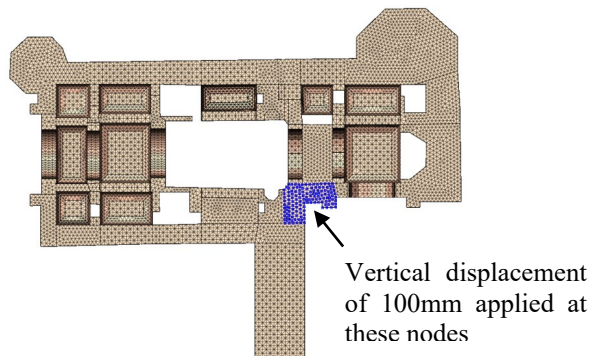
Figure 4. Deformed wall section in elevation and plan

Figures 4 show the walls with maximum settlement as noticed during the site visit. All restraints were removed from the bottom most nodes of these walls and vertical displacement of 100mm have been applied at those nodes. To simulate the platform beside the bastion wall, nodes at the side of the wall upto the height of the platform were considered fully restrained in all directions.

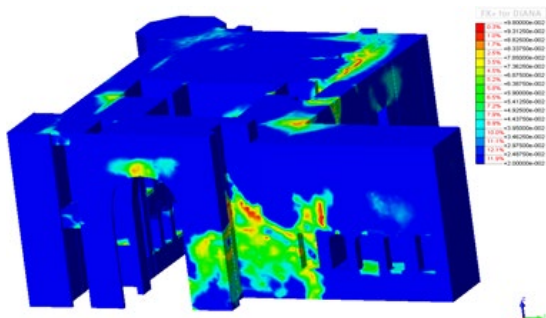
Figure 5. Mean principal stress distributions

The principal stress distributions in the critical section are shown in figure 5. It is evident that the tensile cracks were formed near the opening (Figure 5) and in arch (Figure 6) due to soil settlement.

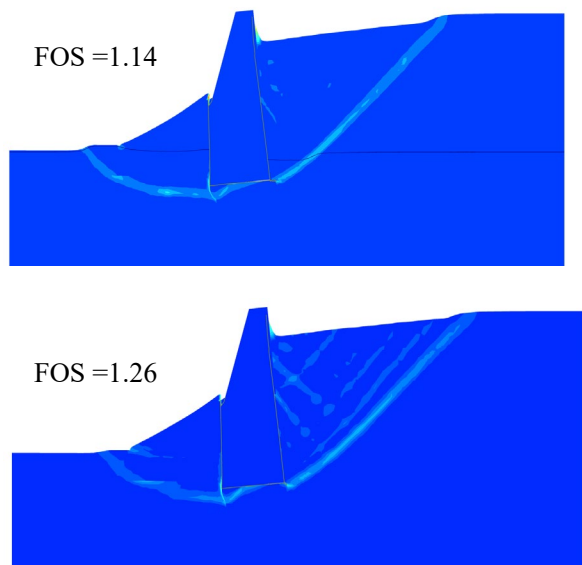
Figure 7. Failure mechanism for analysis carried out with and without ground water table in the vicinity

The factor of safety (FOS) of the curtain fort wall retention system, without the effect of water table in the fill area, is 1.26. However, the analysis which simulates

the water table at the top level of the fill results in a much lower factor of safety of 1.14. Unacceptable build up of water pressure behind the retaining wall is capable of endangering the safety of the fort wall and hence, can result in the collapse of wall due to overturning or basal sliding. The collapse of the bastion wall and the curtain wall can be due to the build up of water pressure behind the retaining wall.
