## Application of multipoint measurement using tilt sensor to slope failure and landslide monitoring

Lin Wang<sup>1</sup>, S. Nishie<sup>1</sup>, M. Fukuhara<sup>1</sup>, J.-J. Chang<sup>2</sup>, C.-W. Chen<sup>2</sup>, T. Uchimura<sup>3</sup>, and I. Towhata<sup>4</sup>

### ABSTRACT

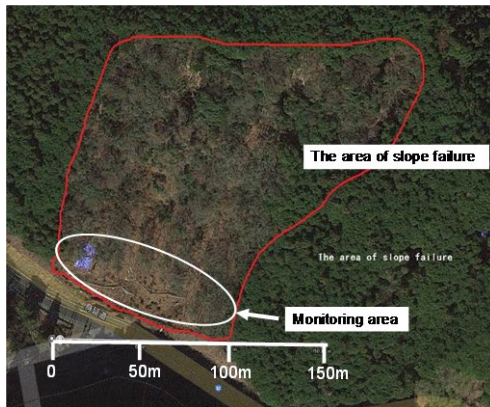
The Manzawa area in the Yamanashi Prefecture of Japan has a large scale reactivation of old slope failures featuring rockfalls that involve the detachment and rapid downward movement of rock.

Fig. 3. Area of slope failure at Manzawa site, Japan.

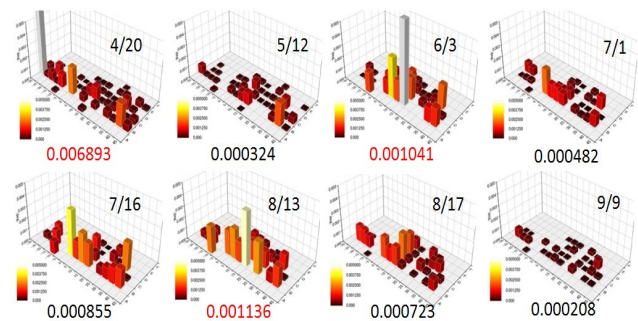
Fig. 5. Distribution of accumulated tilting rates during each rainfall event day.

The 66 sensor units are divided into three groups (Fig.4), left/middle/right zone, and one data receiver unit and one logger/gateway unit for internet collect all the data from respective group. There were eight heavy rainfall events during summer of 2015, and the tilting rate averaged during each rainfall event is shown in Figure 5. Distribution of tilting behaviors is demonstrated out by multi-point monitoring.

monitored slope, and  $\partial_n$  is a constant weight for the n-th sensor decided considering geology, geography, vegetation, and other factors, as the simplest example, values calculated with  $\partial_n = 1$  for all the sensors. The rain on 4/20, 6/3, and 8/13 caused relatively higher value of  $V_{alarm}$  in this case, but did not exceed precaution threshold of  $0.01^\circ/h$ . It means that this slope is not in emergency situation.

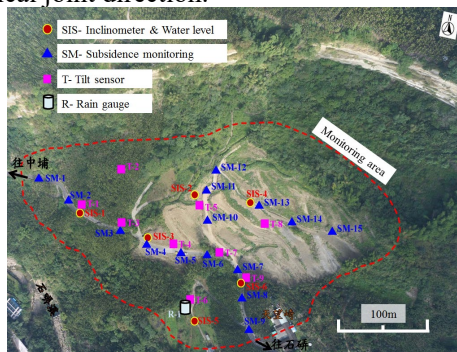
Multi-point tilting monitoring units were installed on a landslide site in Zhongpu, Chiayi County from Jun. of 2017. The slope is close to national route No.135-2, shows typical landslide phenomena, and is moving gradually after rainfall. Figure 6 shows the full appearance of slope, which consist of shale and sandstone shale interbed with shaly sandstone and limestone. The slope is sliding along the established geological joint direction.

Fig. 6. Arrangement of the tilt sensors on the moving slope of national route No.135-2

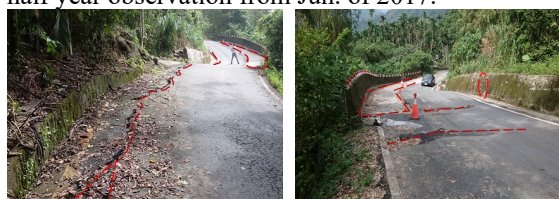
The cracks and lateral deviation of the retaining wall outside the national route No.135-2 is shown in Figure 7. The traffic was stopped by these damages.

Fig. 7. The cracks and lateral deviation of the retaining wall outside the national route No.135-2

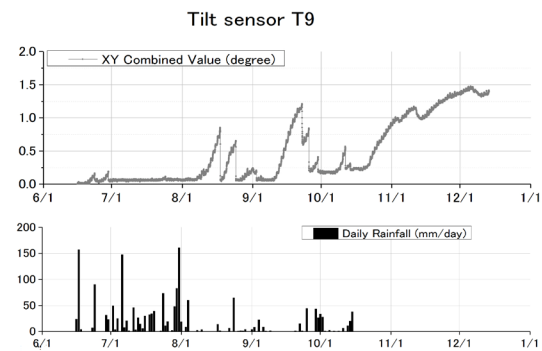
Figure 8 shows the results of XY combined inclination value and daily rainfall of tilt sensor T9 at the top of the slope, which is near the retaining wall where many cracks and lateral deviation happened. It was found that the rate of inclination clearly changed on rainy days based on a half year observation from Jun. of 2017.

Fig. 8. The inclination value and daily rainfall of tilt sensor T9 on top of Zhongpu slope sit, near to national route No.135-2

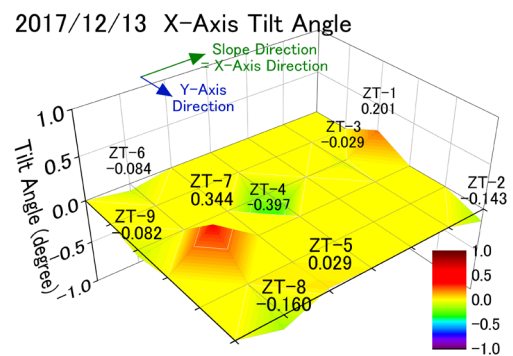
Fig. 9. Distribution of tilt angle at X-axis (slope) direction.

A three-dimensional view of the inclination distribution of slope direction is illustrated in Figure 9. The half year result shows that the head (Sensor ZT-9) and the bottom (Sensor ZT-1) of the slope had a relatively large incline toward the slope direction. A relatively large tilting/inclination also occurred in the middle part (Sensor ZT-4) of the slope toward the opposite direction of the slope. However, all cumulative tilt angles ( $TS-2 = 0.201^\circ$ ,  $TS-4 = -0.394^\circ$  and  $TS-9 = 0.082^\circ$ ) do not exceed 1 degree. At the same time it became clear that all values did not exceed  $0.01^\circ/h$  of the alarm value. Even so, the movement of the slope has not stopped. Therefore warning monitoring is still necessary.

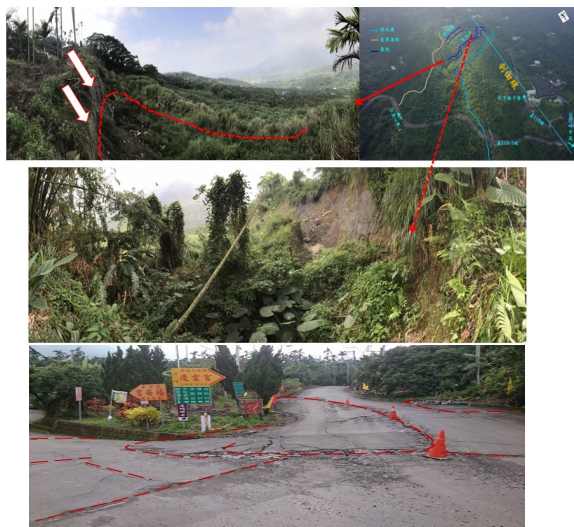
Another monitoring slope site is near to national route No.119 in Zhuqi, Chiayi County. Monitoring started with the same purpose as Zhongpu site (Fig.10). It also showed typical landslide phenomena of sliding down at top of slope, and cracks in the national route No.119 as shown in Figure 11.

Fig. 11. Head scarp at top of slope and cracks in the national route No.119

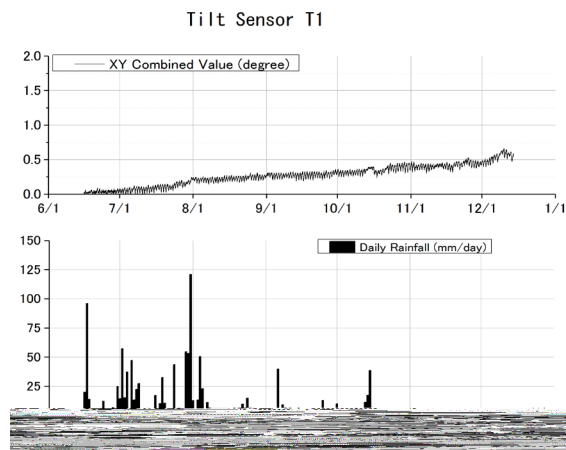
Fig. 12. The inclination value and daily rainfall of sensor T1

Figure 12 shows typical sensor T1 behaviors of XY combined inclination with time histories for which data were obtained from Jun. to Dec. 2017. Notably, sensor T1 is located intersection of route No.119, and constantly recorded the change of inclination regardless of rainfall.
