Geotechnical failures due to excavation in consolidating soft soils deposit

Paulus P. Rahardjo¹ and A. Lim¹

ABSTRACT

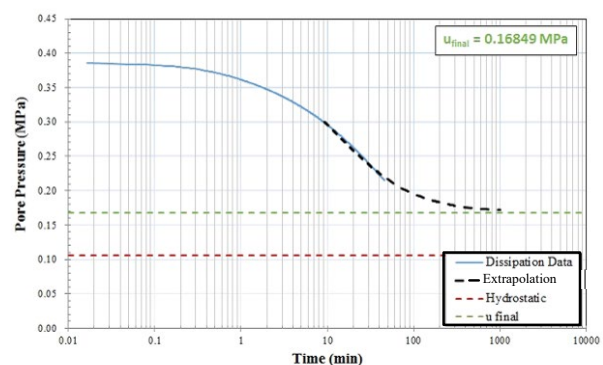
Fig. 1. The result of the dissipation test result of under consolidating the soil

hydrostatic pore pressure and the excess pore pressure, as shown in Fig 1. As for the under consolidating clay, the excess pore pressure consists of the excess pore pressure caused by the cone penetration and the residual excess pore pressure. It should be noted that, for the normally consolidate soils, the residual excess pore pressure is zero.

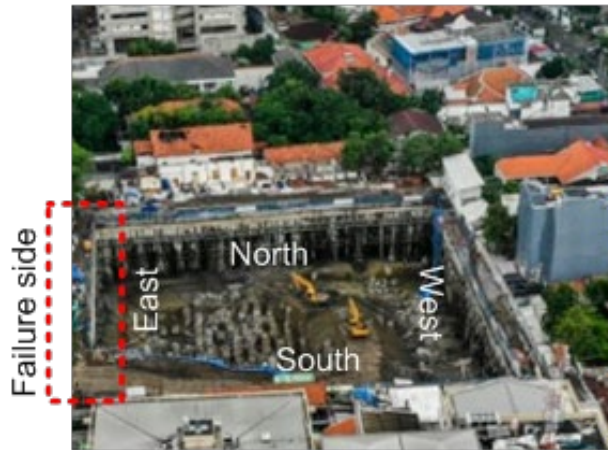
Fig. 2. Photo of the excavation site

The project is the development of mixed-use high-rise buildings consisting of one tower 22-story with three levels of basement. The excavation project was located in Surabaya, the capital city of East Java and it was surrounded by Gubeng road at East, and some low to medium-rise buildings (Fig 2(a)). Fig 2(a) depicts the aerial photo before the failure occurred. The photo was taken two days before the failure. The failure happened around 9 pm on December 18, 2018. Before the failure, in the afternoon, water was leak out from some holes of ground anchors. The water could not be stopped. At that time, the progress of excavation was

(a). Before failures

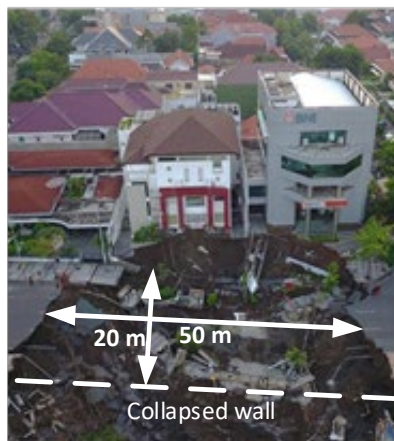
around -12 m. After the failure occurred (see Fig 2(b)), it destroyed about 50 meters along a section of Gubeng road, causing terrible traffic in the area. Also, a commercial store and a Bank are close because the access road to those buildings was collapsed.

(b). After failures

Based on the previous data, the excavation has been done in consolidating soft soil where excess pore pressure is still high. This uncovered excess pore pressure may be the cause of the failure. The seepage has occurred continuously bringing soil particles and causing internal erosions of the soils, which further loosening the anchor.

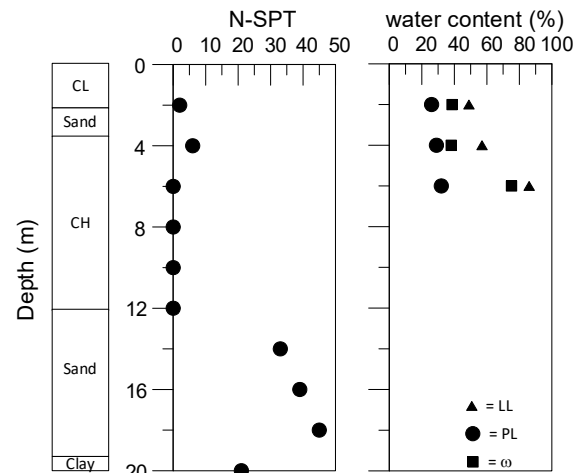
Fig 3. The result of in-situ testing

The excavation site mainly comprises of soft clay and sand layers. The in situ testing data was shown in Fig 3. The groundwater level observed during boring was located about -1.5 m below the ground surface. The soft clay with N-SPT = 0 was found from -4 m to -12 m. The data was consistent with the CPT data result (Fig 3b). The excavation depth was -18.0 m. For the protection of the excavation, two types of contiguous bored piles were used, and they are listed in Table 1. The and it was supported by contiguous bored pile combined (L= 32 m) with three levels of ground anchor. The illustration of the overall retaining wall system is shown in Fig 4. The length of ground anchors are varied from 28 to 35 m, and they were penetrated into the neighborhood area.

(a).The N-value and Atterberg limit of the project

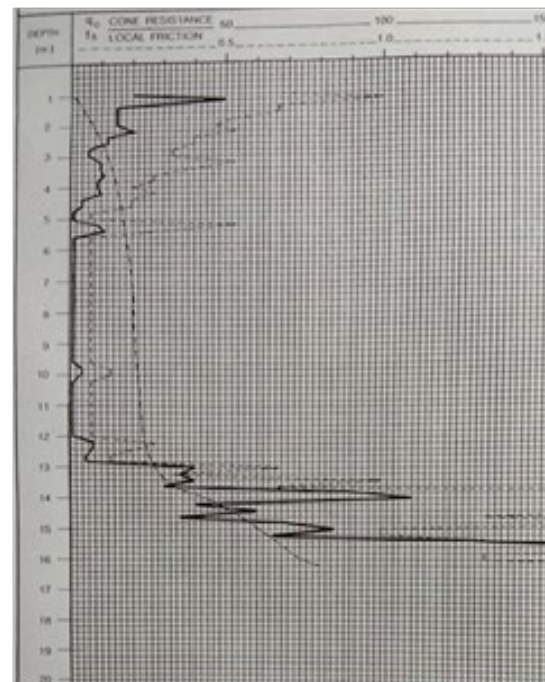
(b).The CPT reading

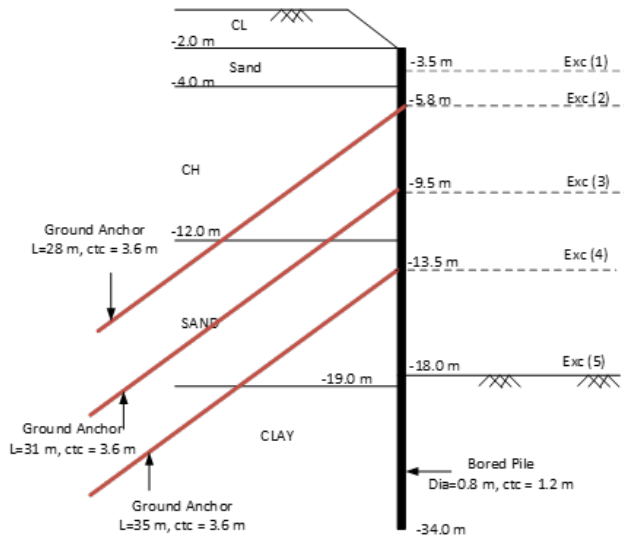
Fig 4. The excavation profile and soil stratification

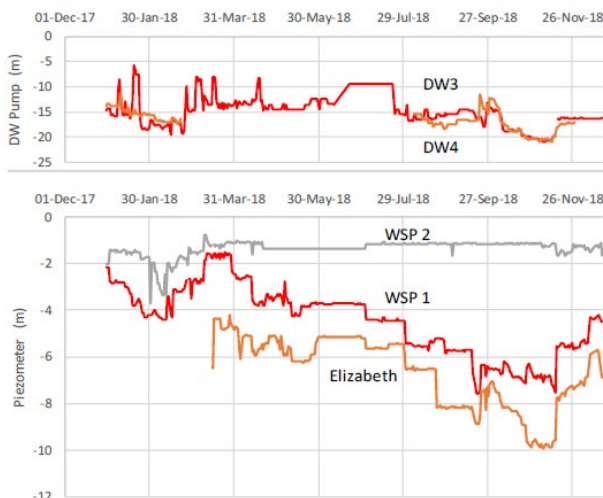
The data measured including piezometer, inclinometers, and settlement markers. Fig 5. shows the elevation of the water table at the dewatering well and at a specific location. The difference of water table is an important factor in the stability of the retaining structures.

Fig 5. The monitoring of groundwater level

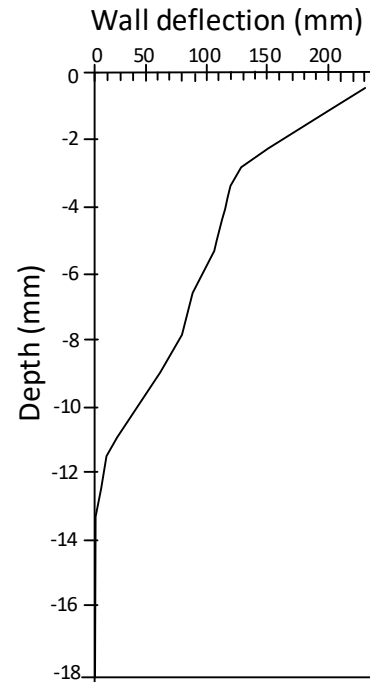
Fig 6 shows the record of inclinometer at the nearest section to the failure wall. The latest reading was taken about 4 months before the failure occurred. As shown in Fig 4, the maximum wall displacement was around 200 mm. This movement was considered very large. If the excavation depth was about 6 m at that time, then the $\delta_{hmax}/H_e = 3.33\%$. According to Indonesian Geotechnical Code, the maximum movement of the wall should be limited on 0.5%. Hence, the large movement was one indication that the retaining wall system has a problem from the beginning of construction.

Fig 6. The reading of inclinometer at 4 months before failure

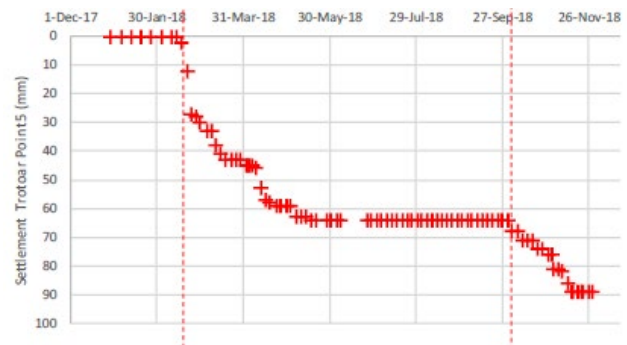
Other data that is of main concern is the settlement of the pedestrian adjacent to the project as shown in Fig 7. The maximum ground settlement is about 90 mm before the accident occurred.

Fig 7. The ground settlement measurement data
