Cyclic drawdown of water causing the slope failure of canal and dam

Suttisak Soralump¹, P.W. Noppadol², K. Panthi³ and J. Sanmuang⁴

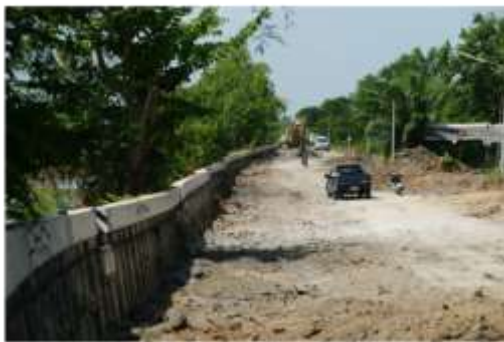
several possible causes of failure, on the basis of information available, it was hypothesized that the failure had occurred due to sudden drawdown of water due to prolong drought. The fluctuation of water level in canal is presented in Figure 9.

Figure 7 : Failure of embankment along Canal Bank

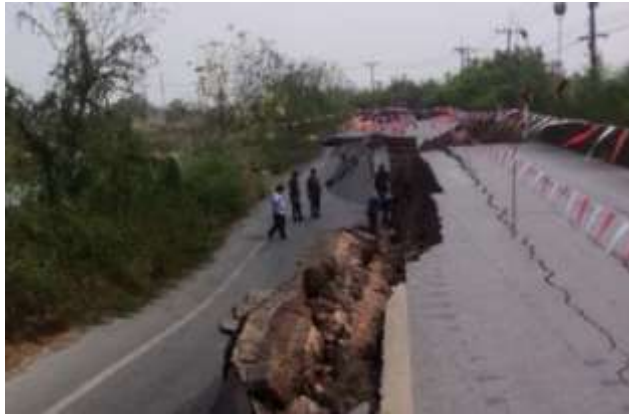
The movement of the slope was also observed at the different section of the canal. The behavior of the soil was tested in centrifuge model (Figure 11) with actual variance of the water level (Sasingha & Soralump, 2017) . The failure of the slope is shown in Figure 10 . After the slope movement, test was conducted by using the pile and without the use of pile. It was found out that the pile can be used for the stabilizing the slide slope

Figure 10: Failure of Road Along the canal (Sasingha & Soralump, 2017)

1. Increase the required FS during the design for the case of sudden drawdown. This methods helps in minimizing the strain movement in each drawdown cycle.
2. Strengthening the slope can be carried out by the use of piles (He, Hazarika, Yasufuku, & Han, 2015). This has been successfully done in many road along the irrigation canal in soft Bangkok clay area. Short wooden piles were used to reinforce the slope and reduce accumulation.

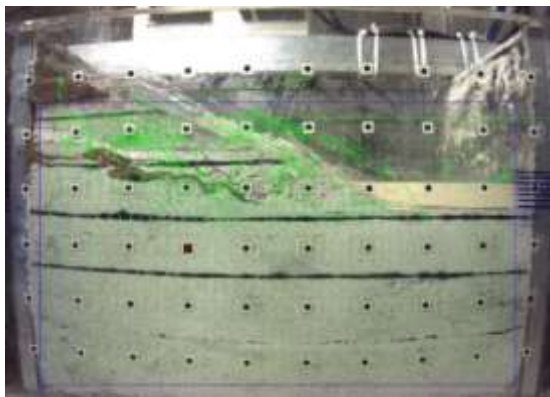
Figure 11: Photo of centrifuge testing to simulate the effect of repeated drawdown

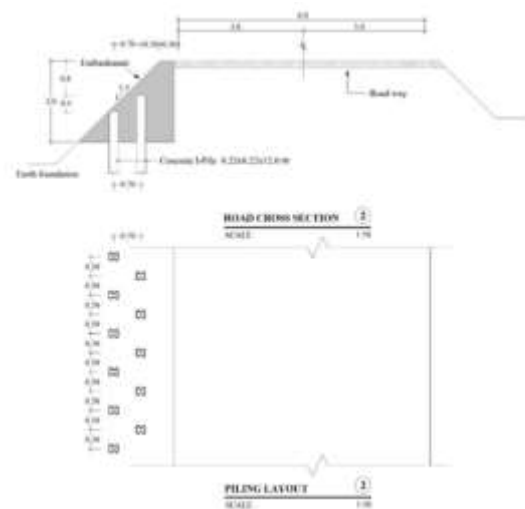
Figure 12: Reinforcement of Slope using Short Wooden Piles
