The effect of fracture zones on a failed reinforced soil wall induced by severe ground motions during the 2016 Kumamoto Earthquake

Keywords: 2016 Kumamoto Earthquake; reinforced soil wall; gamma-ray survey; failure mechanism

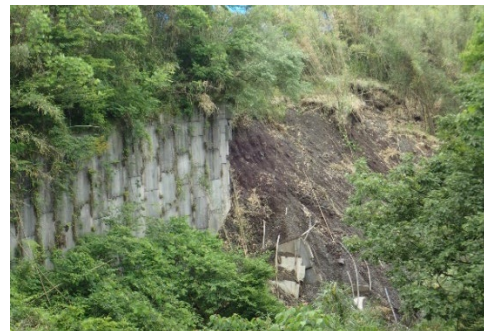
The characteristics of the damages revealed that severe ground fluctuations constructed on active faults and the related fractured zones were responsible for the damages rather than the ground motion arising from the earthquakes. The reinforced soil wall in southern Aso mountains district had totally failed while the adjacent wall remained intact despite being subjected to the same ground motion as shown in Photo. 1.

Photo. 1. Adjacent failed and remaining reinforced soil wall

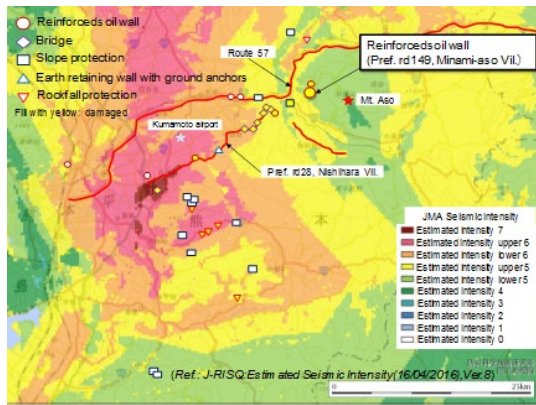
Fig. 1 shows the relationship between the damaged structures and seismic intensity distribution in Kumamoto Prefecture after the main shock of 2016 Kumamoto Earthquake. It is not clear from the damages whether they are due to a pre-quake or a main shock, because the disaster survey was conducted after the main shock. The yellow areas in Fig. 1 illustrate severely damaged structures. The failed reinforced soil wall studied in this paper was situated between the lower 5 and 7 seismic intensity zones. However, undamaged structures were also found in the same zones. Most damaged structures were found along the

Fig. 1. Relationship between damaged structures and seismic intensity distribution after 2016 Kumamoto Earthquake

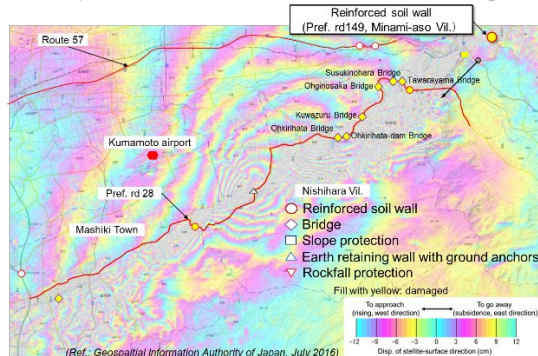
Fig. 2. Relationship between the crustal deformation map analyzed by interference SAR (GSI) and damaged structures

Prefectural road 28 despite the magnitude of the seismic intensity being different. Fig.2 shows the relationship between the crustal deformation map analyzed by interference SAR (GSI) and the damaged structures. As shown on the map, the failed reinforced soil wall in the southern Aso district was situated just in the large crustal deformation area.

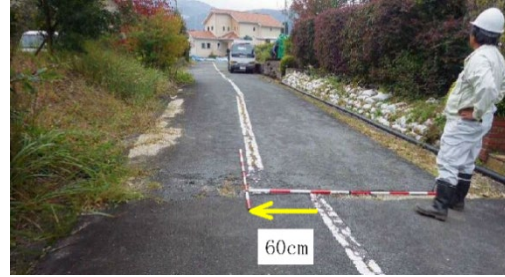
Photo. 2. Horizontal crack displacement, 60cm at point (a)

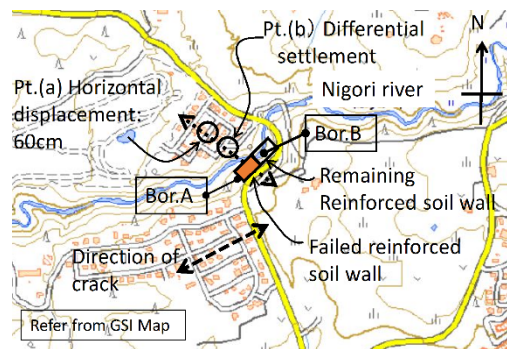
The failed reinforced soil wall is located on Minamiaso, as shown in Fig. 1, and constructed along the Nigori-river of prefectural road No.149. The area was affected by the earthquake induced from the Futagawa fault. Many distinctive cracks, differential settlements, and displacements of the surrounding ground adjacent to the wall were observed, as shown in Fig. 3. In residential areas of right side of Nigori-river, horizontal crack displacement of 60cm on the the pavement at point (a) in Photo. 2 and the differential settlement at point (b) was observed as shown in Fig. 3. The failed reinforced soil wall is located on the line extending in the NW-SE direction connecting these points. On the other hand, in residential areas on the left side of Nigori-river, many cracks and differential settlements with right lateral displacement in the WSW-ENE directions are observed. These directions coincide with the Futagawa Fault, and are conjugate of the NW-SE direction. Fig.4 shows a plan view of the damaged reinforced soil wall. The reinforced soil wall had failed

Fig. 3. Ground damages around failed reinforced soil wall

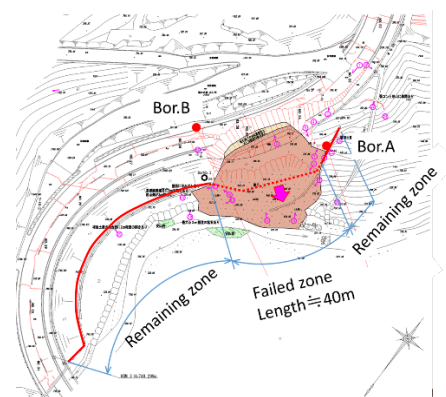
Fig. 4. Plan view of failed and non-failed reinforced soil wall

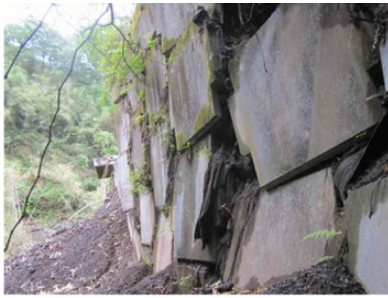
zones on the same wall surface. The features of the reinforced soil wall are as follows: 1) there is a river in front of the wall, and gravity type concrete wall was used for the foundation, 2) in the planar face, the zone where the wall curves to the front side failed, 3) the cross section of the failed zone had a two-step upper embankment; the remaining zone had one step, 4) in the failed zone, a free-standing facing condition was observed with direct sliding movement as shown in Photo. 3.

Photo.3. Self-standing facing of failed reinforced soil wall

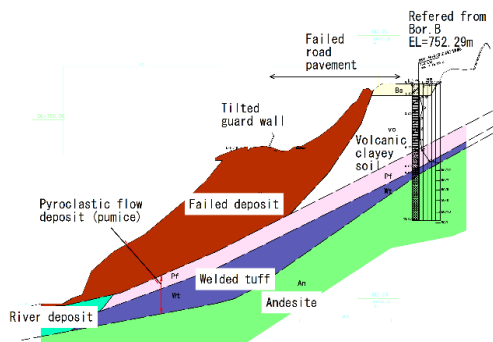
The vertical reinforced soil wall was constructed using integrated band steel-strips and high frictional angle embankment soil. Reinforcements and facings were put in place twenty years after construction, and no degradation was observed in the reinforcements and facings of the wall. Fig. 5 shows the estimated stratum cross section in the failed zone of the reinforced soil wall. The andesite rocks in the base layer is inclined towards the river. The volcanic cohesive soil layer and the collapsed soil layer are deposited on the base layer.

Fig. 5. Stratum cross section at failed reinforced soil wall

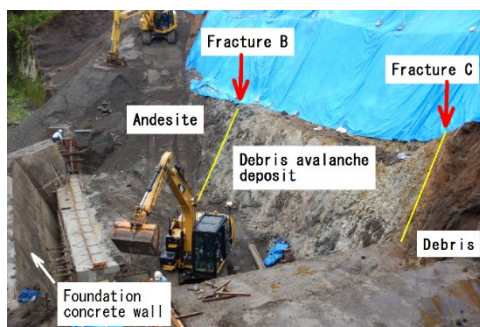
Photo. 4. Appearance of fracture B and C during excavation work

The inclination of the base layer cannot be assumed to affect the failure of the wall. During excavation works for the reconstruction of the reinforced soil wall, two fractures were observed as shown in Photo. 4. These were fracture B between the andesite and the debris avalanche deposit, and fracture C between the debris avalanche deposit and the old debris talus deposit. In the failed zone, a residual horizontal movement of 3cm toward the mountain side was confirmed at the construction joint of the foundation gravity wall as shown in Photo. 5. This demonstrates the intense ground motion that occurred under the reinforced soil wall induced from the soil stratum and fracture condition.

At the beginning, it was assumed that the retaining wall founded under the reinforced soil wall collapsed by a horizontal inertial force due to the earthquake. The foundation wall remained stable without damages as shown in Photos. 4 and 5. In addition, the groundwater and seepage flow were not observed on this site. The grain size distribution test, which was carried out to check the performance of the banking material quickly, showed results that contained fine fracture and the friction angle of the soil satisfied the standard ($F_c=8\% < 25\%$, $\phi=41^\circ > 30^\circ$) respectively.

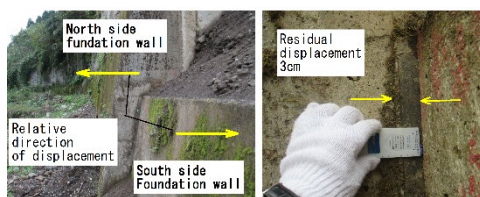
Photo. 5. Residual horizontal displacement toward mountain side induced by intense ground motion

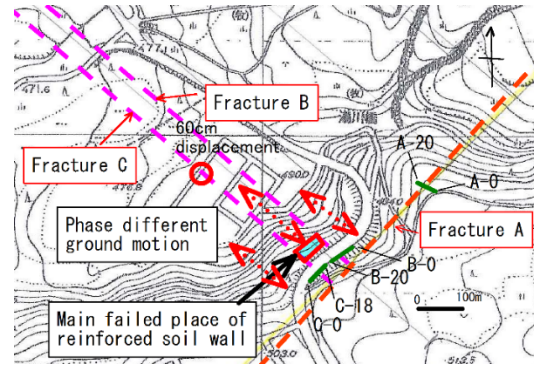
Fig. 6. Fractures distribution confirmed by gamma-ray survey

wall was located directly above the area surrounded by three fractures (fracture A, B, C in Fig. 6), the failure was influenced by complex ground fluctuations at the time of the earthquake. In the vicinity of Minami-Aso village, a passive earthquake fault, inactive fault induced by the earthquake motion of the Kumamoto earthquake, was observed. It is inferred that the three fractures confirmed by the gamma-ray survey are also inactive faults.

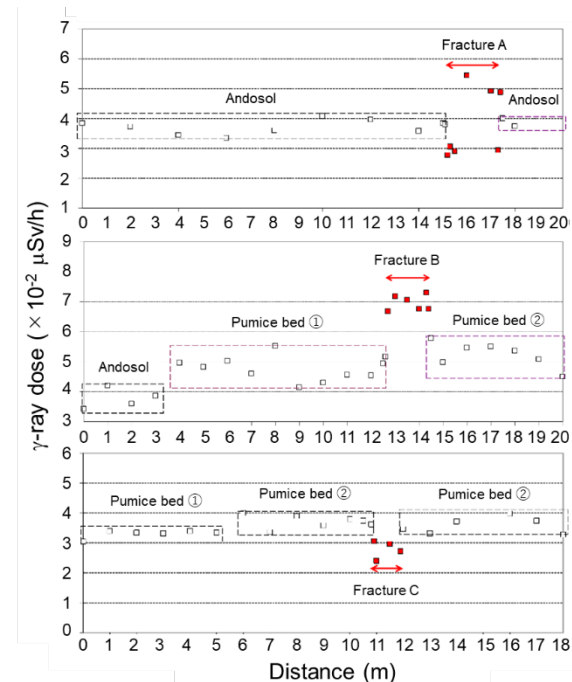
Fig. 7. Relationship between gamma-ray intensity and distance

Yoshimura et al (2012, 2013) proposed the gamma-ray survey method for finding geological weak fractures such as faults, rock joints, and splits, for the design of infrastructures. From topographic analysis, three lineament structures were estimated around the area. Gamma-ray surveys were conducted in directions traversing those lineament structures. Weak gamma-ray radiation of natural origin is emitted from rocks on earth. In original grounds and/or rocks that have undergone fracture phenomenon due to crustal deformation, the magnetism of the substance changes, resulting in an abnormal gamma-ray intensity. Gamma-ray intensity can be measured by using a scintillation survey meter. Fig. 6 shows the locations of three fracture zones (A, B, C) from a gamma-ray survey during reconstruction works. Fig. 7 shows the relationship between gamma-ray intensity and the measured distance in fractures A, B and C. From the measured results, the width of fracture A was 2.2m (N 40° E), fracture B was 1.5m (N 50° W), and fracture C was 0.8m (N 50° W). Since the reinforced soil

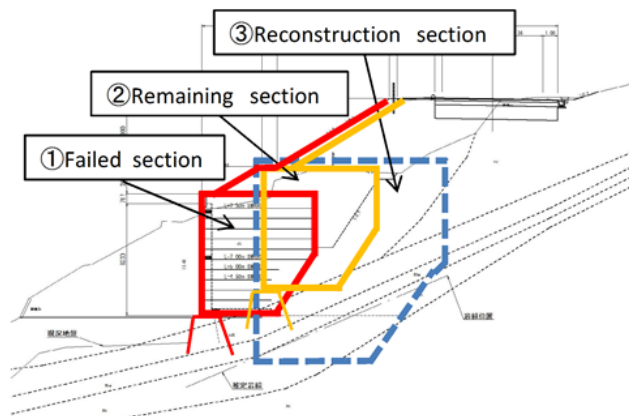
Fig. 8. Cross sections of failed, remaining and reconstruction of reinforced soil wall

Fig.8 shows estimated cross section of the failed wall (①), remaining wall (②) and reconstruction wall (③). ② signifies a perspective of an adjacent wall to the failed wall. And ③ represents a cross section of the wall reconstructed after the earthquake. Safety factors against sliding of the reinforced zone had calculated as 1.20, 1.24 and 1.45 for large scale earthquake in cases ①, ② and ③ sections respectively. This means that the safety conditions were sufficient under the limit equilibrium calculations. As mentioned above, the failed reinforced soil wall was surrounded by three fractures. It is, however, believed that not only were the seismic inertia forces in the reinforced zone, backfill and the overburdened embankment zones responsible for the collapse, but also the phase difference in the ground motion induced from non-active fractures affected to the collapse as shown in Fig. 9. Intense ground motion produced forces that pushed the reinforced soil wall forward, and finally

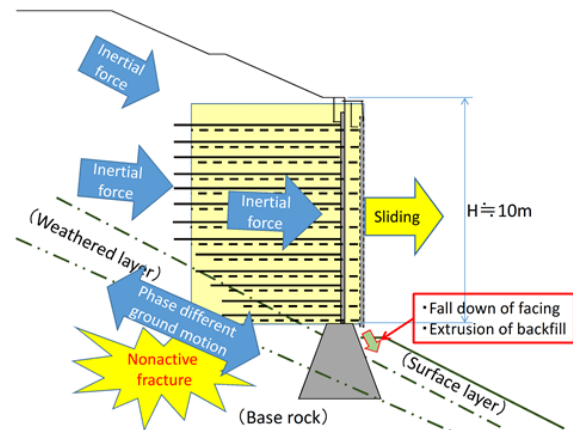
Fig. 9. Three seismic acting forces affection the failed wall

resulted in its fall from the gravity foundation wall.
