## Geotechnical assessment on the failure at Meethotamulla waste fill in Sri Lanka

Asiri Karunawardena<sup>1</sup>, S.H.S. Jayakody<sup>1</sup>, G.D.W.N. Galhena<sup>1</sup>, and S.A.S. Kulathilaka<sup>2</sup>

<sup>1</sup> National Building Research Organisation, 99/1, Jawatte Road, Colombo 05, Sri Lanka.

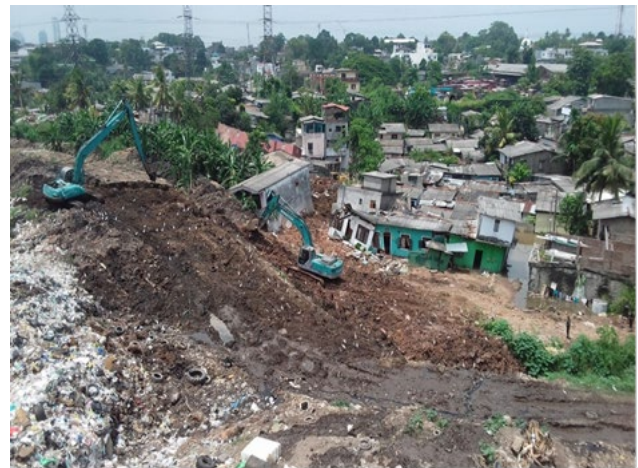
The garbage mound located at Pothwillkumbura, Meethotamulla, collapsed on 14<sup>th</sup> April 2017 at 14.45 hrs., destroying houses and infrastructure situated at the toe region of the south-western side of the garbage mound. According to the situation report of “Meethotamulla Municipal Solid Waste Dump Disaster” by the Disaster Management Center, 60 houses have been completely destroyed, 27 houses partially damaged while 32 bodies have been recovered from the damaged area. According to the Meteorology Department, about 100 mm rain fall had been received during the period of 11<sup>th</sup> – 13<sup>th</sup> April 2017. Due to the heavy rains experienced on two consecutive days, part of the southern slope of the waste dump site has failed and many houses situated at the toe region of the failure had been totally pushed away and damaged (Fig. 1). The on-site observations and aerial images after the incident show that the slope of the waste fill had collapsed at its crest height, and the collapsed mass had almost moved down and subsided, while the toe region of the slope had upheaved.

Fig. 1. Damage due to the failure of the garbage fill

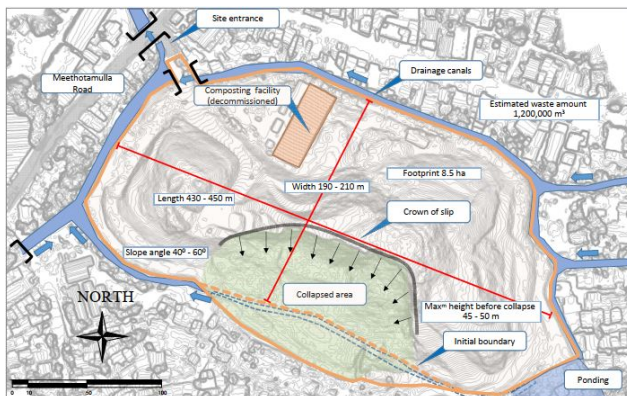
Fig. 2. Detail representation of the site after collapse

The spatial data obtained from the drone survey shows that at the time of collapse, the dump has occupied an area of 78,000 m<sup>2</sup>, having a maximum length of approx. 413 m in the NW to SE direction and a approximate width of 189 m in NE and SW direction. The maximum crest height of the mound was in the range of 45-50 m. At this height, the garbage placement has made a ridge like shape in the NW to SE direction, and its slope inclination towards SW direction was in a range of 40°-60° (Fig. 2). Compared to the failed segment of the waste fill, the rest of the segments were low in height and inclination.

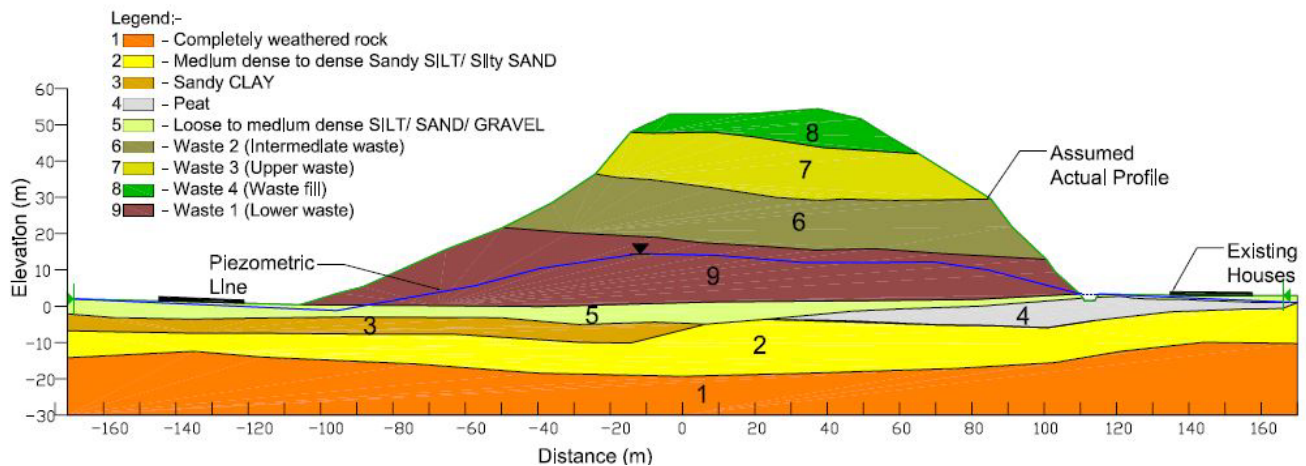
The strength parameters and the unit weight for underneath soil layers of the waste fill were estimated from the borehole investigation carried out at the site in 1998, 2012 and the past experiences related to the similar type of soils present in Sri Lanka as shown in Table 2. The sub-soil profile drawn based on borehole in the site shows that the top most layer is soft peat/clay with a thickness varying from 2-8 m overlain by a residual formation. The assumed full cross-section across the waste fill together with the subsoil profile and waste profile is shown in Fig. 3.

Fig. 3. Assumed full cross section across the waste fill together with the subsoil profile and waste profile

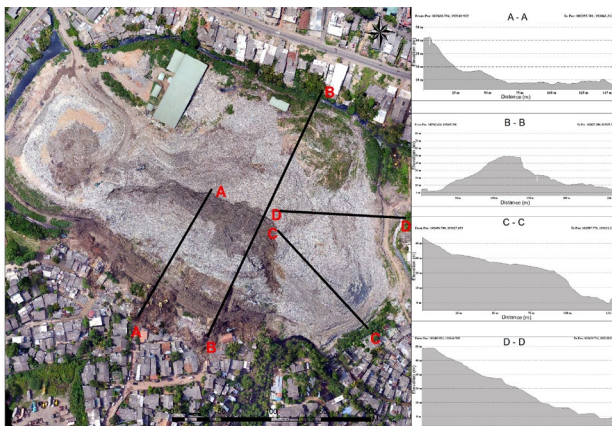
Fig. 5. Selected sections for the stability analysis

The Factor of Safety values calculated for the critical failure surfaces for each cross-section is presented in Table 3. The results clearly show that factors of safety of 0.807 and 0.932 were low at the failed sections A- A and B-B respectively, where waste was dumped at the time of failure. Also, the factor of safety of 0.813 calculated for the section C-C revealed that section C-C was also in an unstable condition although it did not collapse. The appeared cracks on the garbage fill on that section confirmed that it was also in

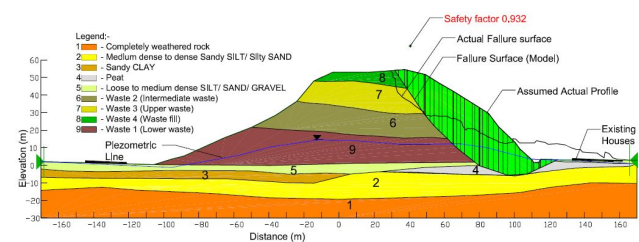
Fig. 4. Results of the stability analysis along the failure section

Stability analysis was carried out for the cross-section obtained through the drone survey and the material properties given in the section 2.1 and 2.2. The analysis was carried out using GeoStudio 2016 from Geo Slope. The Spencer method was utilized in the analysis as the actual slip surface geometry of the failure was irregular in shape. As shown in Fig. 5, the instability occurs at the Right Hand Side (RHS) of the section (where exact failure took place) and further, the failure predicted by the model conforms to the actual failure conditions. Therefore, the model seems to be capable for analyzing the section with the assigned parameters of the sub-soil and waste.

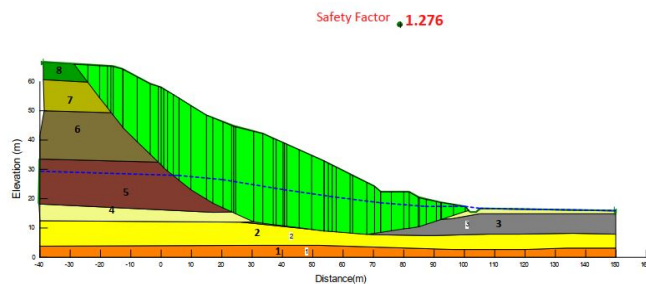
According to the results, Section D-D and LHS of the Section B-B stay at stable condition relative to the other sections with a higher factor of safety greater than 1.25. The results of the stability analysis carried out along the Section D-D is shown in Fig. 6.

Fig. 6. Results of the stability analysis along the section D-D

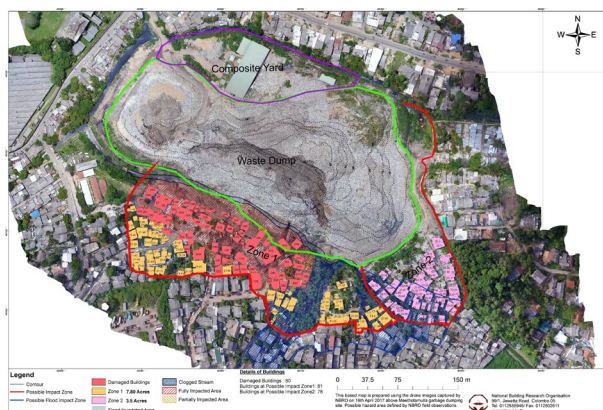
Fig. 7. Impact area map if Meethotamulla waste fill slide

The area demarcated by the red line was considered a high risk zone and the houses located within that area should be kept free from human occupation and recommended to be relocated. Also, it was advised not to carry out future development activities in that areas under the present condition. Based on the analysis results, the other areas seemed to be at relatively low risk. However, if the geometry of the waste fill is changed, the toe region is disturbed or the drainage conditions are altered without following correct stability norms, the low risk areas that are relatively stable at present may also become unstable.
