## Assessment and mitigation of earthquake-induced landslides in Philippine infrastructure

Jenna Carmela C. Pallarca<sup>1</sup>, M.P.V. Follosco<sup>1</sup>, R.A.C. Luna<sup>1</sup>, R.D. Quebral<sup>1</sup>, J.E.B.D. Santos<sup>1</sup>,  
and R.E.B Cabungcal<sup>1</sup>

<sup>1</sup> AMH Philippines, Inc., University of the Philippines, Diliman, Quezon City, 1101 Philippines

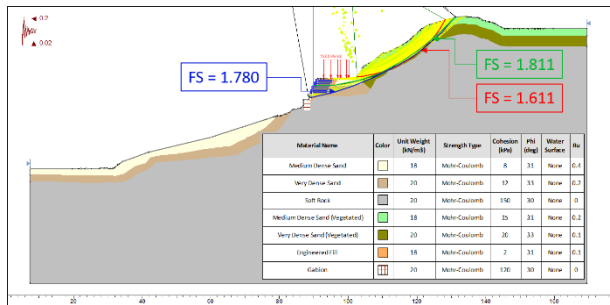
The models in the succeeding figure present the slope stability analyses carried out for the landslide section with slope protection. A portion of the roadway was rebuilt by placing engineered backfill materials on the failed section of the slope. The backfill is then retained by using MSE wall with gabion facing. The summary of the MSE wall geometry is presented in Table 3, while Table 4 shows the recommended bond strength (adhesion and friction angle) for the type of engineered fill.

Figure 1. Slope Stability Analysis for a landslide section with MSE wall.

Some sites where the roads were damaged and cut-off by a deep-seated landslide also needed to be rebuilt. In these cases, mechanically stabilized earth (MSE) walls were proposed (in lieu of conventional reinforced concrete walls. Rigid walls are evidently costly for slopes with high and steep geometry; hence, flexible retaining structures were adopted.

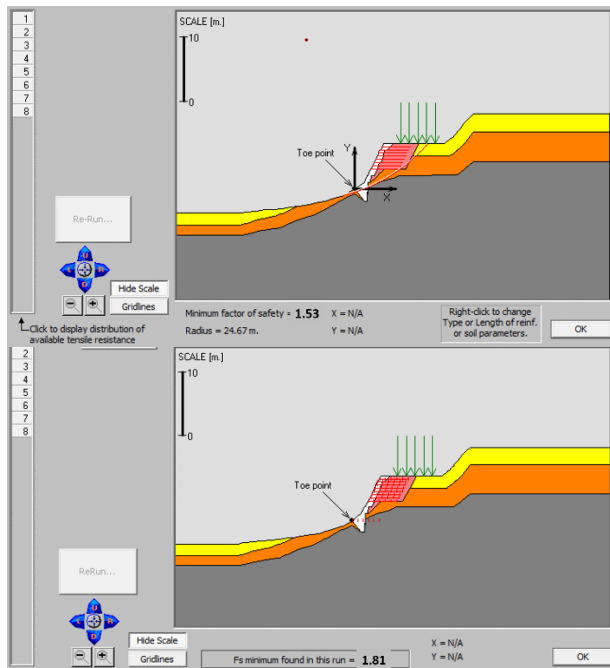
Stability checks were also conducted for the section. ReSSA 3.0 was then used to calculate the factors of safety against rotational and sliding failure. Factors of safety for sliding (FS=1.5) and rotational slip (FS=1.5) were used to check the external and internal stability. Figure 2 shows the results from the ReSSA runs.

Figure 2. Stability checks for the MSE wall. (a) Rotational (b) Sliding.

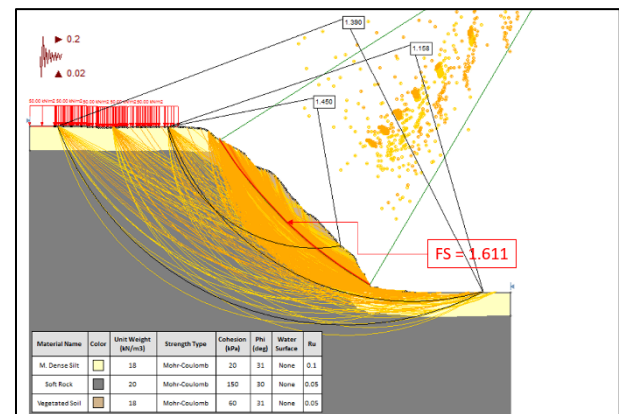
Some slopes were observed to have tension cracks, even as no slope failures have taken place. For these sites, and for sites where constructability is an issue (due to the sheer height of slopes), cut-off walls by utilizing micropiles were recommended. The succeeding figure shows the analysis of a slope with tension crack near a structure.

Figure 3. Slope Stability Analysis for an area with tension cracks.

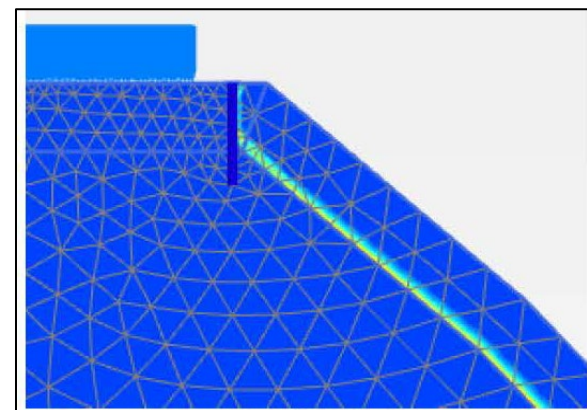
The design consideration is to confine the slope movements outside of the cut-off wall, and the protection of the existing structure as the primary consideration. Deformation analysis using Finite Element Method (FEM) was undertaken, to approximate the slip circular planes at several stages leading to the failure of the slope. Figure 4 presents the effect of the micropile (b) on the slope. The micropile was able to act as a cut-off wall such that the slope movement was confined outside of the structure. The resulting deformation at the top of the micropile was kept at tolerable limits (approximately 30mm), mitigating damage on the structures and plant operations.

Figure 4. FEM results of engineered slope.
