## Safety inspection and reinforcement of South-link line railway tunnels

<sup>1</sup> Geotechnical Engineering Department, Sinotech Engineering Consultants, Ltd., 171, Nanking E. Rd., Sec. 5, 10570, Taiwan.

### ABSTRACT

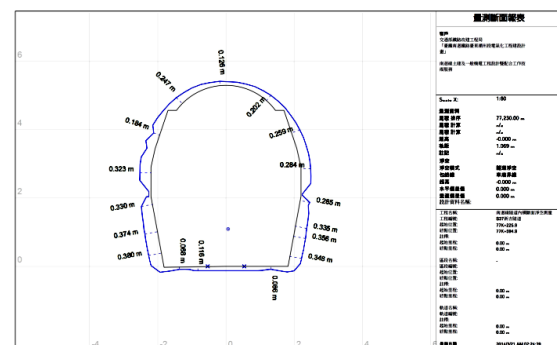
Fig. 3. Cross-section Inner Clearance Diagram

The results of the tunnel section overlapping showed that there were insufficient clearances in many sections. In order to accurately understand the thickness of the ballast for confirming whether there was enough space for adjustment to meet the electrification demand, the samplings for the thickness of the ballast were executed. The results showed that most of the thicknesses of the ballasts were over 25 cm except for partial sections.

In order to establish the electrification system, the clearance requirements for tunnels are stricter than non-electrical sections. The assessment of clearance sufficiency is based on the regulations from Taiwan Railways Administration. Rail level lowering will be the first choice for insufficient inner clearance. If the rail level is impossible to lower, it will be delivered to the future electrical system contractor to solve.

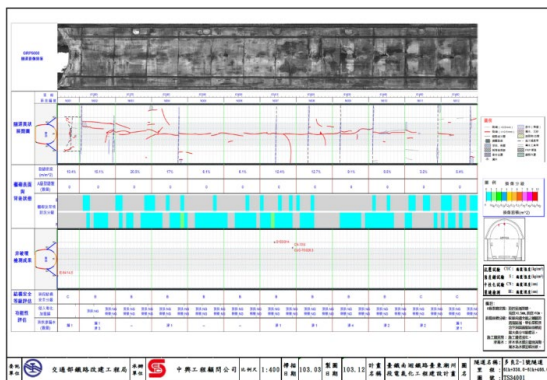
Fig. 4. Lining Condition Interpretation Diagram

After the digital images were completed, they will continue processing the abnormal areas interpretation, including: cracks, spalls, leakages, rebar exposures, and water proof facilities failure. In addition to record the distribution of the abnormal areas and classify the degree of the damage, it is also transformed into a lining condition interpretation diagram (Fig. 4), which provides a reference for visual review, statistic, and safety evaluation. It offered great help for the design and the execution of repair and reinforcement.

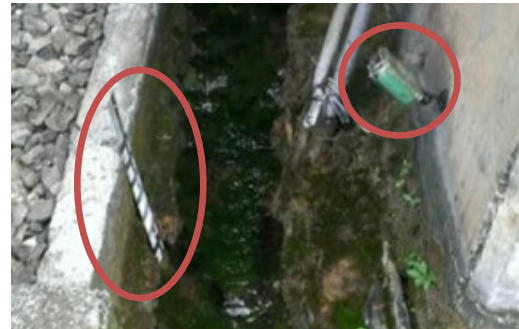
Fig. 5. Drainage Outflow Monitoring

There are 3 kinds of monitoring held in the tunnels for tracing the development and the variation of the ground water, the cracks, and the inner clearances. They are drainage outflow monitoring (Fig. 5), crack development monitoring, and cross-section convergence monitoring.

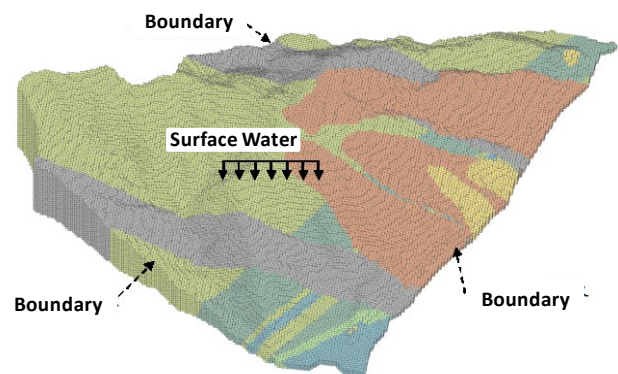
Fig. 6. 3D Hydro-geological Model (Daniao Tunnel)

According to the site investigation, the telemetry image interpretation, and the tunnel inspection, some tunnels were built closely to slope surface. Therefore, they have problems with shallow cover and stress bias. Lining cracks and leakages are easily found in the tunnels, especially during heavy rainfall. These phenomena may due to tunnel position, geological condition, and the impact of climate change. Among the tunnels of South-link line, the Daniao tunnel, the Dawu No.2 tunnel, the Jinlun tunnel, and the Duoliang No.2-1 tunnel, are with more serious leakage problems. Thus, hydro-geological analysis is applied.

The 3D hydro-geological analysis of the above 4 tunnels combines surface water system, regional geological structure, and strata orientation to construct a conceptual model (Fig. 6) to simplify the complex geographical environment. The model is integrated with the hydro-geological parameter setting and regional groundwater flow analysis to conduct regional groundwater environmental impact assessment.

Most of the South-link line railway tunnels are designed and constructed by traditional methods. Most of them are not equipped with water-proof facilities. Therefore, the water-stopping measures may not completely solve the leakage problems. The principle of "water-conducting first, then water-stopping" is adopted to treat the leakages.
