A case history of structures constructed on expansive soils

John D. Nelson¹, D.C. Garcia¹, E.J. Nelson¹, and K.C. Chao²

¹ Engineering Analytics, Inc., Fort Collins, Colorado, 80528, USA

A case history is presented that documents distress, and lessons learned from the failure of foundations constructed on a site with highly expansive soils. Eighteen (18) multi-story buildings were constructed on post-tensioned concrete slabs-on-grade founded on engineered fill. The pre-construction soils report recommended that the in-situ expansive foundation soils be over-excavated, moisture conditioned, and recompacted. A few years after the structures were constructed the buildings began to show signs of distress in the form of drywall cracking, foundation heave, and racked doors. Differential movement as large as approximately 100 mm (4 in) was observed in the slabs. Calculated values of future heave ranged from 160 to 225 mm (6.4 to 8.9 in) with one value of 530 mm (20.8 in). The site is located in a semi-arid environment and was irrigated after development. A well irrigated golf course was located on an adjacent property. Several of the buildings were located parallel to the golf course pr

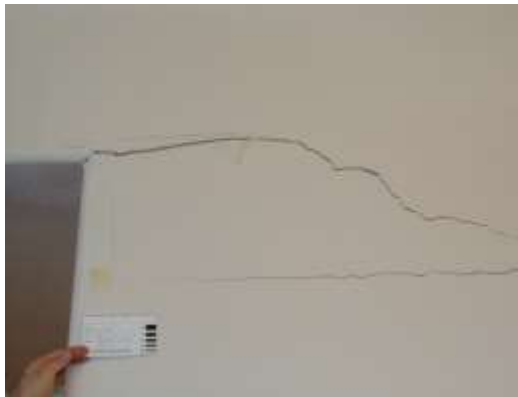
The project consisted of 18 multi-story residential structures that were constructed on post-tensioned slab-on-grade foundations. The structures were constructed over a period of several years beginning in about 2003. Shortly after construction, distress began to occur. Distress was caused by the differential heave of the expansive claystone. It took the form of mild to very severe cracking in the interior walls and differential movement of the slabs. An example of the cracking is shown in Figure 2.

Figure 2. Example of Severe Cracking of an Interior Wall

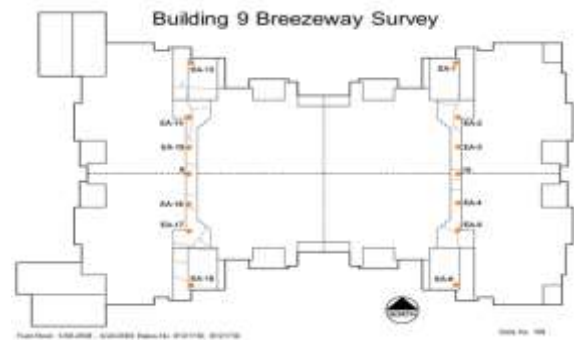
Figure 3. Typical Building Footprint With Survey Locations of Survey Points in Breezeways

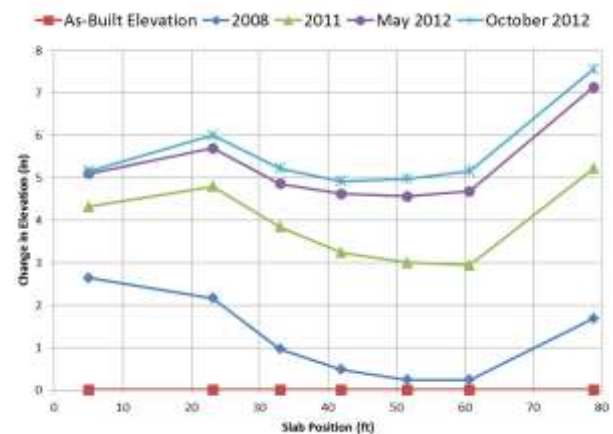
A typical building footprint is shown in Figure 3. The breezeways between the units were convenient locations in which to conduct elevation surveys to monitor the shape of the slabs. The results of one such survey are shown in Figure 4. In that figure, it can be seen that the heave continued to occur over time with heave in amounts up to 190 mm (7.5 in) over a period of about 9 years. The heave shown in Figure 4 is that of the post-tensioned slabs and is representative of the heave encountered inside the units.

Figure 4. Breezeway Survey Results for Building 9

Those computations used limited data from the shallow (6 m; 20 ft) borings. In the forensic investigation, data from the deeper borings performed by EA were used to compute the remaining heave. Values computed using the data from the 2008 borings ranged from 66 to 114 mm (2.6 to 4.5 in). The data from the 2011 borings yielded values ranging from 160 to 225 mm (6.4 to 8.9 in) with one very high value of 530 mm (20.8 in). Those values represent future heave that would occur in addition to that which had already occurred. As shown in Figure 4, heave in amounts up to about 190 mm (7.5 in) had already occurred by 2011.
