Stabilizing a highway in the fragile Himalayan terrain – Case study of Gulabkoti landslide

ABSTRACT

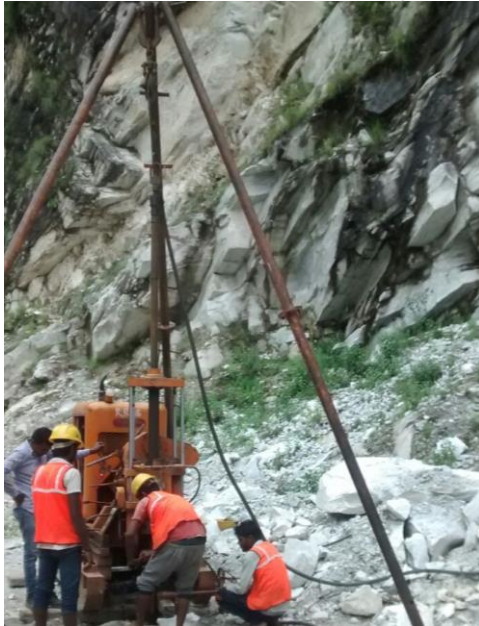
Fig. 2. Drilling in progress

Fig. 2 presents a photograph of the geotechnical investigation in progress. The steeply dipping rocks on the hill-side and the rock pieces that have fallen down as a result of the slide is depicted in Fig.2.

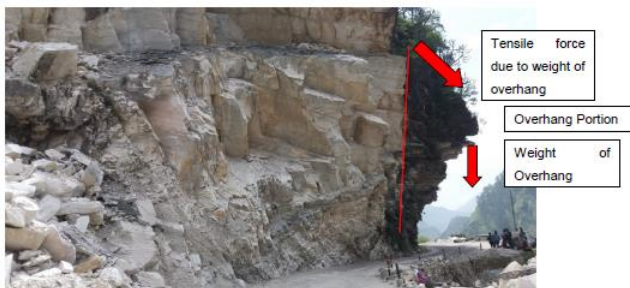
Fig. 7. Rock Overhang at Gulabkoti

The site comprises of heavily jointed rock mass with weak planes along the foliation. At places, tensile force was developed in the rock-mass overhangs due to weight of the overhang. The fractured rock mass is prone to collapse, particularly if water seeps through the joints. Fig. 7 shows the overhanging fractured rock-mass.

After cutting the hill side between Ch 464+400 and Ch 464+430, rock-fall was arrested with a system of secured drapery i.e with nails and high-resistance mesh.

The system was composed of anchors (steel bars), to stabilize the slope and a mesh which contains the debris or the rock blocks that might move between the anchors. The system, illustrated on Fig. 10 is passive, because both mesh and anchors start to develop resistance if one or more blocks start to move.

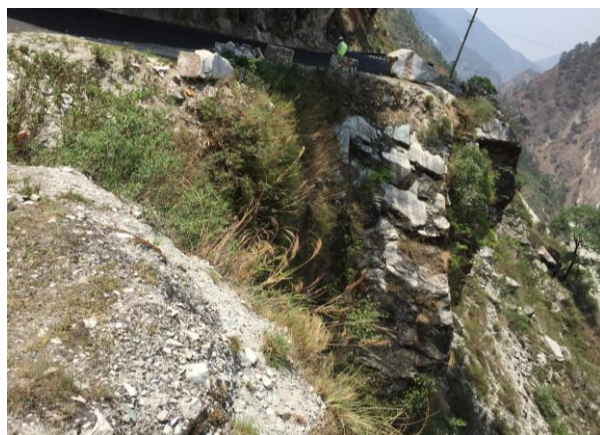
Fig. 8. Foliated rock & blocks of rock below road level

In addition, there are weak layers, comprising mica, along the foliation plane. The foliation is dipping towards the road (at shallow angle) and kinematically free rock blocks may slide over the weak mica planes towards the road side (refer Fig. 8).

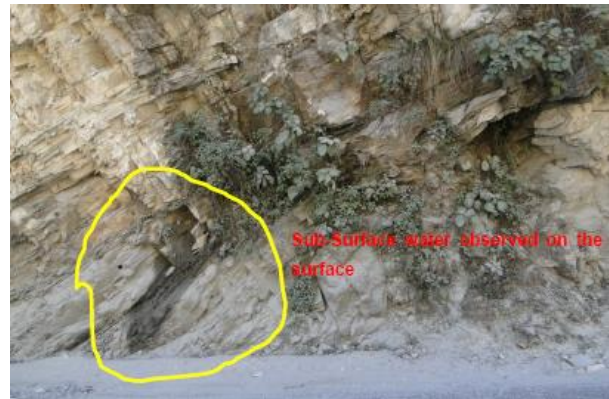
Fig. 9. Water seeping through jointed rock-mass

During rains, water percolates through the joints, generating pore-water pressure which makes the slope more susceptible to rock-fall. Fig. 9 illustrates water seepage through exposed rock-face.

Shotcreting was done on the slope surface at drain location. Perforated PVC pipes were provided at

locations where sub-surface water is observed, along with provision of basin to absorb falling-water impact. The water from the basin was diverted to the road side drain and discharged to the existing culverts.
