## Case History

### Some aspects of the M6.3 April 6 2009, L'Aquila, Italy, earthquake

By Armando L. Simonelli (Università del Sannio, Email: [alsimone@unisannio.it](mailto:alsimone@unisannio.it))

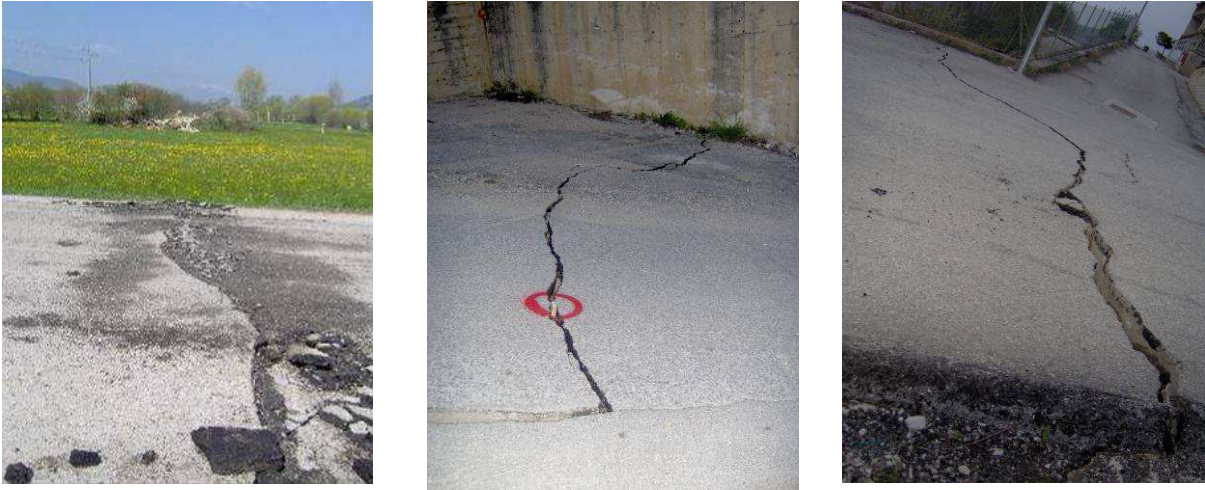
Geotechnical damage was widespread in the meizoseismal area. Here a selection of damage pictures is shown; most of the photos are taken from works [1] and [2]. A wide pattern of ground cracks, in soil and (especially) in road pavements was observed, as evident in Figs. 6 and 7. No conclusive evidence of co-seismic ground rupture has been presented to date. References of possible co-seismic rupture have been made at Paganica and Onna regions.

Figures 6. Cracks in road pavements: near Onna (left) and Paganica (centre and right).

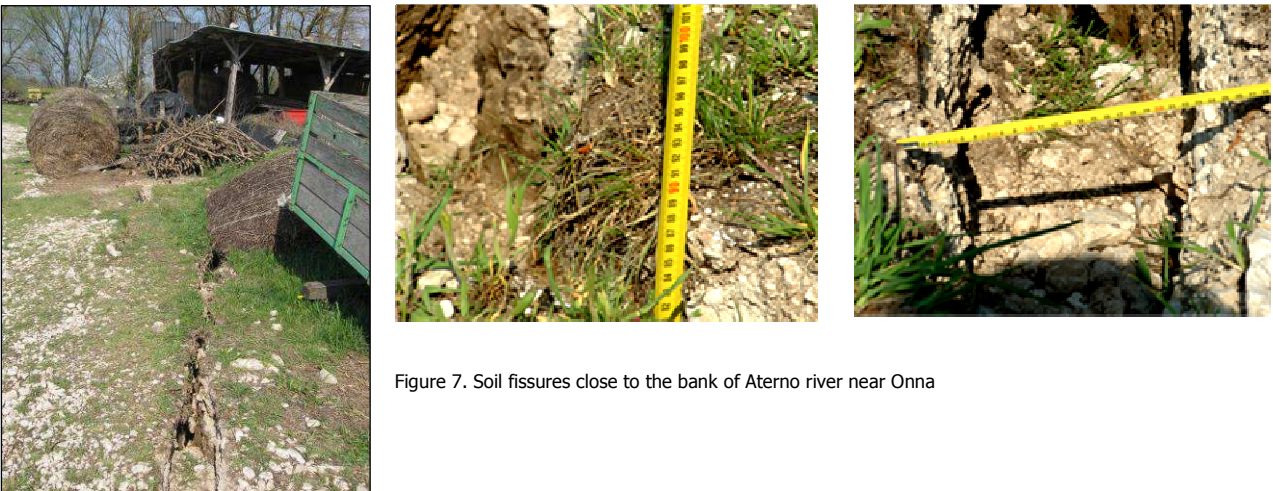
Figure 7. Soil fissures close to the bank of Aterno river near Onna

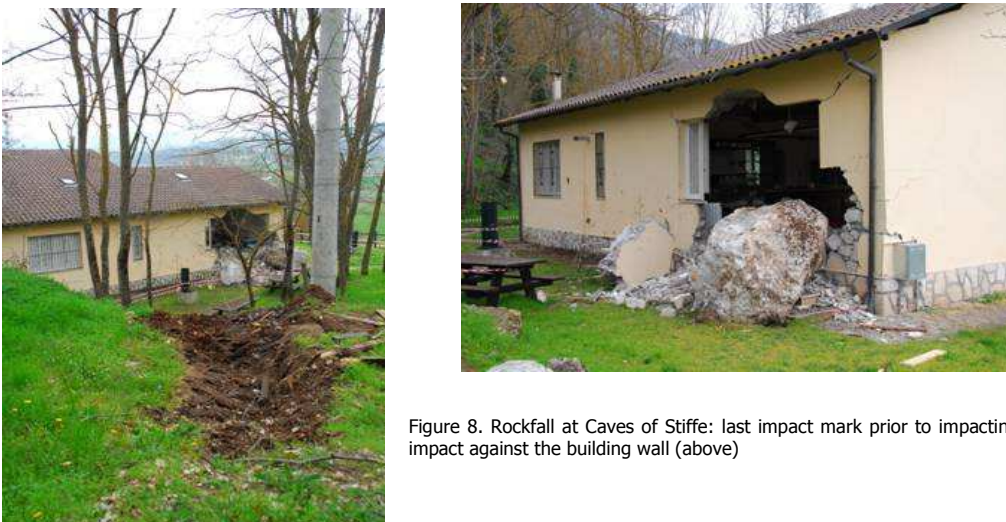
Several rockfalls, including the severe case shown in Figs. 8 and 9, were observed. On the other hand, few landslides appear to have been triggered.

Figure 8. Rockfall at Caves of Stiffe: last impact mark prior to impacting the building (left); the rock fall impact against the building wall (above)

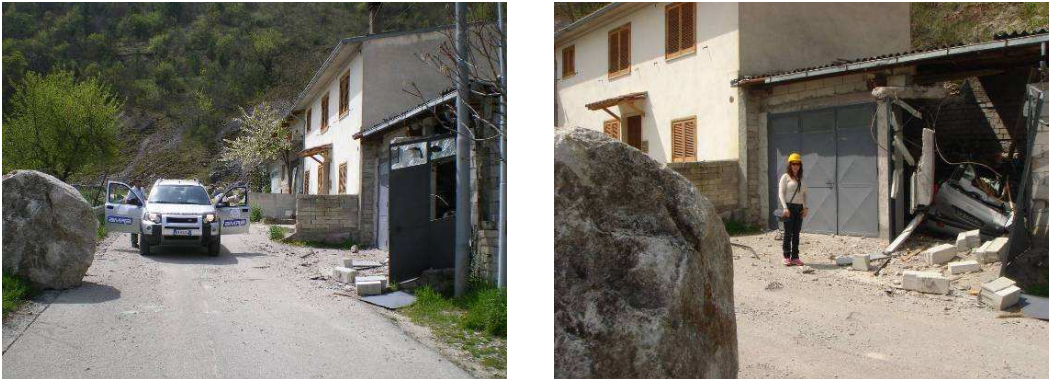
Figure 9. Rockfall at Fossa: the rock fell from the hill on the right, crossed the garage and stopped across the street.

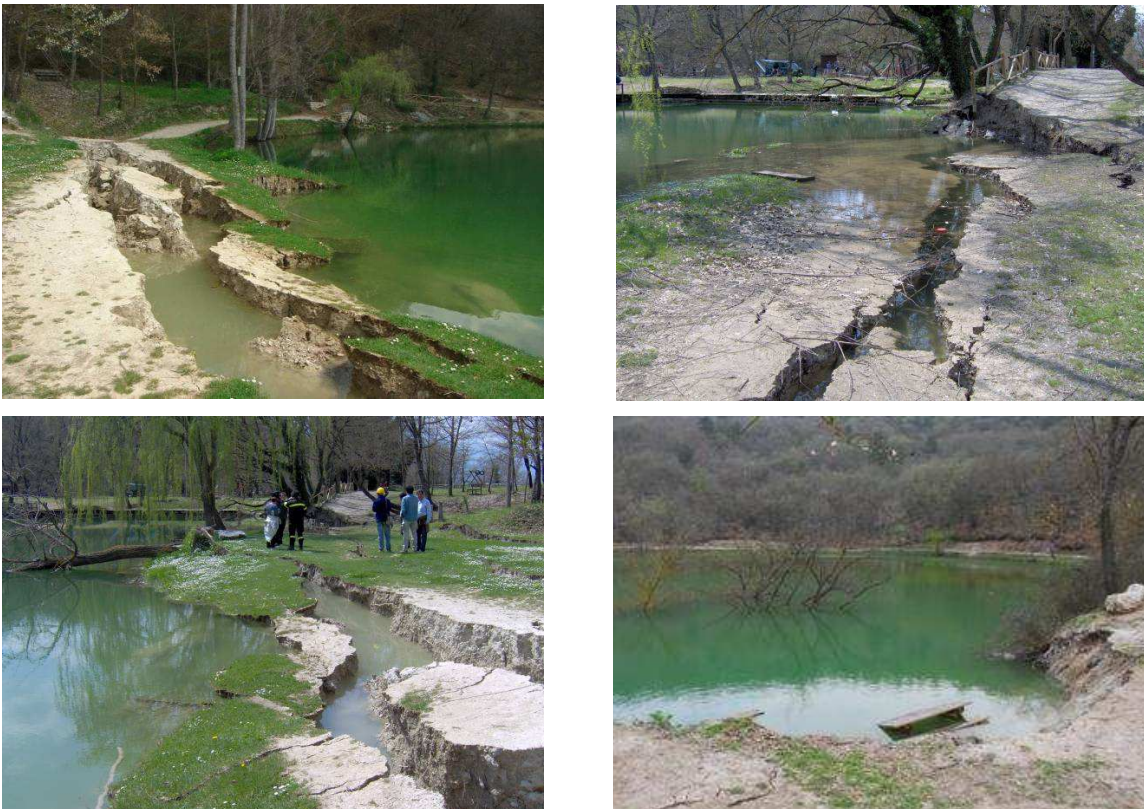
An interesting case of ground failure was observed at Lake Sinizzo, near the small town of San Demetrio ne' Vestini, SE of the city of L'Aquila. Almost 80% of the perimeter of the lake collapsed towards the water, exhibiting large sliding and rotational movements (Fig. 10). The lake behaved essentially as a "sink-hole", being situated in a Karstic natural depression. Bathymetric and Lidar measurements are currently in progress to document and monitor the evolution of the phenomenon. Note in this regard that near-surface soil is cohesive and that no sand ejecta were observed.

Figure 10. Lake Sinizzo near San Demetrio ne' Vestini. Ground cracks and large displacements along the eastern perimeter (above, left), northwestern perimeter (above, right) and western perimeter (below, left). Submerged trees along the western perimeter (below, right)
