Case History

Geotechnical structure damages during the 2009 Typhoon Morakot

Dr. Wei F. Lee (National Taiwan University of Science and Technology)
Prof. Ikuo Towhata (University of Tokyo)

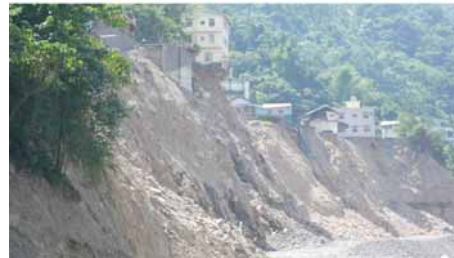
Typhoon Morakot caused a heavy rainfall in a very short time. Therefore, the river water level rose suddenly and made emergency action very difficult. Fig. 6 shows a significantly eroded river channel that endangered dwellings of people. Steep mountain slopes and valleys with deposits of weathered materials produced debris flows (Fig. 7).

Figure 6. Erosion along river channel

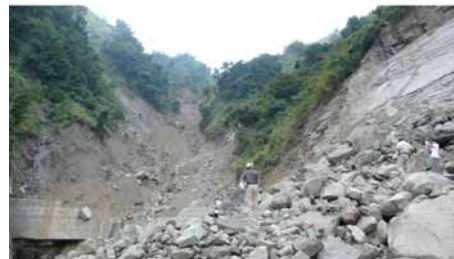
Figure 7. Source valley of debris flow

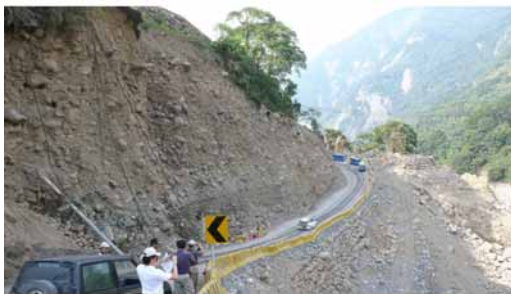
Cut slopes along roads were destroyed at many places. Fig. 8 demonstrates an example in which a gravelly deposit, which was probably produced by an ancient debris flow, failed and a road structure was affected. A new road is being reconstructed in the steep slope. Noteworthy is that many retaining structures were destroyed as well. In Fig. 9, the damaged wall did not have a stable foundation and was easily affected by scouring in the base, leading to its total collapse. In Fig. 10, a ground anchor that had supported a retaining wall was pulled out.

Figure 8. Failure of natural slope along road

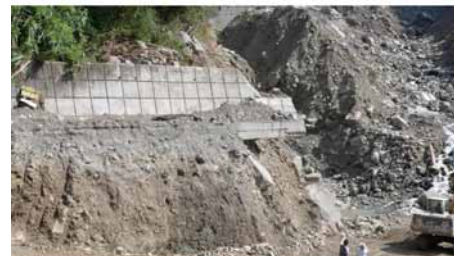
Figure 9. Collapse of retaining wall without stable foundation

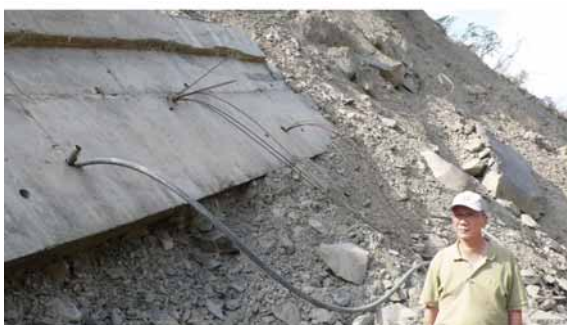
Figure 10. Destroyed shape of ground anchor.

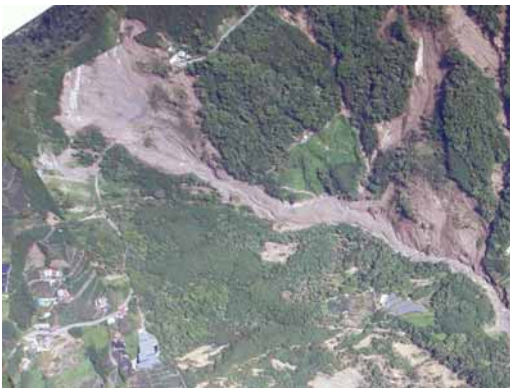
Figure 11 demonstrates an areal view of a slope failure and flow of debris. As indicated in Fig. 12, not only the surface deposits but also base rock failed. Fig. 13 shows a damaged situation of a road along a valley. It appears that the stability of this slope was affected to some extent by the erosion at its toe during the flooding. Reconstruction of road in this section poses a question about stability of this road during a future heavy rain storm.

Figure 11. Aerial view of large slope failure

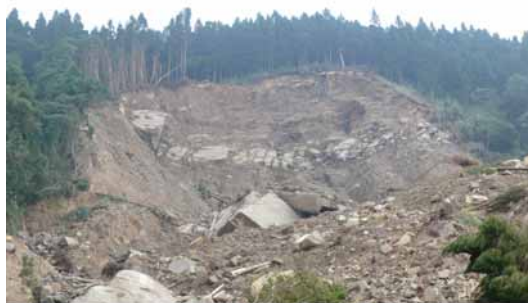
Figure 12. Deep-seated failure of slope

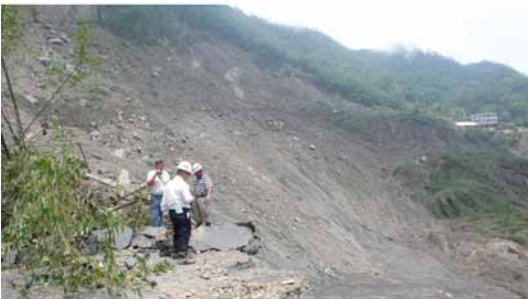
Figure 13. Mountain road destroyed by slope failure

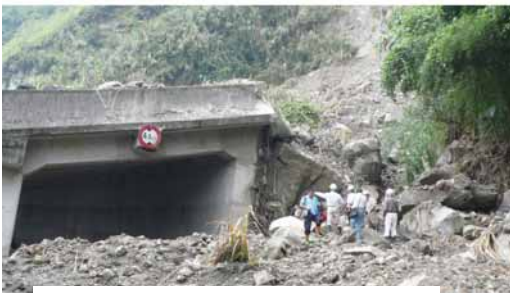
It is noteworthy that the present natural disaster was so powerful as to affect massive structures that had been considered stable under an extreme natural actions. Fig. 14 shows a rock-shed tunnel which was situated in an unstable slope. Apparently, a big amount of soils and debris came down from this slope. Fig. 15 indicates a distortion of this tunnel. It seems that this problem was induced not by the earth pressure of the flowing soil mass but the instability and deformation in the foundation of this tunnel (Fig. 16).

Figure 14. Rock shed tunnel subjected to slope failure

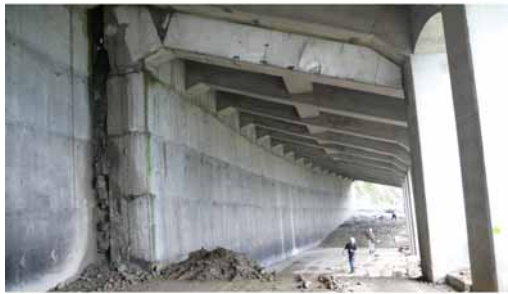
Figure 15. Distortion of rock-shed tunnel

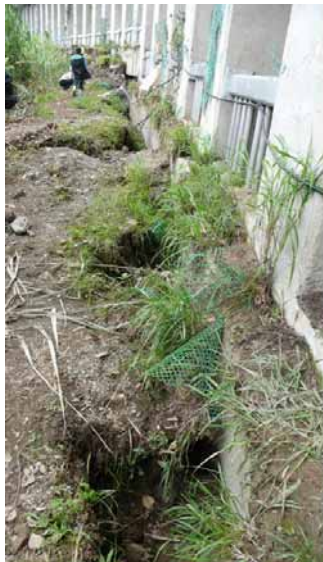
Figure 16. Subsidence in foundation of rock-shed tunnel

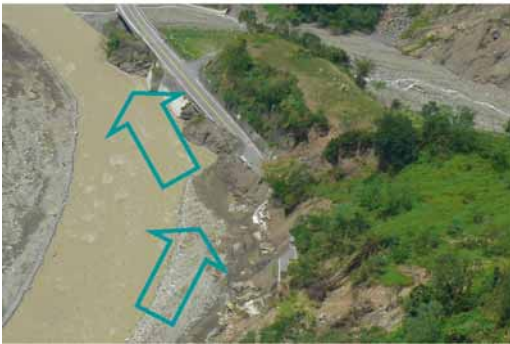
Along the Chi-San River, erosion and scouring were significant. Fig. 17 shows erosion in the toe of a cliff that affected road in the higher elevation. The power of erosion and scouring was substantial during the present event. Fig. 18 indicates a bridge that was washed away due to foundation scouring. Further, Fig. 19 indicates erosion of abutment and embankment approaching a bridge. Erosion at the toe of road embankment occurred at many places (Fig. 20).

Figure 17. Toe erosion in river channel

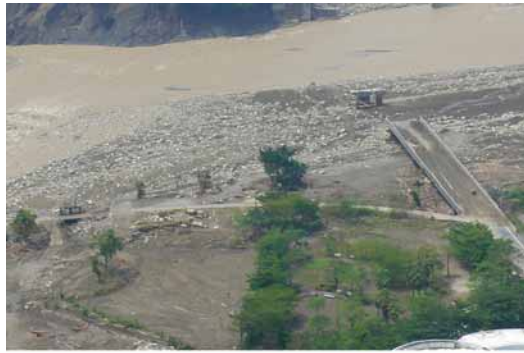
Figure 18. Destroyed bridge because of scouring

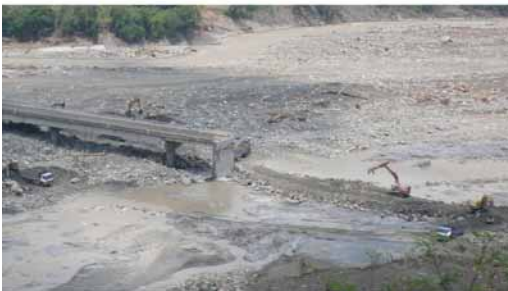
Figure 19. Bridge abutment and embankment destroyed by erosion

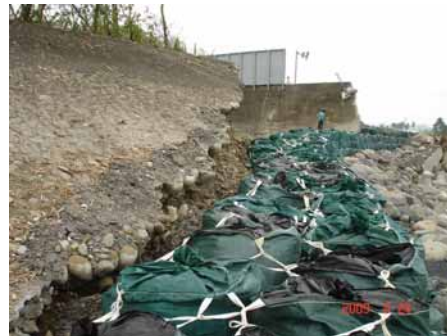
Figure 20. Erosion at toe of road embankment

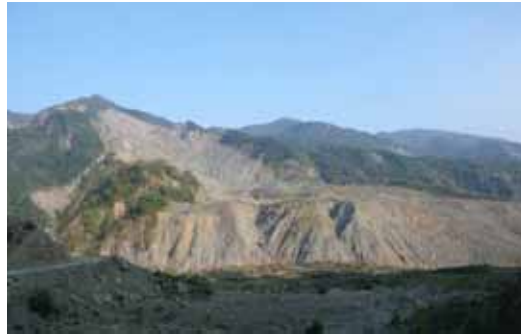
One of the most tragic events during the present typhoon was the total devastation of the Shao-Lin Village. In Fig. 21, minor streams behind the village had been considered vulnerable to possible occurrence of debris flow. During the present typhoon, a huge slope failure of $1.9 \times 10^7 \text{ m}^3$ in volume occurred (Fig. 22) and formed a landslide dam in the river channel on the upstream side of the village (Fig. 23). This dam breached shortly and totally destroyed the village (Fig. 24). The number of victims reached 474.

Figure 22. Gigantic slope failure behind Shao Lin Village

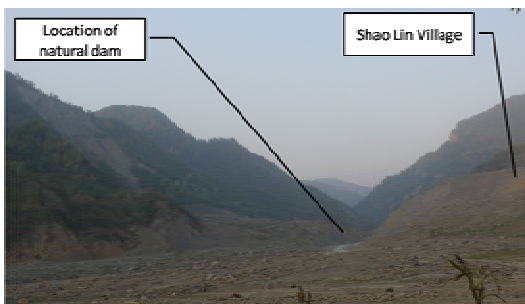
Figure 23. Location of natural dam

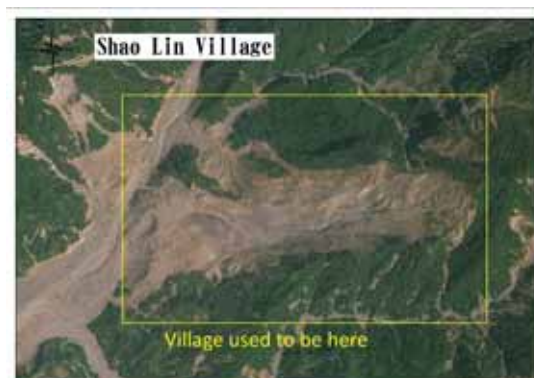
Figure 24. Areal view of Shao Lin Village after the disaster

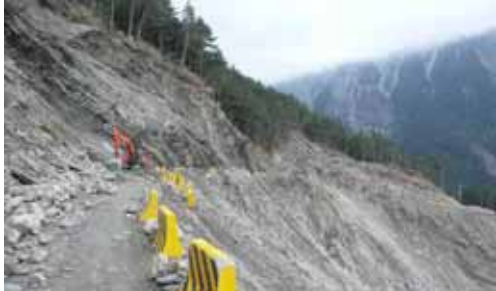
Many slope problems occurred in this area as well (Fig. 25). Fig. 26 indicates erosion along a river channel and consequent failure of a retaining wall. It is important to note that erosion occurred at special points alone in a curved narrow river channel (Fig. 27) probably because the direction of rapid water flow was winding and hit limited places. The same situation may occur in a bridge as well. For example, the bridge in Fig. 28 was damaged only in its part where the power of the flooding was most significant during the typhoon.

Figure 25. Big slope failure

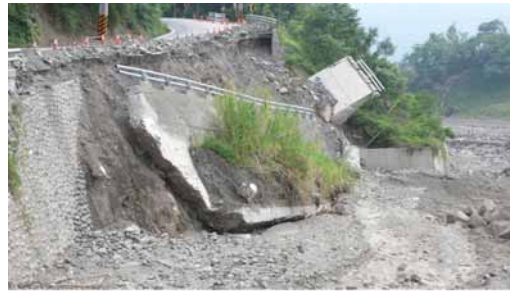
Figure 26. Erosion at bottom of retaining structure

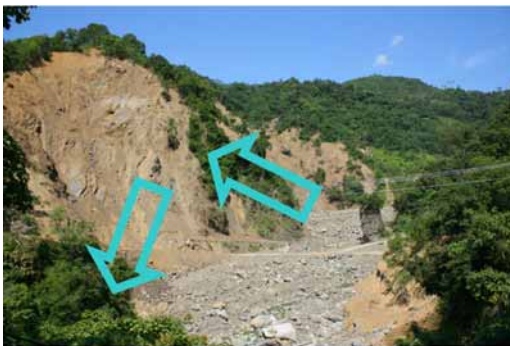
Figure 27. Erosion along curved river channel.

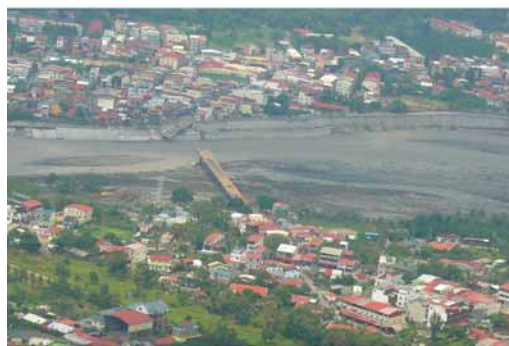
Figure 28. Destroyed bridge

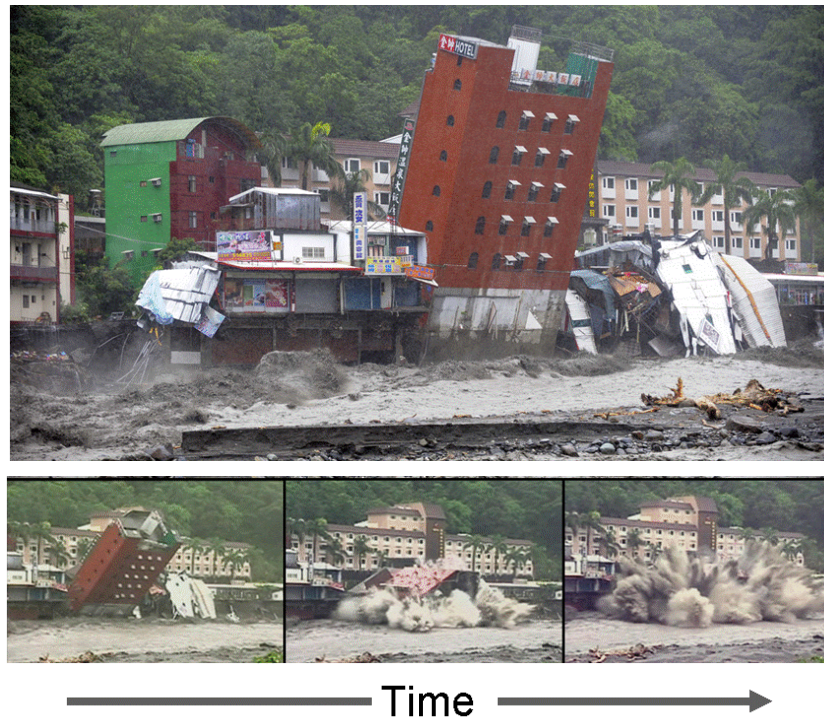
This area is situated in a coastal plane in the south-eastern part of Taiwan. Rivers brought a huge amount of debris together with water and caused damages. Fig. 29 reveals erosion of a river wall and collapse of a building as its consequence. Note that the upper photograph in this figure was taken after the water-front wall had been eroded. Thus, the scale of the flooding was greater than the design level, and the backfill soil was easily eroded.

Figure 29. Erosion-induced failure of river wall and collapse of building

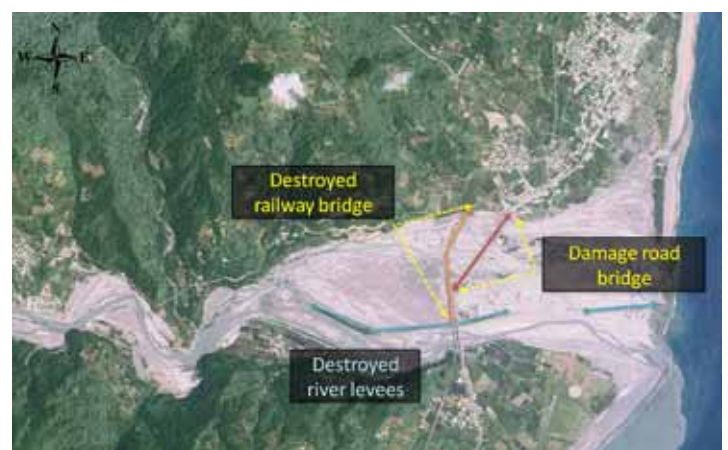
Figure 31. Damages in bridges and river levees

Figure 30 shows an air photograph of the previous topography in the mouth area of Taimali River. Although the ancient river flowed on the left (north) side, human activities shifted it towards the right bank. When the flooding occurred in 2009, the river flow destroyed the levees and came back to its original channel on the left side (Fig. 31). Consequently, both railway and road bridges were destroyed on that side. See Figs. 32 and 33 for those bridges during flooding and reconstruction.

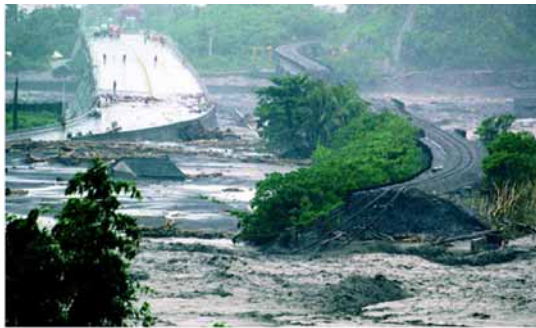
Figure 32. Bridges during flooding

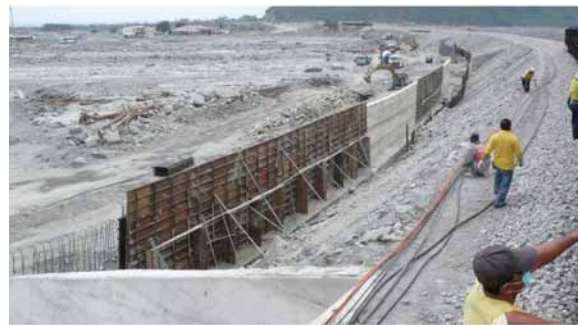
Figure 33. Reconstruction of railway bridge

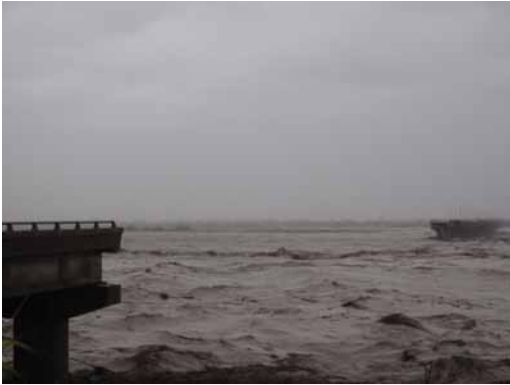
The geotechnical damages caused by the Typhoon Morakot clearly indicate the problem of such an extreme natural event for which the design consideration is insufficient. The heavy rainfall triggered many slope failures in the mountain area, resulting in high water level in the downstream area (Fig. 34) and debris flow. Consequently, erosion and scouring destroyed river walls and bridges. The extent of scouring during a single flooding was unexpectedly substantial (Fig. 35) and needs more elaborate design consideration in future. Moreover, the effect of drifting woods on failure process of bridges deserves attention. As shown in Fig. 36, a huge number of trees fell down from mountain slopes into rivers, and hit bridges in the downstream areas.

Figure 34. Extremely high level of river water

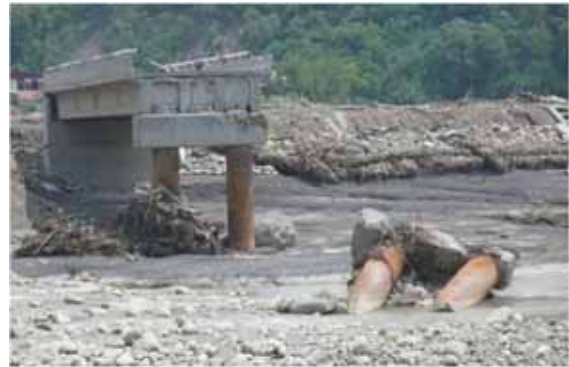
Figure 35. Scouring in bridge foundation

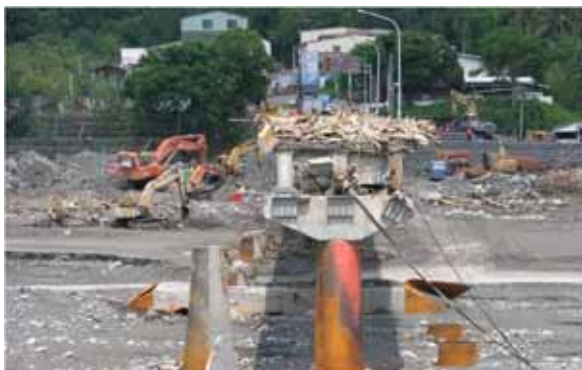
Figure 36. Accumulation of drifting wood on bridge deck
