## Case History

### Geotechnical damage caused by the 2010 Maule, Chile earthquake

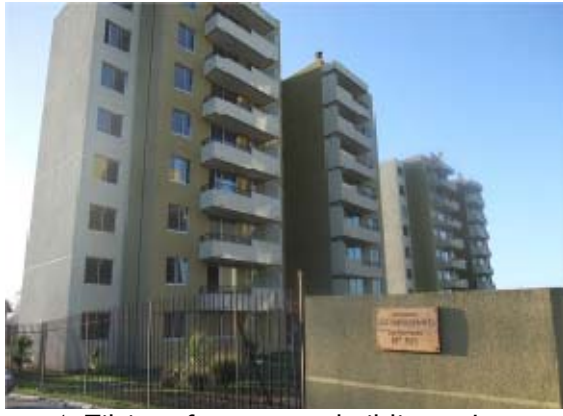
The actual number of liquefied sites was quite small in spite of the large earthquake magnitude. This is probably because the low level of annual precipitation does not make many water-saturated sandy subsoil. The reconnaissance survey detected liquefaction at fill or replaced backfill in and around Concepción only, except the tailing dam at Las Palmas. In Concepción area, subsoil liquefaction caused settlement of buildings and houses as well as uplift of underground tanks at sites shown in Fig. 3. Photo 1 demonstrates a 0.77-degree tilting of an 8-storied apartment building at Los Presidentes in Hualpén. Sand boils were found around the building to verify the occurrence of liquefaction. As the original topography here was swamp, subsurface soil was excavated down to the depth of 4 m and then sand was placed at the time of construction (see Fig. 4). Ground water table was as shallow as 1.0 m below the surface, and it made the effects of subsoil liquefaction more influential. Similar settlement occurred to a 5-storied hospital building in Curanilahue at about 30 km south of Concepción.

Photo 1 Tilting of apartment building at Los Presidentes

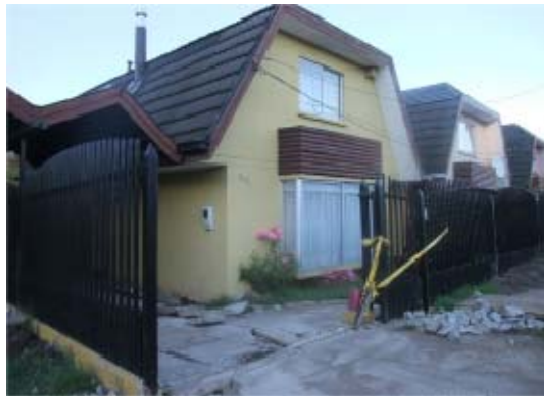
Many houses settled in three housing lots in Concepción as shown in Photo 2. The maximum settlement was about 17 cm. Because the original topography here was swamp as well, the backfilled sand in the swamp liquefied and caused house to subside. Furthermore, underground tanks uplifted in cities of Concepción, Chillan, and Arauco. Photo 3 shows uplifted sewage tanks. It seems that backfilled sand liquefied and caused this uplift.

Photo 2 17-cm Subsidence of houses in Bayona, San Pedro de la Paz

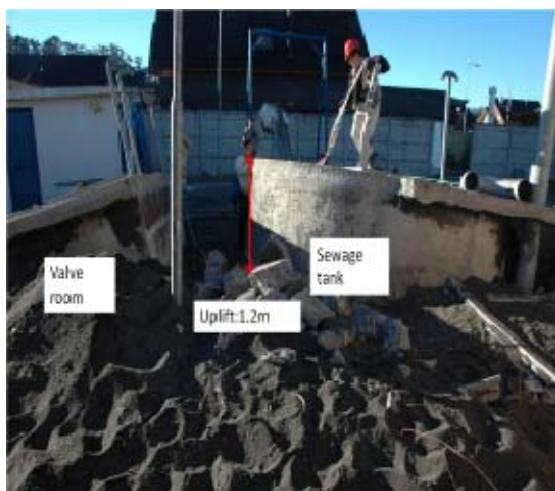
Photo 3 Uplift of buried sewage tank in San Pedro de la Valle

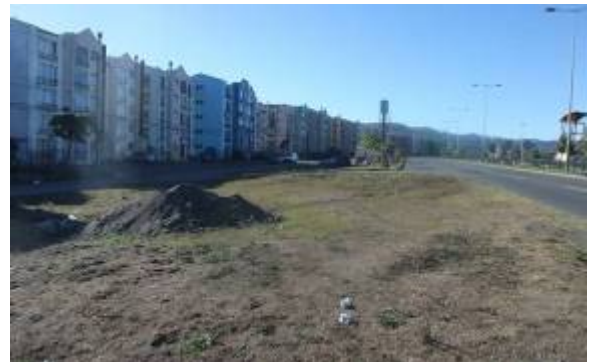
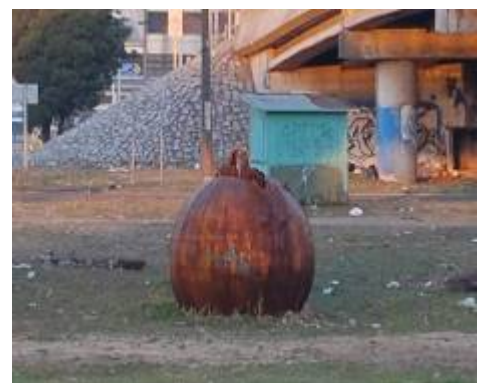
(Densification by dynamic compaction)

Photo 4 Apartment buildings without damage in Concepción

On the contrary apartment buildings in Photo 4 survived the quake although liquefaction occurred in its neighborhood. This is because the foundation soil of these buildings had been densified by dynamic compaction method and liquefaction resistance had been increased. This is an important evidence to validate the effects of this soil-improvement technology.

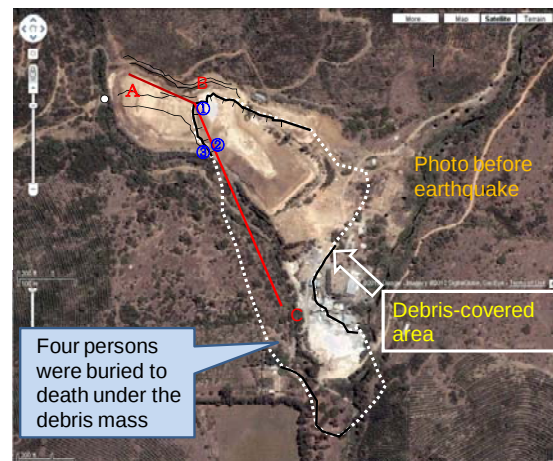
Liquefaction of mine tailings occurred at Las Palmas near Curico, Veta del Agua, and La Florida (Fig. 5). Among them, the authors were able to visit the significant damage at Las Palmas. This tailing dam was used for wastes from a gold mine between 1981 and 1997. An abandoned tailing dam collapsed as shown in Photo 6. Photo 7 illustrates details of the collapsed dam. Accordingly, water and liquefied tailings erupted from many cracks at the surface (see Photo 8). The liquefied mine tailings flowed down about 400 m and hit a farmer's house (Photo 6). Consequently, four people were buried to death under the tailing mass.

Photo 6 Extent of damage at Las Palmas tailing dam.

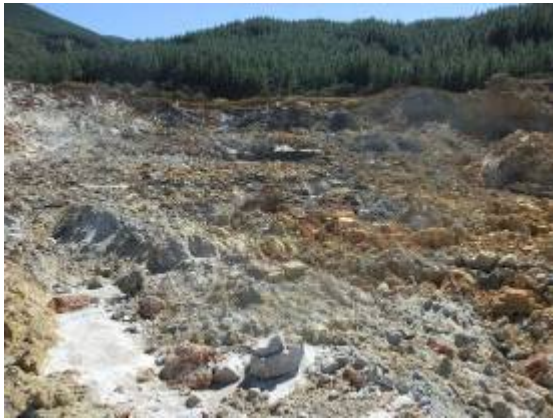
Photo 7 Tailing deposit after liquefaction

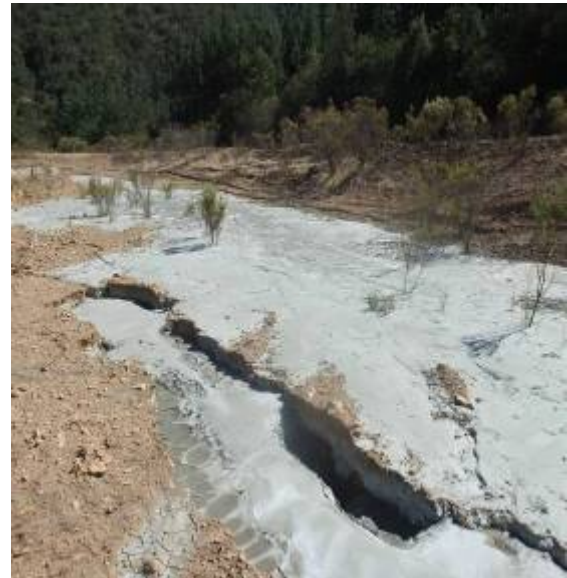
Photo 8 Eruption of liquefied tailings at Las Palmas

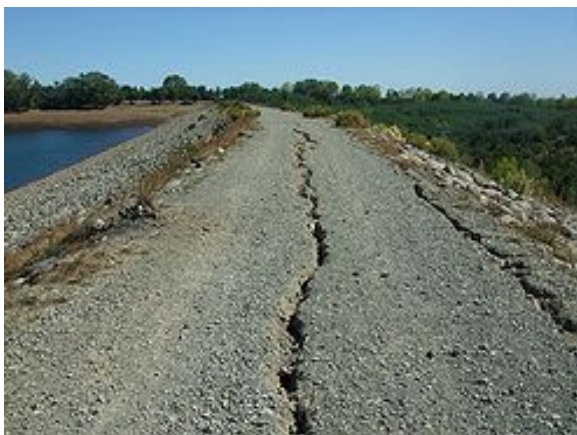
Coihueco Dam is situated at around 130 km to the east of Concepción. It is an earth dam and measures 975 m in length, 31 m in the maximum height, 19 degrees in the upstream slope, and 21 degrees in the downstream slope. The reservoir area is 2.26 million m<sup>2</sup>. Photo 9 indicates two longitudinal cracks along the crest of the dam; one in the centre and the other at the downstream (right side) shoulder. The width of the crest is 5.2 m. The depth of the crack reached at maximum 1.9 m. Photo 10 demonstrates the downward slip movement of the slope on the reservoir side. This movement resulted in at maximum 3.3 m subsidence near the shoulder.

Photo 9 Longitudinal cracks at the crest of Coihueco Dam

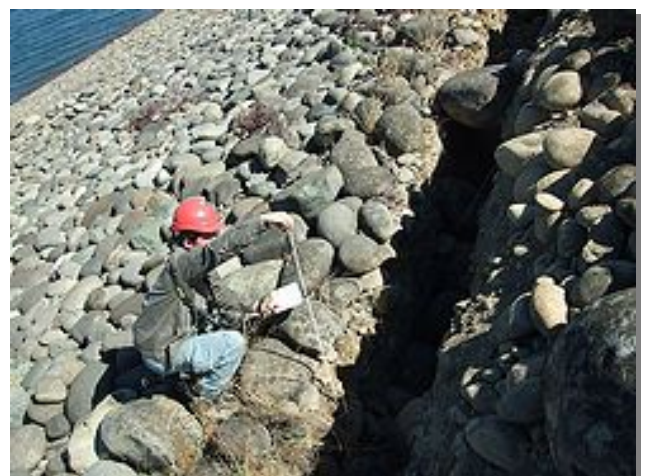
Photo 10 Downward slope movement in upstream face

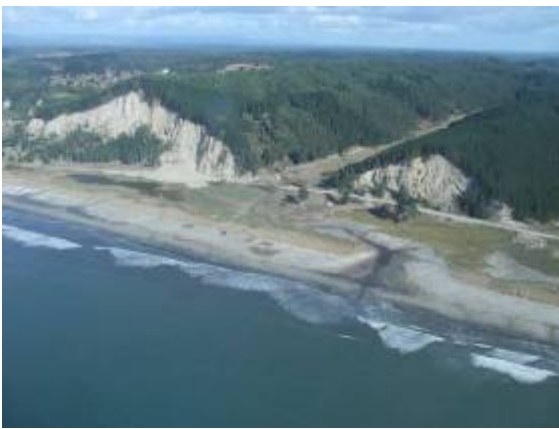
It was fortunate that the size of failures in natural slopes was small. This is because the Andes Mountains where there are many unstable slopes were far from the earthquake-affected area. The Coastal Mountains conversely do not have many steep slopes except cliffs at the coast. Therefore, the present report on natural terrain addresses only the coastal region. There are many steep cliffs along the coast from Arauco to Lebu through Cape Lavapie and they are subject to shallow failures. Photo 11 and Photo 12 indicate surface failures near Arauco and Cape Lavapie, respectively. Height of the cliff shown in Photo 11 is about 100 m.

Photo 11 Slope failure at Las Peñas near Arauco

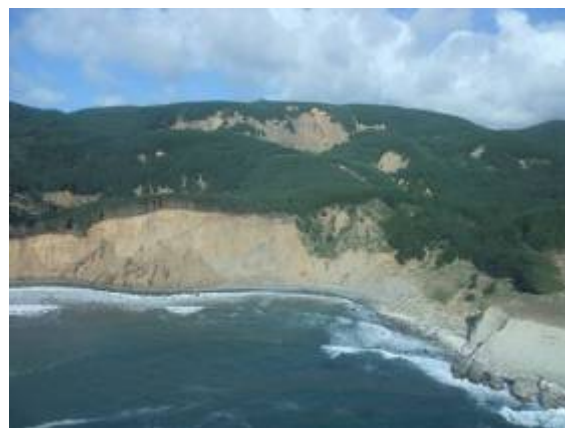
Photo 12 Slope failure at Lavapie

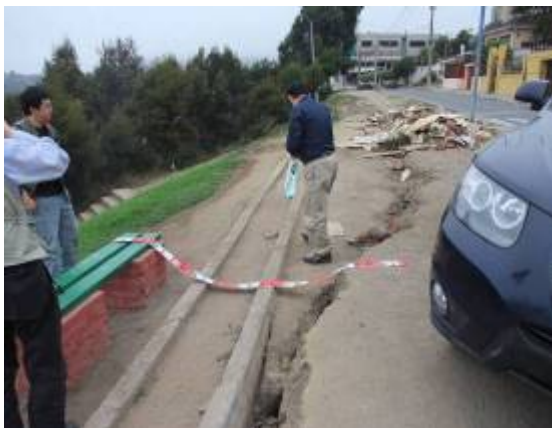
Photo 13 Minor slope failure at San Antonio

Although being very minor, a slope failure with the longest epicentral distance occurred in San Antonio (Photo 13). Its epicentral distance of about 300 km is plotted against the seismic magnitude in Fig. 6 to support the relationship between magnitude and maximum distance of slope failure that was proposed in the Seismic Zoning Manual by TC4 (TC4, 1999). The plotted point is between two curves for dry countries and wet countries. Because the slope failure in Photo 13 is very minor, it may be reasonable to shift the point to the left. Anyway, although the magnitude of the earthquake was huge, the size of slope-failure area was small as compared with that in wet countries.

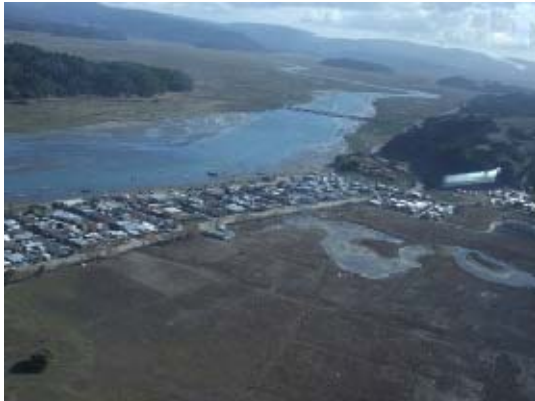
Photo 14 Peaty ground in and around Tubul

The subsoil condition between Arouco and Tubul consists of very soft and peaty soil (Photo 14). Consequently, three bridge girders fell down (Photo 15) and approach embankments collapsed as shown in Photos 16 and 17. The mechanism of the collapse of girders needs further investigation, but the effects of soil condition deserve careful study.

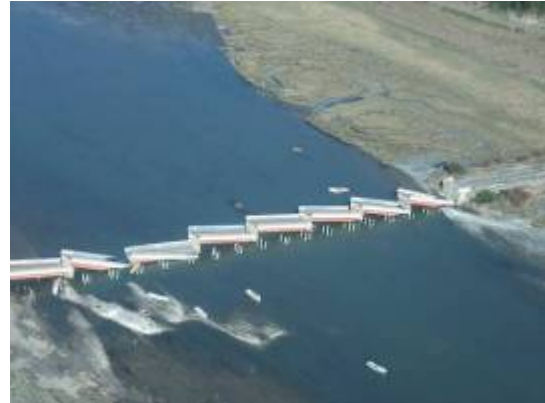
Photo 15 Collapsed bridge in Tubul

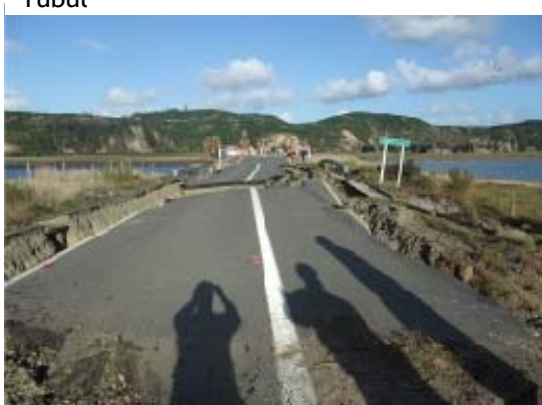
Photo 16 Collapsed approach embankment of Raqui II bridge

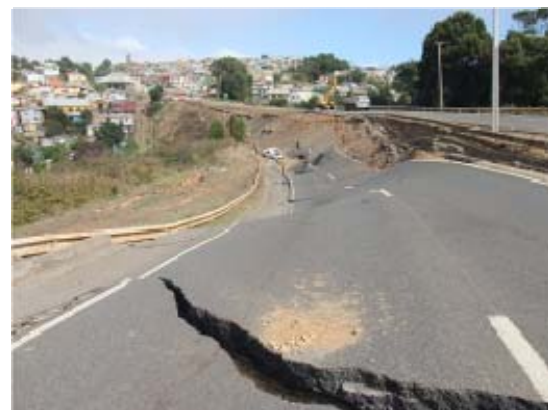
Photo 17 Big slide of road embankment in Lota Norte

In Chile, road embankment is generally constructed only at approaches to bridges. Thus, damaged embankment was found at a limited number of places. Photo 17 shows the biggest failure of road embankment that occurred in Lota. This embankment was constructed upon a swampy soil with a height of 16 m. Its construction material was clean sand. It seems therefore that pore water pressure increased at the bottom of the embankment during shaking, leading to loss of shear strength and shear failure.

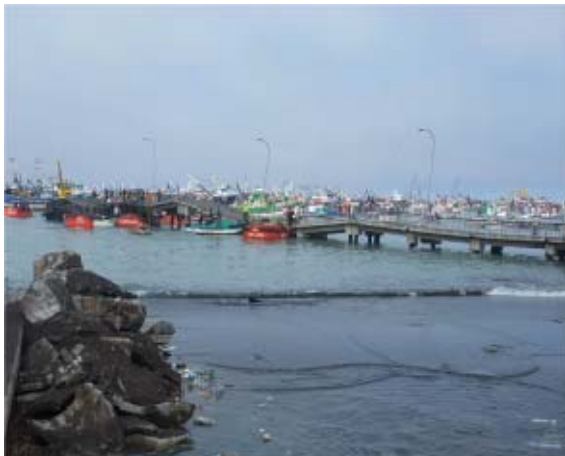
Coronel Harbor is located at about 450km to the south of Valparaiso. A distortion occurred in a fishermen's pier there (Photo 18). The damaged structure connects the land and the main part of the harbor and is supported by a pile foundation. Because substantial translation and tension cracks were found on the land side of the pier (Photo 19), it is inferred that the structure was subjected to compression from the land side, and, because of the very rigid foundation of the main part of the offshore pier, the connecting part developed significant compressional deformation and buckling. This soil-structure interaction deserves further study. Note that two larger commercial piers next to this place received only minor effect from the earthquake and were able to start operation one day after the earthquake.

Photo 18 Damaged pier in Coronel

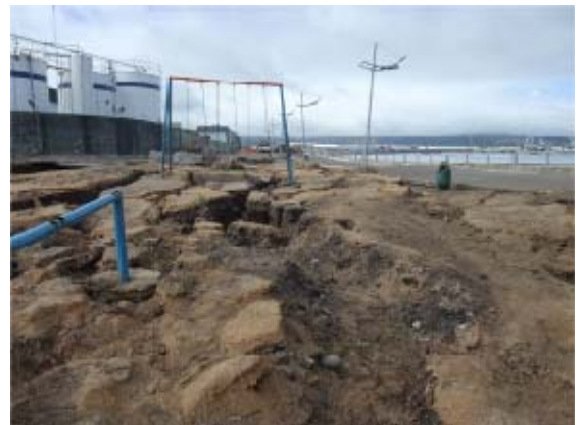
Photo 19 Lateral flow of soil adjacent to the pier

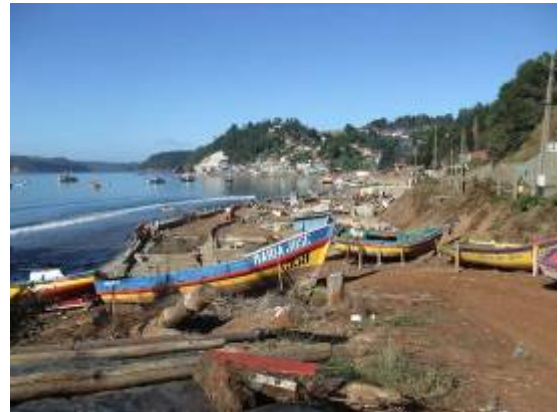
Photo 20 Tsunami damage near Cape Blanca

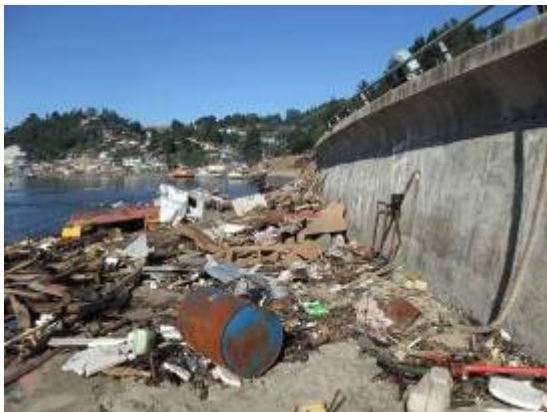
Tsunami disaster was reported widely after the earthquake. The height of the wave was 5.6 to 28.3 m in Constitución, 5.3 to 7.3 m in Dichato, 2.8 to 6.4 m in Talcahuano, and 5.2 m in San Antonio. High waves claimed significant human loss and destroyed many structures. One of the reasons for different tsunami heights at different places is the local topography. This section addresses the Coliumo Bay and Dichato area for example (Fig. 7). Photo 20 shows the total devastation near Cape Blanca. This damage occurred on the southeastern side of the cape facing the Coliumo Bay. This is in a clear contrast with the Pacific Ocean side of the cape where no significant damage occurred. It deserves attention that a sea wall in this damaged area functioned satisfactorily (Photo 21).

Photo 21 Successful performance of sea wall in Cape Blanca area.

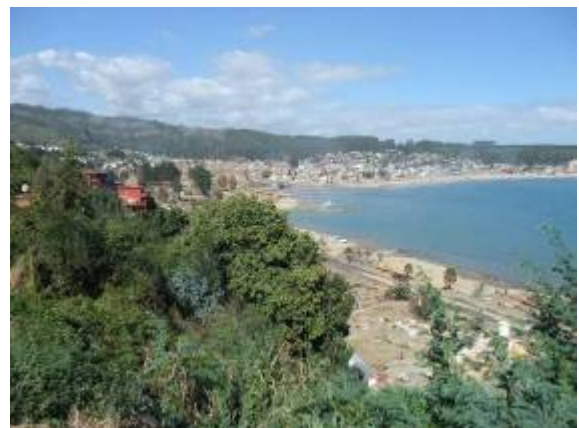
Photo 22 Tsunami erosion in coastal area of Dichato

Photo 22 indicates a long-distance view of Dichato. Although it is not visible in this photograph, the coast of this town was eroded by the tsunami as shown in Photo 23. It is noteworthy that even an underground facility was affected by tsunami-induced erosion of soil; see Photo 24. Photos 25 and 26 demonstrate effects of foundation on damage extent of houses. The house in Photo 25 floated when the water level rose and was transported over a long distance. In contrast, the house in Photo 26 was tightly connected to the foundation and was able to stay in the same place. The intact shape of this house may suggest that the impact force of the tsunami was not very strong. Finally, Photo 27 presents an interesting case where a 6-m-high road embankment protected a freight container yard from the tsunami attack.

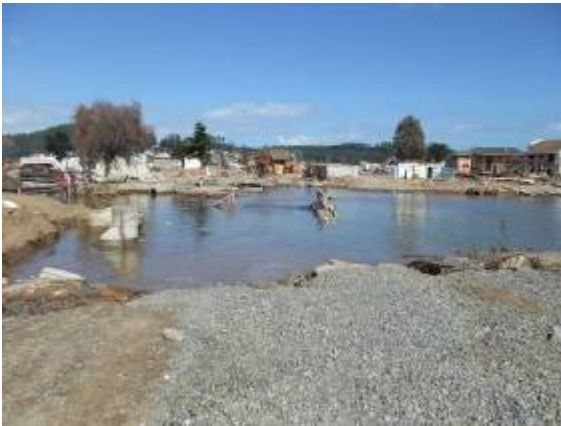
Photo 23 Tsunami-induced erosion in Dichato

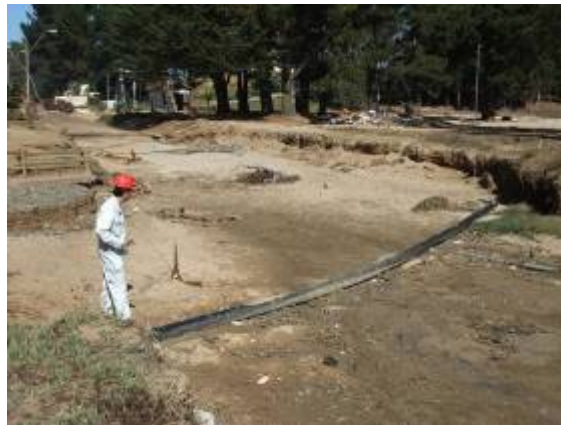
Photo 24 Exposure of buried lifeline after tsunami erosion

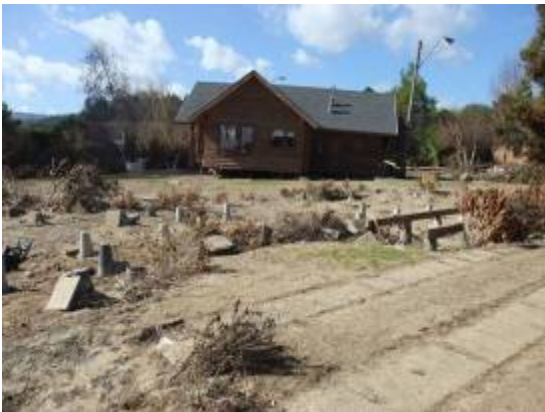
Photo 25 House that floated when tsunami came

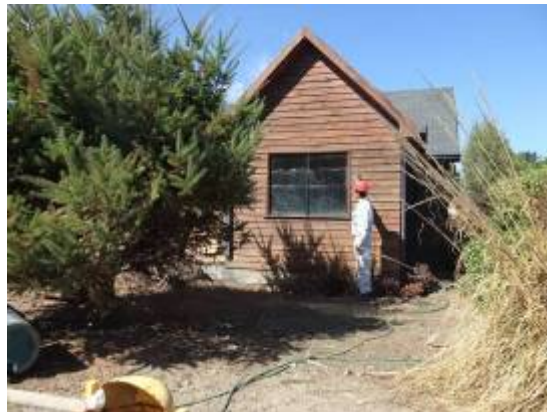
Photo 26 House that did not float when tsunami came

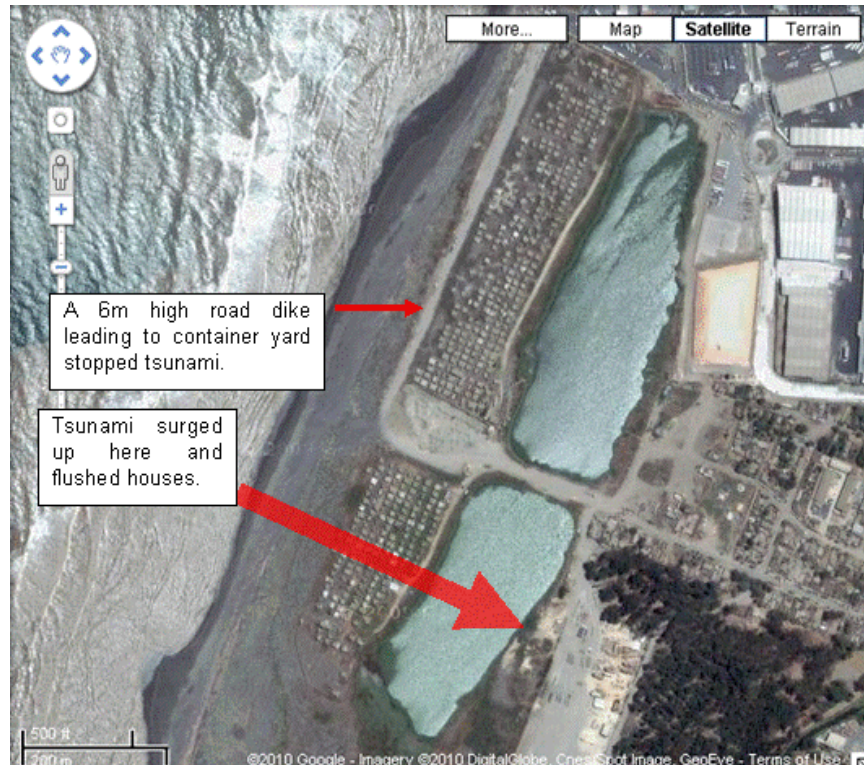
Photo 27 Tsunami protection by embankment (drawn on Google Map)

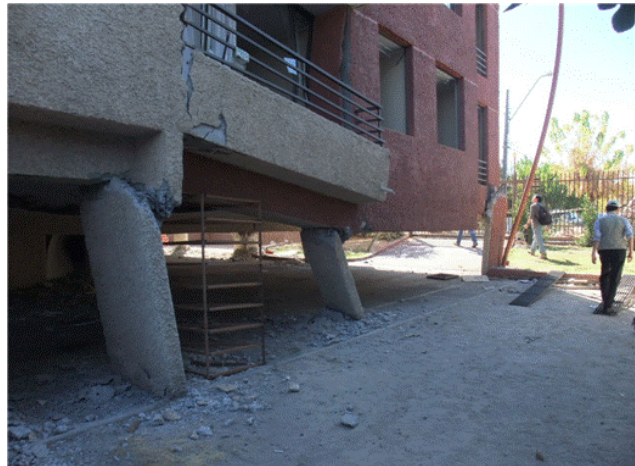
Several buildings collapsed in Santiago, Curico and Concepción. Some of them had weak pillars as shown in Photo 28. When substantial inertia force occurred in the massive superstructure, the ground floor, that consisted only of pillars without a reinforced wall, was easily destroyed. This type of structural failure has been experienced in many past earthquakes.

Photo 28 Collapsed building at Maipú in Santiago
