## Case History

### The Geotechnical Aspects of the Haiti Earthquake

Ellen M. Rathje, University of Texas

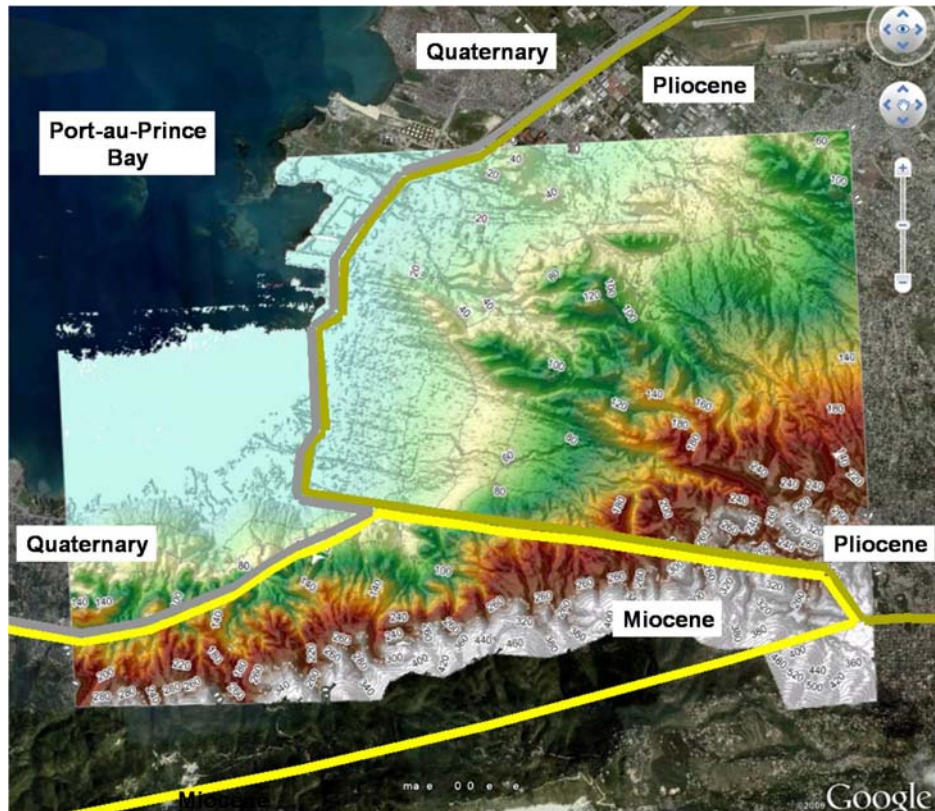
Figure 3 is a shaded relief map for a portion of Port-au-Prince derived from a 1-m LIDAR DEM collected by RIT for the Worldbank (<http://ipler.cis.rit.edu/projects/haiti>). Also shown in this figure are the geologic boundaries from a geo-referenced version of the geologic map shown in Figure 1. Interestingly, the geologic map indicates that the Pliocene deposits extend almost to the coastline within the central part of the city, yet the topographic data indicate that the flat plain (which presumably corresponds to the Quaternary deposits) extends a significant distance inland. Additional geologic field mapping by the GEER team confirmed that this flat plain was underlain by Holocene and Pleistocene alluvium, and these observations were supplemented with shear wave velocity profiles measured by MASW (Cox, personal communication).

Figure 3 Shaded topographic relief map of the Port-au-Prince area with geologic boundaries from the geologic map shown in Figure 1.

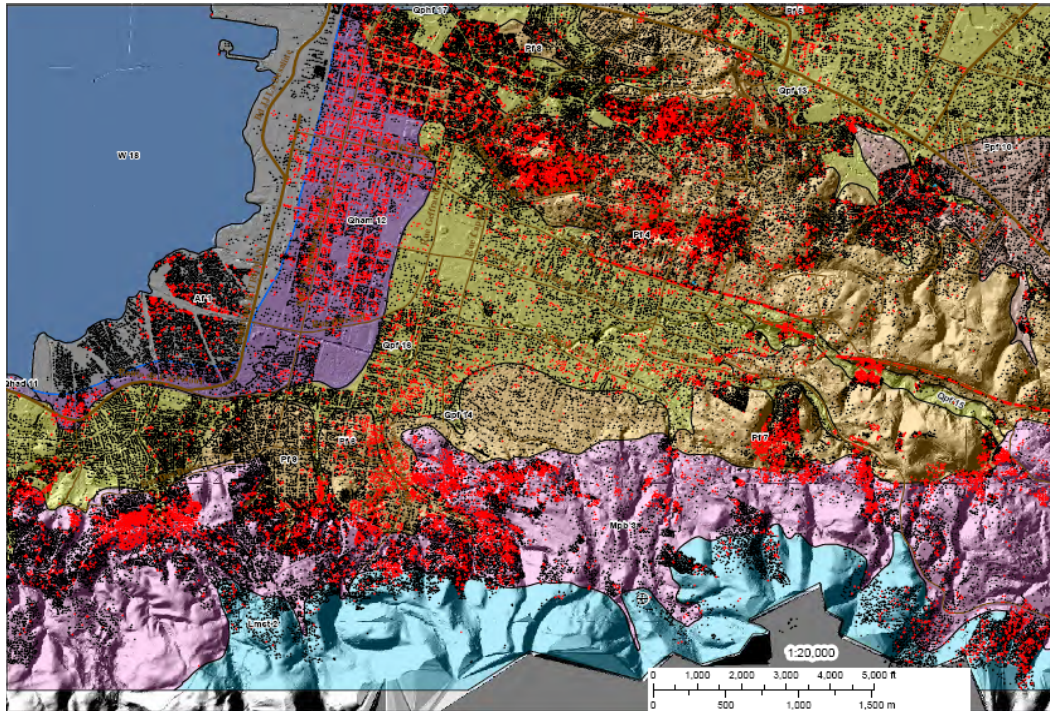
An updated geologic map of Port-au-Prince is shown in Figure 4 along with the damage data from the UNOSAT assessment. The geologic units in Figure 4 represent artificial fill (Af), Holocene alluvium (Qham) and Pleistocene fan deposits (Qpf) in the flatter areas, with Pliocene fan (Pf), Mio-Pliocene conglomerate (Mpb), and Miocene limestone (Lmst) found in the hillsides. The damaged buildings (which represent damage categories 1 through 3) are shown in red, while the undamaged buildings are shown in black.

In the flat, Quaternary units that underlie much of downtown Port-au-Prince, it is clear that the damage was more severe in the Holocene alluvium (Qham) than in either the artificial fill (Af) or Pleistocene fan deposits (Qpf). The percentage of buildings damaged (i.e., Damage Intensity) in the Qham deposit was approximately 38%, while the percentage of buildings damaged in the Af and Qpf deposits was approximately 10% to 15%. The concentration of damage in the Qham deposit was influenced by a combination of two factors: site amplification due to lower velocity materials ( $V_{s30} \sim 330$  m/s) and a high concentration of poorly reinforced, 2 to 5-story reinforced concrete buildings. While the Af deposits consist of lower velocity materials ( $V_{s30} \sim 250$  m/s), the Damage Intensity was smaller because they building stock in this area consisted mostly of single-story, reinforced concrete or corrugated metal structures that were less vulnerable to soft soil amplification. The Damage Intensity in the Qpf deposits was smaller due to the higher velocity materials ( $V_{s30} \sim 485$  m/s).

Figure 4 Revised geologic map of Port-au-Prince along with damaged buildings from UNOSAT survey (red=damaged building, black=undamaged building).

Figure 4 also shows localized areas of heavy damage in the hillsides north and south of the main alluvial plain. Damage Intensities in these zones were as large as 40 to 60%. These areas are underlain by the older Pf and Mpb deposits that consist of stiffer materials ( $V_{s30} \sim 500$  to  $550$  m/s). The slopes in Pf deposits range from  $5$  to  $20^\circ$ , while the slopes in the Mpb deposits range from  $10$  to  $40^\circ$ . These areas represent zones where it is believed that topographic amplification caused enhanced ground shaking and larger damage intensities.

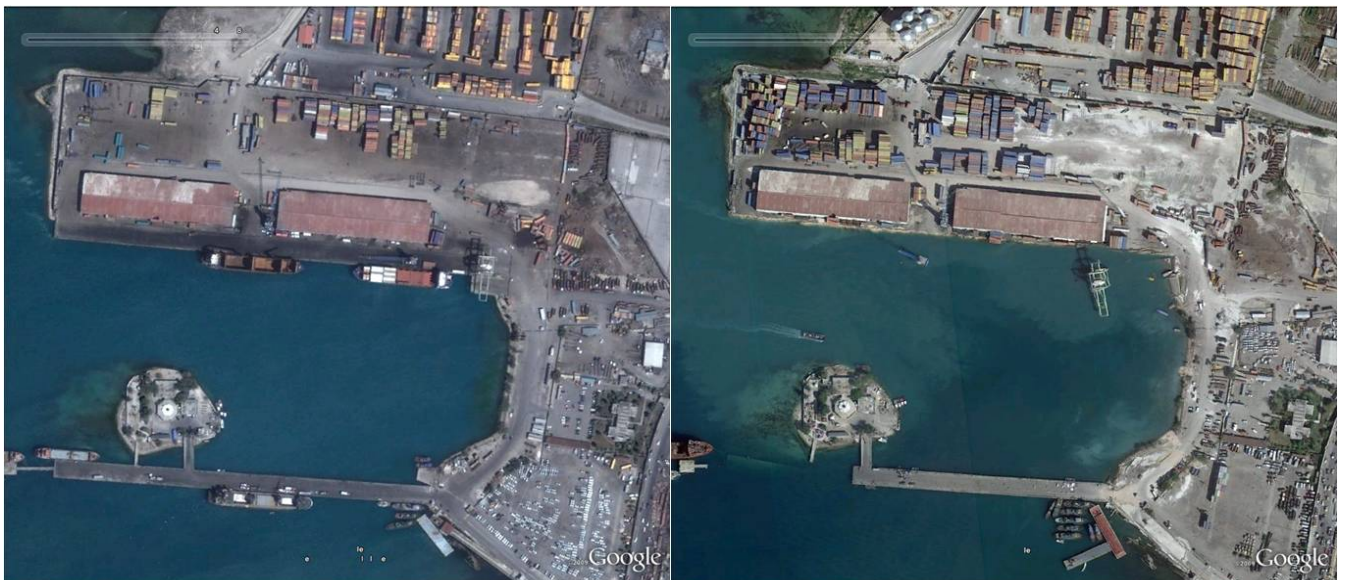
Pre- and post-earthquake aerial images of the port are shown in Figure 6, and these images clearly show evidence of liquefaction and lateral spreading, failure of the North Wharf, and collapse of portions of the South Pier. This damage inhibited the delivery of relief supplies to areas affected by the earthquake. Light-colored areas on the ground surface in the post-earthquake image in Figure 6 are sand boils/ejecta and can be seen in the eastern half of the container storage yard and behind and between the two warehouses. Locations of large lateral spreading fissures were observed all along the shoreline.

Figure 6 Pre- and post-earthquake satellite/aerial imagery (left and right, respectively) of the port at Port-au-Prince, Haiti (N18.555058°, W72.351144°). Imagery courtesy of Google Earth.

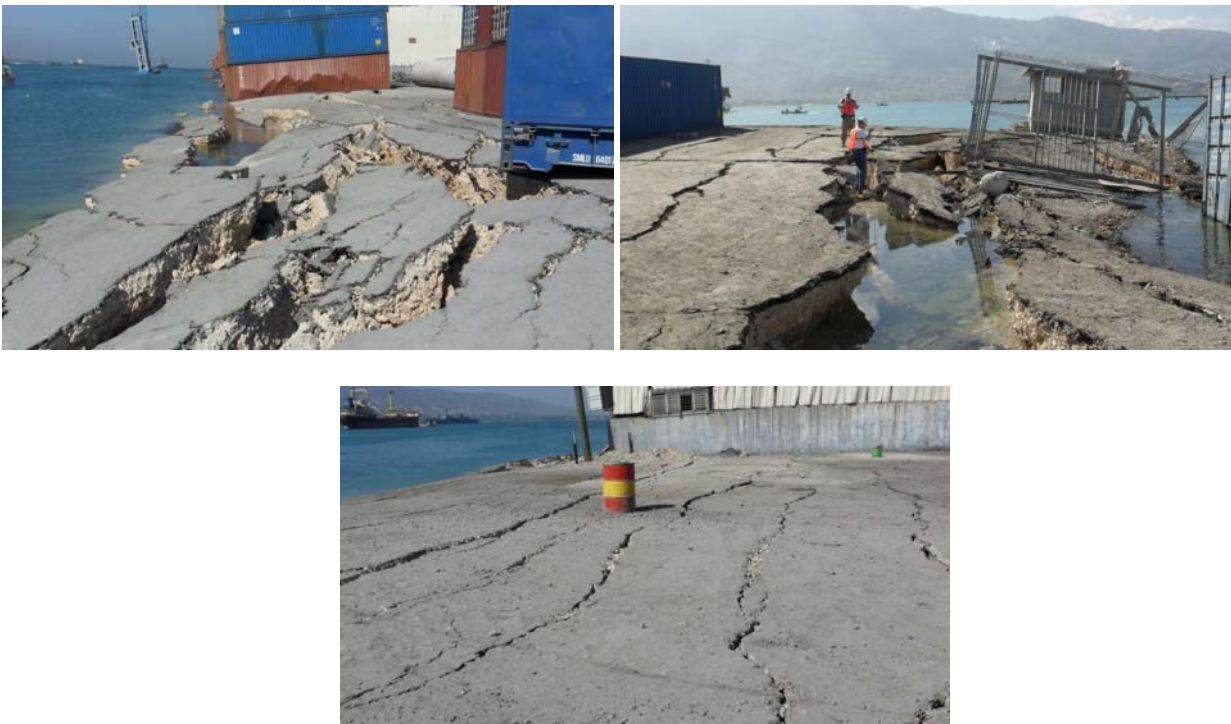
The North Wharf consisted of a pile-supported marginal wharf that was approximately 450 m in length and 20 m in width. The water depth is 8 to 10 m. Immediately adjacent to the wharf are two steel-frame warehouses, each approximately 150 m by 40 m. The North Wharf collapsed, most likely due to liquefaction-induced lateral spreading and the associated failure of the piles supporting the wharf. Numerous surface manifestations of liquefaction and lateral spreading were present in the vicinity of the North Wharf (e.g., Figure 7).

Figure 7 Lateral spread cracking and deformations along the North Wharf of the port.

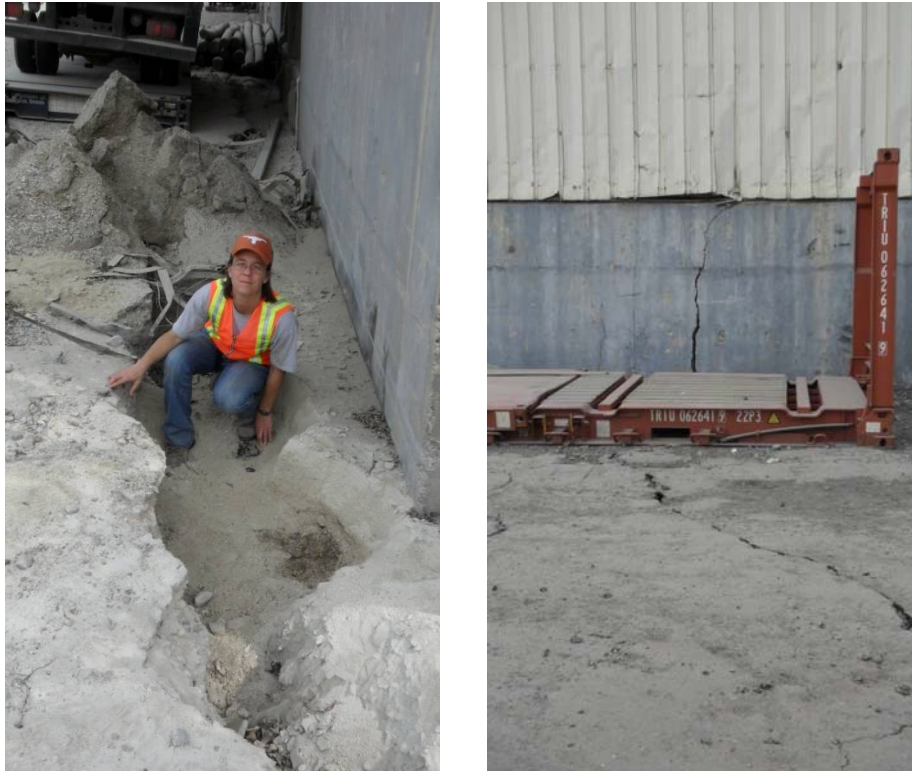
The warehouses along the North Wharf suffered severe damage as a result of the lateral spreading and settlement (Figure 8). Lateral spreading cracks running in the East-West direction cut through each warehouse foundation wall (Figure 8). A detailed field survey was performed of the relative elevations and lateral movements of the west warehouse slab. Due to lateral spreading, the south wall (adjacent to the shoreline) moved approximately 0.7 to 1.4 m laterally towards the shoreline. The relative elevations across the interior were variable, with the some areas almost 1 m lower than others. It appeared that the warehouses were founded on strip footings around their perimeters, which settled significantly. Settlements measured at the inland corners of the warehouses indicate 15 cm of settlement relative to the ground surface for the west warehouse and 40 cm of settlement for the east warehouse.

Figure 8 Ejecta and cracking adjacent to warehouses along the North Wharf

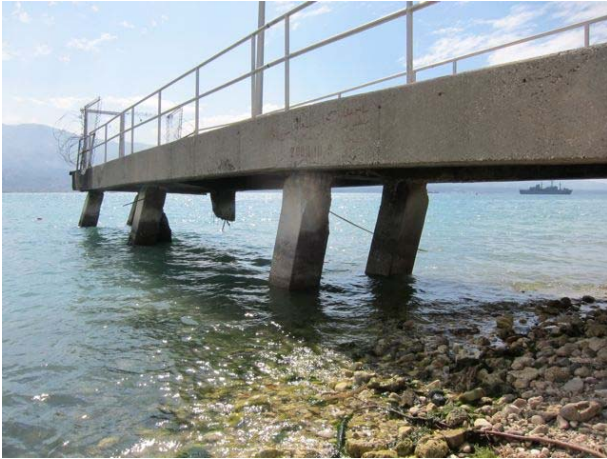
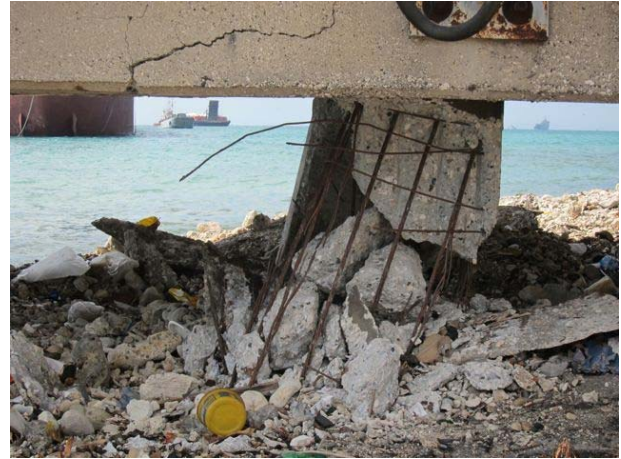
The South Pier (Figure 6) is a pile-supported structure that was originally 380 m in length and 18 m in width. A large bridge and a small pedestrian bridge that are approximately perpendicular to the longitudinal axis of the pier connected the pier to an island where the port security office is located. The western end of the pier was also connected to three dolphins by small pedestrian bridges. All of the bridges were also pile-supported structures. The piles supporting the pier are approximately 51-cm square concrete piles on 4.3 to 4.9-m centers and include both vertical and battered piles. The pile bents are 1.5 m deep and 0.9 m wide and the deck is 45 cm thick (Brian Crowder, personal communication). During the earthquake, the western-most 120 m of the South Pier and portions of the pedestrian bridges linking the dolphins collapsed and became submerged. The portion of the pier that is still standing was heavily damaged. US Army divers inspected the piles following the earthquake to determine whether the pier could support loads imposed by trucks carrying relief supplies. They found that approximately 40% of the piles were broken, 45% were moderately damaged, and 15% were slightly damaged. Generally, the batter piles were more heavily damaged than the vertical piles. The damage to the piles supporting the small pedestrian bridge connecting the South Pier to the island could be readily observed (Figure 9).

Figure 9 Damage to piles supporting the pedestrian bridge connecting the South Pier to the island

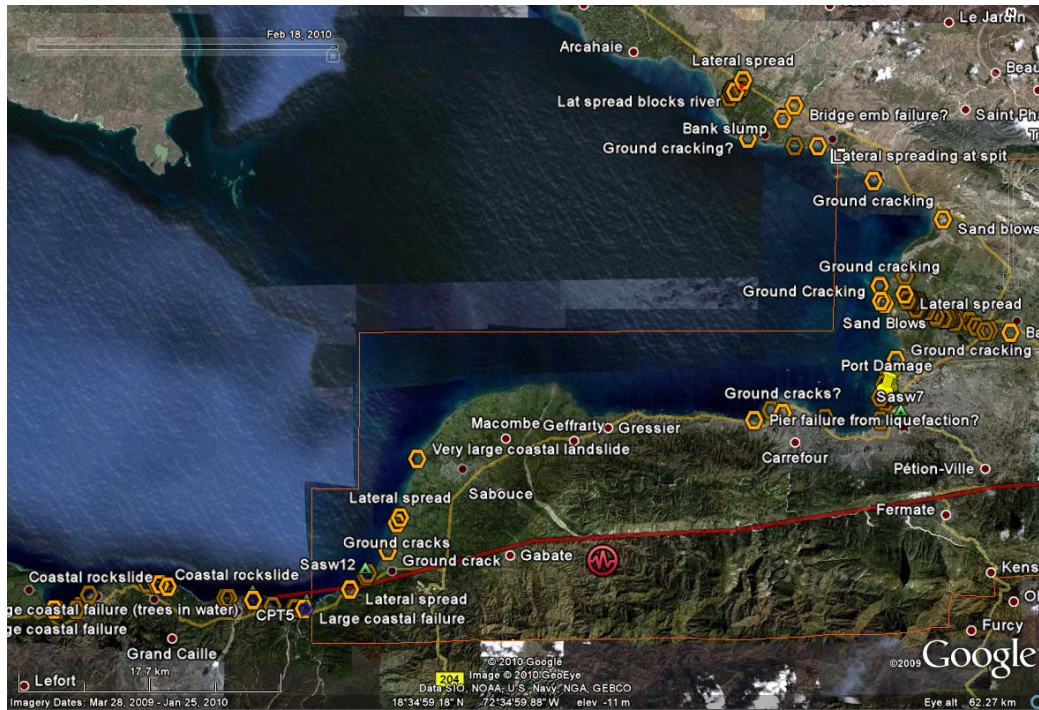
Numerous liquefaction features near the coastline were identified using aerial imagery, as shown in Figure 10. Potential liquefaction-induced failures were identified up to 38 km from the epicenter and up to 26 km from the fault trace. These data plot well within the boundaries for most distal liquefaction sites proposed by Ambraseys (1988) using worldwide data (Figure 11). This suggests that the natural coastal and alluvial soils near Port-au-Prince Bay are only moderately susceptible to liquefaction, although liquefiable Quaternary sediments were generally noted only within short distances from the coast.

Figure 10 Liquefaction, lateral spreading, and coastal failure sites identified from post-earthquake aerial photography (sites identified as open hexagons)

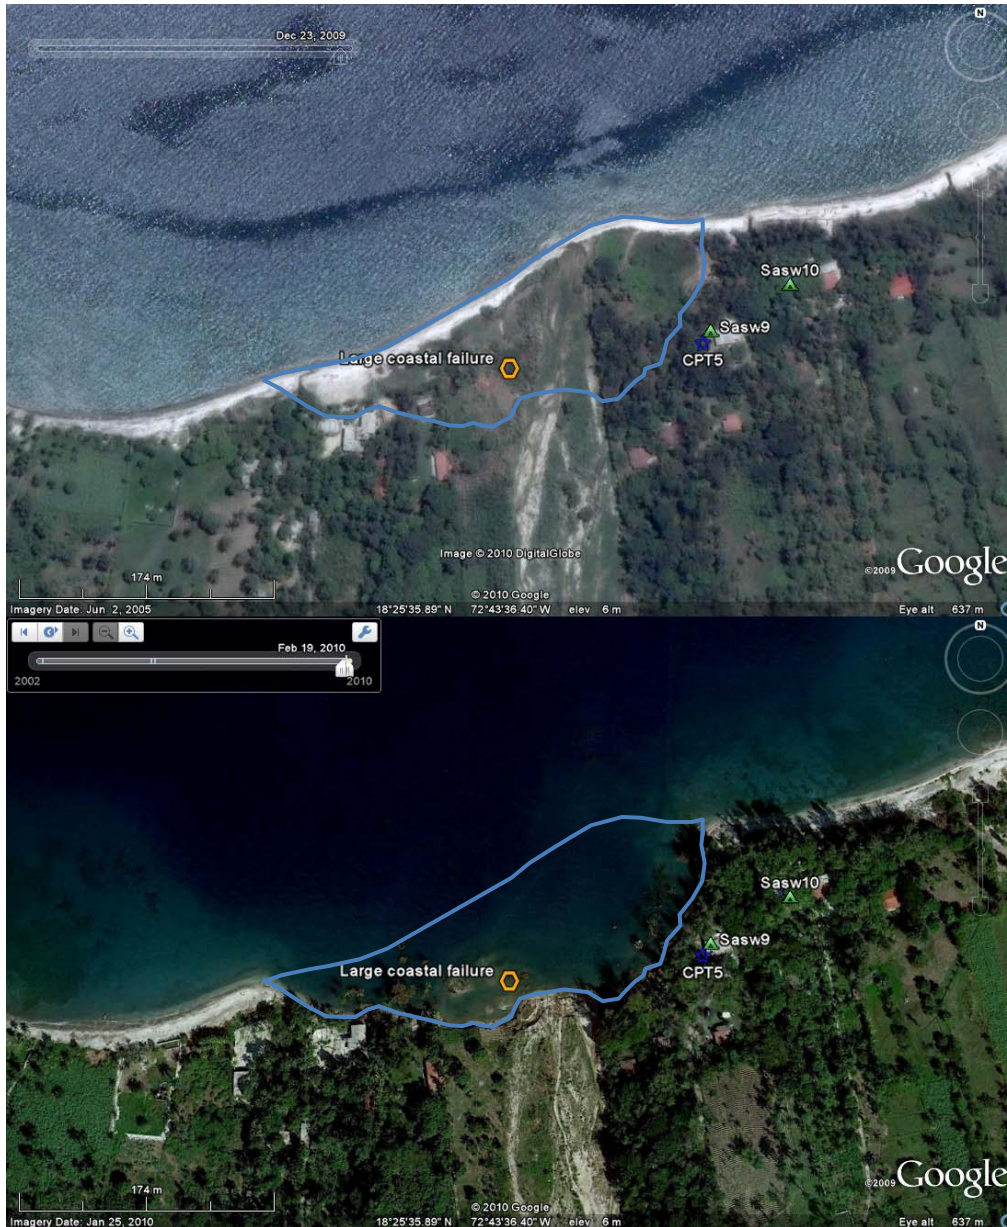
During the reconnaissance mission, the GEER team performed more detailed investigations of five potential liquefaction sites, including the Port-au-Prince port (previously discussed) and four coastal sites. One of these significant liquefaction failures occurred near the village of Fouche, close to the western edge of the fault rupture. At this site, approximately 330 m of coastline failed, as illustrated in pre- and post-earthquake imagery in Figure 12. At this site, as much as 100 m of land (perpendicular to the coast) was lost as a result of the failure. The primary manifestations of failure included scarps, cracking, and graben formation in an arcuate path along the coastline (Figure 13), as well as substantial damage to a stone wall running perpendicular to the coast and parallel to a braided stream that emptied into the bay and moderate-sized sand blows along the inland extent of the failure. One sand blow area included gravel clasts of up to about 2.5 cm in maximum dimension. The gravels may have been plucked from the sidewalls of the liquefaction feeder dike/fissure, or could have been entrained in the actual liquefied sediments.

Figure 12 Pre- and post-earthquake images of coastline near village of Fouche. Note in the lower, post-earthquake image the significant loss of coast as outlined in blue.

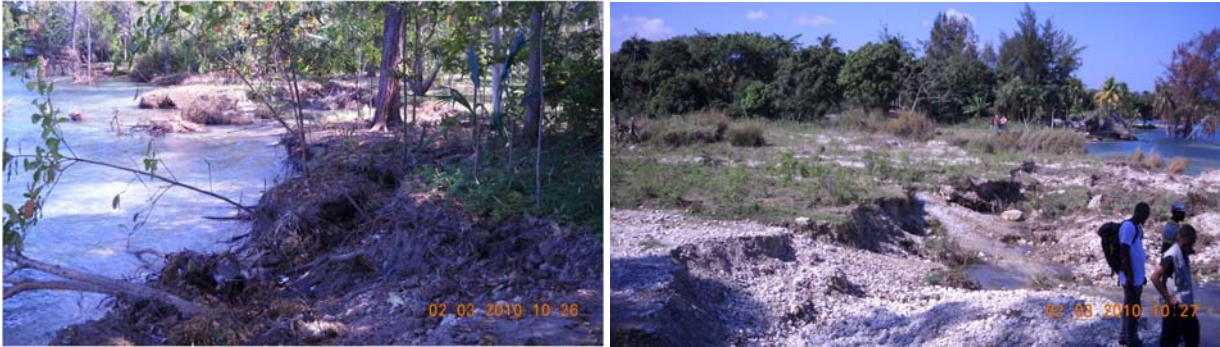
Based on the arcuate scarp, graben formation, sand blow development, and the results of the in-situ tests, this failure is attributed to liquefaction and lateral spreading of the loose to medium dense sands below a depth of 0.7 m (2.5 ft). Headscarps and slump block scarps were up to 1.5 m high in the central parts of the failure, suggesting that failure extends perhaps 1.5 to 2 m below the original ground surface. Liquefaction likely extended to a depth of 1.6 m and may have occurred at greater depth, but penetration with the DCPT was limited in these denser sands. This failure appears to coincide directly with the presence of the braided stream dumping loose sand into the sea, rather than in the marine sands present along the coast.

Figure 13 Scarp of coastal landslide near village of Fouche.

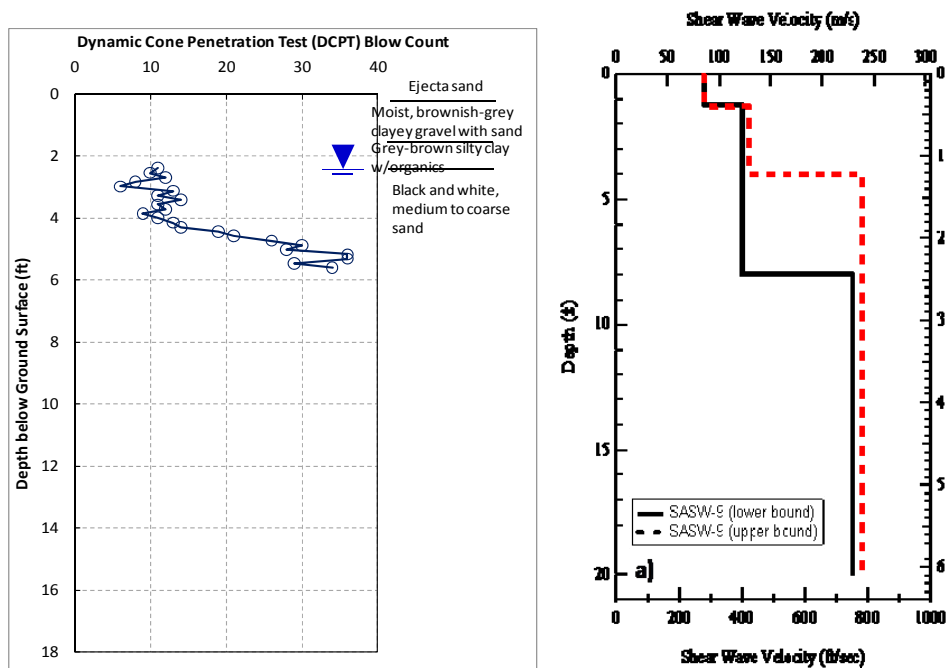
During the reconnaissance efforts, the team conducted one Dynamic Cone Penetrometer (DCPT) test and one SASW line near several sand blows at the eastern end of the failed zone. Figure 14 presents the results of the DCPT and SASW in the failed zone. As illustrated in Figure 14, loose sand was encountered at a depth of about 0.7 m (2.5 ft), underlying a low permeability cap layer consisting of clayey sand and silty clay. The sands became medium-dense to dense at a depth of about 1.6 m (5.5 ft). The SASW shear wave velocity profile shows  $V_s \sim 120$  m/s material in the top 1 to 2 m, underlain by stiffer, non-liquefiable material ( $V_s \sim 240$  m/s).

Figure 14 Results of DCPT and SASW testing at coastal failure site near village of Fouche.
