2010 Darfield (New Zealand) Earthquake: Impacts of liquefaction and lateral spreading

Misko Cubrinovski, University of Canterbury, Christchurch, New Zealand
Rolando Orense, University of Auckland, Auckland, New Zealand

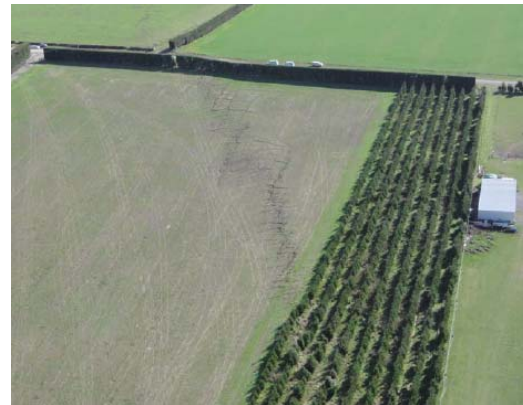
Figure 2. Surface fault rupture on farm land. The right lateral offset was approximately 4 m at the tree line (top of the photo)

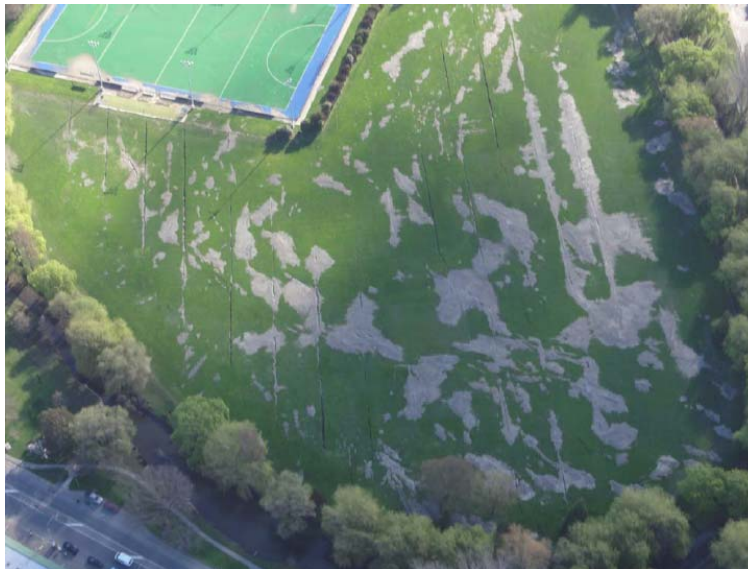
The areas most severely affected by liquefaction and lateral spreading were close to waterways (rivers, streams, swamps). Figure 5 shows an aerial photo of the Porritt Park, in Wainoni, Christchurch, taken from a helicopter flyover on 10 September. The park is enclosed by the Avon River and a diverted stream around its perimeter. Large sand boils with significant volume of sand ejecta covered substantial areas of the park. Parallel cracks spaced regularly along drainage lines were indicative of slumping and spreading towards the north and south branches of the stream. A couple of hockey fields located in the park were severely damaged by the liquefaction, resulting in a very uneven, bumpy surface of the fields.

Figure 5. Evidence of extensive liquefaction (large sand boils) in Porritt Park, Christchurch. Using the vehicles (bottom of photo) or the hockey field (top of photo) for scale gives a good indication of the significant volume of sand ejecta.

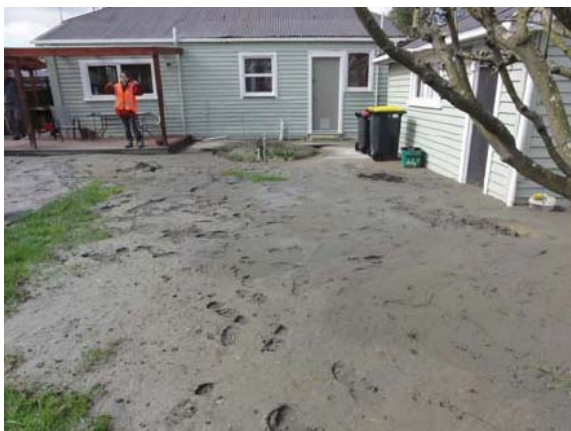
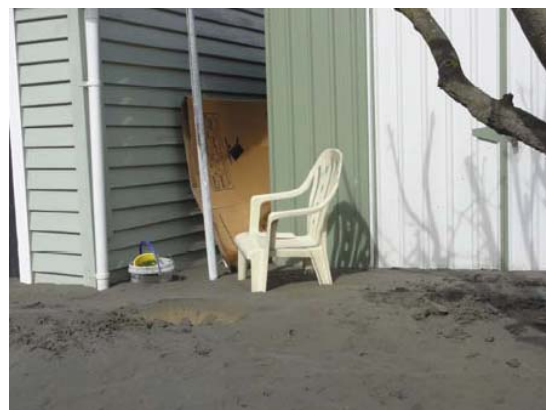
Typical manifestation of liquefaction in the backyard of a residential property is shown in Figure 6. Sand boil ejecta covered most of the lawn and was about 20 cm thick in places. There was evidence of massive liquefaction and large surface distortion in the neighbouring streets. The potable water and sewer systems were out of service at the time of the inspections. Despite significant amounts of liquefaction ejecta and broken utilities throughout the neighbourhood, the house shown in the pictures suffered relatively minor damage in terms of differential settlement and cracking.

Figure 6. Evidence of extensive liquefaction (large sand boils) in residential areas of Avonside. Notice the chair embedded in 20 cm thick sand ejecta in the backyard of the property.

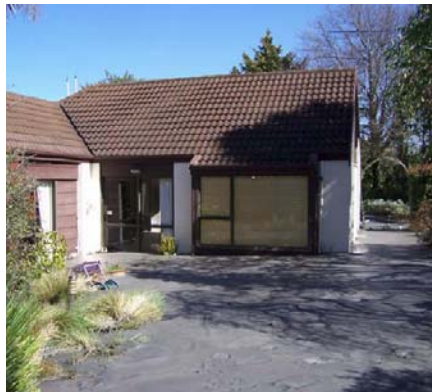
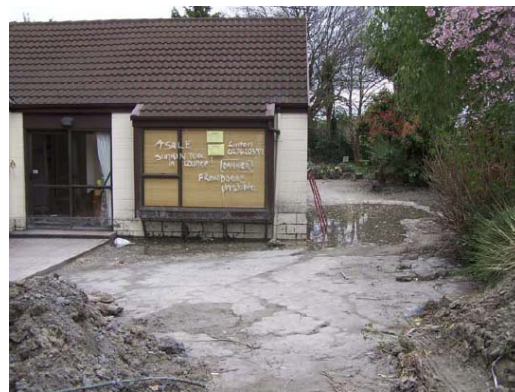
In the worst hit area, the silty sand ejecta was about 400 mm thick (Figure 7). Some residents reported geysers appearing in the backyard following the earthquake, often forming a small pond near the house that remained for several days after the event. The severe liquefaction often led to large settlement of houses, including differential settlement that resulted in structural and foundation damage. The large ground distortion, cracks and fissures in the ground also caused significant damage to buried lifelines. This area of Kaiapoi also liquefied during the 1901 Cheviot earthquake (Berrill et al., 1994).

(a) ~40 cm thick layer of silt-sand-water mixture covering a residential property affected by very severe liquefaction; (b) same-angle view, but after the clean up of sand ejecta

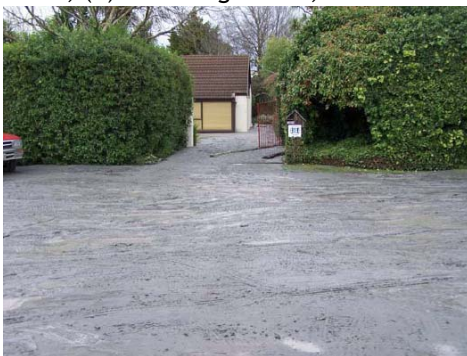
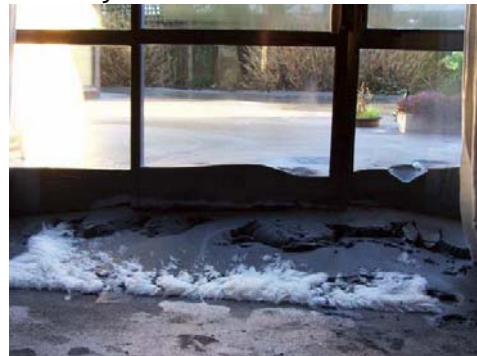
(c) View from the street (before clean up); (d) liquefied silt-sand-water mixture covering a rug inside the house and the ground outside the house (seen through a window from inside the house)

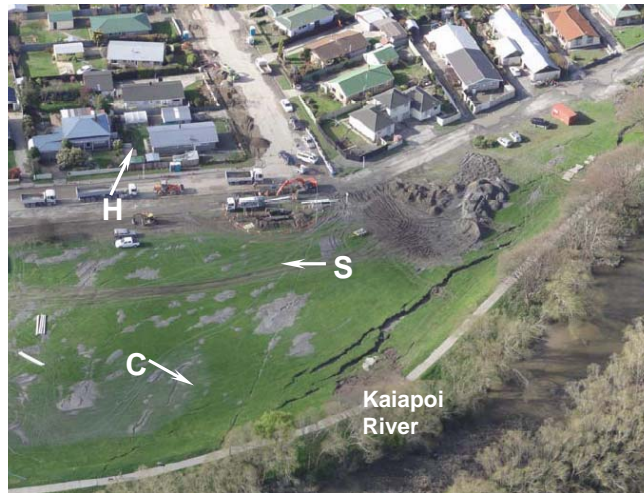
Residential houses in this area were severely affected both by liquefaction and lateral spreading. A large number of houses settled, tilted and suffered structural/foundation damage. Large size sand ejecta, spread across the area between the stopbank (levee) and street, are seen in Figure 8. The huge piles of cleaned up sand indicated as position S clearly illustrate the massive liquefaction that occurred in the area. The liquefaction was accompanied by a significant lateral spreading towards the Kaiapoi River that affected a number of houses along the street.

(a) Aerial view of North Kaiapoi (from a helicopter flyover on 10 September)

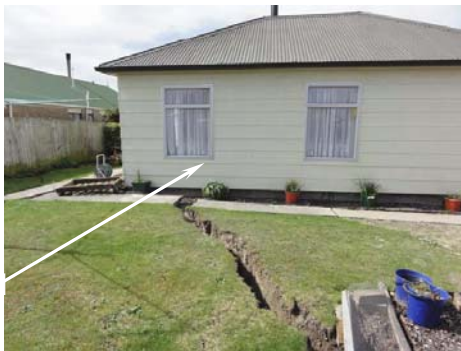
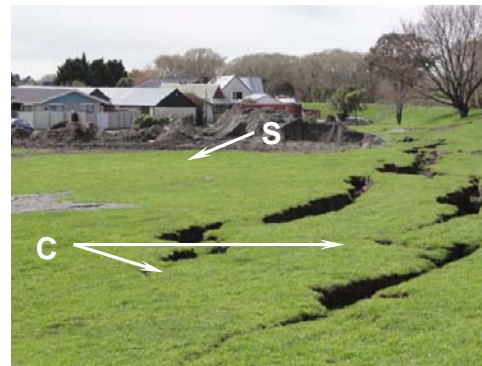
(b) Lateral spreading crack running through a residential property; (c) Lateral spread and slumping of the north stopbank of the Kaiapoi River; note the huge piles of cleaned up sand obstructing the view of the houses

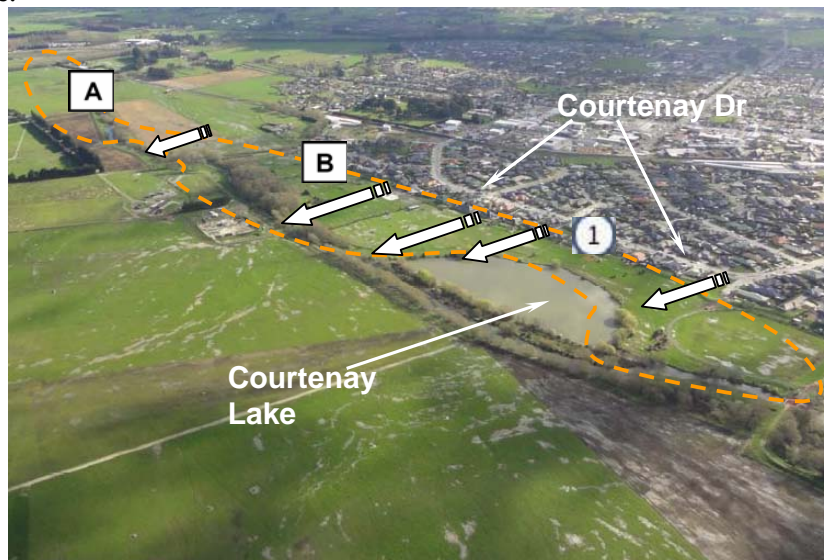
In South Kaiapoi, the most dominant ground failure feature was the liquefaction and massive lateral spreading that affected the eastern branch of Courtenay Drive. The area affected by lateral spreading, shown in Figure 9, was approximately 1-km long in the north-south direction and extended between 200 m and 300 m inland from the Courtenay Stream and Courtenay Lake. The lake was artificially created during the construction of the northern end of Courtenay Dr. Borrow material was removed from the area where the lake is presently located and used as hydraulic fill (about 1 m thick) for the northern branch of Courtenay Dr.

The area where massive lateral spreading occurred coincides with the old Waimakariri River channel from 1865. On the eastern side of South Kaiapoi, the old channel passes underneath the present day Courtenay Dr area shown as position 1 in Figure 9, where severe damage to residential properties occurred due to lateral spreading.

Figure 9. Massive lateral spreading at South Kaiapoi; sand ejecta and area affected by lateral spreading around Courtenay Lake

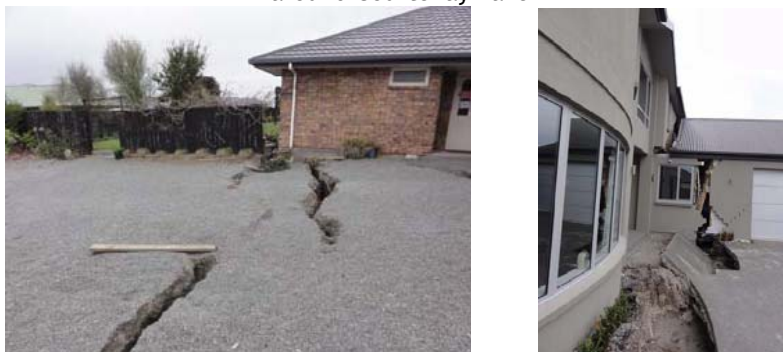
Lateral spreading resulted in large permanent lateral displacements on the order of 1.0-3.5 m with large ground cracks of about 0.5-1.5 m wide running through residential properties/houses. In this area, single storey and two storey houses suffered very severe damage due to large lateral ground movements including substantial tilt, loss of foundation support, tension cracks in foundations and slabs (Figure 10). It was significant that despite the extreme lateral movement of the immediate foundation soils and the foundations themselves, all houses showed large ductile deformation capacity and continued to carry gravity loads, despite literally being ripped in half in some cases. Detailed inspections revealed that in some parts of the affected area the lateral movement continued to increase well after the main event (Figure 11). Two consecutive measurements of the width of a large ground crack carried out on 11 and 15 September showed an increase in the width of 20 cm over this period (from 1.4 m to 1.6 m). The neighbouring residents also reported new cracks appearing in their house over the same time period. It is believed that this continued deformation was the result of a combination of creep due to static shear stresses, significantly softened soils and effects of aftershocks on a structure marginally stable under gravity loads.

Figure 10. Severe damage to residential houses/properties due to lateral spreading in South Kaiapoi; (a) Lateral spreading crack running through residential property; (b) Severe damage to timber dwelling on slab foundation affected by lateral spreading displacements of about 1.5 m across the footprint of the house. In areas severely affected by lateral spreading, damage to spread footings and foundation slabs was common, and often significant.

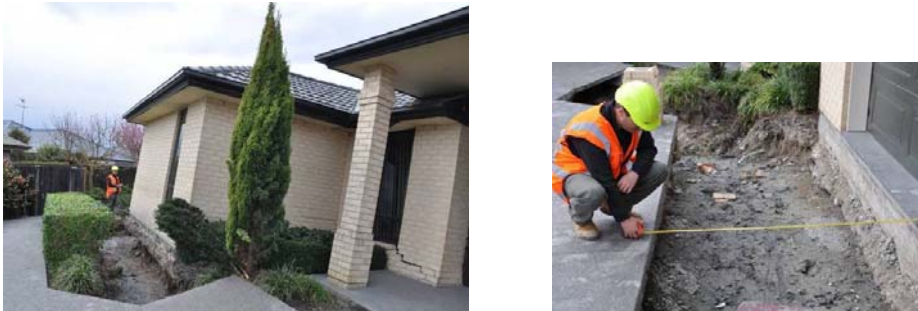
Figure 11. Severe damage to residential houses/properties due to lateral spreading in South Kaiapoi; (a) Excessive tilt and uplift of foundations due to lateral spreading; (b) The width of this crack increased from 1.4m to 1.6m in the period between 11 and 15 September (7-11 days after the mainshock).

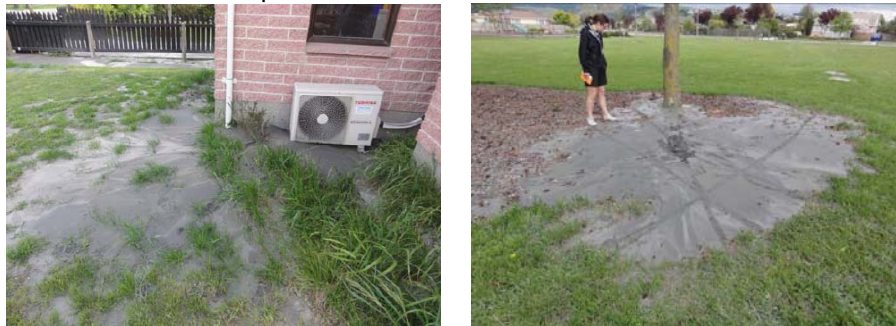
On 19 October 2010, a M_w 5.0 aftershock struck the region, with an epicentre about 10 km southwest of the CBD. The aftershock caused re-liquefaction in the area of Hoon Hay, a suburb located at an epicentral distance of about 8 km. Figure 13 shows large amount of sand ejecta on a residential property and in a park due to the re-liquefaction during this aftershock. Many residents in the area reported that houses suffered additional damage during the aftershock including widening of the cracks in walls and foundations due to lateral movement of foundation soils. This area of Hoon Hay heavily liquefied during the mainshock of the Darfield earthquake.

Figure 13. Sand ejecta at the perimeter of house foundations and in a park in Hoon Hay due to re-liquefaction during a M_w 5 aftershock; the aftershock occurred 45 days after the mainshock.

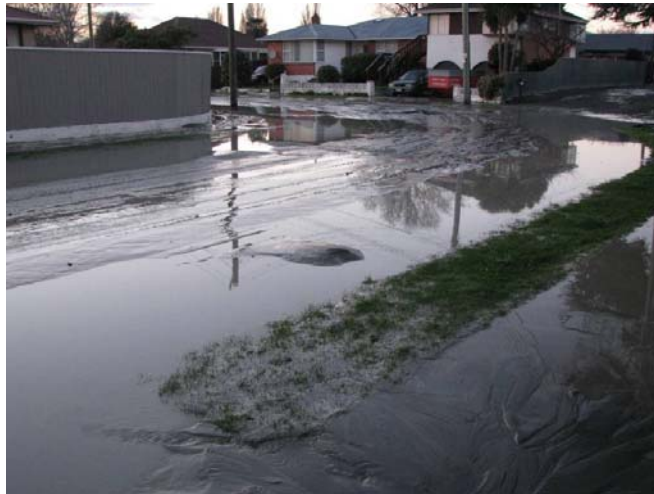
Photo 1: First light - liquefaction street scape in the neighbourhood

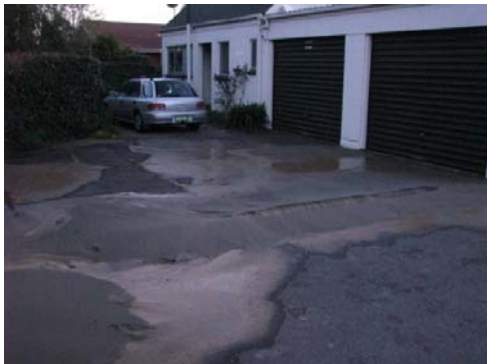
Photo 2: First light - a view of my driveway with liquefied soil and water

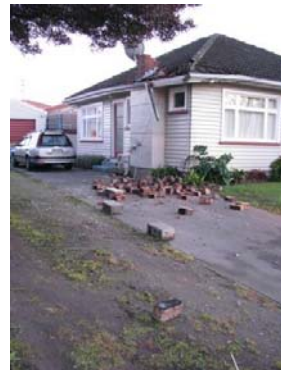
Photo 3: First light: typical chimney debris of a house in adjacent street
