## Case History

### Attabad Landslide- Dam Disaster in Pakistan 2010

On January 4, 2010, in the remote Hunza Valley of Northern Pakistan a massive landslide buried the village of Attabad, destroyed 26 houses and killed 20 people. The landslide dammed Hunza River and formed an extensive lake of 100m depth. Until the end of July 2010, 381 houses were ruined; out of which 141 were directly affected by Attabad landslide, others were submerged due to expansion of the lake. By the end of May 2010 local authorities excavated a spillway to guide the flow of impounding lake over the natural dam. Until August, 2010, the spillway is performing well but internal response of the loosely deposited debris is unknown.

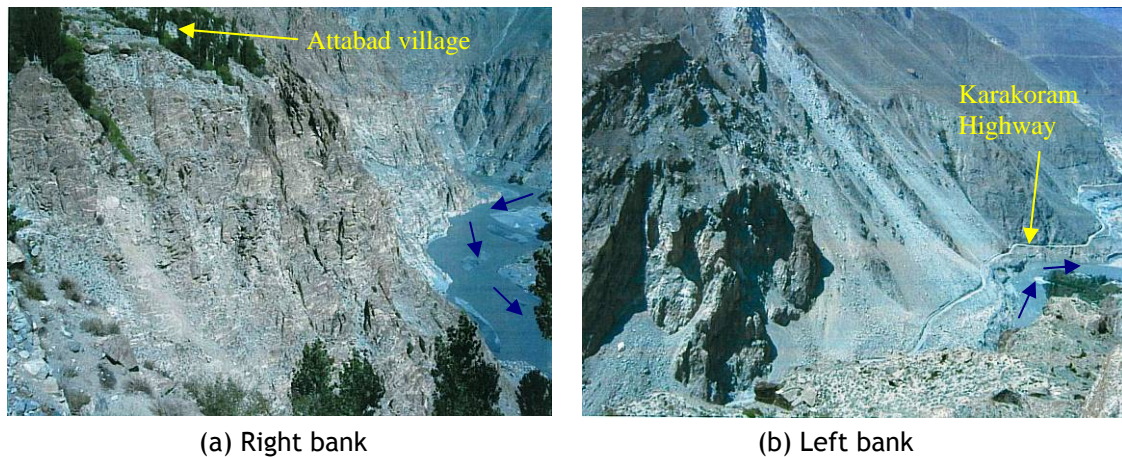
Figure 3 Site of Attabad landslide in pre-disaster period (August 2009)

2. A fault is passing through the affected area having a strike NS and crossing the river. A huge landslide has developed across the river (Fig. 3(b)). This landslide is associated with the fault. The movement along this fault has weakened the shearing strength of the rocks and decreased the angle of repose.

3. High slope angle is the major triggering factor of the eastern Attabad. A slope angle at terraces is ranging from  $30^{\circ}$  to  $40^{\circ}$ , at the back-slope from  $35^{\circ}$  to  $55^{\circ}$  and toe of terraces is nearly vertical (Fig.3 (a)).

Based on those studies Attabad was declared as high hazard zone. Local authorities were suggested by Geological Survey of Pakistan to take necessary action for the evacuation of dwellings from vulnerable area. A suggestion was given to monitor the hazardous area during the winter and snow melt season.

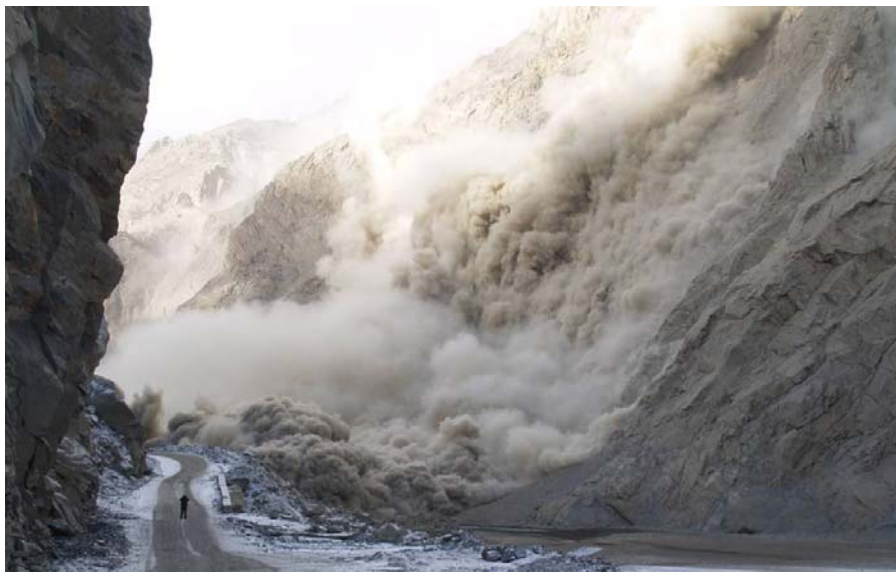
On January 4, 2010 a huge mass failed, destroying the village of Attabad and damming the Hunza River. Fig.4 shows the secondary landslide taking place at the site. The blocked length of the river was about 2 kilometers with the width of 500m. The landslide itself blocked 1.3km of Karakoram Highway. Till the end of May 2010, the lake stretched to a length of 22km. The estimated potential storage of the lake, if it impounds up to the maximum height of the dam, is 305 million m<sup>3</sup>.

Figure 4 Secondary landslide on January 22, 2010 at Attabad (image courtesy PAMIRTIMES)

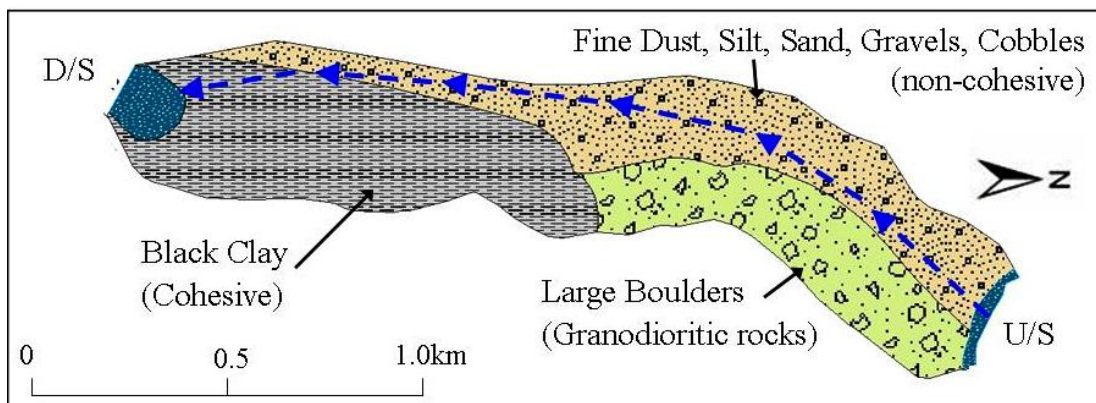
The distribution of deposited debris is shown in Fig. 5. A longitudinal profile through the flow path of Hunza River is shown in Fig.6. Deposited mass is mainly composed of non-cohesive rock flour (fine dust, silt, silt gravels and cobbles) at the toe of the failed slope. Large boulders of granodioritic rocks with intrusions of granite, pegmatite and apatite were deposited close to the left bank of Hunza River. The deposit on the downstream side is composed of black clay with high plasticity and organic content.

Figure 5 Distribution of debris material

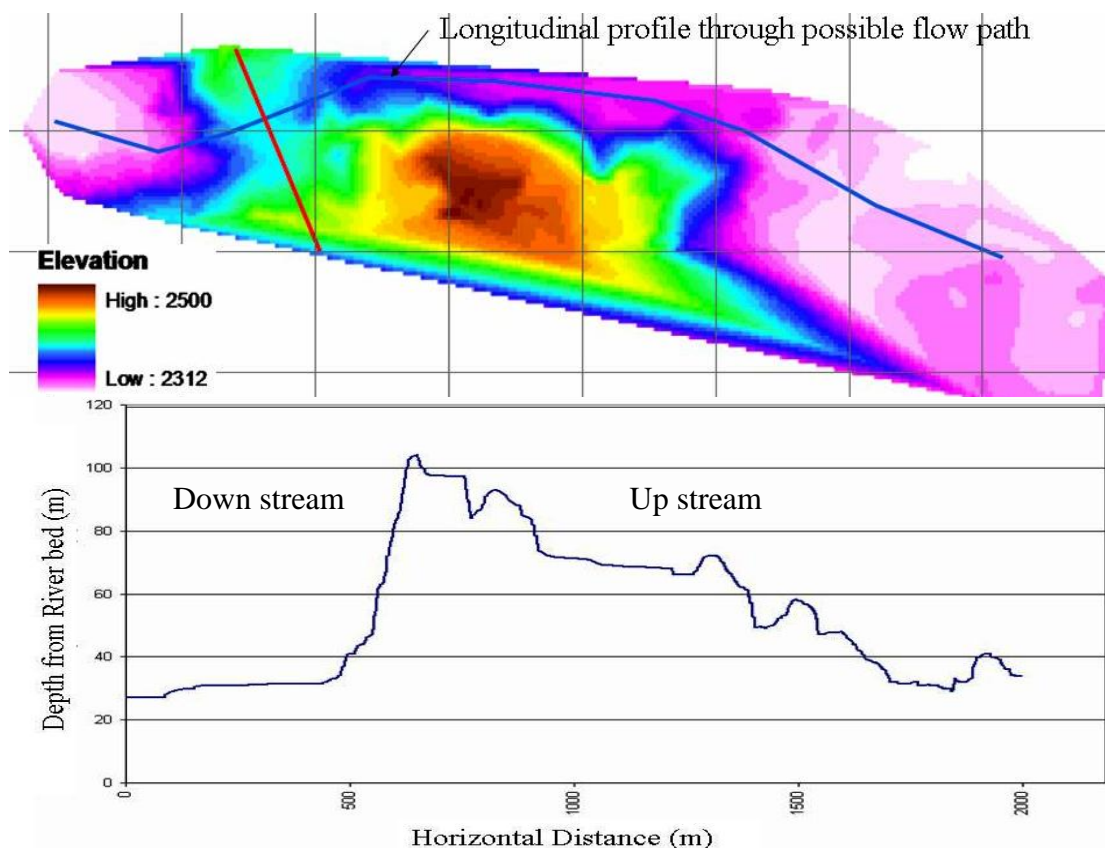
The longitudinal profile (Fig.6) indicates that the upstream shoulder of the natural dam has mild slope, however downstream slope is quite steep. With such length (2 km) of the dam there are rare chances of piping failure. Fig.7 shows drowned villages of Shishkat and Gulmit along with the stretches of Karakoram Highway.

Figure 6 Topography and Longitudinal profile of failed deposited material

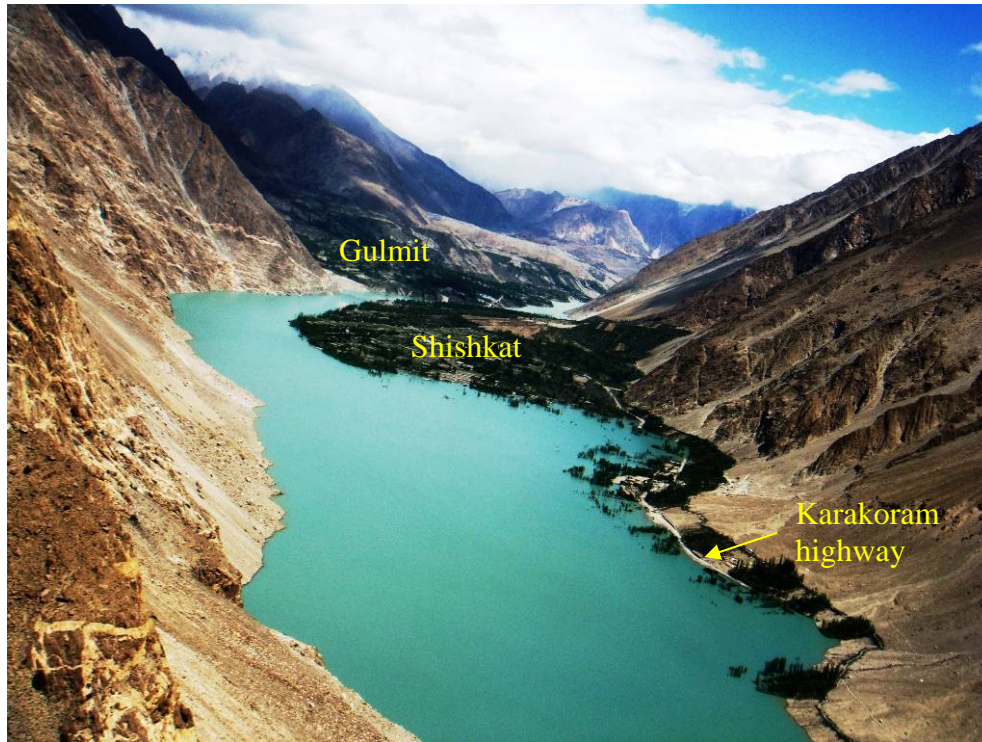
Figure 7 Drowning of villages due to expanding lake (image courtesy PAMIRTIMES)

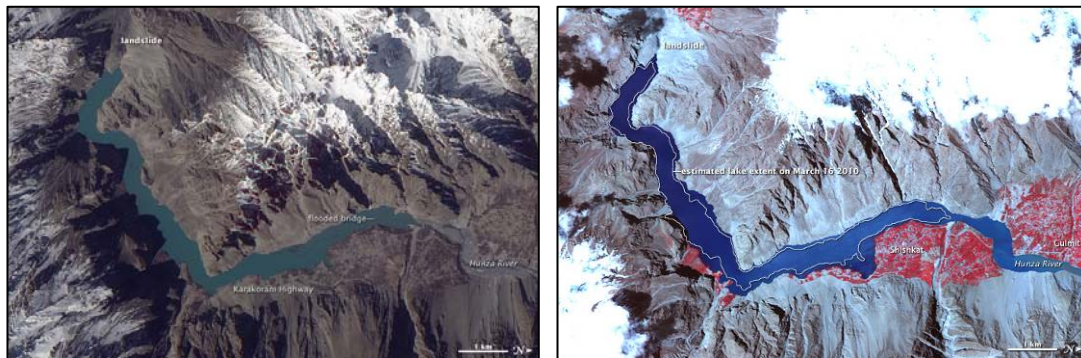
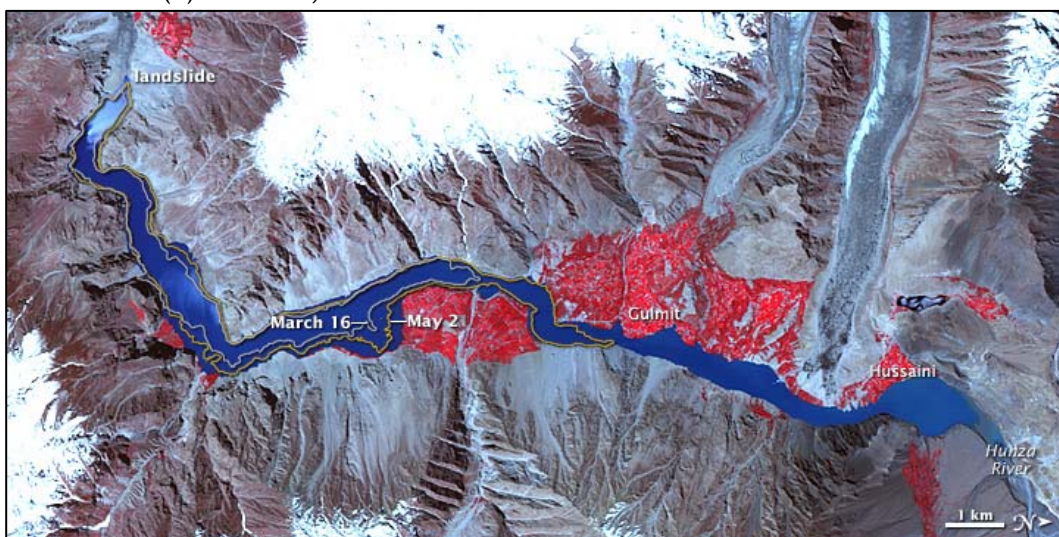
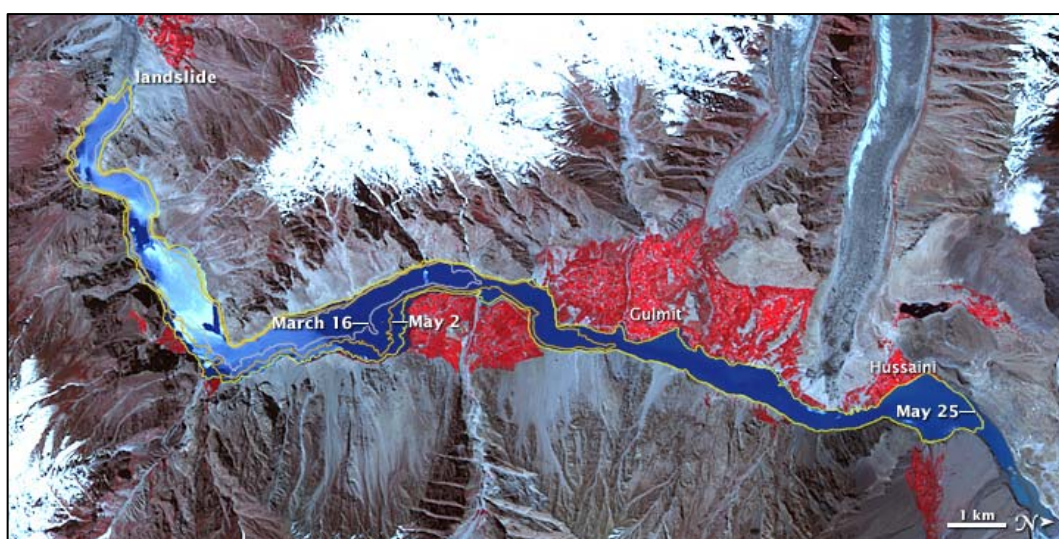
Figure 8 Images of lake expansion by NASA before it overflows

NASA monitored the expansion of lake by taking satellite imageries as shown in Fig. 8. It was believed that the lake expansion has direct relation with the increase in temperature which is the cause of snowmelt and increased inflows. Timely evacuation of the inhabitants was carried out from the drowning villages of Shishkat and Gulmit.

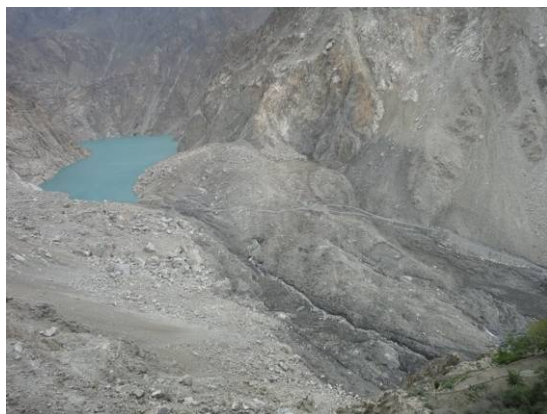
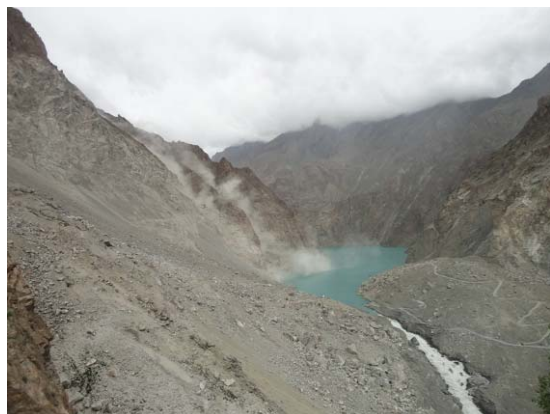
Figure 10 Performance of spillway (courtesy by PAMIRTIMES)

A Dam breach study was conducted by NESPAK (National Consulting Firm). They reported the study in March 2010 to National Disaster Mitigation Authority (NDMA) and proposed the excavation of spillway as a safe way to drain the water. The recommended spillway was 24 m deep and 45 m wide. The excavation works for the spillway were finished in the mid of May. As anticipated the overflow began on May 29, 2010. Time histories of stage over spillway crest and discharge that was measured downstream at the Ganish Bridge (down stream of Attabad) show the performance of the spillway (Fig. 9). The consistency of stage and discharge curves contradicts because the measured discharge also includes the seepage allowance. However, inflow depends on the snowmelt which is directly related to the rising temperature in summer. Data shown in Fig. 10 was reproduced from the daily pager reports given by NDMA. Fig. 10 shows the situations before and after over spilling of the downstream slope. The marks of erosion are quite visible in Fig. 10(b). NASA satellite image shows the overflowing spillway in Fig.11.

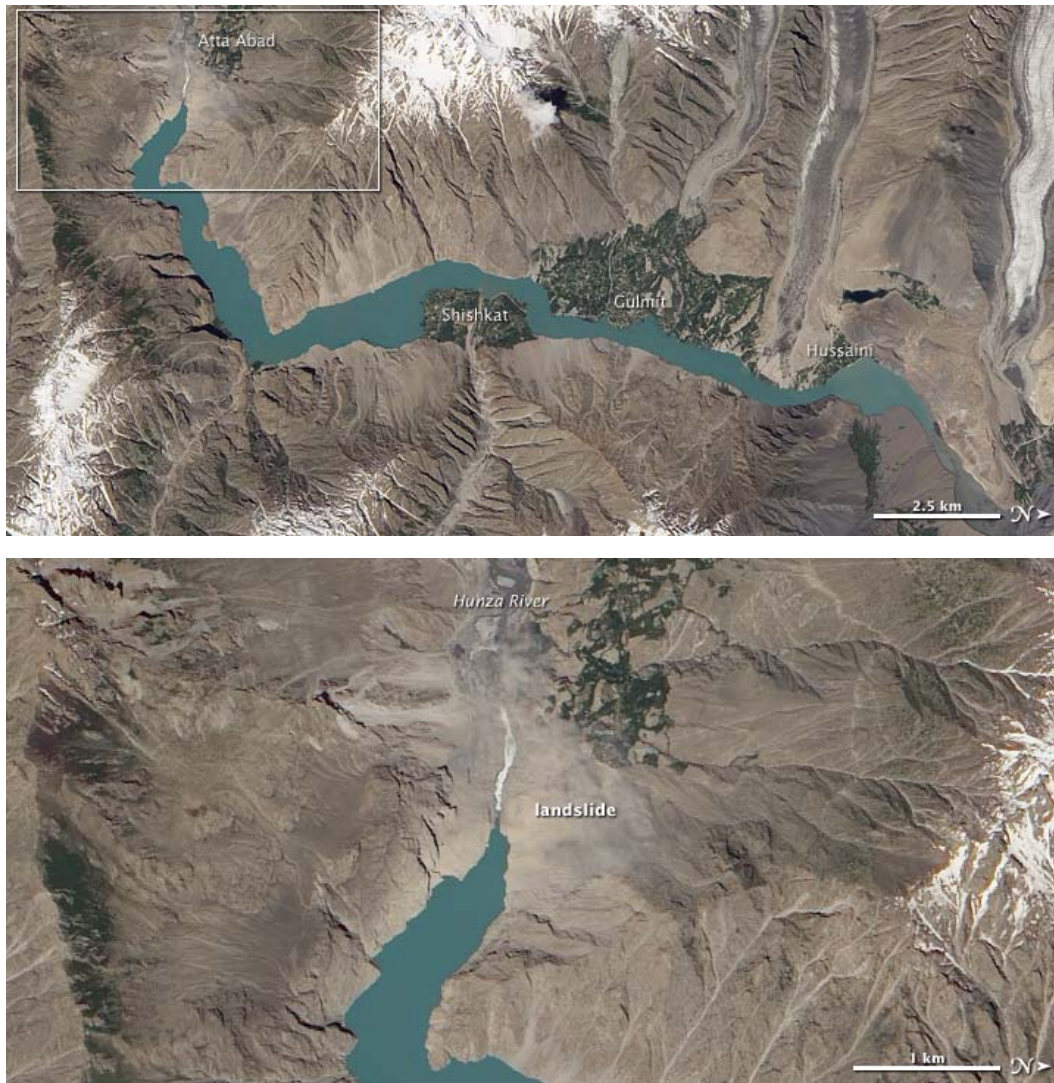
Figure 11 Image of over spilling Attabad landslide dam on July 7, 2010

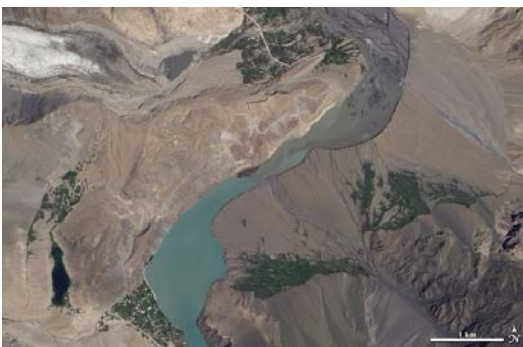
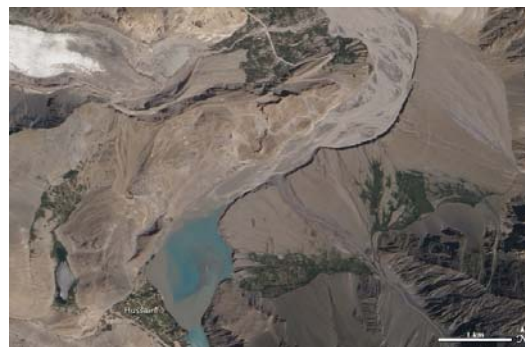
Figure 13 Decreasing inflow of water into the lake in August, 2010 (NASA images)

More recently, the situation is being relaxed. Fig. 13 compares two images from NASA that were taken on July 7 and August 23. These images compare the part of upstream edge of the lake. It is therein seen that the inflow has been reduced. In the month of June and July, the temperature was high to produce more inflow due to ice melting. In contrast in August, the temperature dropped, and thus the inflow decreased.
