Geotechnical Damage due to the 2011 Christchurch, New Zealand

Suguru Yamada, Assistant Professor, University of Tokyo
Rolando Orense, Senior Lecturer, University of Auckland
Misko Cubrinovski, Associate Professor, University of Canterbury

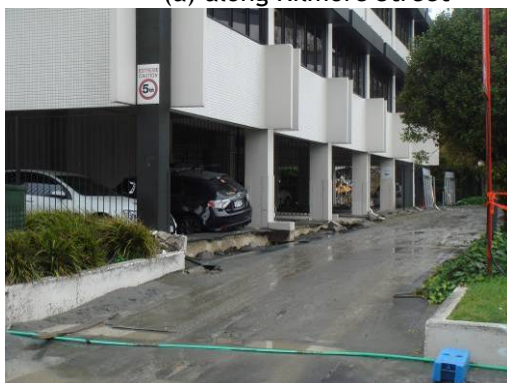
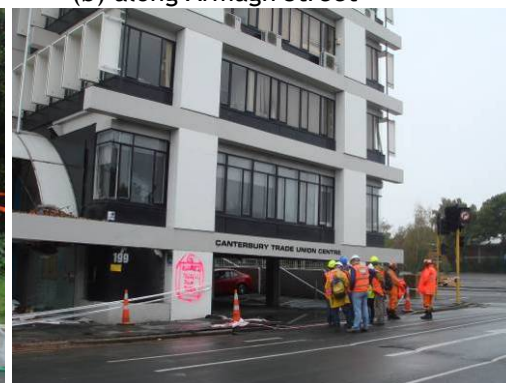
In the Central Business District (CBD), several buildings collapsed, while many of the buildings that survived suffered significant or some form of structural damage. Severe liquefaction was also observed in the CBD, such as along Kilmore Street (Figure 11a) and Armagh Street (Figure 11b). The relation between the building structural damages and liquefaction of the foundation ground is currently under investigation.

(a) along Kilmore Street

(b) along Armagh Street

Figure 11. Liquefaction-induced damages in CBD.

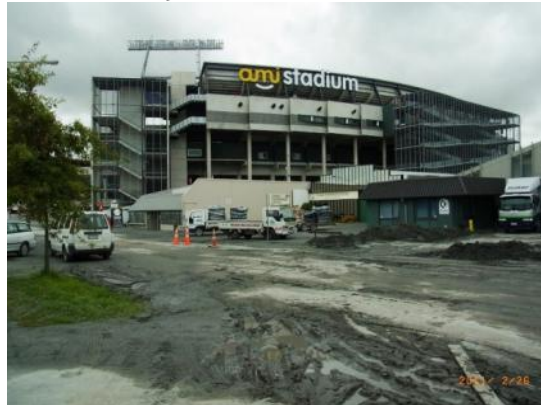
There are very few structures in the area where liquefaction countermeasures have been implemented in the foundation ground. One example is the AMI stadium located near CBD, where the ground under the east stand was stabilized with stone column. Minor liquefaction was observed near the east stand in spite of the severe liquefaction all around the stadium (Figure 12).

(a) Massive amount of sand ejecta in front of the west stand of AMI stadium.

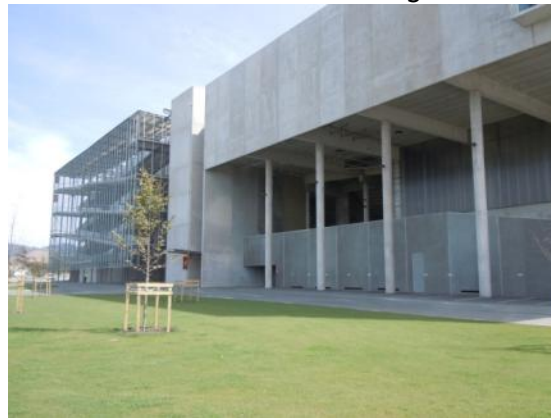
(b) The ground in front of the east stand of AMI stadium. The green turf was not covered by sand boils.

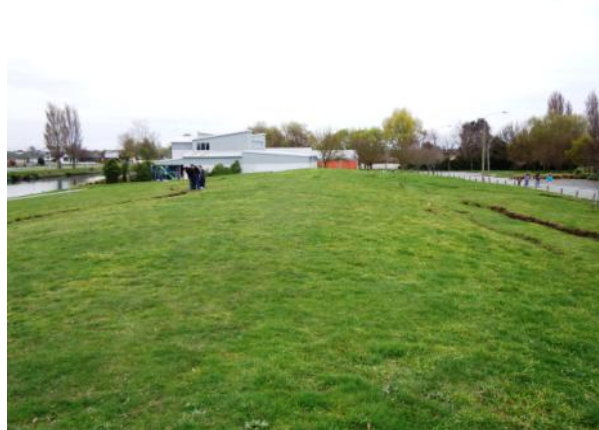
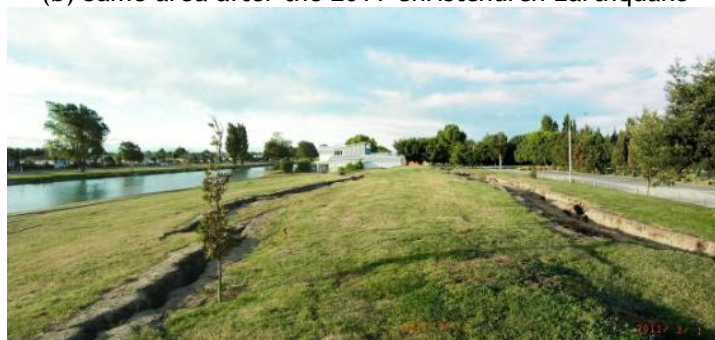
Because of short time interval between the two gigantic earthquake events, the earthquake caused additional damages to many facilities which suffered liquefaction-induced damage and had not been repaired. Figures 13 (a) and (b) are photos of a river embankment in Porritt Park (east bank of Avon River), after the 2010 earthquake and 2011 earthquake, respectively. The width of crack openings on the shoulder and settlement of the crown became larger due to repeated liquefaction of the foundation ground of the embankment. Extensive repeated liquefaction was observed in entire Porritt Park, where half of green grassy area was covered by sand boils again following the previous earthquake.

(a) Damage in Porritt Park after 2010 Darfield Earthquake (JGS, 2010)

(b) Same area after the 2011 Christchurch Earthquake

Figure 13. Lateral spreading and the crown settlement of a stop bank near Porritt Park.

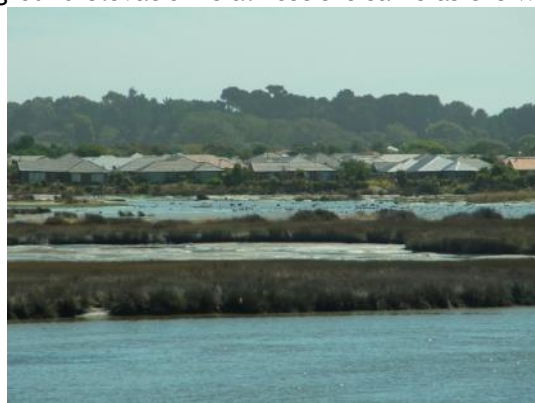
Extensive liquefaction was observed widely in residential areas along Avon River. The very shallow ground water table (1.0m to 1.5m) has been recognized in western suburb of Christchurch, particularly in areas close to the coastal line. Bexley is a newly constructed residential area developed by reclaiming the wetland near the mouth of Avon River. Figure 14 shows a broad panorama overlooking Bexley, taken from the South Brighton Bridge crossing the river mouth of Avon. It can be seen that residential houses are now located on an area where the ground elevation is almost the same as the water surface.

Figure 14. A photo overlooking the Bexley residential area.

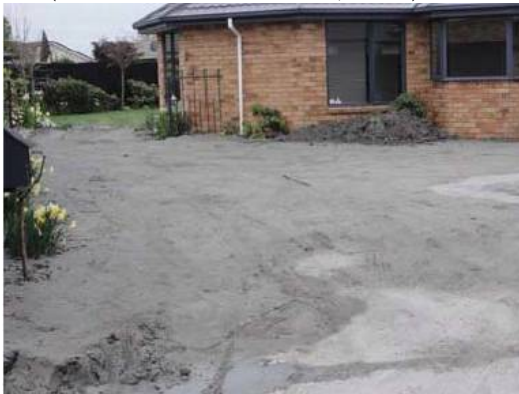
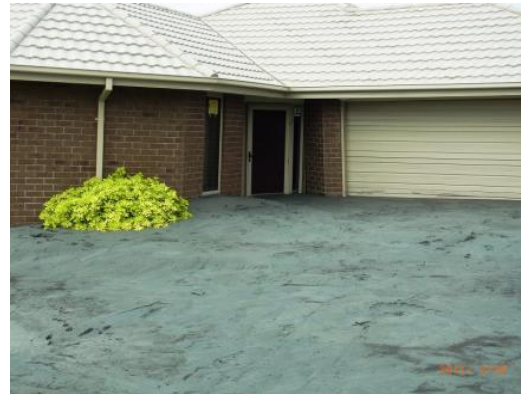
In Bexley, a large number of residential houses/properties suffered severe damage from liquefaction in September 2010 earthquake. After the 2011 earthquake, it was again one of the worst hit areas in terms of liquefaction-induced damage. Figures 15 (a) and (b) show damaged residences after the 2010 and 2011 earthquakes, at Seabreeze Close in Bexley. Massive amount of sands were ejected and deposited around the houses. Differential ground settlement was caused by severe sand boils, resulting in tilting in many houses.

(a) After the 2010 Darfield Earthquake
(Cubrinovski and Orense, 2010)

(b) after the 2011 Christchurch Earthquake

Figure 15. Damage to residential houses due to repeated liquefaction in Seabreeze Close, Bexley.

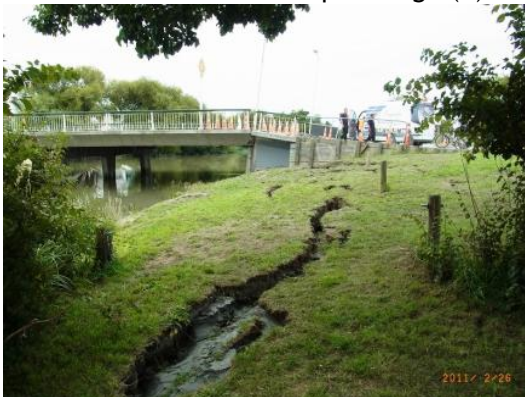
Damages in levees along Avon River were observed everywhere, spanning from inside the CBD to the river mouth. Many bridges crossing the Avon river suffered tilting in their abutments, as a result of lateral spreading and loss of bearing capacity due to liquefaction (Figure 16a). Damage to pipelines was also observed at the connections between bridge and backfill. In most cases, the settlement of the bridge abutment itself is smaller than that of the adjacent soil because the bridge is supported by pile foundations (Figure 16b).

(a) Tilt in abutment due to lateral spreading

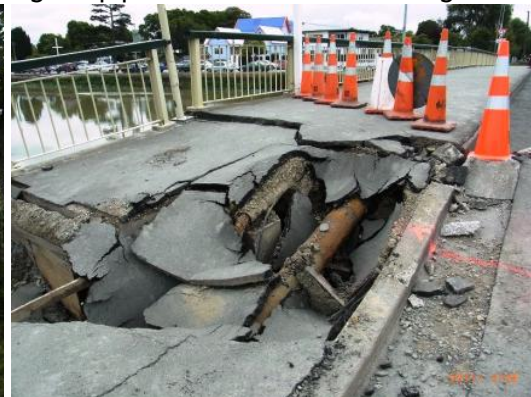
(b) Damage to pipeline installed in the bridge

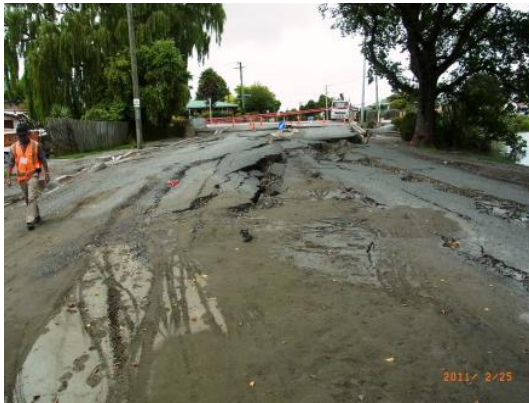
Due to lateral spreading and heaving of the river bed, the cross-sectional area of the Avon River has become smaller than before the earthquake (Figure 17). Therefore, people living in areas adjacent to the river will now have to worry about flooding during the rainy season.

(a) River dike moved laterally toward the river

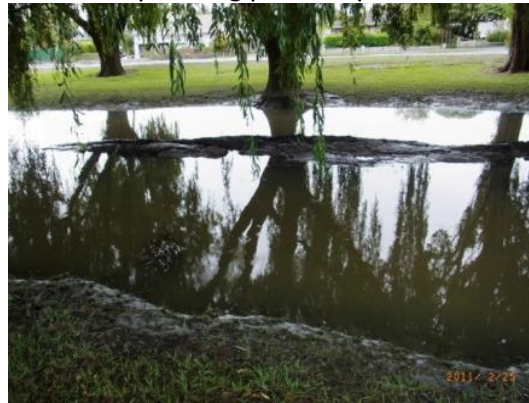
(b) River bed appeared above water surface as lateral spreading pushed up the river bed

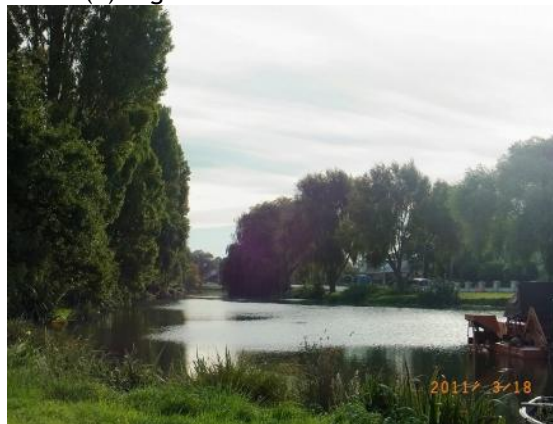
(c) High water level in Avon River

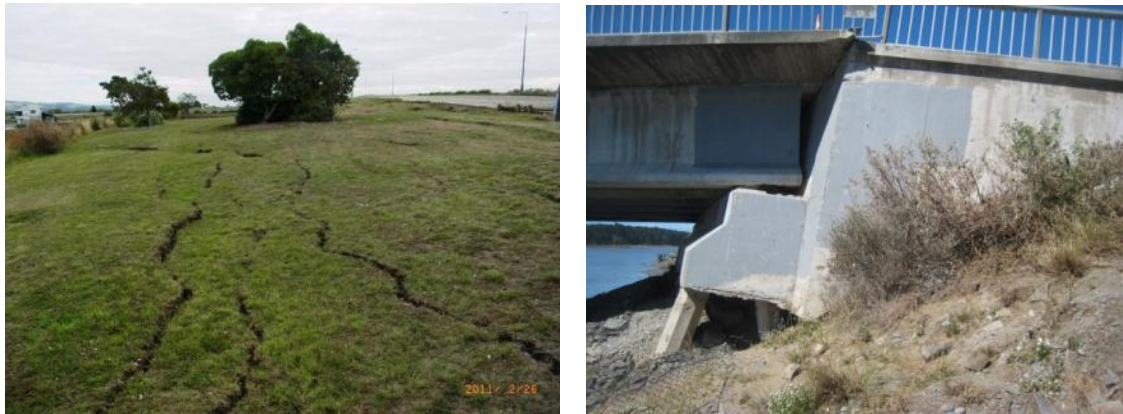
The South Brighton Bridge which crosses the mouth of Avon River was severely affected by liquefaction on ground basement. Observed damages near the bridge were lateral deformation and crown settlement in the bridge approach, large tilt of abutments, tension and compression cracks in pile foundations and failure of pipeline installed underneath bridge girder (Figure 18). The body of the embankment spread laterally, with the top settling down due to liquefaction of the ground underneath and causing large tilt of the abutments. The back side of the abutment settled down, the front side lifted up, and the pile foundation protruded to the ground surface. Tension and compression cracks were observed in the battered pile foundation; however no pile was broken. Thus, it can be considered that the loss of lateral bearing capacity of the pile foundation was induced by liquefaction below the abutment.

(a) Damage to the body of the embankment (b) Tilted abutment and protruding battered pile foundation

Figure 18. Liquefaction-induced damage to South Brighton Bridge.

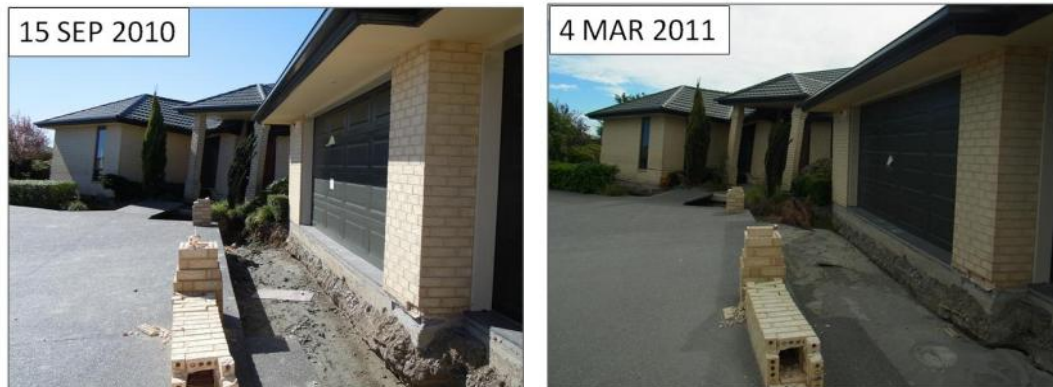
Figure 19 shows two photos of a residential house which suffered severe damage due to lateral spreading in 4 September 2010 earthquake. This residence is standing on a ground that moved toward Waimakariri River, resulting in tilting of the house and formation of 1.6 m wide crack. An investigation was carried out at the residential property shown in the figure on 4 March 2011. Sand boils were observed only in the crack, with the width of crack increasing to 1.9 m. It is unknown, however, whether the increase in crack opening was caused by this earthquake alone. Creep deformation in this area due to the aftershocks of 2010 Darfield earthquake has been reported (Cubrinovski and Orense, 2010). Therefore, there is a possibility that the width of the crack was more than 1.6 m before the February 2011 earthquake and the impact of the recent earthquake to this area was minor. No other remarkable additional damage to residential house/properties was observed in South Kaiapoi.

Figure 19. Minor additional damage to a residential house which underwent foundation failure due to lateral spreading and liquefaction in 2010 Darfield Earthquake. (South Kaiapoi)

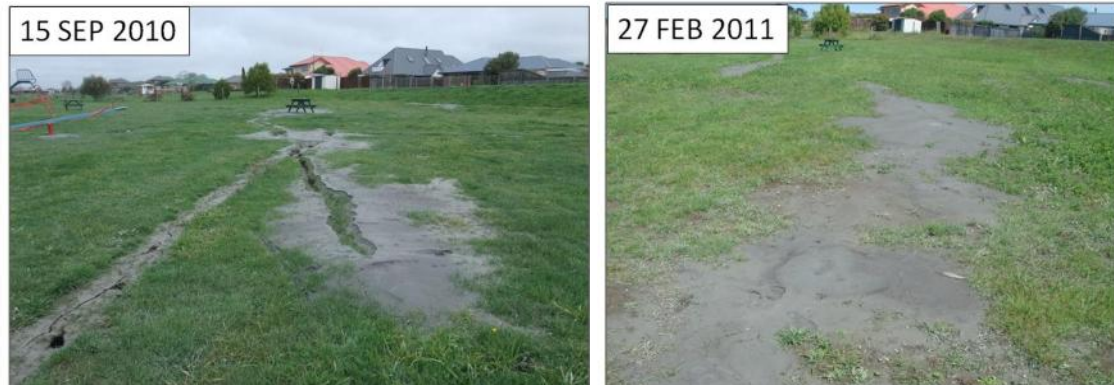
In areas close to the waterways, most of sand boils were observed at existing/repairs cracks caused by the 2010 earthquake. Aside from the lower intensity of ground shaking in Kaiapoi, it is possible that the excess pore water pressure generated by the earthquake motion could have been dissipated easily through the existing cracks and therefore, significant ground distortion was not caused by this earthquake (Figure 20 and 21).

Figure 20. Repeated liquefaction at a park adjacent to Courtenay Lake (South Kaiapoi). Liquefied soil was ejected from existing cracks, but ground distortion was minor compared to the ones observed in September 2010 earthquake.

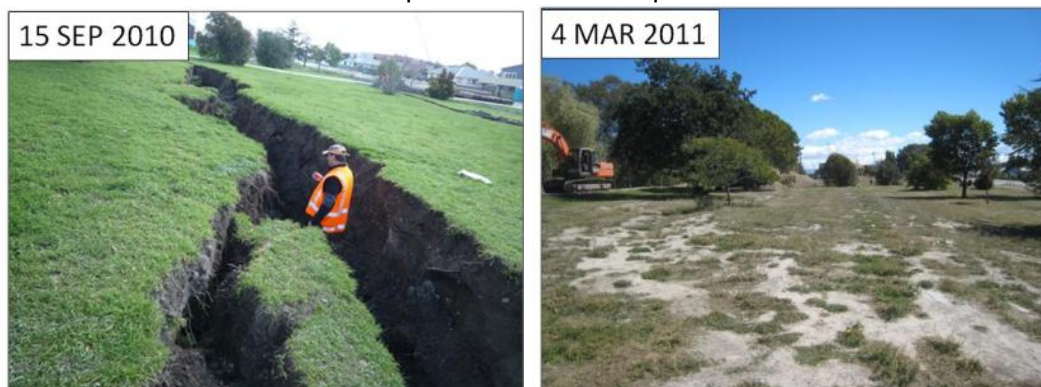
Figure 21. Damage to the stop bank along Kaiapoi river (North Kaiapoi). Sand boils were observed on restored cracks. The damage to the stop bank was minor and lots of small fissures were observed at restored cracks.
