## Earthquake News

### On Gigantic Tohoku Pacific Earthquake in Japan

Ikuko Towhata, Professor, University of Tokyo  
 Hiroyuki Goto, Assistant Professor, Kyoto University  
 Motoki Kazama, Professor, Tohoku University, Sendai  
 Takashi Kiyota, Assistant Professor, University of Tokyo  
 Susumu Nakamura, Professor, Nihon University, Fukushima  
 Kazue Wakamatsu, Professor, Kanto Gakuin University, Yokohama  
 Akihiko Wakai, Professor, Gunma University, Kiryu  
 Susumu Yasuda, Professor, Tokyo Denki University, Saitama  
 Nozomu Yoshida, Professor, Tohoku Gakuin University, Tagajo

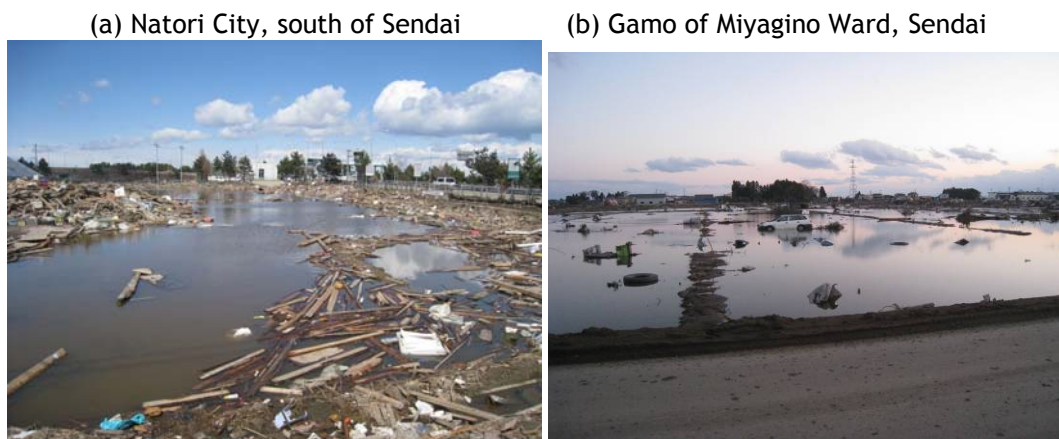
Geospatial Information Authority of Japan announced that the coseismic displacement of the earth crust in the coastal area was at maximum 5.3 m in the horizontal direction towards the Pacific Ocean and 1.2m in subsidence. Thus, many areas along the affected coastal area got under water, the tsunami effect was made more serious, and the tsunami water remained in the area for a longer time, making the rescue very difficult. Fig. 2 illustrates the coseismic subduction in Sendai area. Note that similar subsidence occurred at many places in the world during past gigantic earthquakes: Kohchi of Japan in 1946 and at several more times in the history, Valdivia and surrounding area in Chile in 1960, South Alaska in 1964, and Izmit Bay of Turkey in 1999. Kohchi and Valdivia came upwards again after the quakes.

Fig. 2 Coseismic subsidence in Sendai (Photographs by Daiken Suzuki, former student of University of Tokyo)

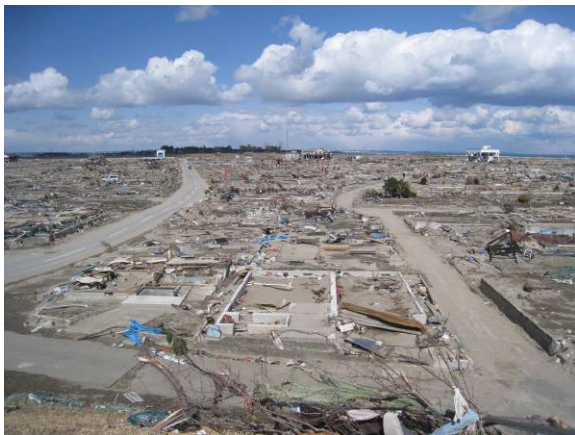
Fig. 8 Yuriage township near Natori River mouth to the south of Sendai (Photo by Daiken Suzuki)

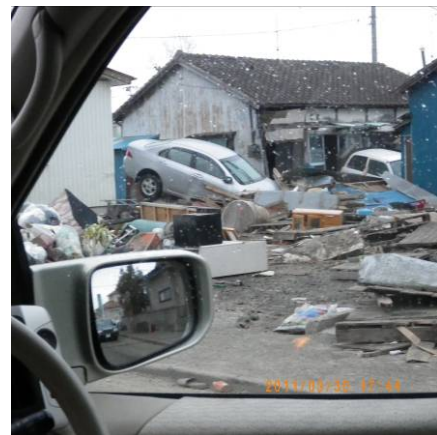
Fig. 9 Tsunami debris in Tagajo Municipality

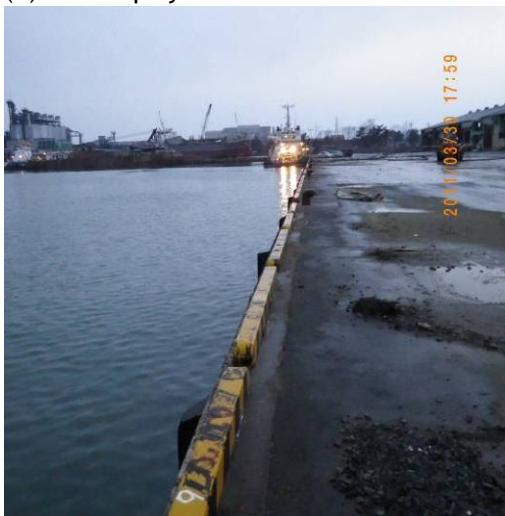
(a) Intact quay wall

Fig. 10 Post-tsunami situation in Ishinomaki Harbor to the east of Sendai

Figure 10(a) shows that the quay wall of Ishinomaki Harbor was intact, although the retreating tsunami water was so powerful to erode sand in building foundation (Fig. 10b). Despite this good seismic performance of the quay wall, the operation of the harbor was stopped for many weeks because facilities for cargo handling were destroyed. Hence, rescue stuffs could not rely on mass transportation by ship. Fig. 11 demonstrates tsunami erosion in bridge abutment. There are local people who have been working hard to reestablish previous life conditions. Fig. 12 shows recovery of fish restaurants in Nakaminato Harbor in Ibaraki Prefecture, 100 km NE of Tokyo, where the tsunami height was 4.2 m, being 1.0 m above the ground surface. The loss of backfill soil behind a coastal levee near the mouth of Abukuma River (Fig. 13) suggests that erosion by the arrival of tsunami was the main cause of the damage, which was more serious than the effect of retreating tsunami.

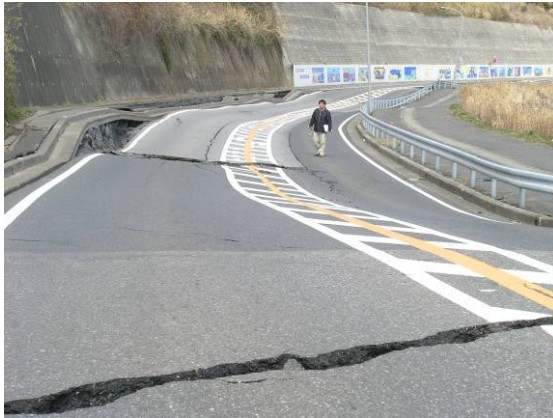
Fig. 21 Distortion of road embankment in Nakaminato of Ibaraki Pref.

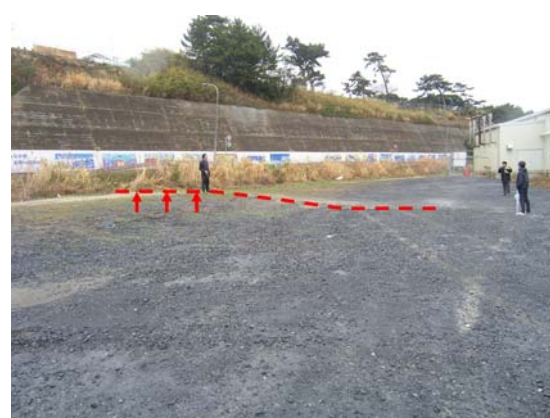
Fig. 22 Uplift near the toe of distorted slope in the previous figure

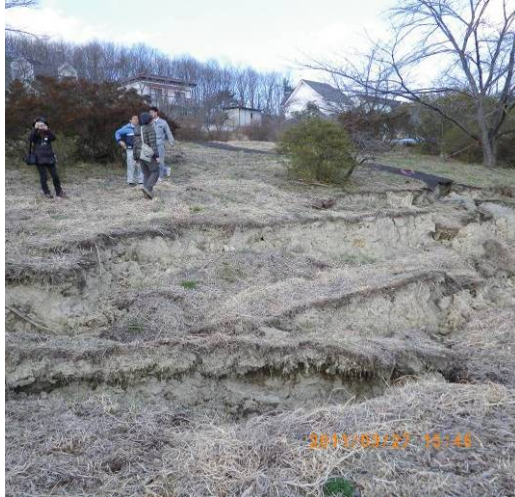
(a) At the top of slope

On the contrary, many problems were detected in artificial earth fills for residential land development in hill areas. Fig. 35 demonstrates a slope failure at Midorigaoka area of Shiroishi City, south of Sendai. Formerly known as Kotobuki-Yama, this development slope failed during the 1978 Miyagiken-Oki earthquake when the earth filling was going on. It appears that engineers in those days judged that the slope would not be perfectly stabilized, and the land was converted to a green park instead of selling it for residence. That decision was right because the upper part of the slope failed once more (Fig. 35a). Note that part of the lower half of the slope has been stabilized by drainage of ground water (see drainage well in Fig. 35b) and was stable during the 2011 earthquake.

Fig. 35 Slope failure at Midorigaoka of Shiroishi City of Miyagi Prefecture, south of Sendai

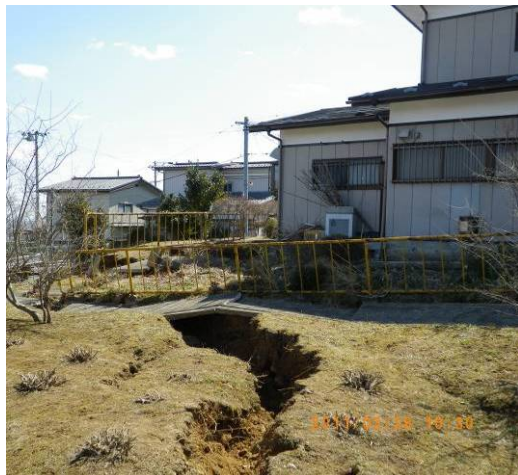
Fig. 36 Failure of residential development slope in Midorigaoka of Sendai City

Slope failure was repeated similarly in a land development area in Sendai City. Fig. 36 shows that the slope failure during a future earthquake was feared and this area has been left vacant until the slope failed once more in 2011. This right decision, however, was not made in a nearby area of Fig. 37. This figure indicates that ground was subjected to compressive distortion at the bottom of a moving slope. Fig. 38 shows soil liquefaction in a hilly area of Sendai City. A local person said that there used to be a small stream here and that it was backfilled at the time of land development. Therefore, the mechanism of this liquefaction is similar to what has happened in larger artificial islands near Tokyo.

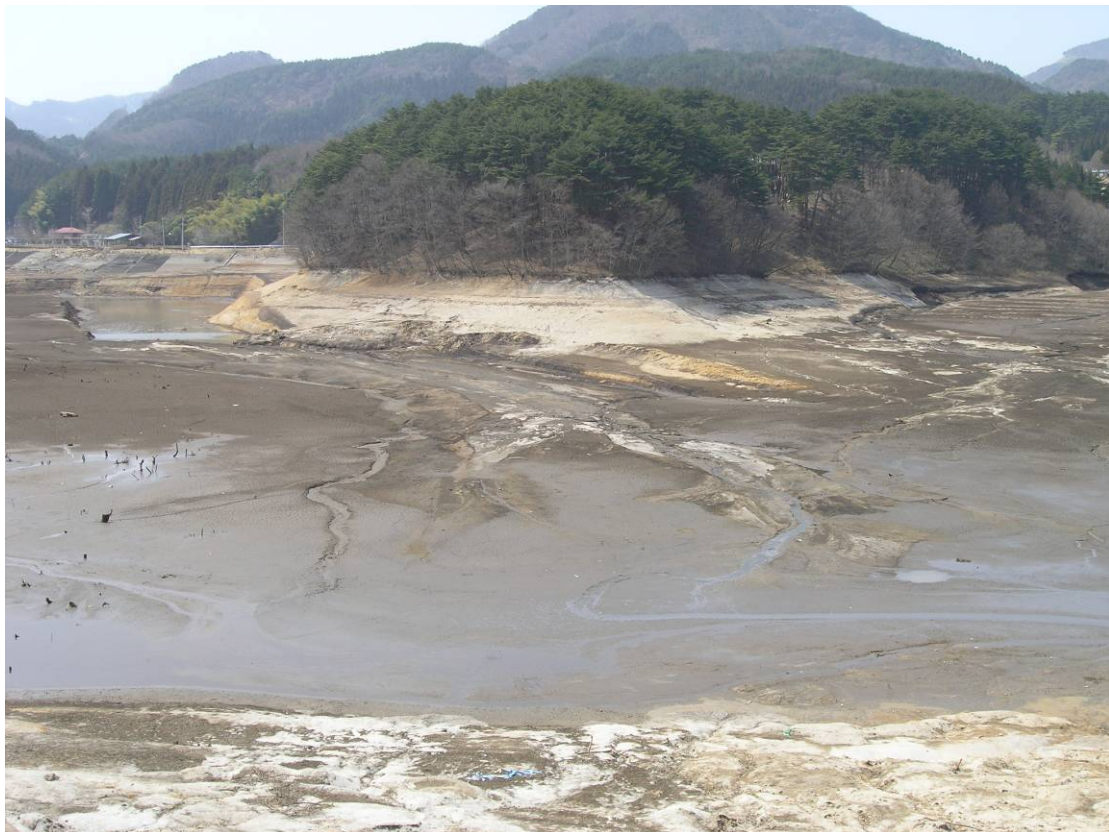
Fig. 40 Empty reservoir of Fujinuma Dam in Sukagawa City of Fukushima Prefecture

Fujinuma earth dam (Fig. 40) in Sukagawa City was constructed from 1937 to 1949. Its height was 17.5 m and the slope gradient was 1:2.5 on the downstream side, while 1:2.8 on the reservoir side. Being of uniform cross section, this dam was probably not well compacted because modern compaction machine was not available in those days. There were two dams here and No. 1 Dam was eroded and breached (Fig. 41a) and caused flooding of 1.5 million cubic meters of water. No. 2 Dam failed towards the reservoir but did not breach (Fig. 41b). The flooding torrent rushed downstream from No. 1 Dam through a narrow small valley (Fig. 42) and attacked a village (Fig. 43) to destroy houses where 8 people were killed.

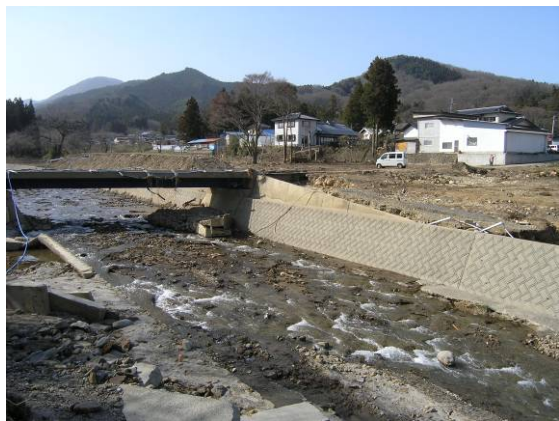
Fig. 43 Village attacked by flood
